# Phase 2 Site Investigation Report Bignor Street Park, Cheetham Hill

## Prepared for Conlon Construction Ltd

July 2023

10/2204/002 Rev. 02

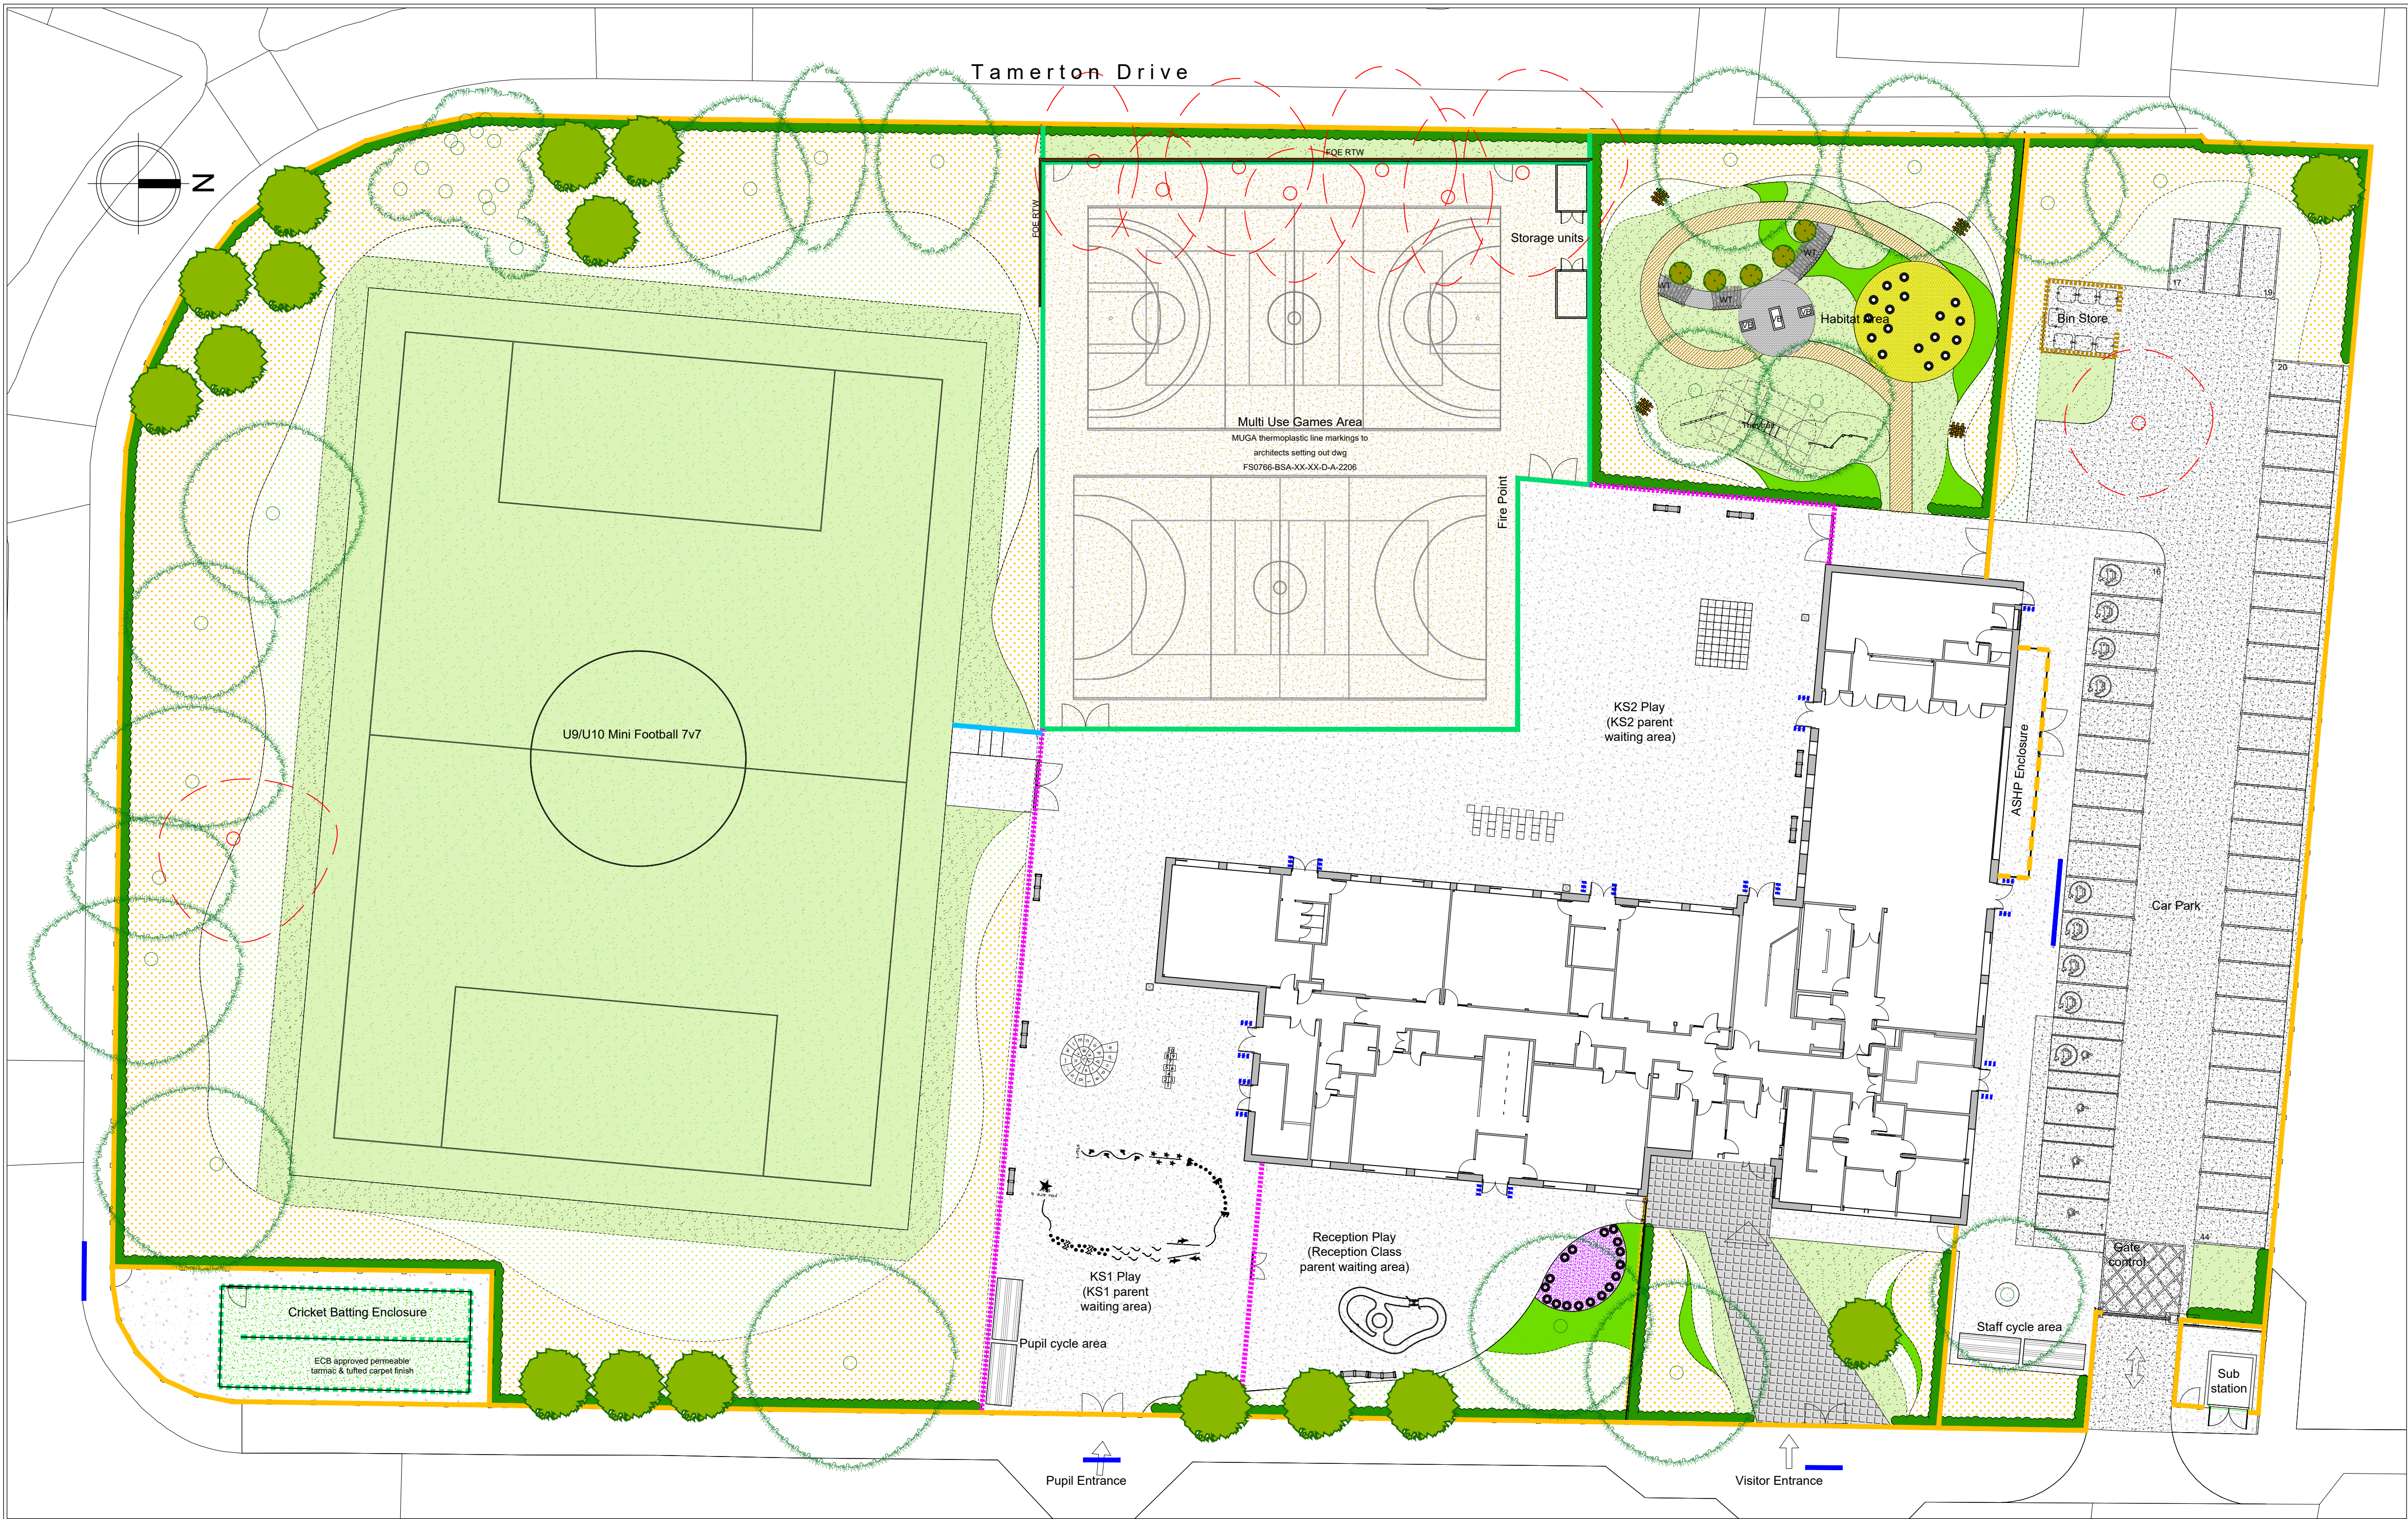
The areas requiring clean soil cover are referred to as "*amenity turf*", "*sports turf*" and "*ornamental shrub planting*" as shown on the Savill's Landscape Masterplan drawing presented in Appendix I. Areas of wildflower seeding and tree root protection zones are excluded given these areas will remain undisturbed and to avoid potential damage to the existing tree root systems.
