## Heritage statement

### 139313/FO/2024 Hollinwood Workshop, Clayton Street, Manchester,

in support of Application for Change of Use 139313/FO/2024

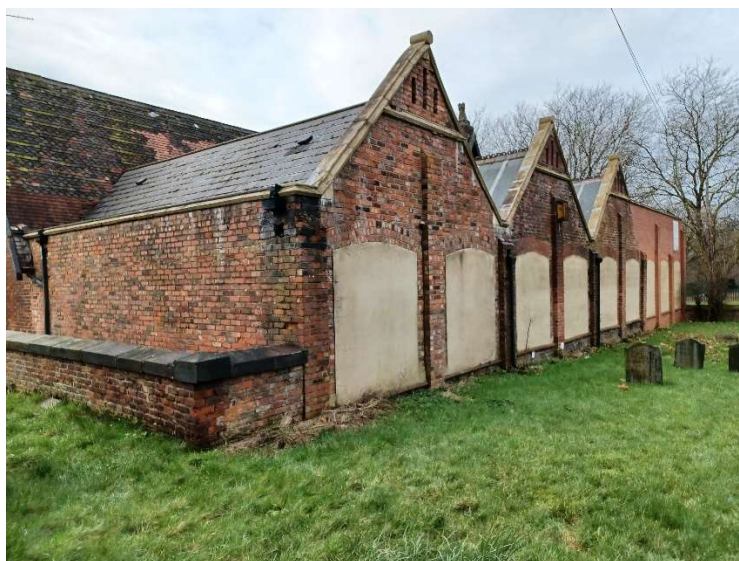
1. Photo of north elevation taken from Church of Cross grounds

North Elevation. It is proposed to reopen the window apertures to the north elevation and install double glazed openable windows to this elevation. Though no photographs or plans exist of this elevation, the window installed will be designed in a sympathetic manner to the local listed buildings using natural Wood frames, installed, and supplied by a local craftsman. These windows are required to allow natural light into the north elevation of the building and will be partially frosted on the lower panels. We have the local Diocese support in this installation.

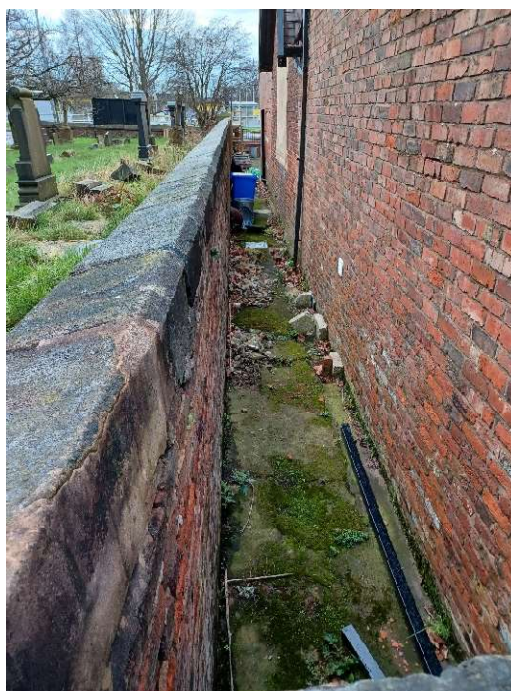
2. Photograph depicting planned location of air conditioning condenser and difference in ground levels.

Installation of air conditioning condensers at ground level, due to the different ground levels, Church patrons and other members of the public will not be able to see or hear the condenser . See attached elevation plans and photos for further explanation

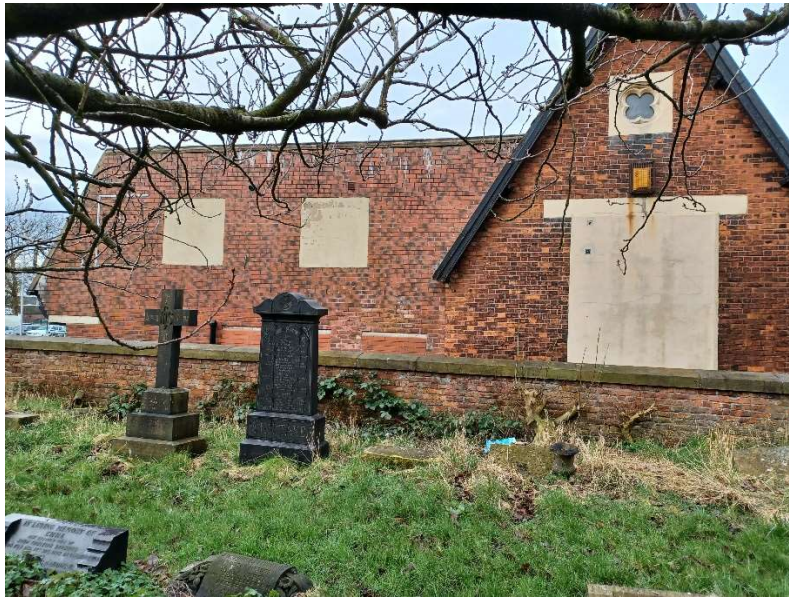
3. Photograph of east elevation from Church grounds

East elevation to old Church hall its proposed to replace the existing single glazed metal framed windows with wooden double glazed units. Please see attached elevation plans and photos. Dependant on Budget or repaired and redecorated with internal secondary glazing.

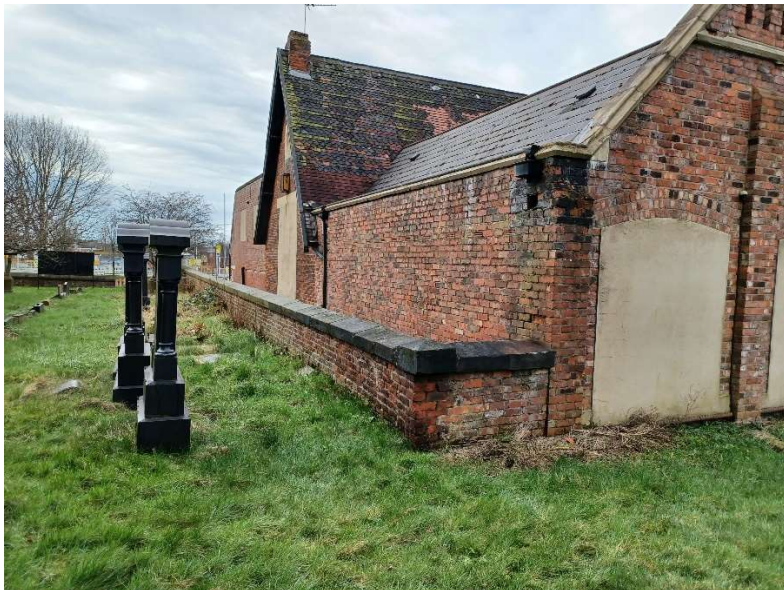
4. Photograph of east elevation from Church grounds.

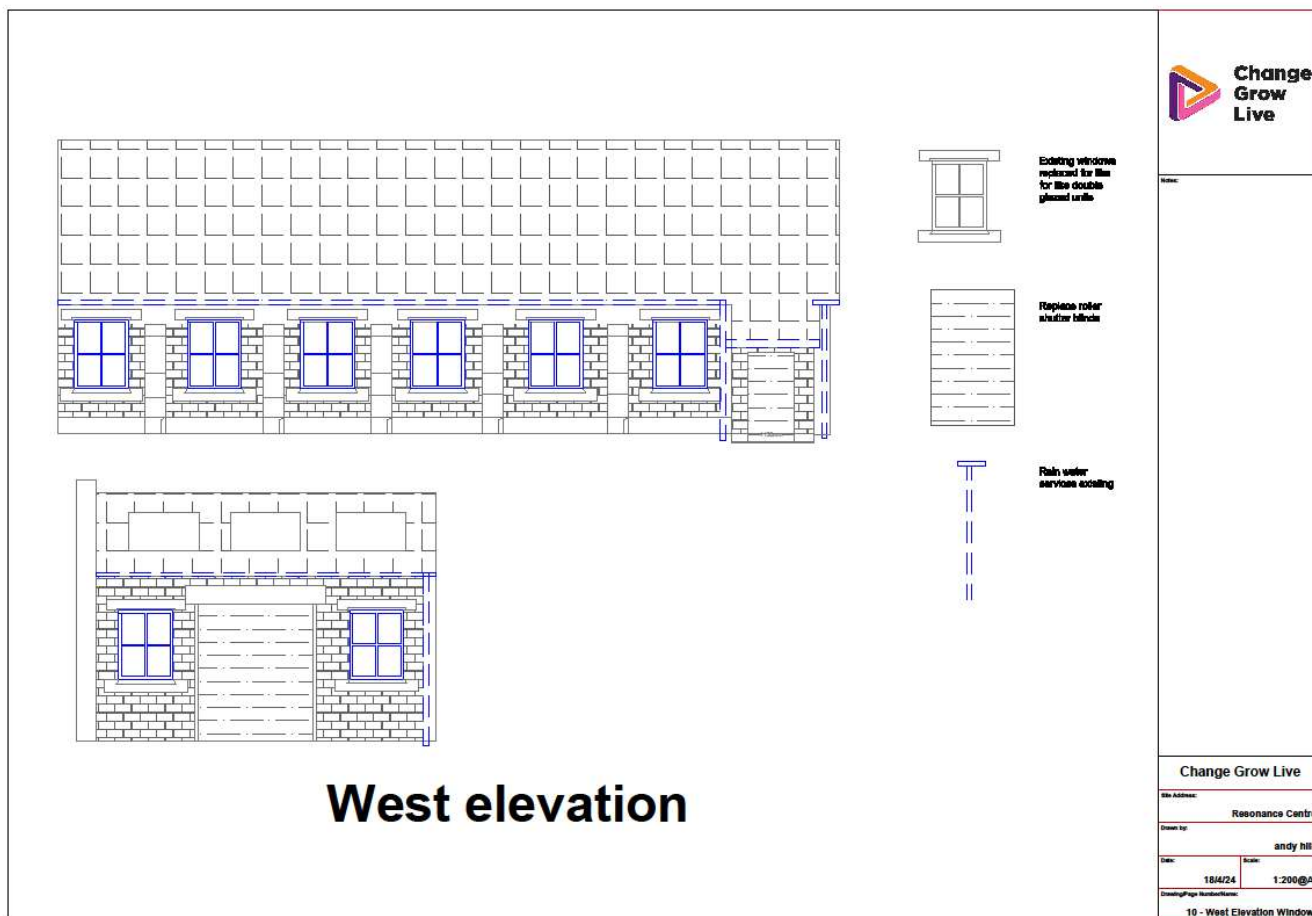
## West Elevation

Copy of Plans attached to this application.

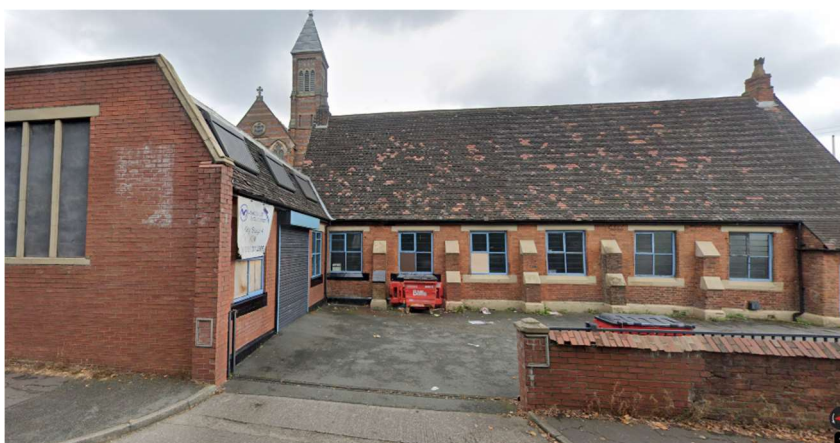
5. Photographs of West Elevation depicting planned window replacement.
