# Phase 2 Geoenvironmental Investigation & Assessment

Oakwood Lodge, Wythenshawe

| <b>Report Title:</b> | <b>Oakwood Lodge, Wythenshawe<br/>Geoenvironmental Investigation and Assessment</b> |
| <b>Report Reference:</b> | <b>8928G-WML-00-XX RP-G-0002</b> |

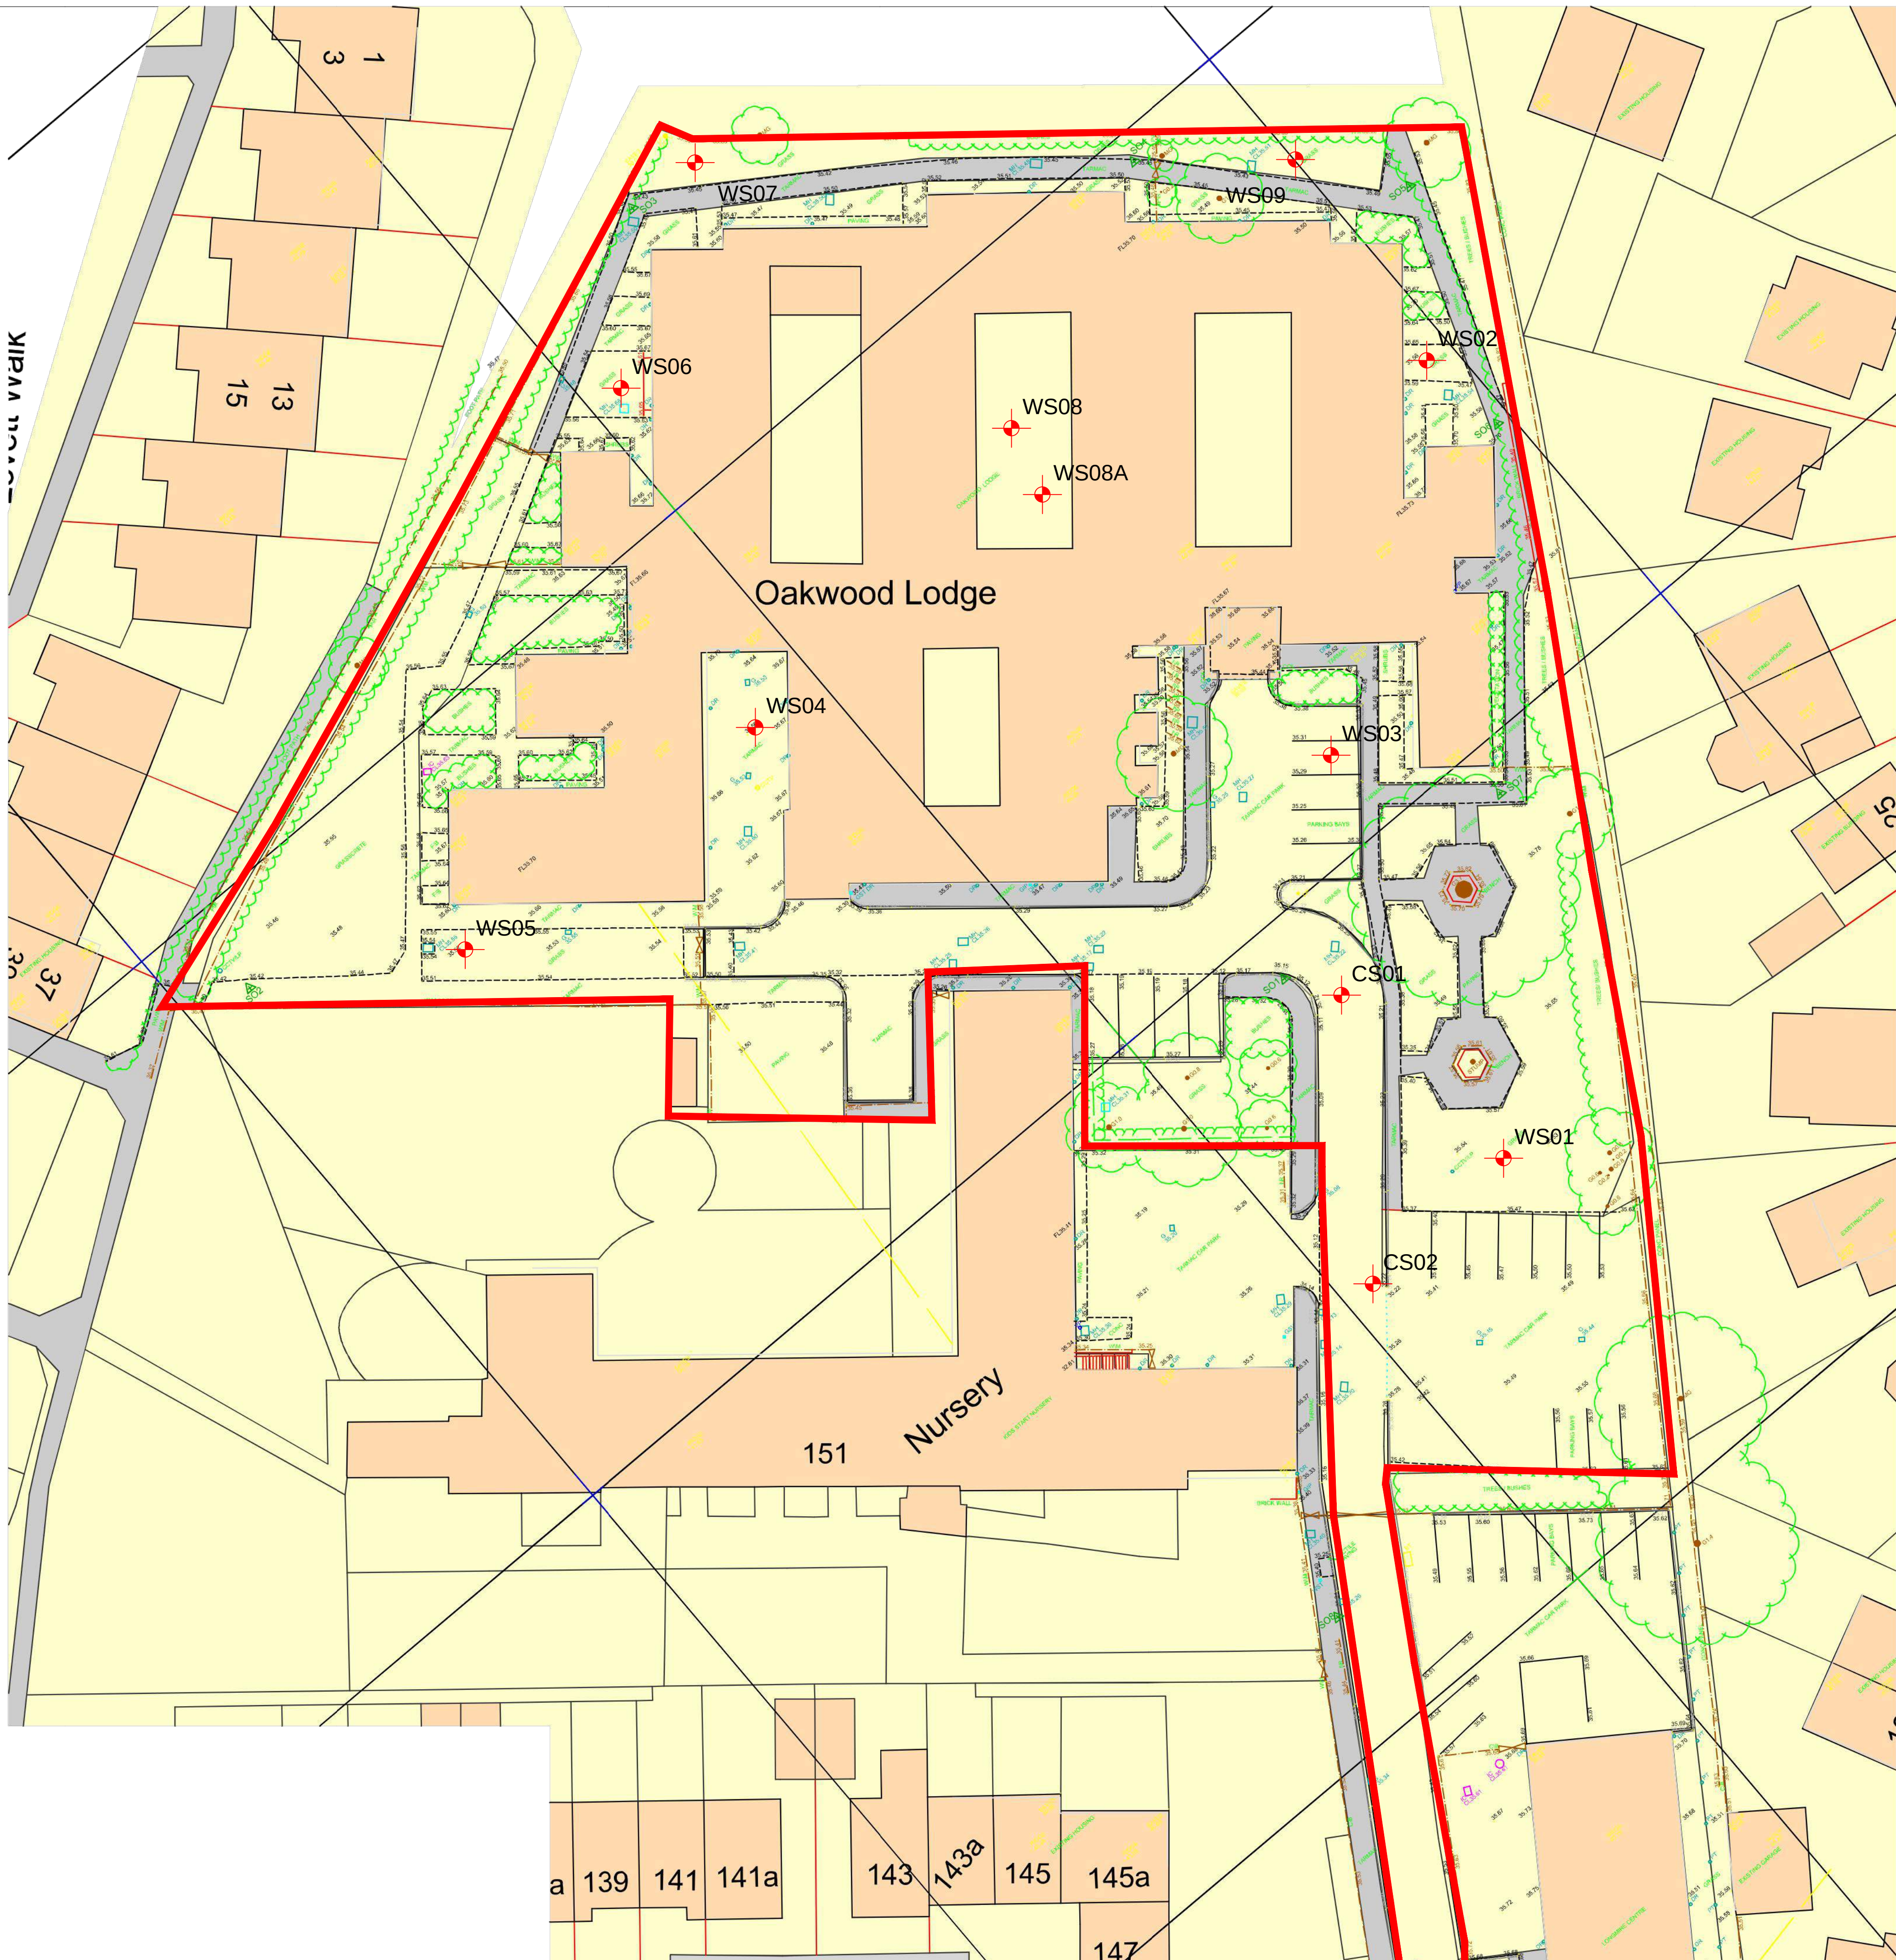
site plan 1:500

2b4p house @ 83m<sup>2</sup>  
14No

3b5p house @ 96m<sup>2</sup>  
6No
