# Great Marlborough Street Manchester Preliminary Bat Roost Assessment & Nesting Bird Check

*Prepared For: Tier Projects Ltd.*

*Document Reference: 10184.001*

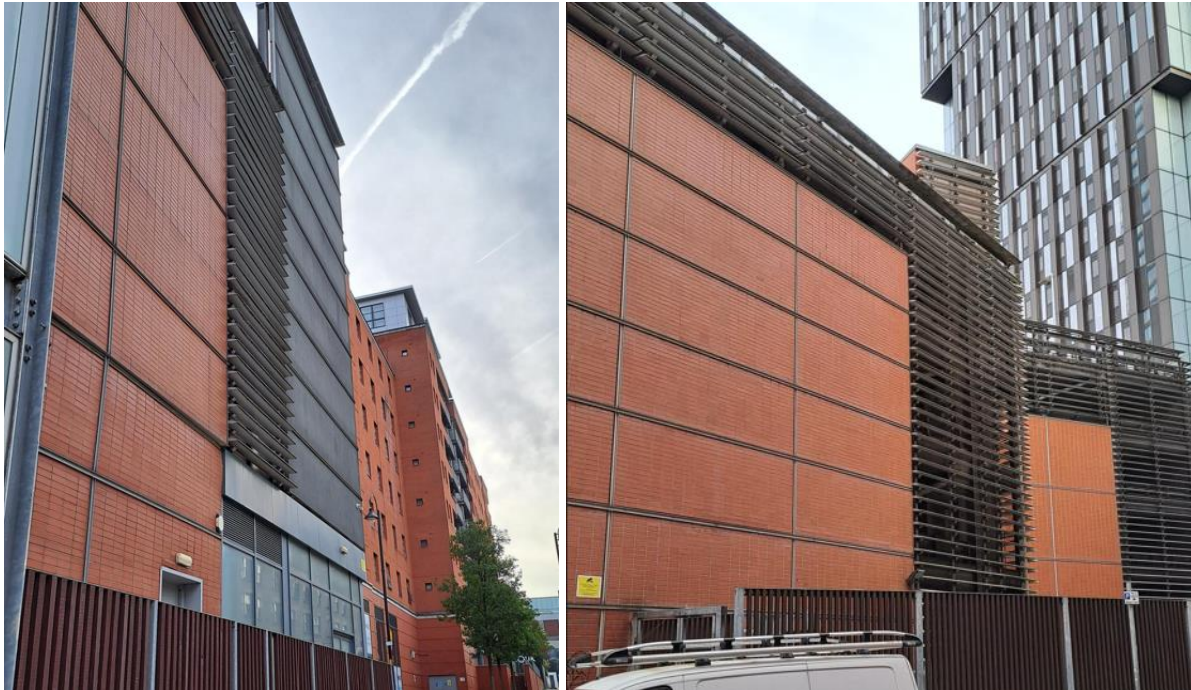
- 3.1 The car park building on site is a four-storey brick building, with one floor below street level and an open-air top floor concrete car park on the roof. There are two brick faced structures on the top floor that house the staircases and lift access for all levels. The building on all aspects is made up of part red brick facing, concrete cladding and fixed louvre screens that allow air to penetrate the building from all aspects. There is a small security building outside of the entrance to the main car park building that is brick built with a flat bitumen roof. Within the site boundaries, vegetation is limited to two window boxes on the north aspect of the building containing a number of small buddleia plants. A small number of young street trees are present to the east and the River Medlock lies adjacent to the east, but it culverted beneath the site.

*Figure 2. External views of the building from the west and south aspects.*

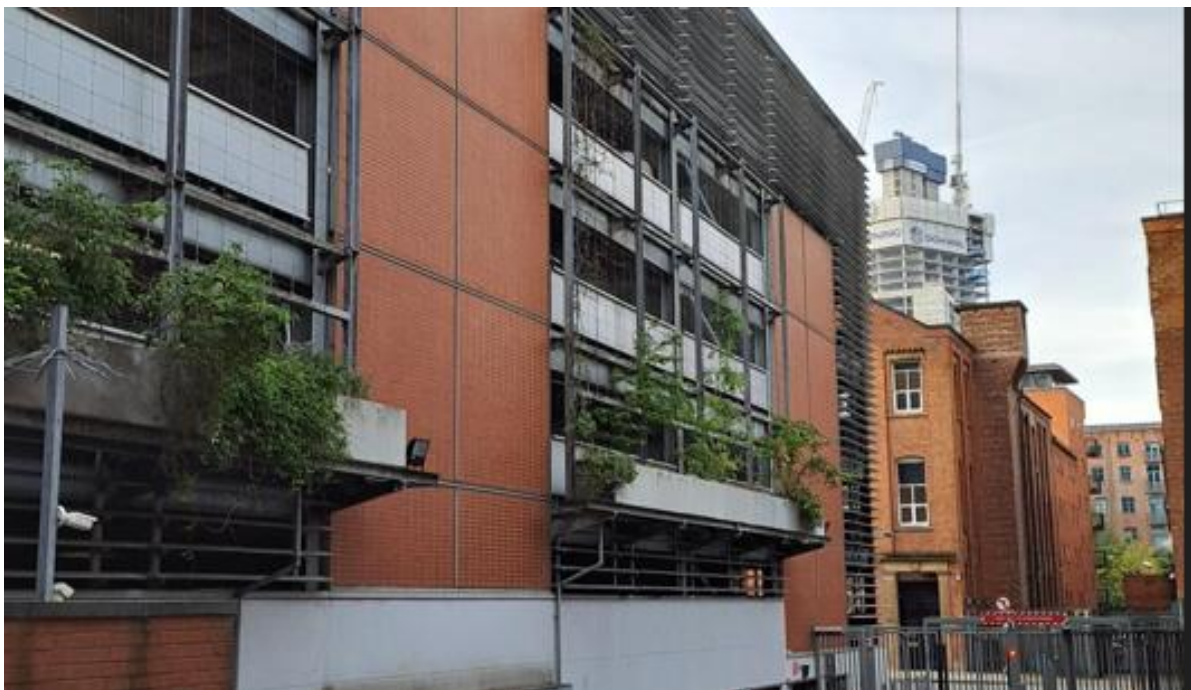
*Figure 3. Buddleia in planting boxes, north aspect.*

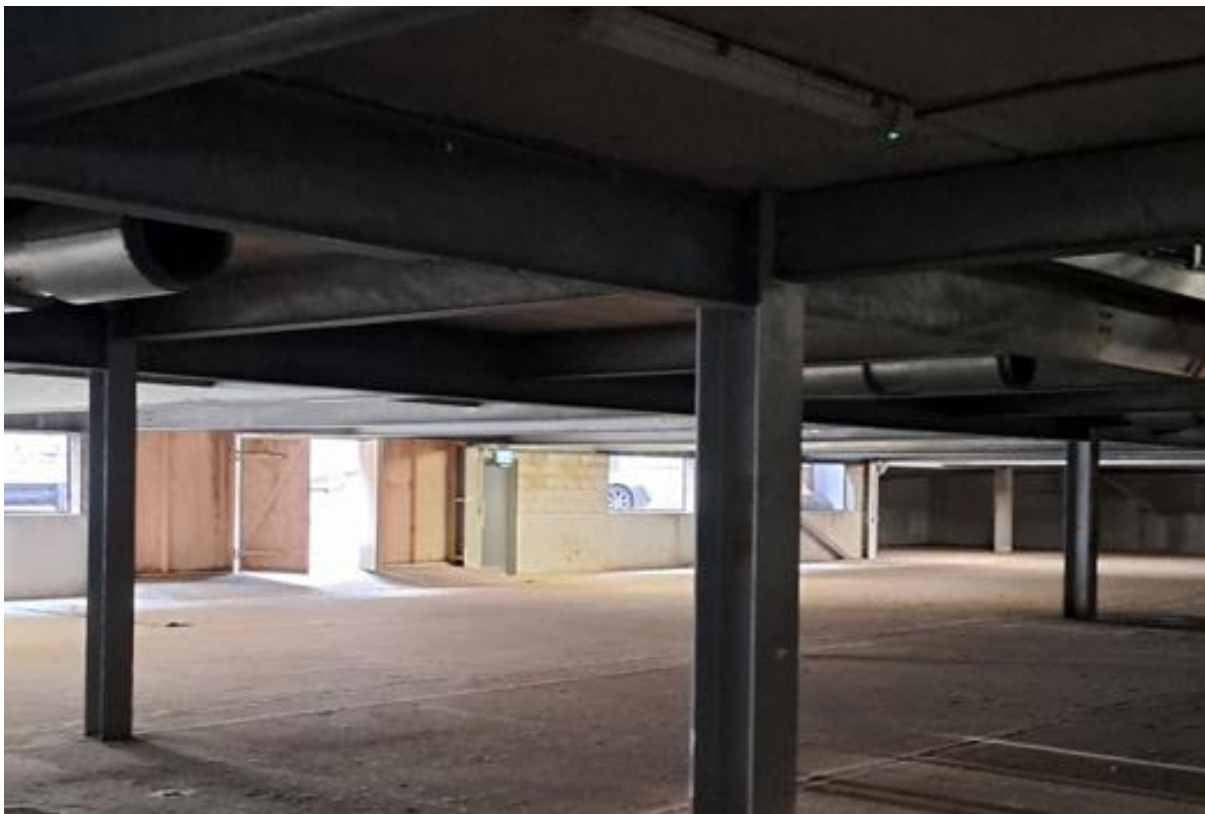
- 3.4 The lower ground level of the car park is less disturbed as it is currently unused. No staining or droppings indicative of current or historic bat presence was recorded during the survey. Light leak is present on the west and east aspects of the lower ground level where open window spaces are present, these open areas also allow wind and rain to penetrate the lower ground area, temperatures are likely to fluctuate. Evidence of historic pigeon nesting was present in the lower ground level as well as all above ground levels of the car park building.

*Figure 5. Lower ground floor of car park building light leak.*

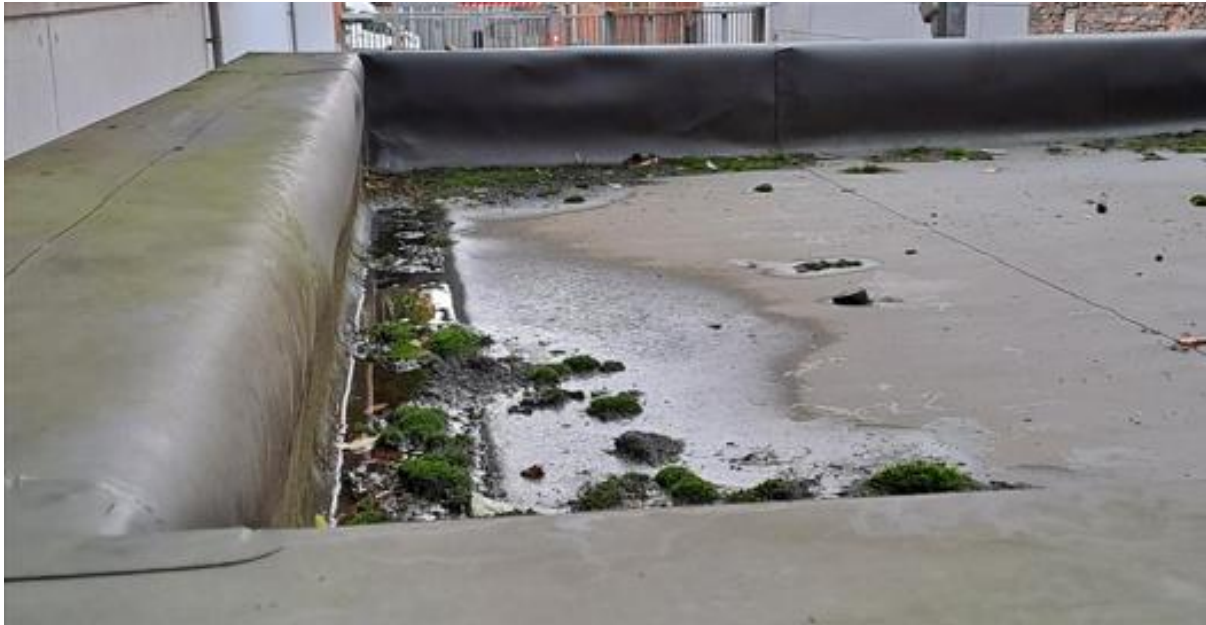
- 3.5 The separate small security building is a one storey brick structure with a flat bitumen roof and no roof void. The bitumen lining is tight to the brickwork, providing no entry point for bats and brickwork is in good condition, presenting no crevice spaces.

*Figure 6. Flat bitumen roof of security building.*

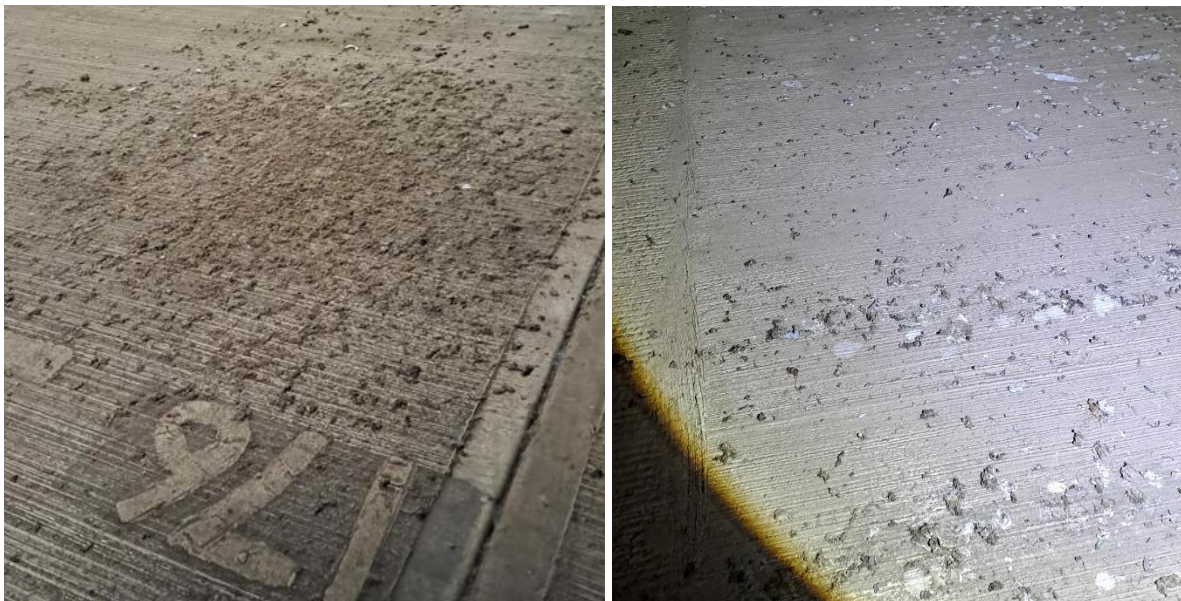
*Figure 7. Evidence of previous bird presence on multiple levels.*

- 4.5 The multistorey car park does provide suitability for nesting birds, evidence of previously nesting feral pigeons was observed on several storeys during the survey. It is recommended that any site clearance or demolition works are undertaken outside of the nesting bird season of March – August inclusively.

- 4.6 If it is not possible to complete works outside of the nesting bird season, a nesting bird check must be carried out by a suitably qualified ecologist no more than 24 hours prior to the works commencing, to establish that no active bird nests will be disturbed or destroyed by the works. If active nests are found all works should be delayed and/or a protective buffer should be retained around the nesting area until the chicks have fledged. The length of time and size of buffer is species-specific.
