**WAG**

15 Jan 2024

Identified 26 Issues

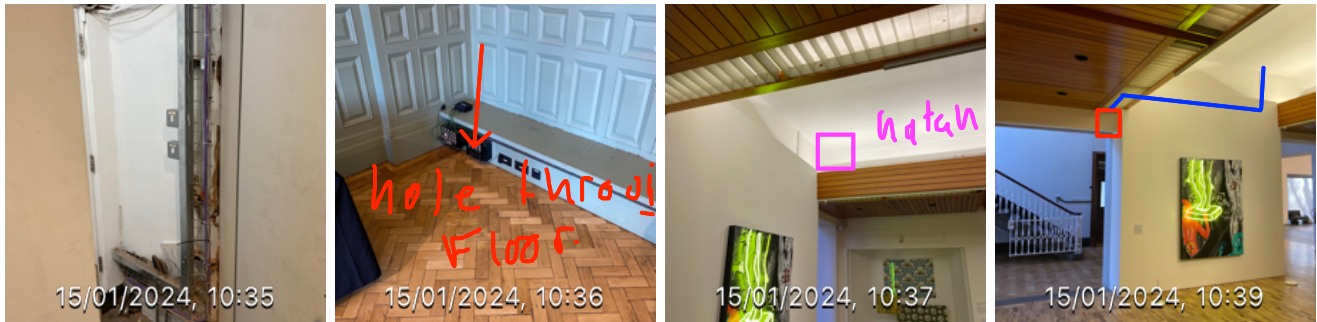
AP 014

Route cables from data cab on exist containment into bench seating in grand hall.  
Remove top from bench seating a drill hole through to the floor below.  
Install new hatch within plasterboard ceiling below. Hatch required as there is a void of approx 1.5m between floor above. Some timber slats will need to be removed to install hatch.

Cables to be routed via hatch into existing cable riser, then into new mini trunking hidden behind exhibit wall.

AP to be moved to opposite side of door opening for ease of cable routing.

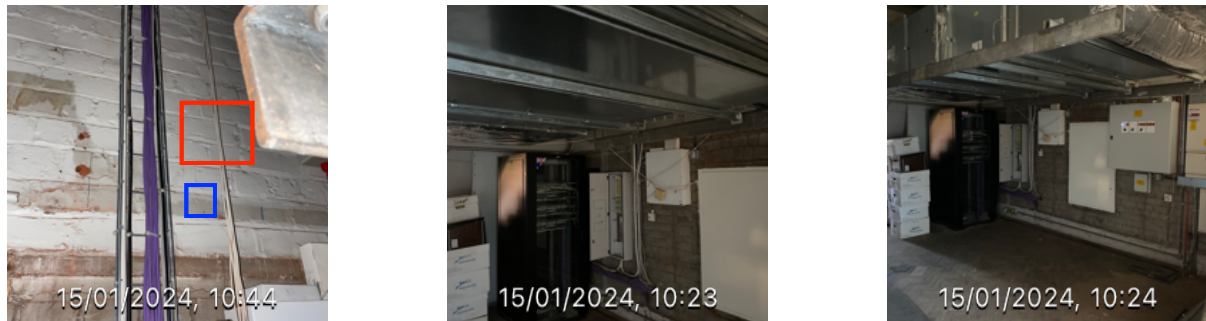
AP 202

Cables routed on existing basket tray. AP and data outlet to be mounted adjacent.  
Note this is in a Plantroom.

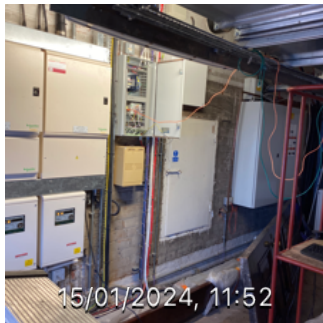
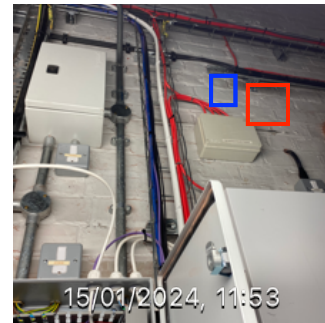
AP 201

Mount AP and data outlet adjacent existing basket tray.  
Cables routed on basket tray back to data cab.  
Note this is a Plantroom.

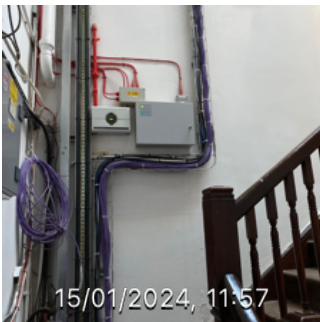
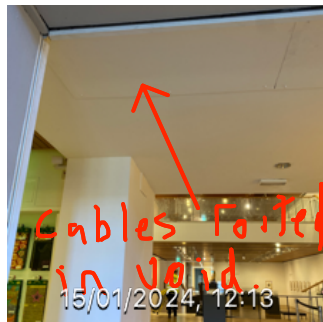
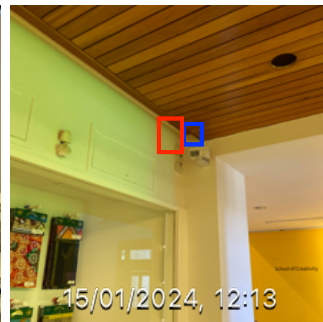
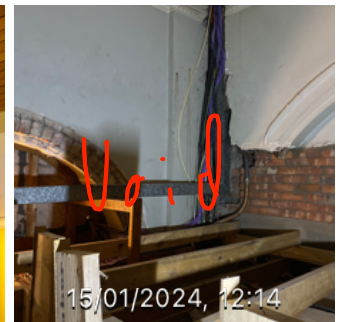
AP 017

Cables drop from cab on existing basket tray to ceiling void below.  
Cables routed within void to AP position.

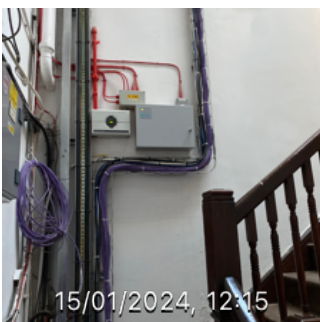
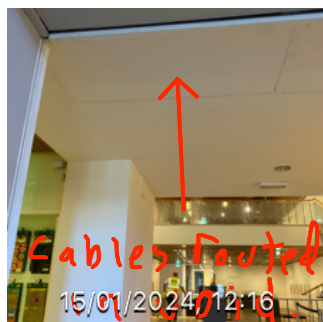
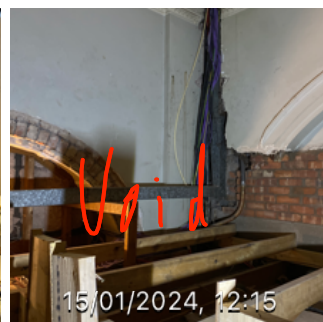
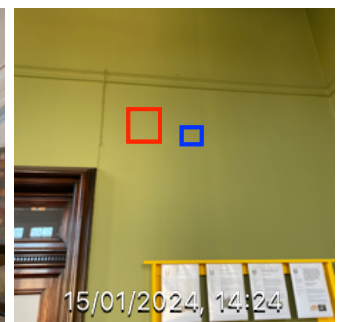
AP 018

Cables routed from cab on existing containment and drop to the ceiling void below.  
Cables to be routed through void to AP location.

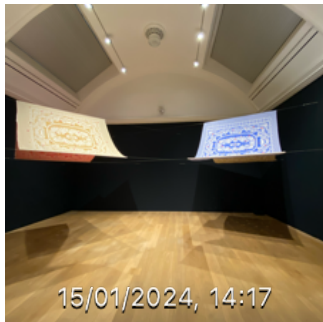
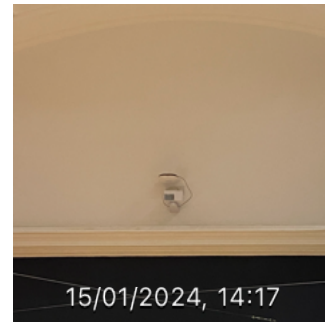
AP 005

AP already installed. To remain in existing location.

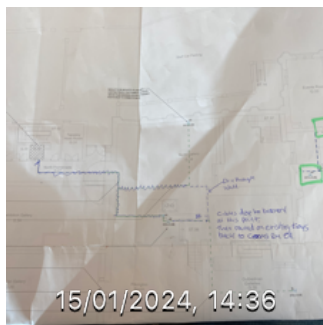
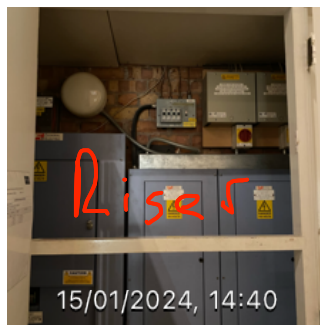
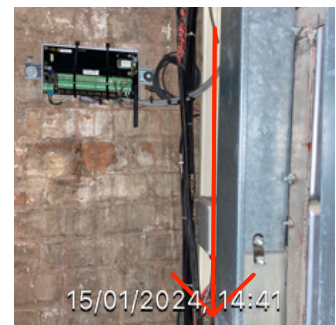
AP 011 & AP 013 Revised route back to data cab.

Cable to be routed into the riser and drop down to basement.  
Once in basement cable will be on existing containment back to cab 0A.

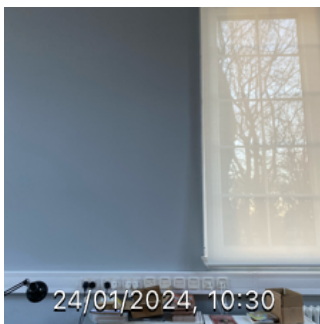
AP 001

AP no longer required to move.  
To remain in existing location.

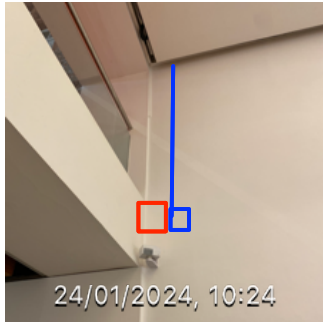
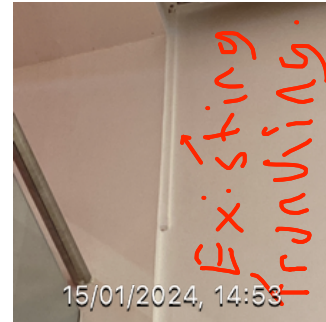
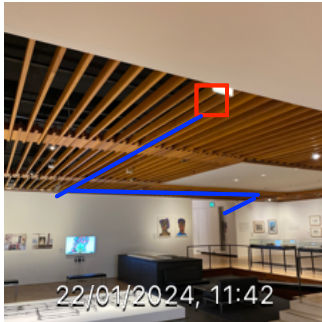
AP 002

New PVC conduit to be installed flush into existing wall.  
 Wall to be patched and painted after conduit installation.  
 New cables to be routed into void above back to comms room 2B.  
 AP to be mounted above existing intruder alarm detector.

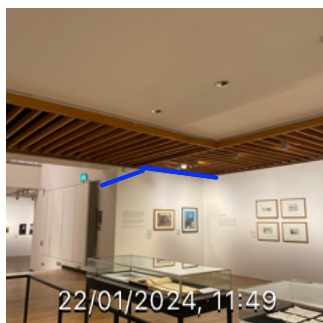
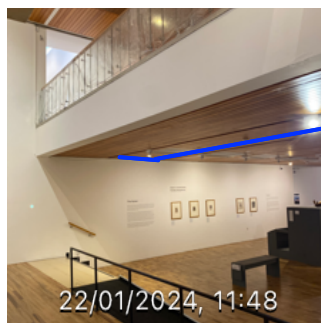
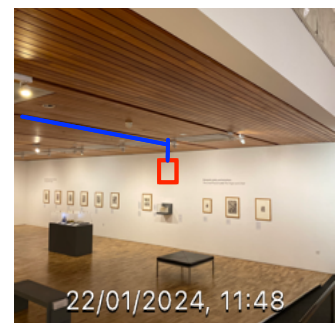
AP 011

New PVC black conduit routed above existing wooden ceiling back to existing riser. Note, section of wooden ceiling will need to be removed to allow installation of conduit. Cables will drop to basement within riser to pick up existing containment routed back to comms rm 0A.

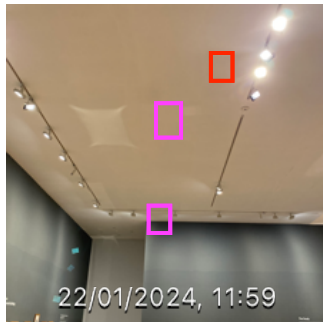
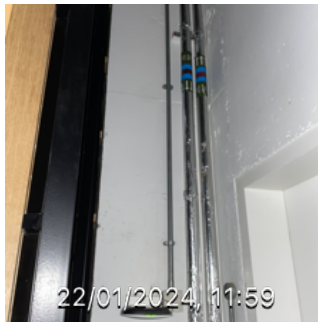
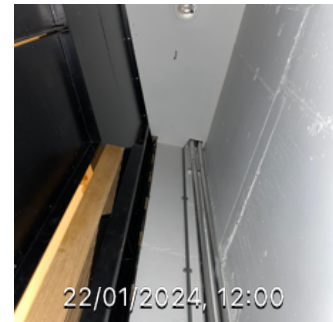
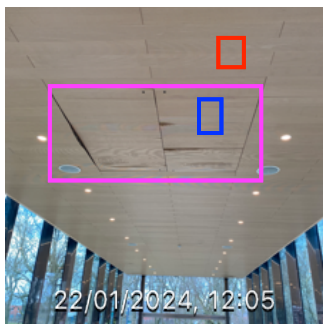
AP 008

Cables from existing AP in cupboard to be pulled back to centre of gallery ceiling.  
Access hatch's will need to be cut into plasterboard ceiling to allow cables to be pulled back.  
Hatches if required can be patched up and painted out to match existing decor.

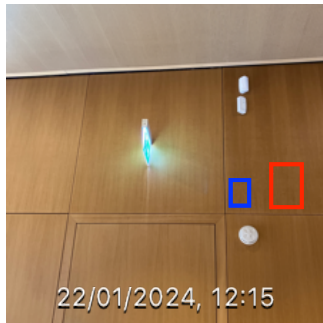
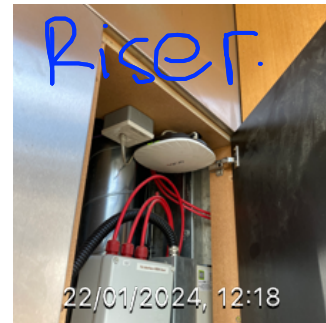
AP 003

Cut 1g back box into panelling for data outlet. Drill through back box into riser behind.  
Reroute existing cables.  
Install AP next to back box.

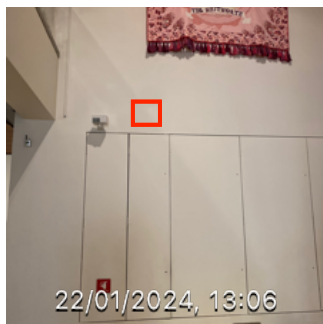
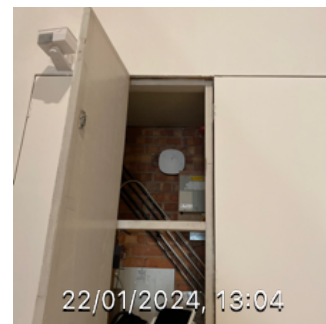
AP 013

AP to be relocated from inside riser to outside riser.  
Existing cable to be reused.

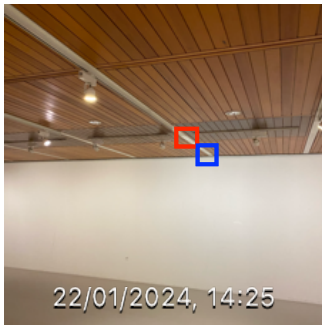
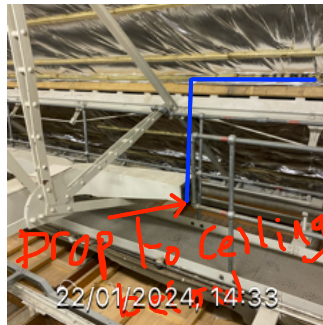
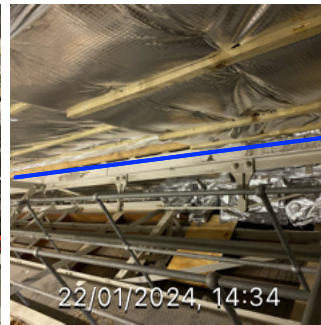
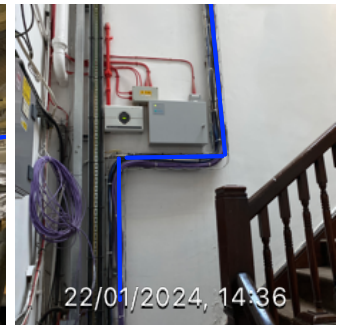
AP 0502

Mount AP at the end of existing lighting track.

Cables to be routed in new PVC conduit from the gantry behind back stair core then onto existing containment back to comms room 2A

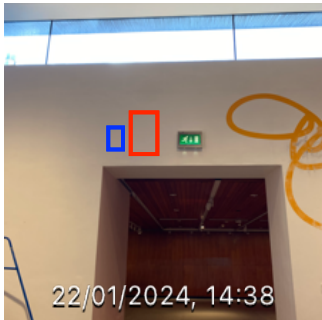
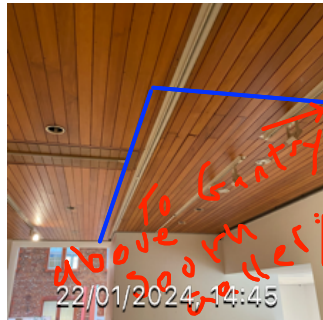
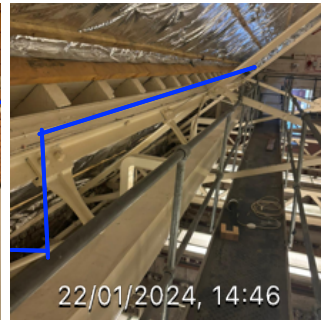
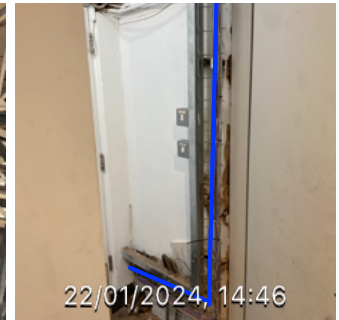
AP 0503

Mount AP and data outlet adjacent exit sign. Drill through back of data outlet into ceiling void behind.

Cables to route above wooden panelled ceiling in new PVC conduit. Note some panelling will need to be removed to allow conduit installation.

Conduit to route through existing hole with ducting to gantry above south gallery. New conduit in gantry back to existing containment within stairwell back to comms rm 2B

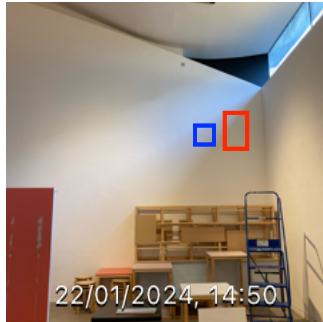
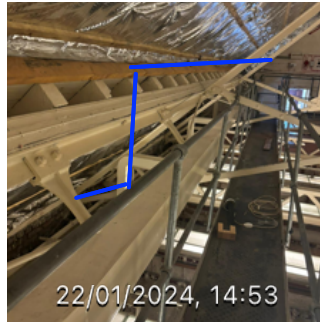
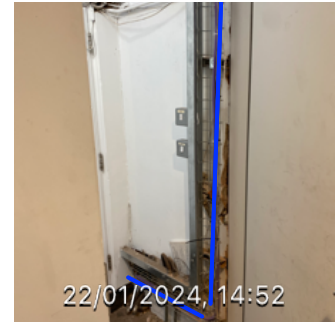
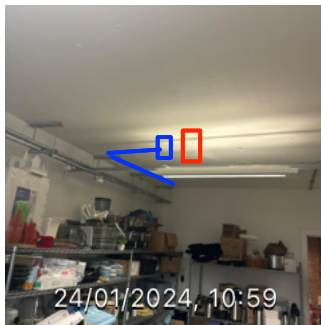
## AP 0503 Alliterative Route

Move AP to side wall. Drill out back of data outlet back box direct into gantry above south gallery.

New PVC conduit in gantry back to existing basket tray in stairwell and up to comms room 2B

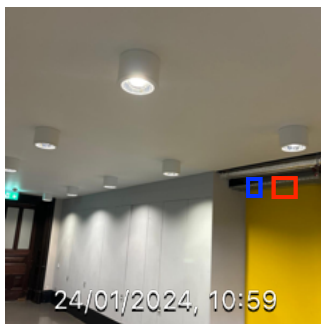
## AP -103

New PVC surface conduit installed from existing dado riser, run alongside existing containment to AP position.  
Cables run back to comms room 0A.

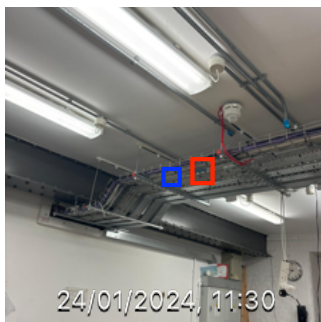
## AP -101

AP to be mounted to underside of existing containment adjacent the riser.  
Cables in back to comms room 0A

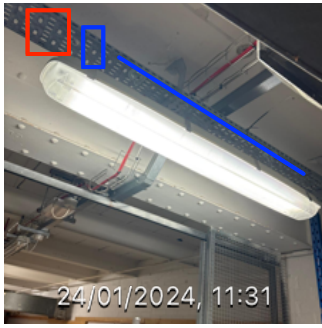
## AP -114

AP to be mounted on underside of existing containment.  
Cables run back to comms room 0A

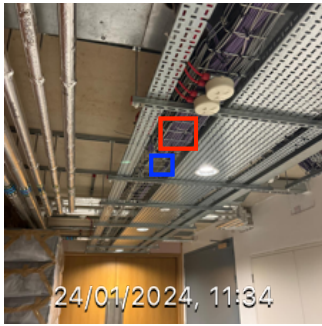
AP -116

AP mounted to underside of existing tray. New PVC conduit installed on tray back to dedicated data basket for segregation of cables.

Cables run back to comms room 0A

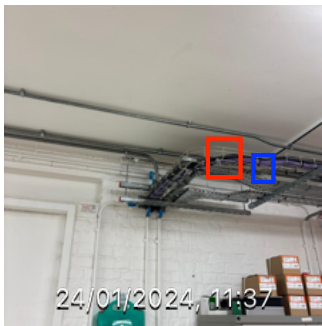
AP -112

AP to be mounted to underside of existing containment. Cables routed back to comms room 0A

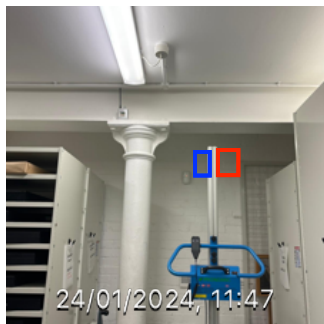
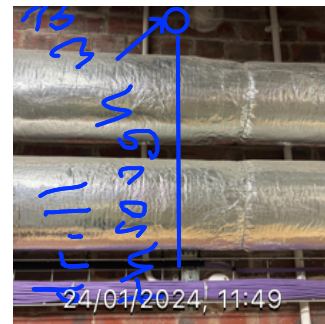
AP -107

AP to be mounted high level on the back wall.

Cables to be routed from behind and run back to comms room 0A.

1.5m of new PVC conduit from existing data basket on back side required to serve AP.
