A2 Site Investigation Limited were appointed by BG&E to undertake a geotechnical ground investigation 6 Deansgate, Manchester M3 1RH. This report describes the work undertaken and presents the findings to date.

The site is located within the Central Retail District of Manchester City Centre, Manchester, M3 1RH. The site is roughly triangular with Deansgate to the east, River Irwell to the west, Victoria Bridge Street to the north and Blackfriars Street to the south. The site forms part of a wider development associated with the existing hotel. The River Irwell is situated within a man-made channel understood to be supported by concrete and masonry walls.

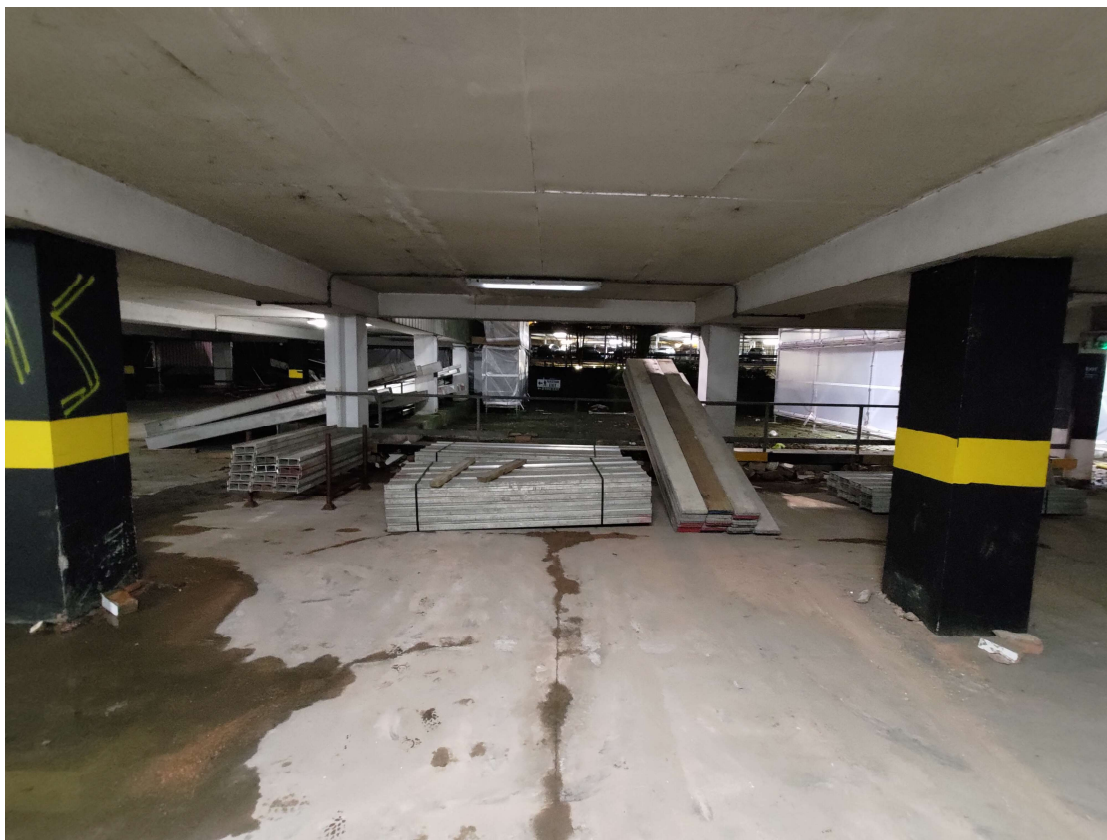
**Figure 7.4.1 Possible RBH102 location with obstruction.**

During the site walkover, all previous installed wells at the basement car park level were identified with the exception of RBH102, which at the time of the walkover had heavy pallets, possibly obstructing the headworks as shown in the photo 7.4.1.
