## Archaeological Evaluation

Downley Drive, Ancoats,  
Manchester

Rowlinson Constructions Ltd

SA/2022/89

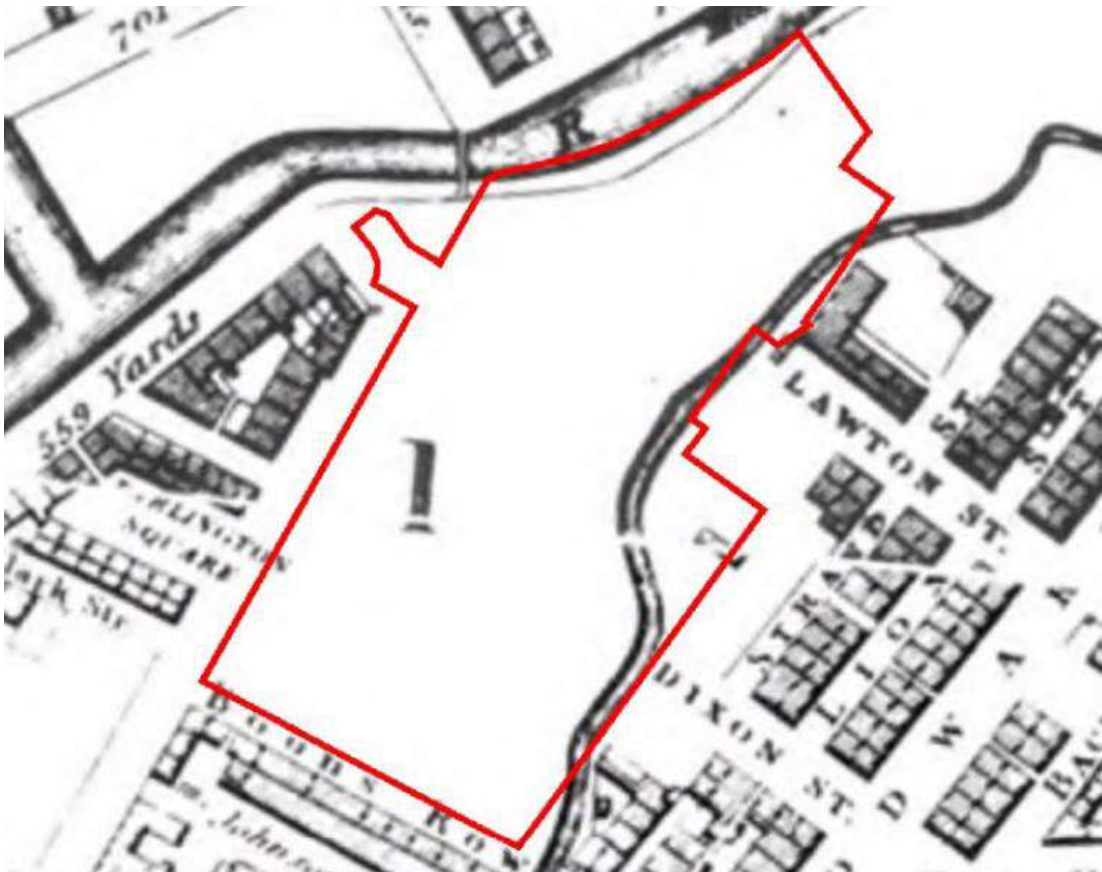
Plate 4: Site boundary superimposed onto Bancks & Co.'s map of 1831

- 4.5.8 The Banks & Co map of 1831 details the development that continued around the edge of the site with the creation of Pott Street, which ran along the western side of

the site, and Boons Row, which bordered the southern side (*ibid*). Dixon Street and Lawton Street ended at Shooters Brook on the eastern side of the brook (*ibid*). Running parallel to the brook a small new street of back-to-back housing called Woldens Strand was also built (*ibid*). The small reservoir built to provide water for New Islington Mill seen on the Bancks & Co's map of 1831 (Plate 4) was superseded and on the Ordnance Survey Town Plan of 1851 the brook was the most significant geographical feature on the site at this time (*ibid*).

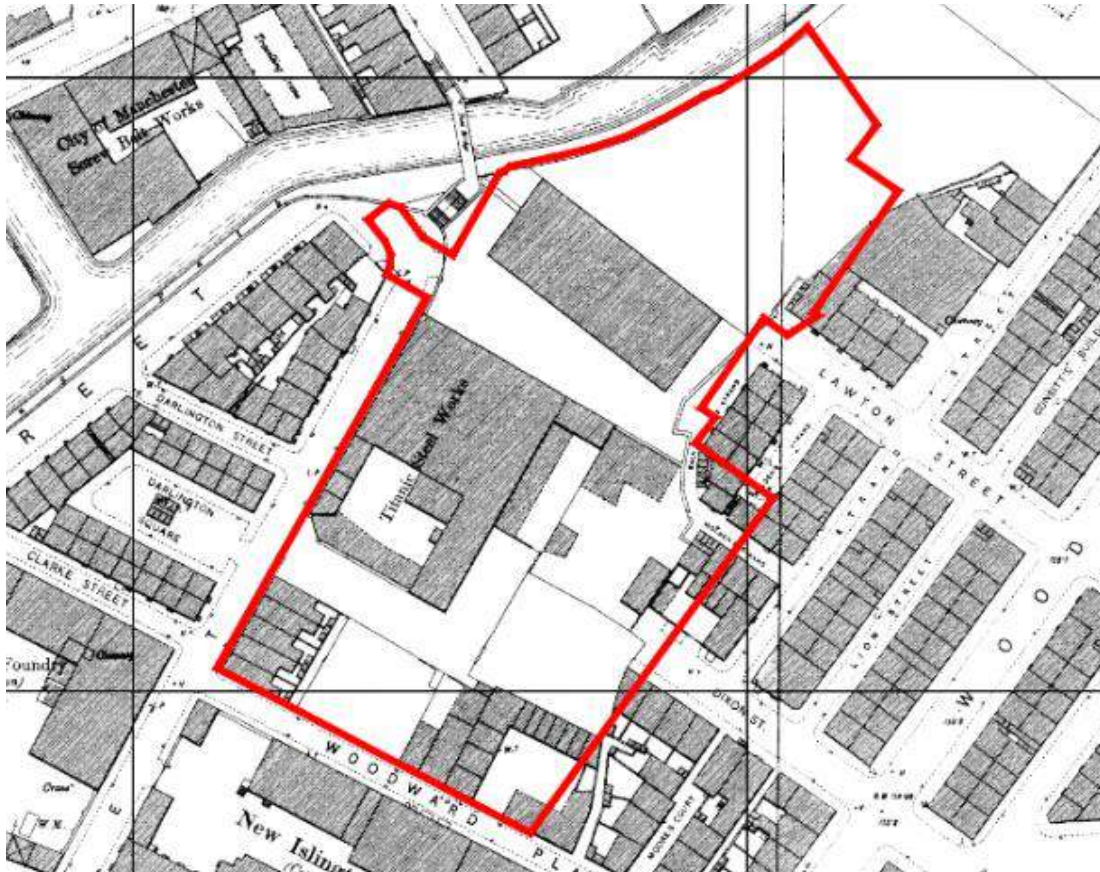
Plate 6: Site boundary superimposed onto the 1:500 Town Plan of 1891

- 4.5.10 The Ordnance Survey Town Plan of 1891 shows, for the first time, five houses in the south-western corner of the site fronting on to Pott Street, and in the south-eastern corner a series of buildings were also built (*ibid*). It is unclear if these were residential, as no record could be found in the census, and no street name is listed on the map (*ibid*). It is possible that they were an extension of the New Islington Mill or were part of the new industrial buildings on the site (*ibid*). The major change to the site by 1891 was the arrival of the Titanic Steel Works (*ibid*).

7.1.2 The earliest structures recorded on site were a brick wall {001}, with built in brick arch, and wall {002}. These walls likely represent the remains of the foundry that became the Titanic Steel Works. When superimposed on the Town Plan of 1891 it is apparent that the wall with the brick arch {001} corresponds with the northern external wall of the foundry (Plate 6).

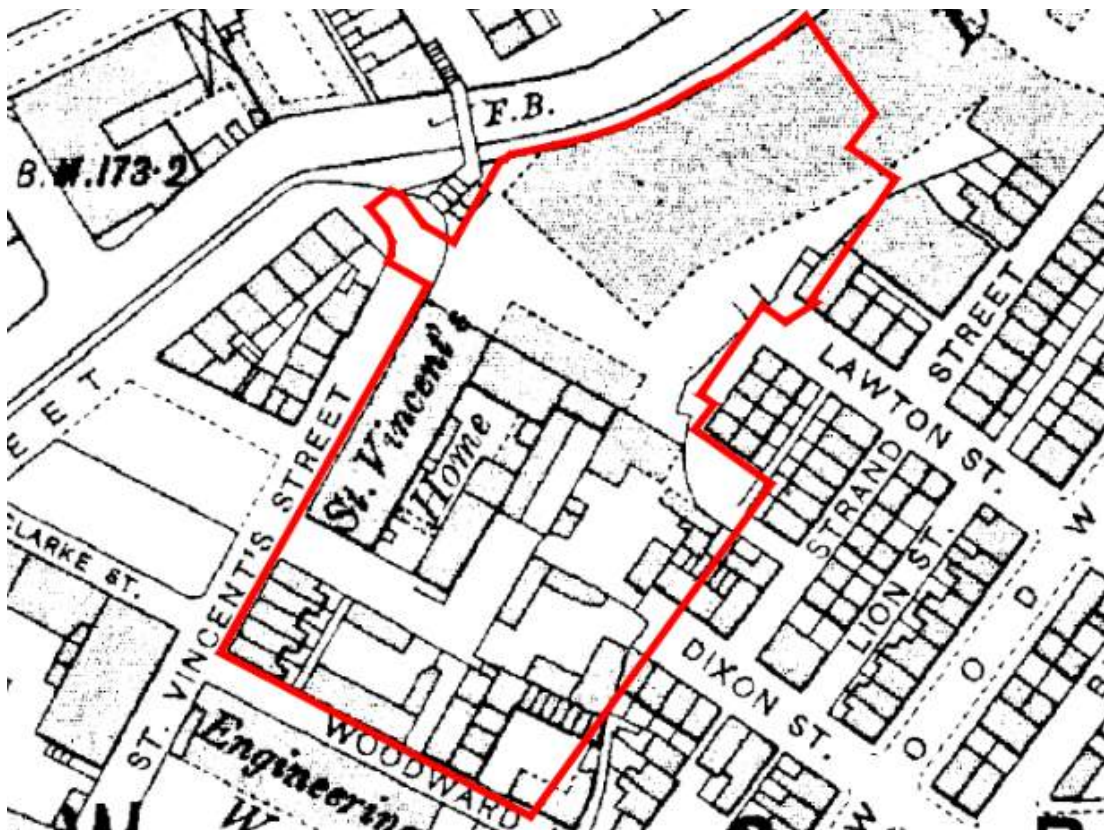
Plate 7: Site boundary superimposed onto the 1:2500 County Series map of 1908

- 4.5.15 By 1908, Ducie Sawmills, located to the north of the site, had expanded southwards (*ibid*). The timber stores of the sawmills were located within the site boundary (*ibid*).

The 1908 Ordnance survey map also shows the Titanic Steel Works had also been replaced by St Vincent's home (*ibid*). A plan of St Vincent's Home is held at the Manchester Archives (*ibid*). The entry in the archive for the plan, dated 1902, revealed that The Sisters of Charity were the owners of the site, and that the plans were for a Magdalen laundry that provided refuge for the destitute (*ibid*).

- 7.3.2 When superimposed with the County Series Map of 1908 (Plate 7) it is apparent that wall {009} corresponds with a northeast by southwest aligned internal wall within St Vincent's Home. It is likely that a northwest by southeast aligned wall {019} recorded in the southern part of the trench represents an internal wall within St Vincent's Home.

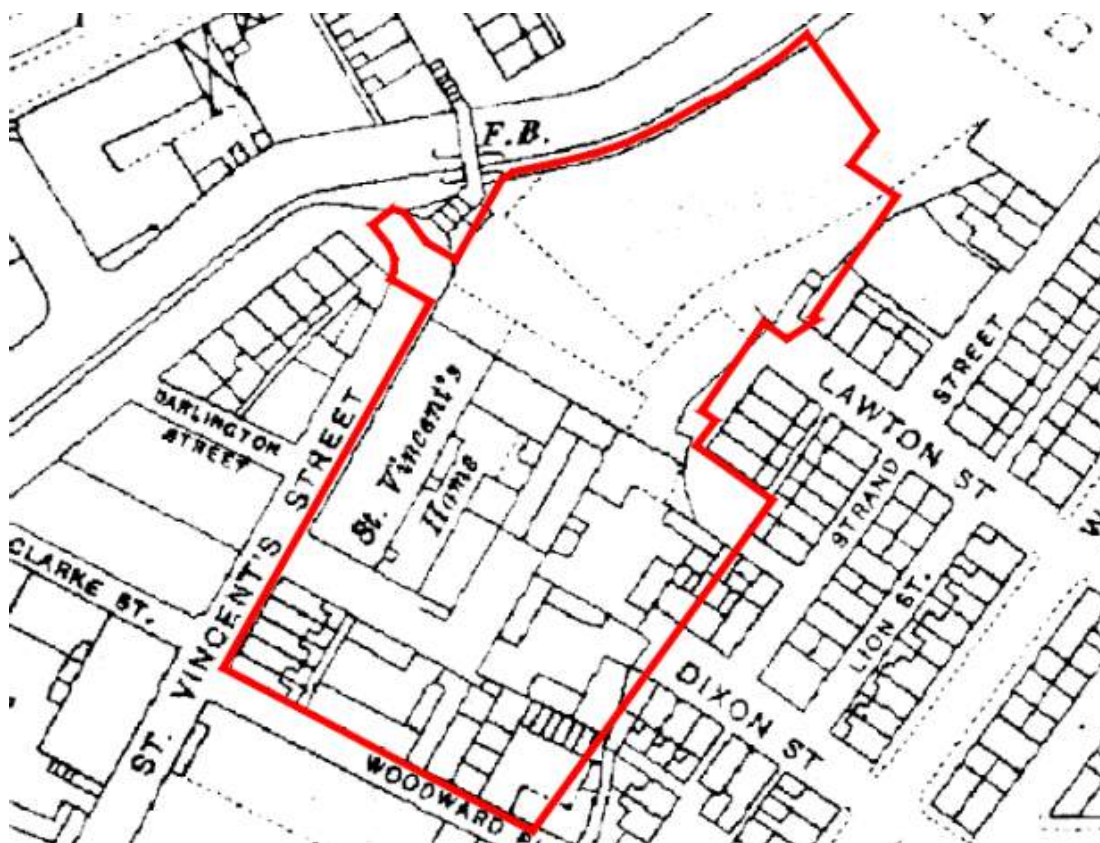
Plate 8: Site boundary superimposed onto the 1:2500 County Series map of 1922

- 4.6.1 The Ordnance Survey map of 1922 (Plate 8) shows that little changed on the site from the 1908 Ordnance Survey map (*ibid*). The St Vincent's Home was still present as was number 90 to 98 St Vincent Street (*ibid*). The buildings located in the south-eastern corner of the site remained also the same (*ibid*). The lack of census data for these buildings indicates that they were probably industrial and/or related to the operation of the home (*ibid*).

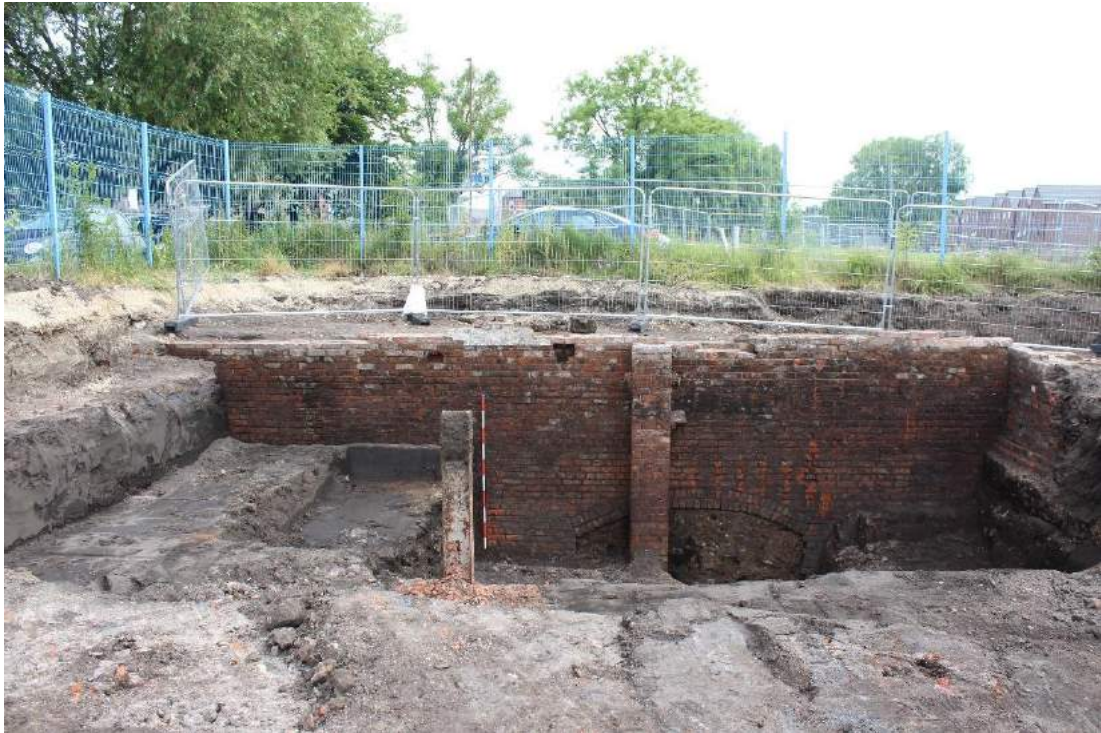
*Plate 11: Shot of wall {001} looking north. Scale = 1 x 2m.*

- 6.3.1 The earliest phase of activity on site related to the remains of the foundry that became the Titanic Steel Works. Wall {001} was aligned north-west to south-east and measured a maximum of 6m long x 0.35m wide x 0.28m tall (Plate 11). It was constructed of handmade, unfrogged grey brick each measuring an average of 230mm long x 120mm wide x 90mm thick, laid stretcher and bonded with a sandy greyish-yellow lime mortar. Areas of this wall also showed evidence of being lime washed. A large arch was also present within wall {001} (Plate 11).

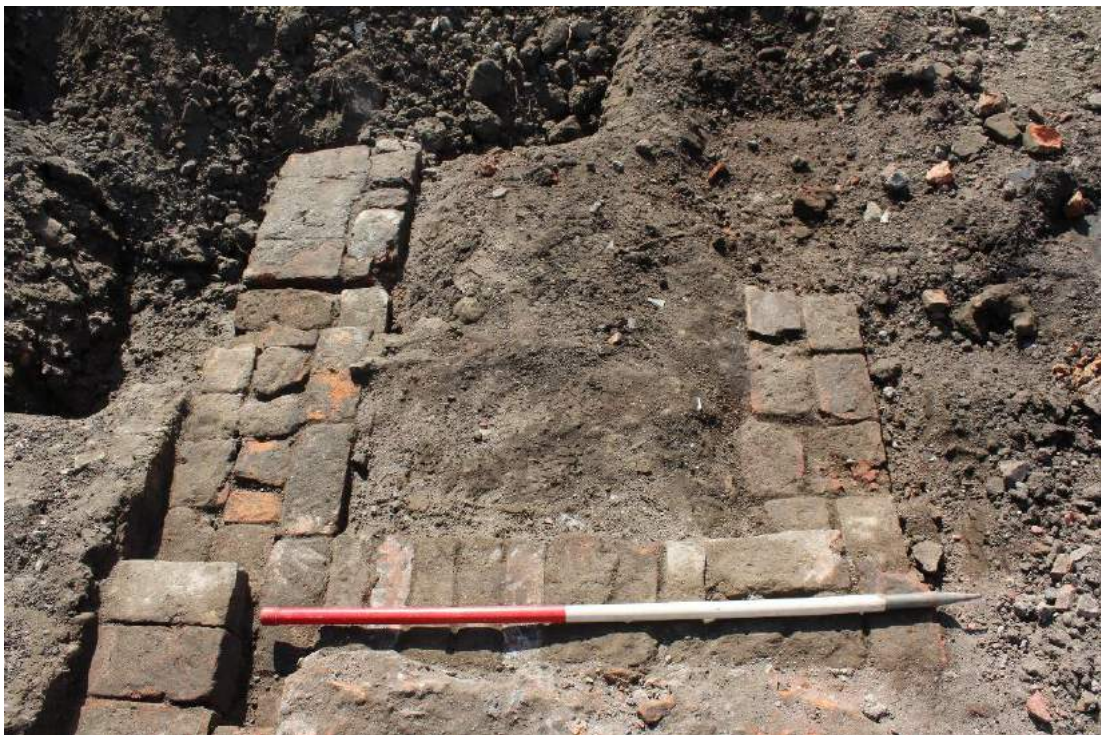
*Plate 12: Shot of wall {002} looking south-east. Scale = 1 x 1m.*

- 6.3.2 The south-eastern end of wall {001} was abutted on its south-western face by L-shaped wall {002} (Plate 12). Wall {002} was aligned north-east to south-west and measured a maximum of 1m long x 0.26m wide x 0.1m tall. This again was constructed of handmade, unfrogged grey brick laid header bond, and bonded with a sandy greyish-yellow lime mortar. Areas of this wall also showed evidence of being lime washed.

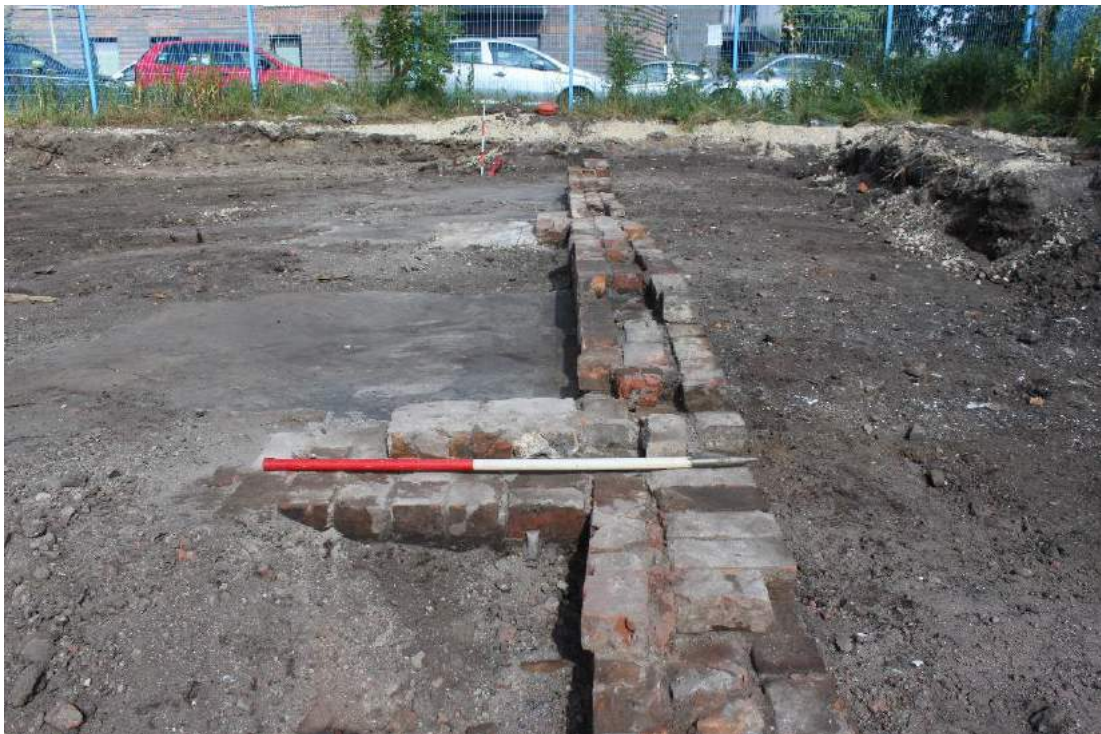
*Plate 13: Shot of wall {004} and floor surface {005} looking north-west. Scale = 1 x 1m.*

tall (Plate 13). Wall {004} was constructed of modern red brick laid stretcher bond and bonded with a modern cement mortar. This wall was heavily damaged with only a small section surviving.

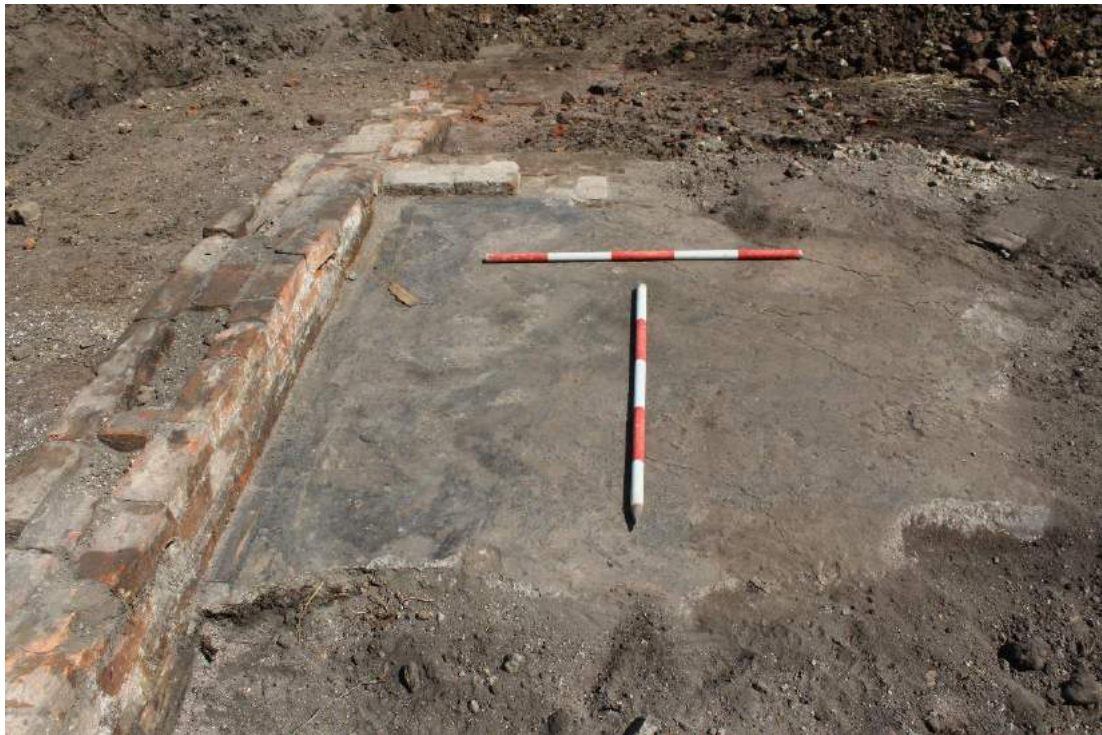
*Plate 14: Shot of floor surface {005} looking north-east. Scale = 2 x 1m.*

- 6.4.3 The remains of a concrete floor surface with a layer of bitumen upon it was observed as two separate areas {005} and {007} which were located south-west of wall {001} and north-west of wall {004} (Plate 14 and Plate 15). It is likely that these were originally one floor surface, however, it had been heavily truncated.

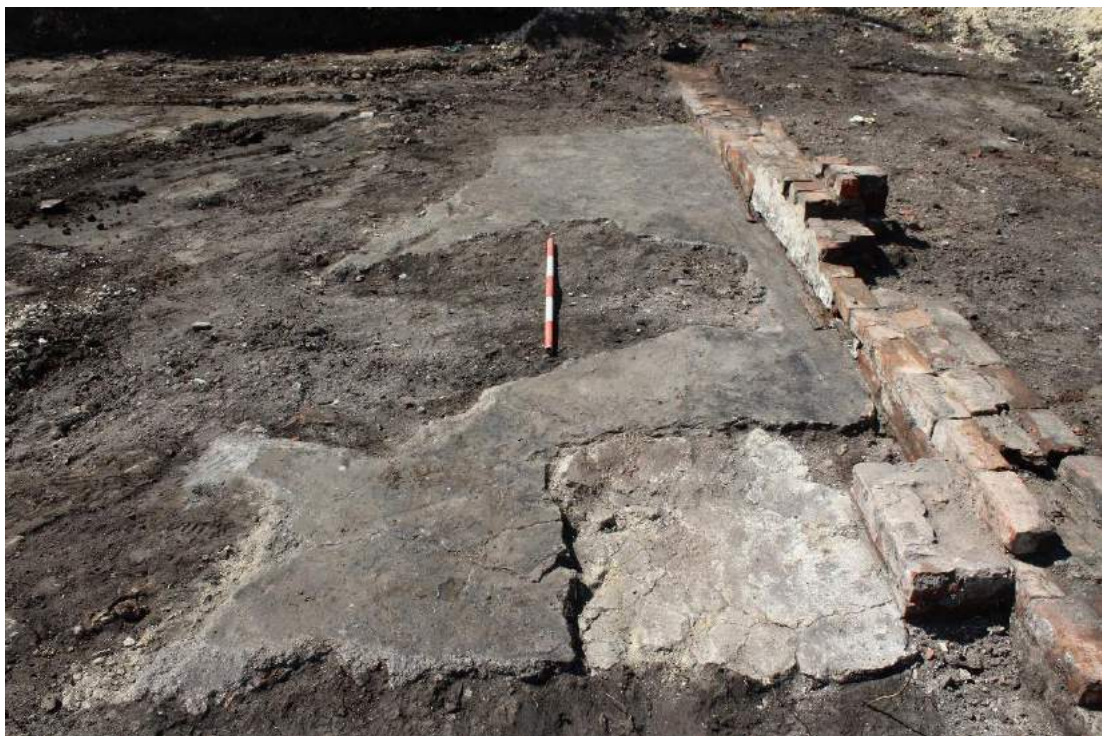
*Plate 15: Shot of floor surface {007} looking north-west. Scale = 1 x 1m.*

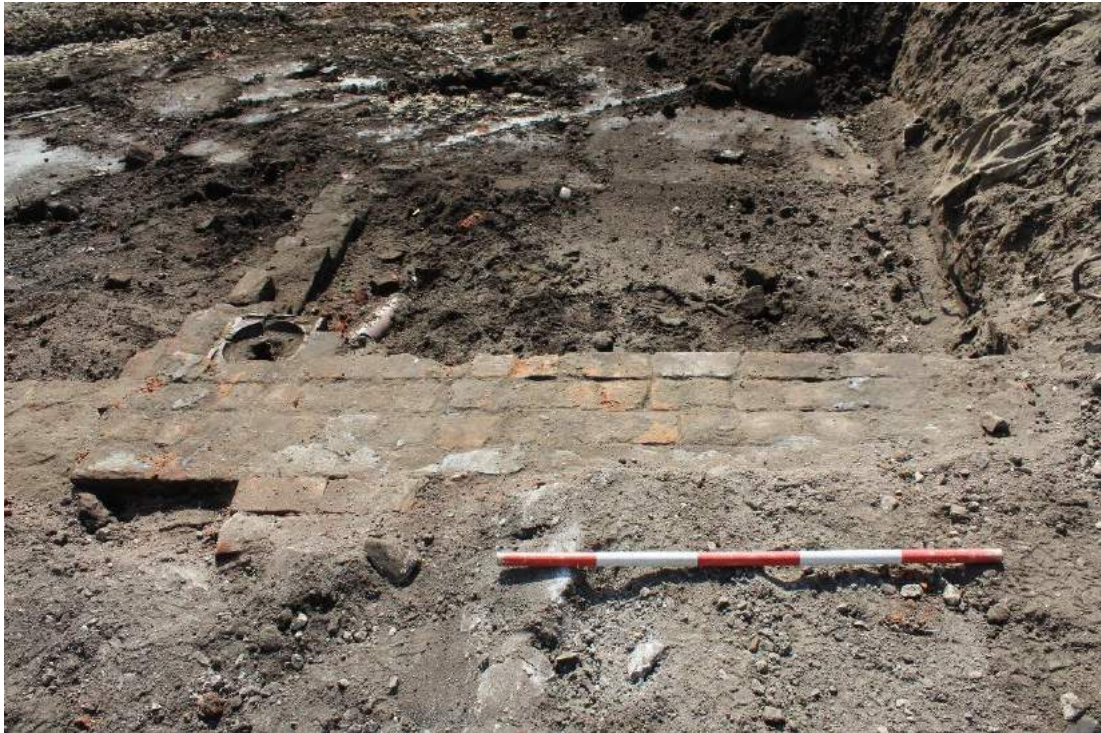
*Plate 16: Shot of wall {009} and drains {013} and {014} surface {007} looking south-east. Scale = 1 x 1m.*

- 6.4.4 A north-west to south-east aligned wall {010} was observed abutting wall {009} on its south-eastern face. Wall {010} measured a maximum of 1.84m long x 0.24m wide, was laid stretcher bond and bonded with a black ash mortar. A stone lined drain {013} and a ceramic drain {014} were also observed to the south-west of this wall.

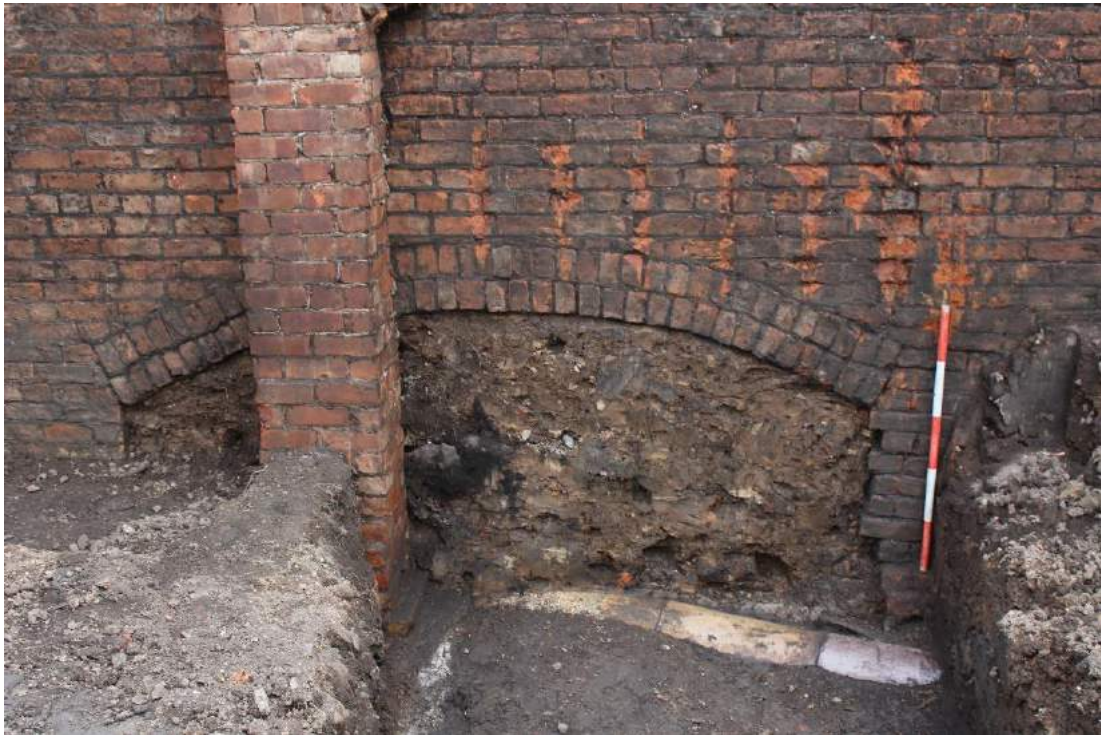
*Plate 17: Shot of wall {001} with arch and buttress {006}, looking north. Scale = 1 x 1m.*

- 6.5.2 Brick buttress {006} was added on the south-western face of wall {001} (Plate 17). Buttress {006} measured 0.25m long x 0.45m wide x 0.14m tall and was constructed of modern frogged red brick laid header bond and bonded with a modern cement mortar. A repair {008} to the concrete floor surface {007} located south-west of buttress {006} was observed that likely dates to this phase of activity. Repair {008} comprised modern white concrete that measured 0.8m long x 0.9m wide.

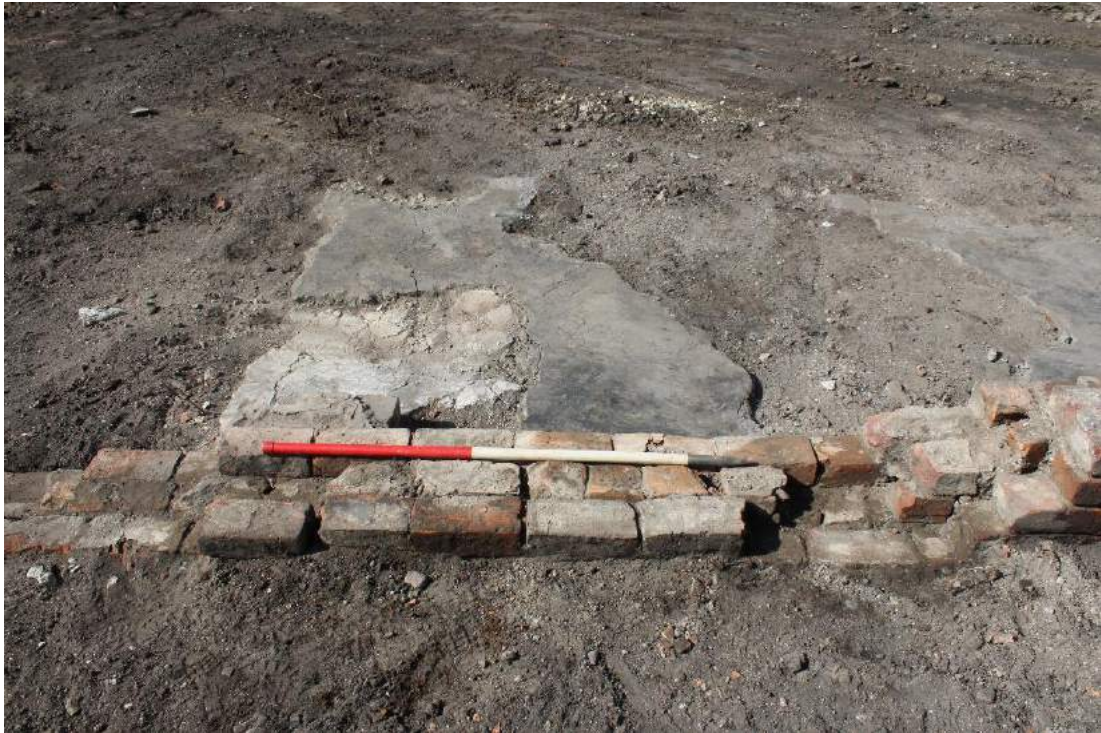
*Plate 18: Shot of buttress {012} and concrete {011}, looking south-west. Scale = 1 x 1m.*

- 6.5.8 A construction cut [015] was observed on the north-western face of wall {009} for the insertion of buttress {012}. Buttress {012} measured a maximum of 0.23m long x 0.45m wide x 0.09m tall and was constructed of modern red brick laid stretcher bond and bonded with a modern cement mortar (Plate 18). Cut [015] was then filled with a clay/ clinker mix (016). A deposit of modern concrete {011} was laid to the south-west of buttress {012} which measured 0.8m long x 0.86m wide x 0.1m thick (Plate 18). This was likely a repair to a floor surface that no longer survives.

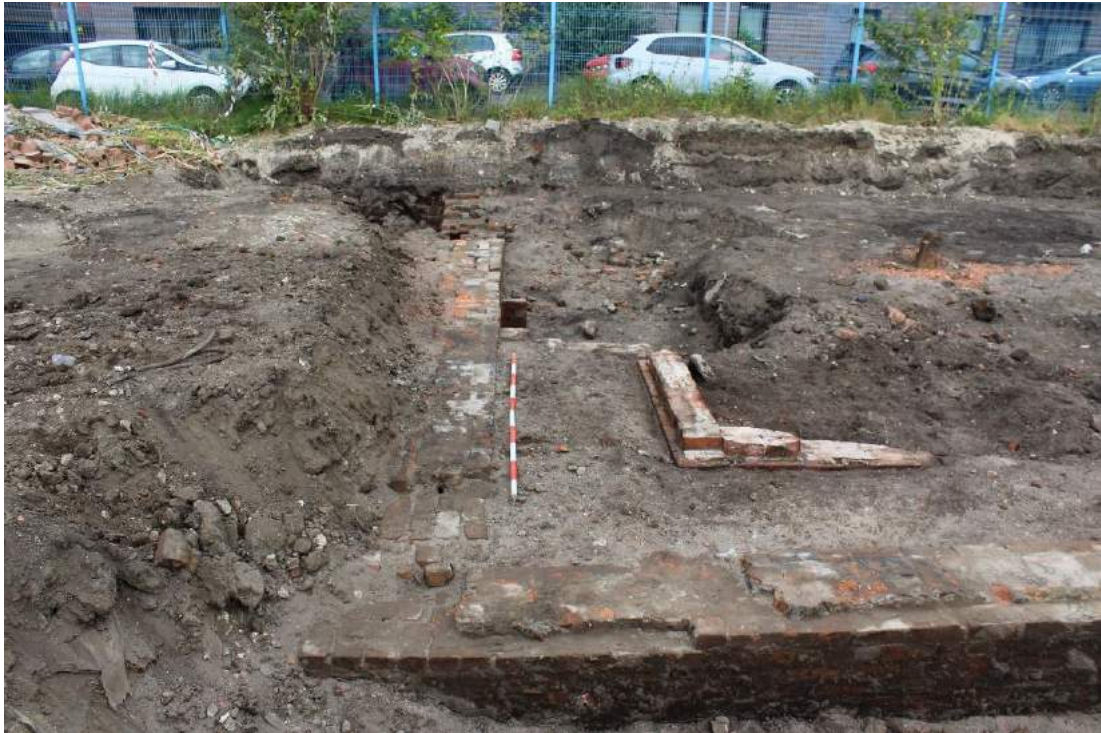
*Plate 19: Shot of walls {018} and {024} abutting wall {009}, looking north-west.*

- 6.6.2 Wall {024} was observed abutting wall {009} on its north-eastern face (Plate 19). Wall {024} was aligned north-west to south-east, measured a maximum of 0.84m long x 0.3m wide x 0.11m tall, and was constructed of modern red bricks laid both stretcher and header bond and bonded with a modern cement mortar.

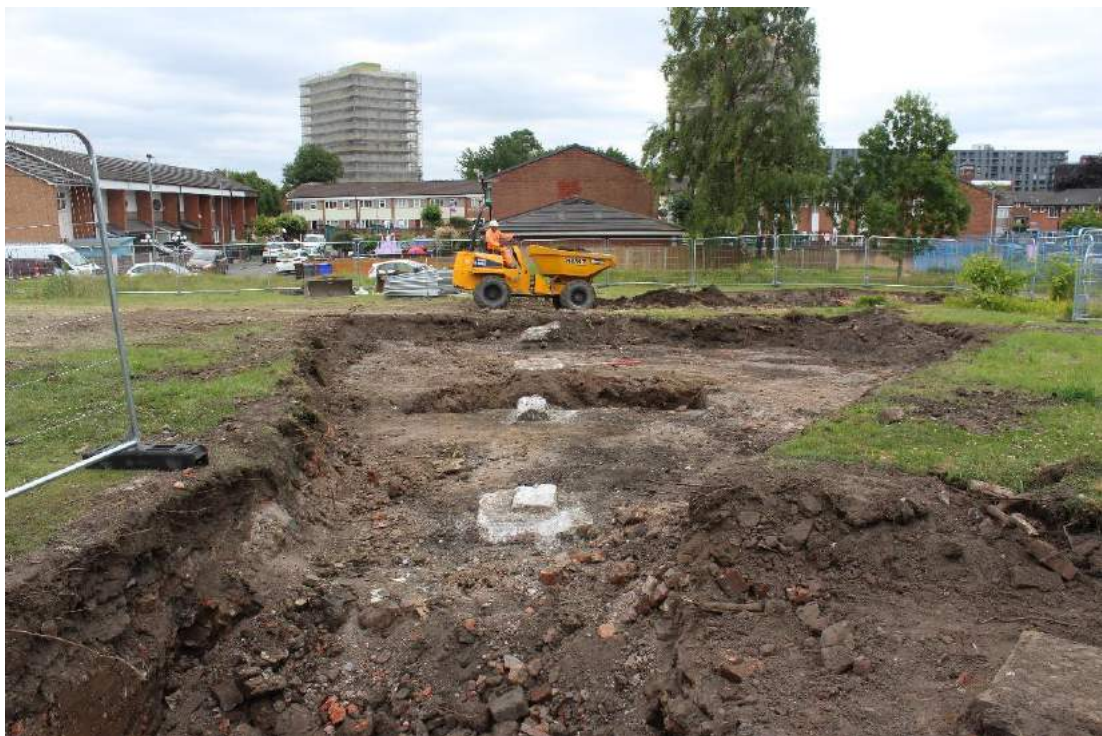
*Plate 20: Shot of concrete stanchions {047}, looking south-east. Scale = 1 x 2m.*

6.9.2 A series of modern reinforced concrete stanchions {047} were also observed to lie directly onto the geological natural substrate (050) in Plot B, that likely date to this phase of activity (Plate 20). They were aligned north-west to south-east and each measured an average of 0.85m long x 0.81m wide x 0.12m thick.

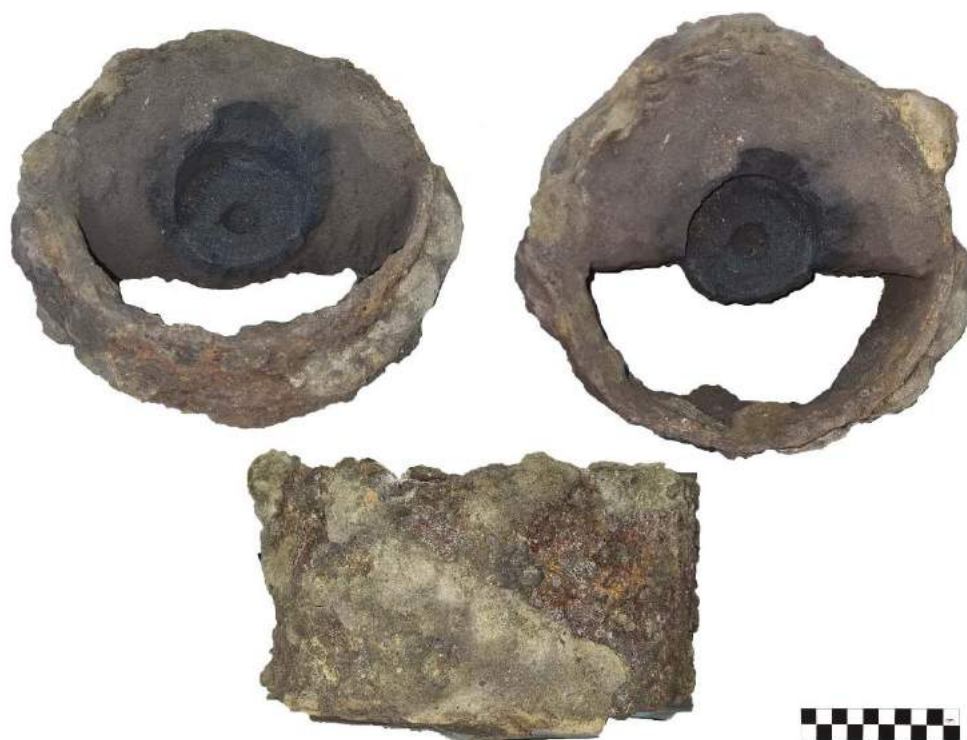
*Plate A1: Casting box 40.1 from deposit [40], partly excavated, 10cm scale*

The object was lifted from its context [40] complete with its contents and hand excavated in the finds laboratory. Pre-excavation revealed a friable grey sand (Sample 2), which encircled a cylindrical shaped area of heat affected, compact dark grey sand (Sample 3), within which lay friable, dark almost black, heat affected sand (Sample 1). When Sample 1 had been removed a cylindrical void was revealed, with a diameter of 80mm ( $3\frac{1}{4}$  inches). The wall being formed by Sample 3 material.

Evidence from casting box RF40.1, which was retrieved complete with its contents, demonstrates how such devices were used during the casting of crucible steel. The cylindrical object noted on the two upper images in Plate A1 is known as a draw ring that acted as a feeder reservoir when the 'melt' was poured. It held molten metal that was insulated by the sand such that it remained molten while the casting cooled. As the casting will have shrunk as it cooled, the reservoir provided molten metal to fill any gaps. This was a process known as 'drawing' (*pers comm*, I Miller, 13/03/2023). An indication of this procedure was depicted on a 1938 Crucible Steel Company of America debenture (Plate A3). The casting boxes, square in this instance, can be seen sitting on top of the crucible as the 'melt' is poured in.

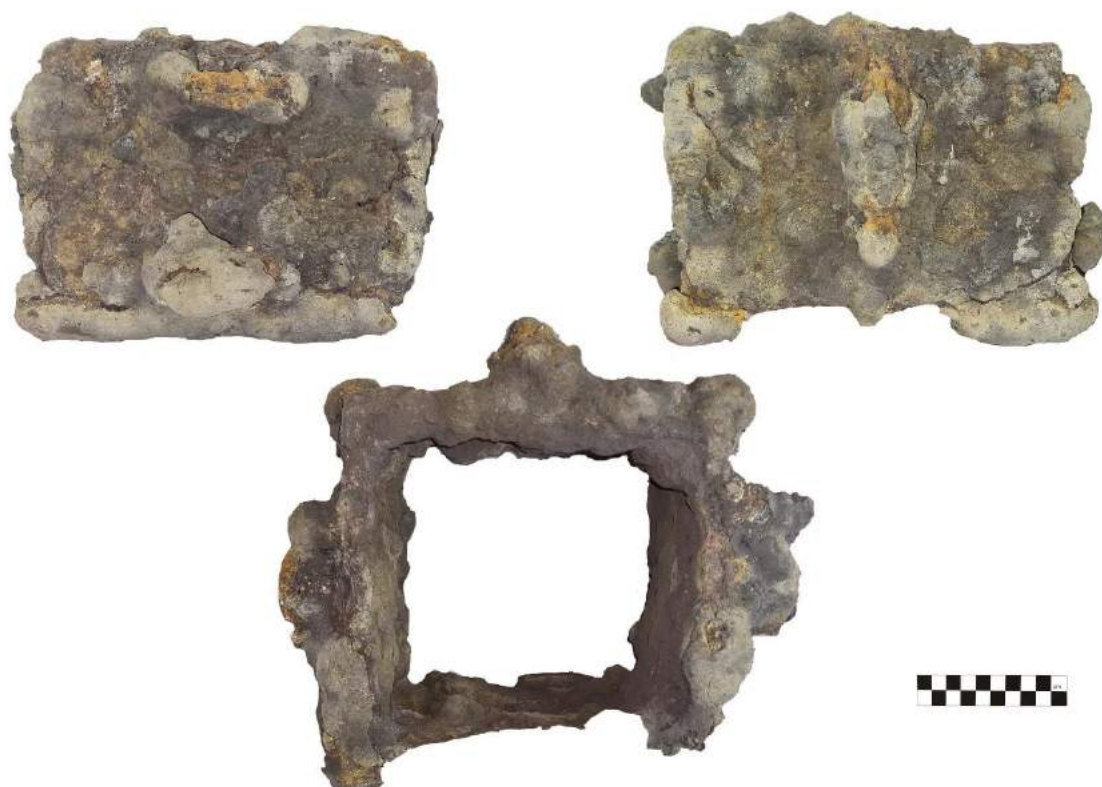
*Plate A2: Casting box 40.4 from deposit [40], fully excavated, 10cm scale*

Casting box 40.4 (Plate A2): is square in plan measuring 330mm x 330mm (13 inches x 13 inches) x 190mm high ( $7\frac{1}{2}$  inches), with walls approximately 20mm ( $\frac{3}{4}$  inch) thick. Interior and exterior face are heavily corroded obscuring most surface detail. Protrusions on each exterior face may represent features to fasten the two sides of the boxes together.

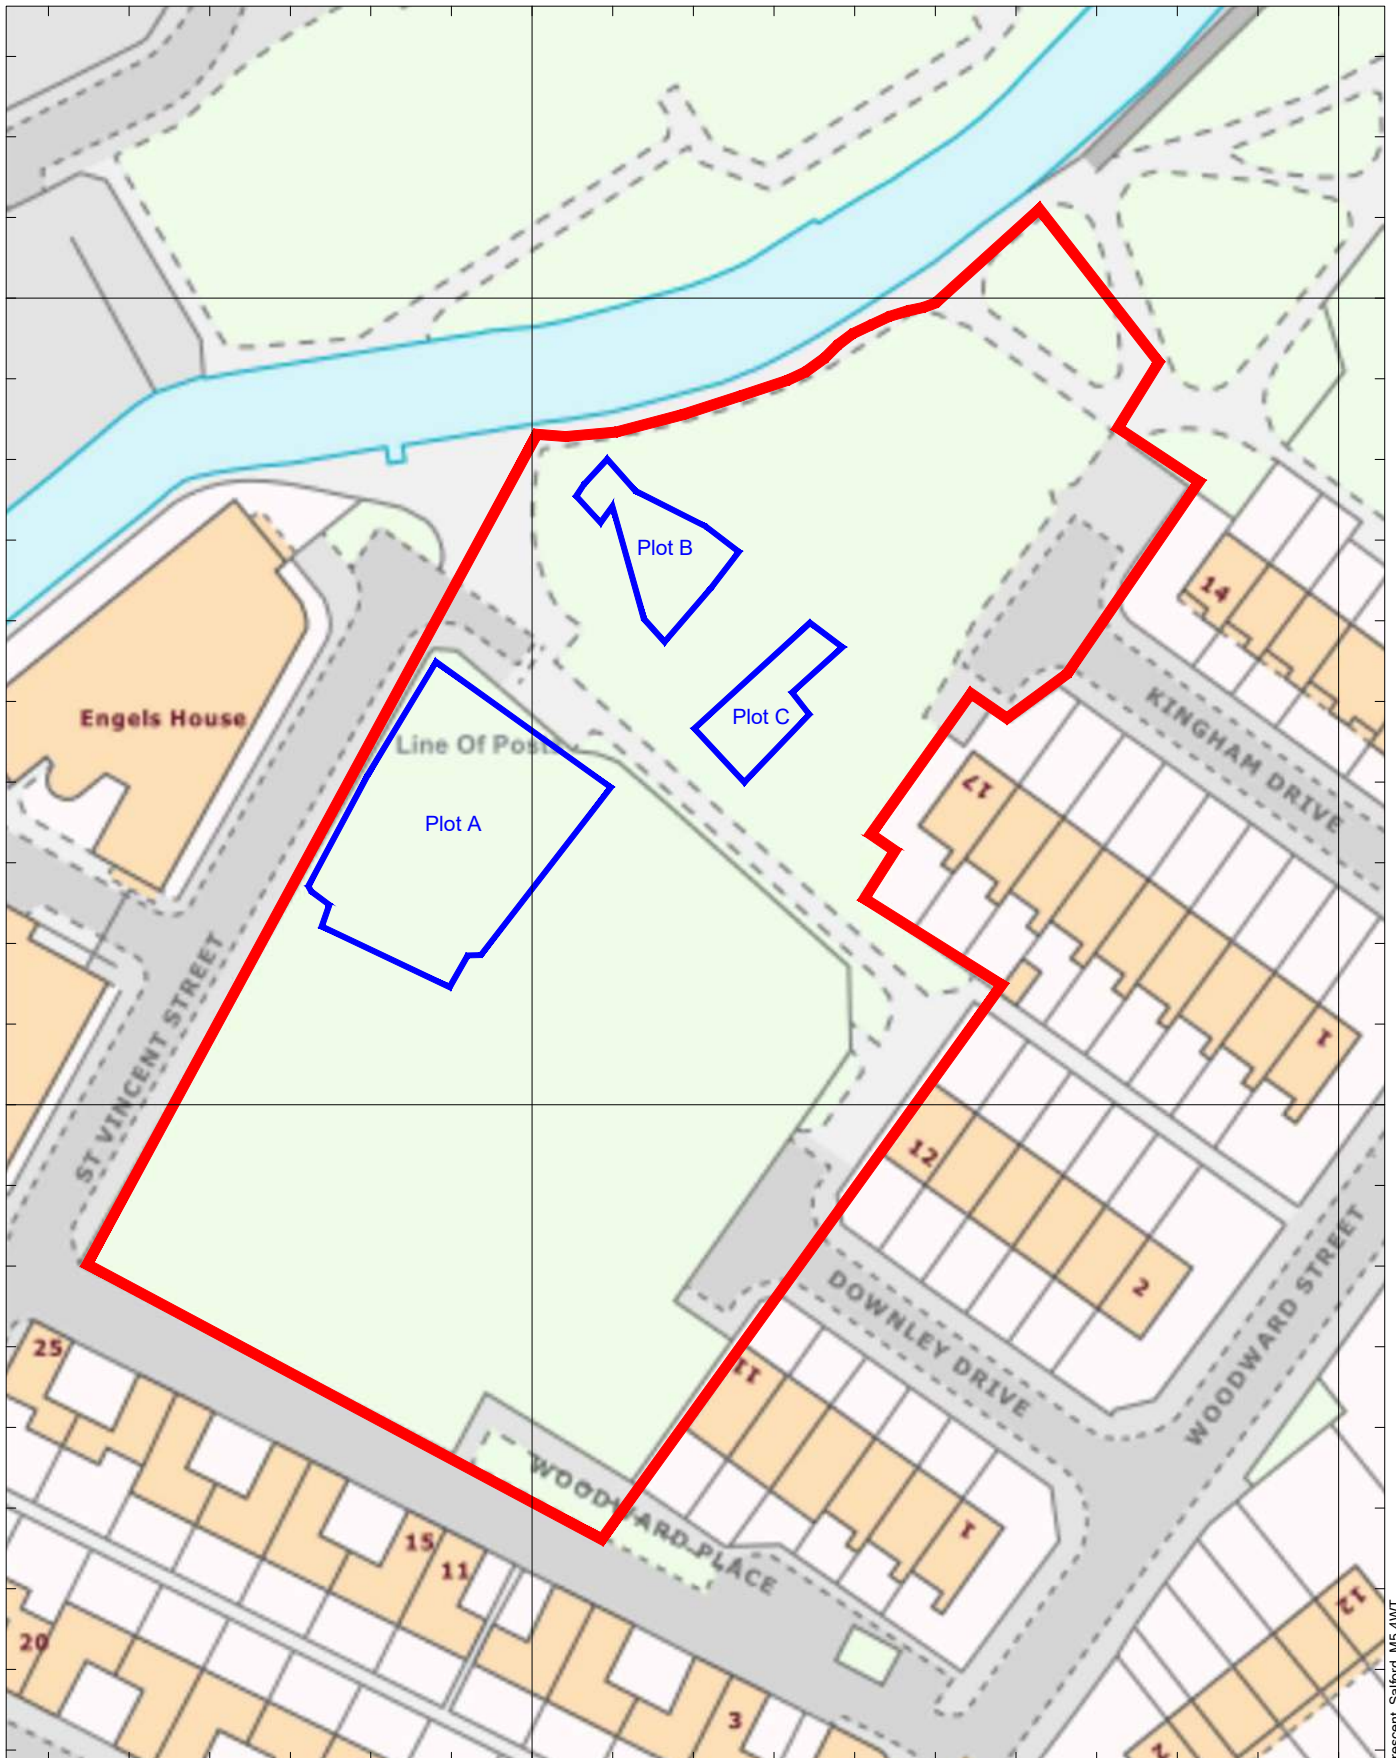
Figure 2:

Trench Location Superimposed onto Modern Mapping

1.1.5 On the 20<sup>th</sup> of June 2022, archaeological mitigation of the site, comprising the strip and plan evaluation of the proposed development area (Figure 2). This programme of archaeological evaluation recorded two walls dating to the late 19<sup>th</sup> century Titanic Steel Works, along with extant remains of St Vincent's Home which had been extended and modified throughout the 20<sup>th</sup> century.

2.1.2 Following the results of the desk-based assessment (DBA) (Cole 2021), and in consultation with GMAAS, it was recommended that the evaluation comprised the excavation of two 'strip and plan' areas as indicated in figures 2 and 3. The 'strip and plan' areas were targeted on the main production areas of the former Titanic Steelworks. This approach to devising proposals to mitigate the impact of development on the archaeological resource of the development area is in accordance with national guidelines set out in the National Planning Policy Framework: Section 16.

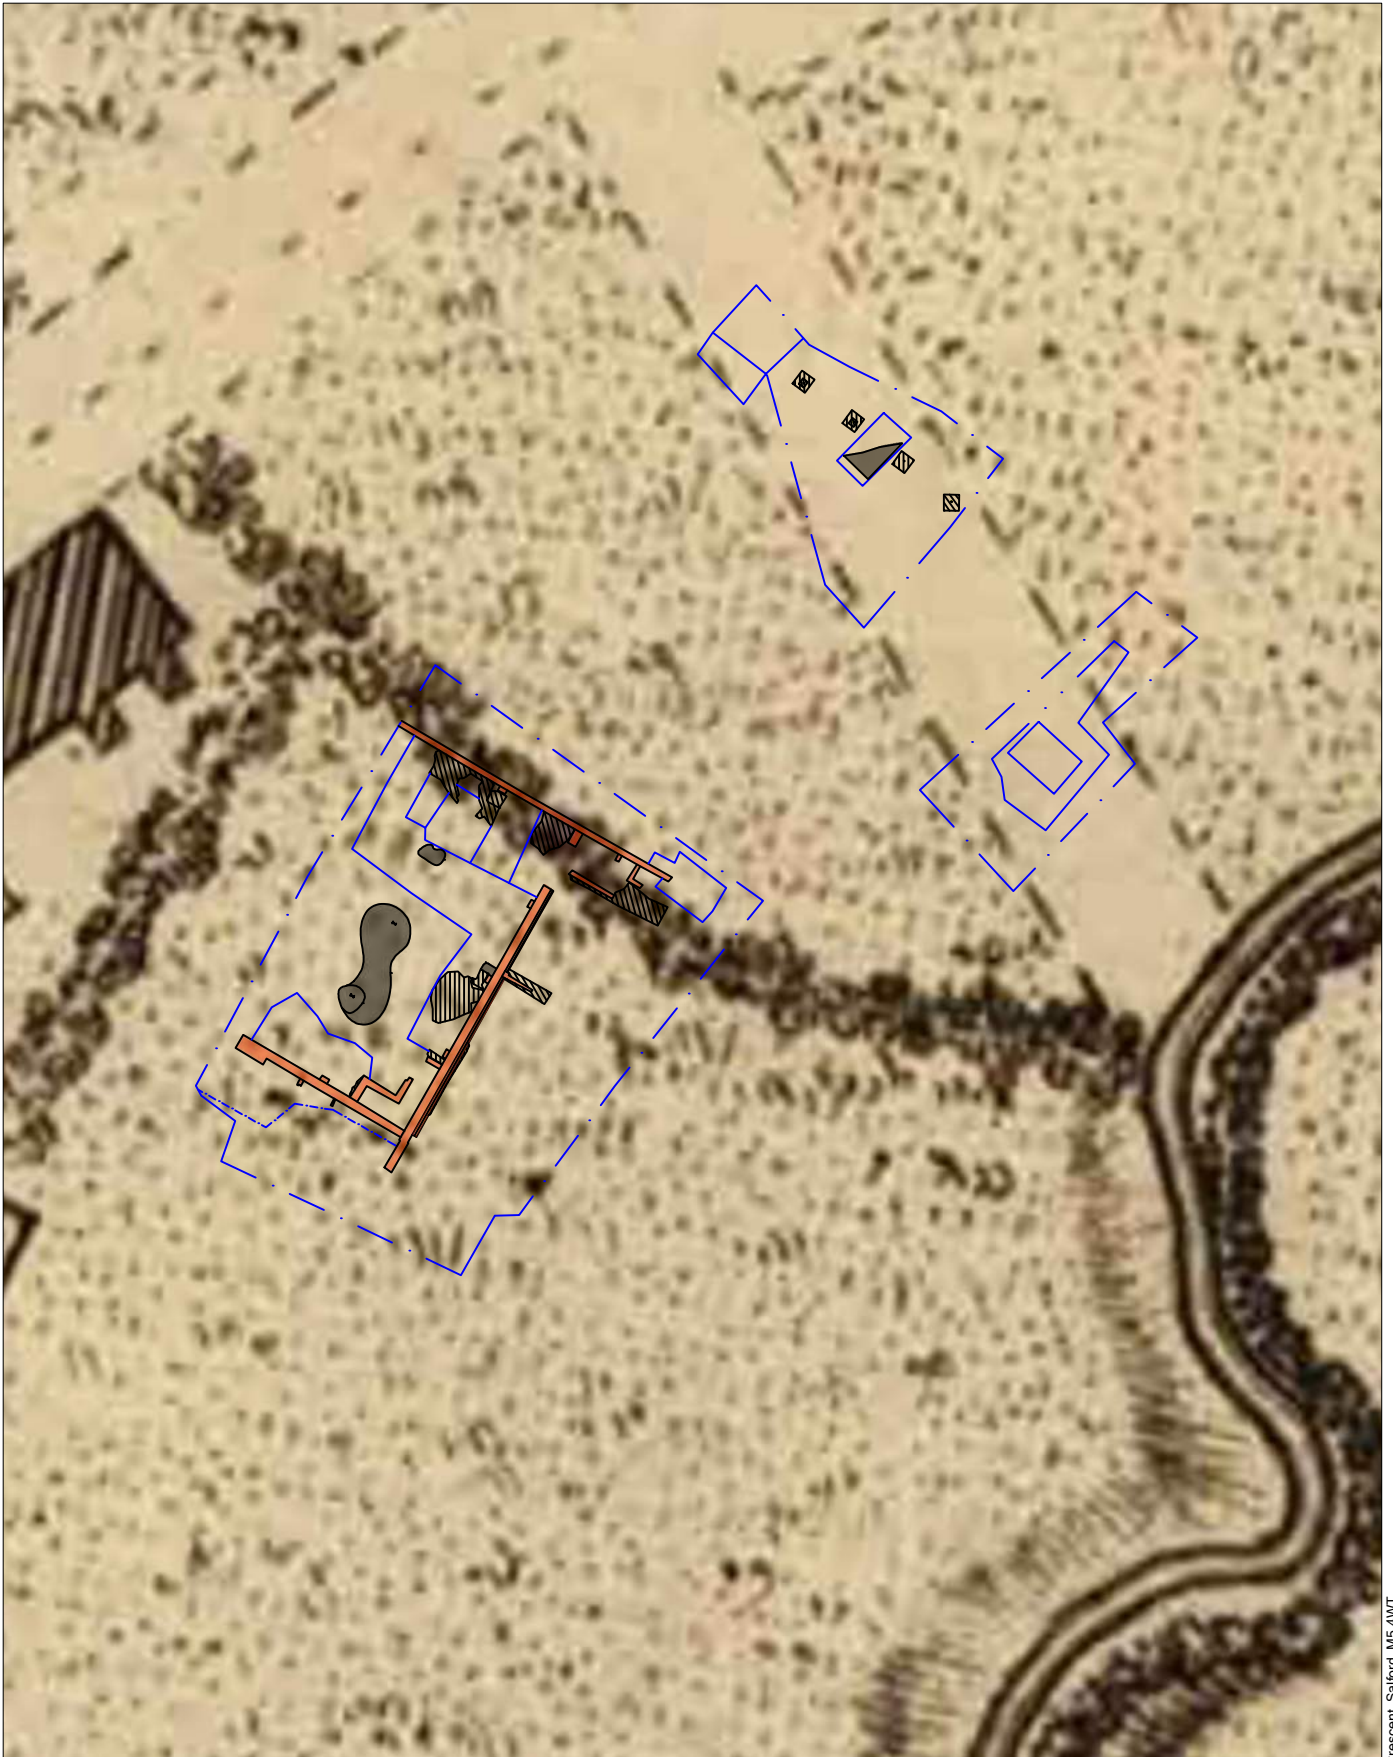
Figure 6:  
Results of the Evaluation Superimposed onto Green's Map of Manchester & Salford 1787-94

Figure 6: Results of the evaluation superimposed onto Green's map of Manchester and Salford 1787-94
