## Archaeological Evaluation

Downley Drive, Ancoats,  
Manchester

Rowlinson Constructions Ltd

SA/2022/89

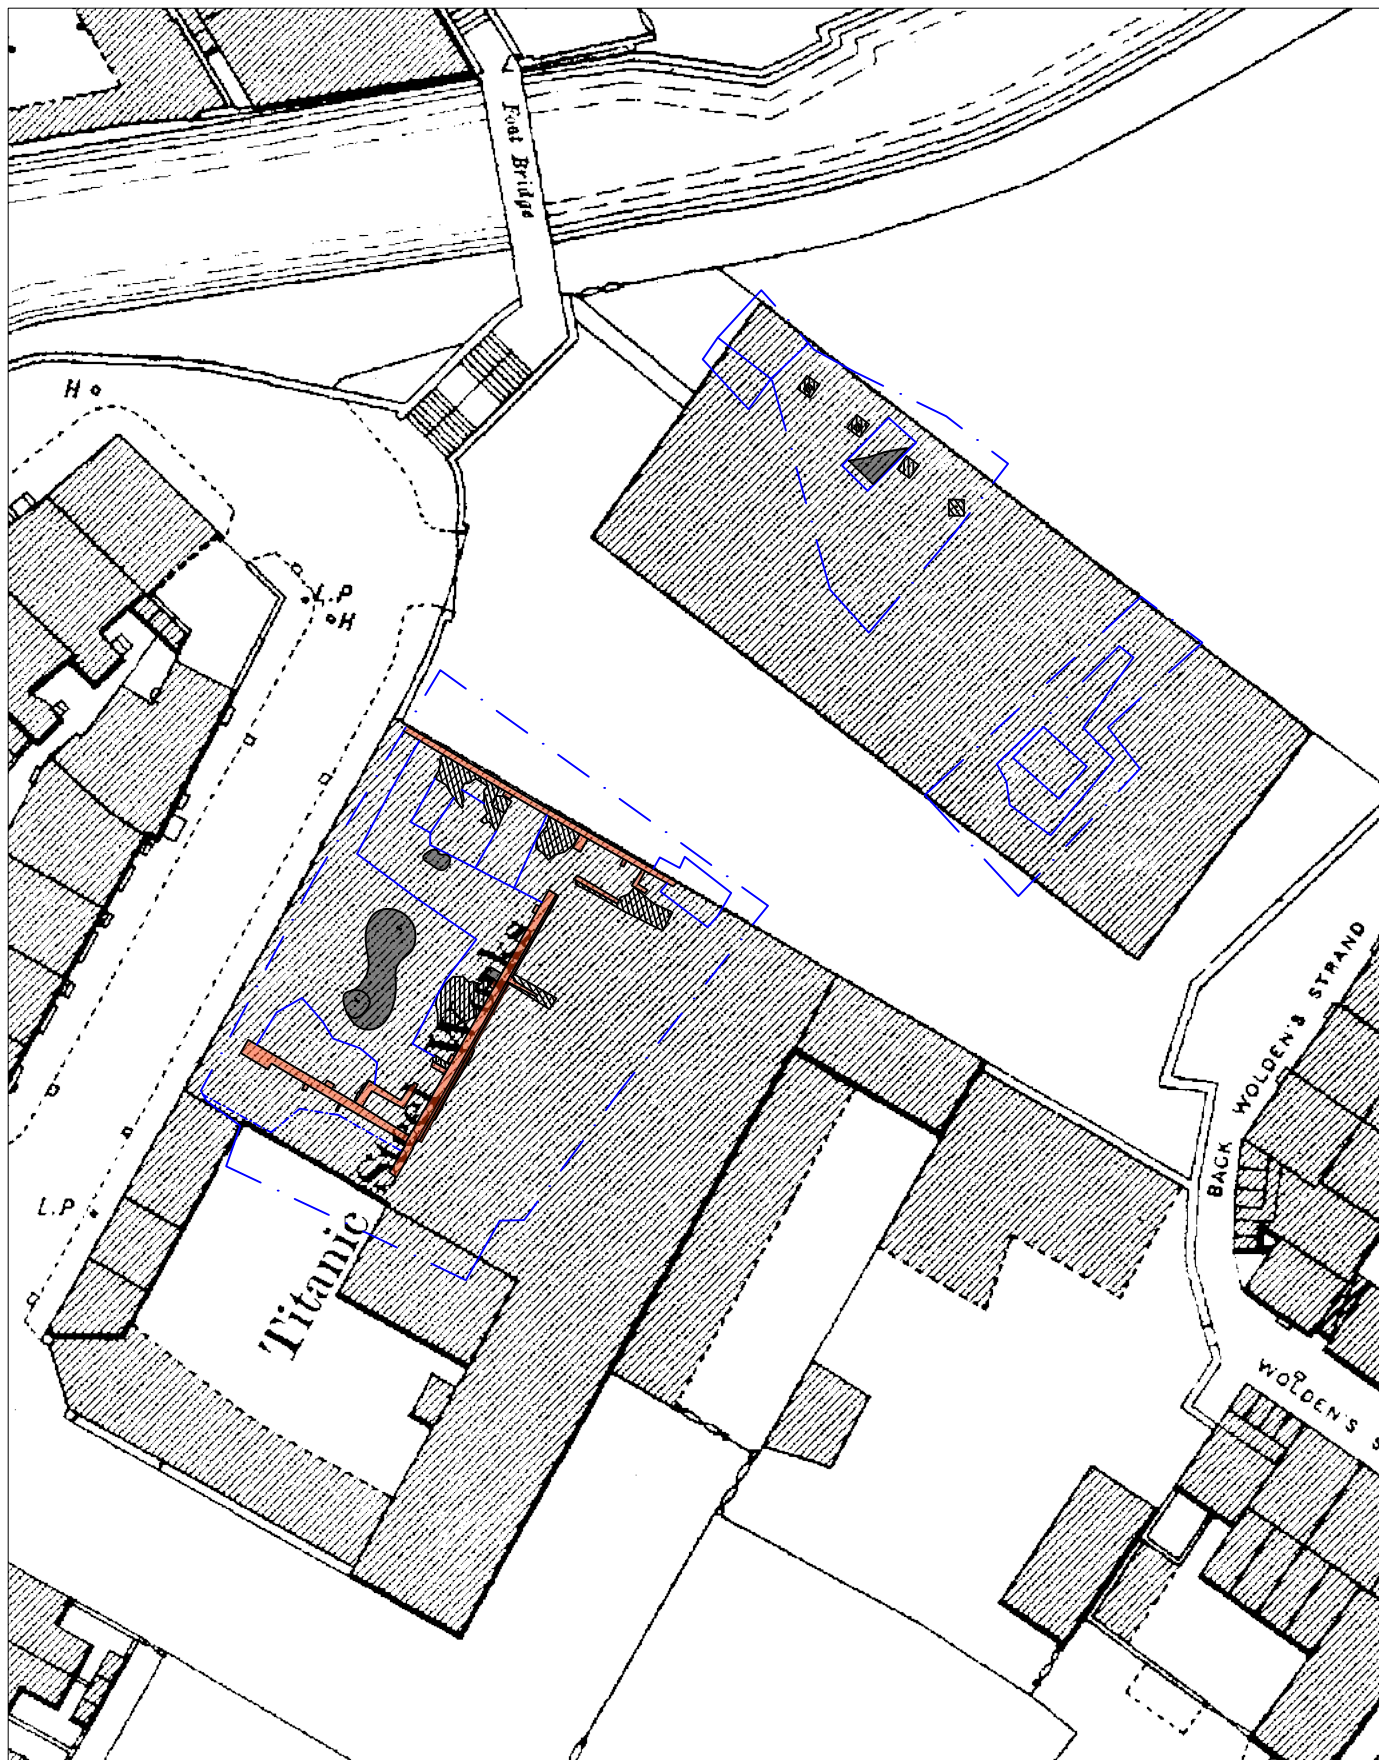
Results of the Evaluation Superimposed onto the 1:500 Town Plan of 1891

7.1.1 Cartographic evidence suggests that the foundry was constructed between 1851 and 1891 when it was first depicted cartographically on the Town Plan of that year (Figure 8).

7.1.2 The earliest structures recorded on site were a brick wall {001}, with built in brick arch, and wall {002}. These walls likely represent the remains of the foundry that became the Titanic Steel Works. When superimposed on the Town Plan of 1891 it is apparent that the wall with the brick arch {001} corresponds with the northern external wall of the foundry (Plate 6).

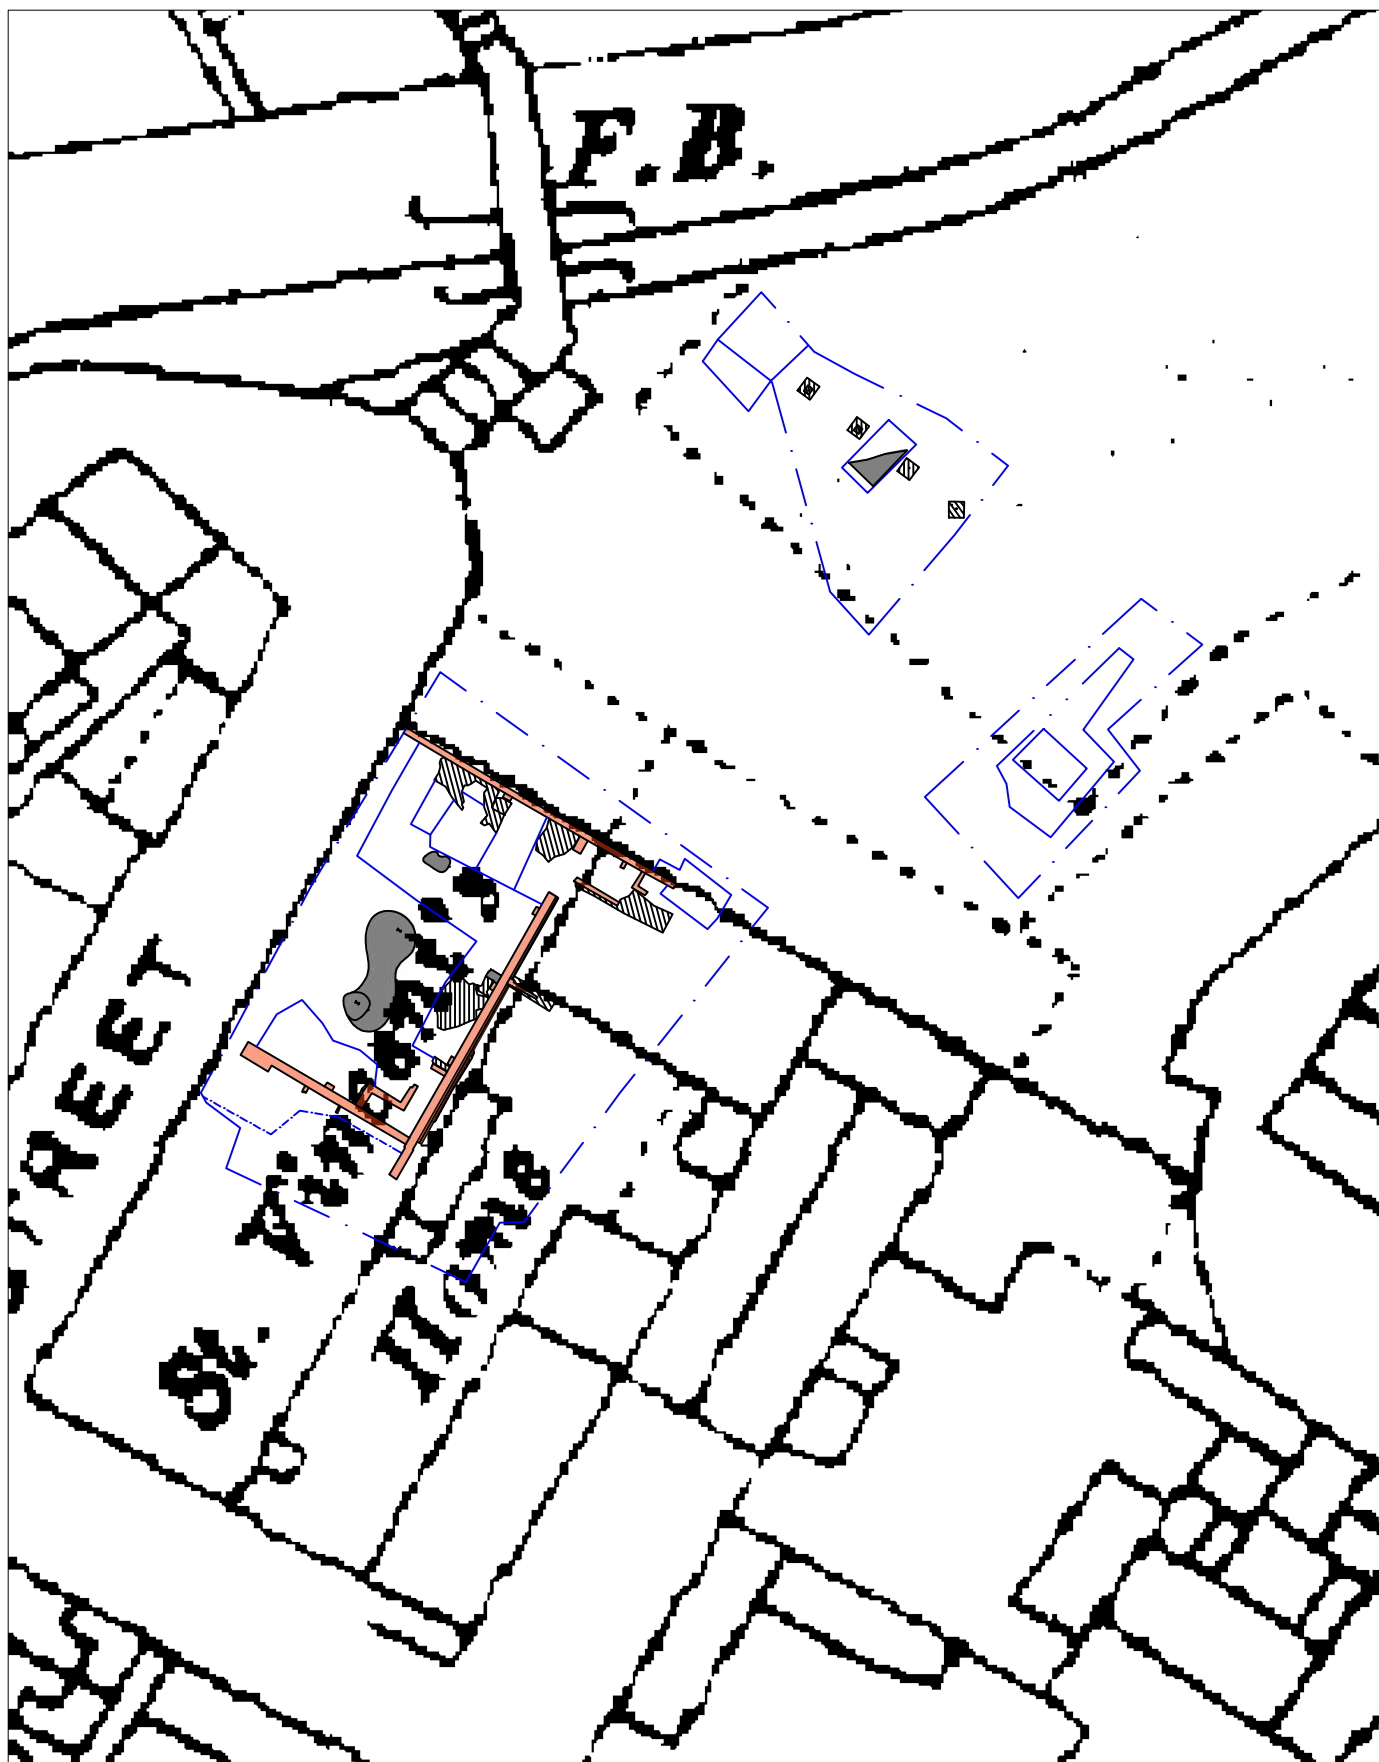
Results of the Evaluation Superimposed onto the 1:2500 County Series Map of 1922

Figure 10: Results of the evaluation superimposed onto the 1:2500 County Series Map of 1922
