Hotel Gotham, Manchester

### Defect Locations on King Street

Marshall Commercial  
Property Development Ltd

CN23-016-J722-SK004

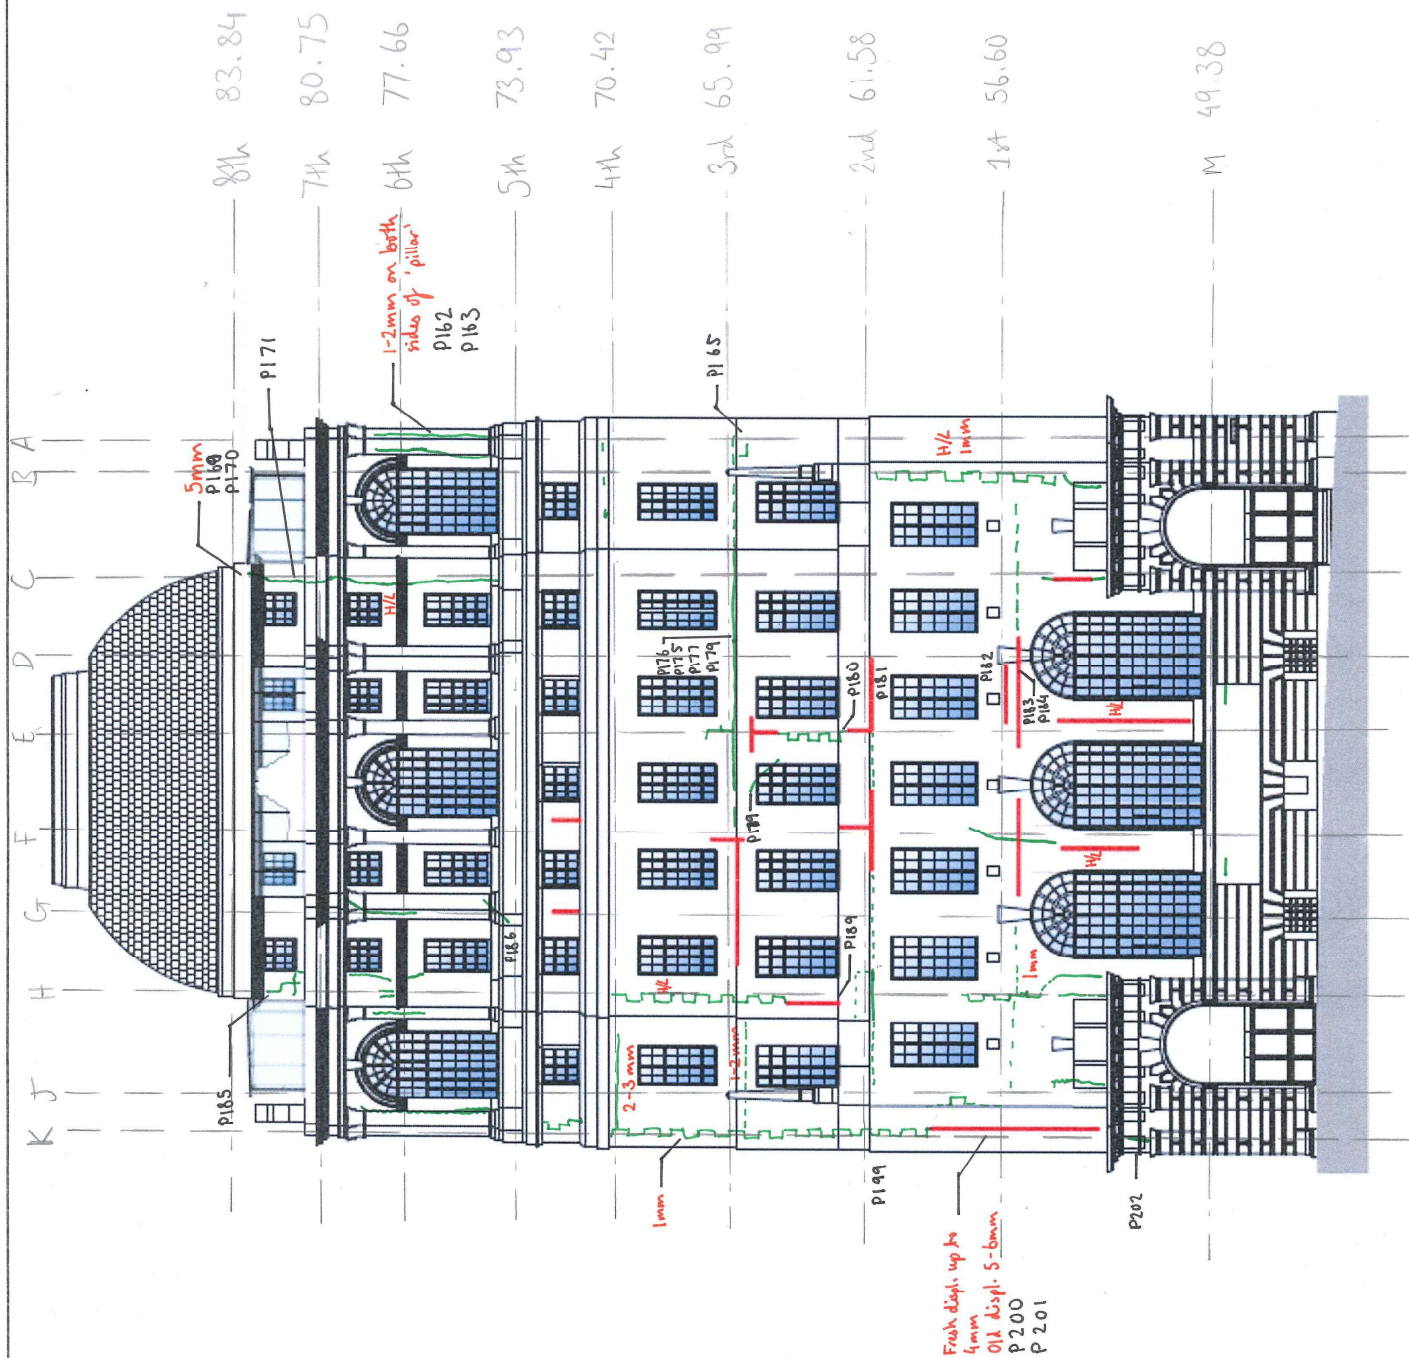
denotes approximate locations  
of masonry cracks from ARP  
bone survey

denotes approximate locations  
of masonry cracks and defects  
from CES site survey.  
open joints
