**Former Woodpecker Pub,  
Kingsgate and Selstead Road,  
Wythenshawe,  
M22 1TP.**

**On behalf of C P Property and Developments Ltd.**

## **Preliminary Ecological Appraisal and Bat Scoping Report**

Report number: WOO/23-001

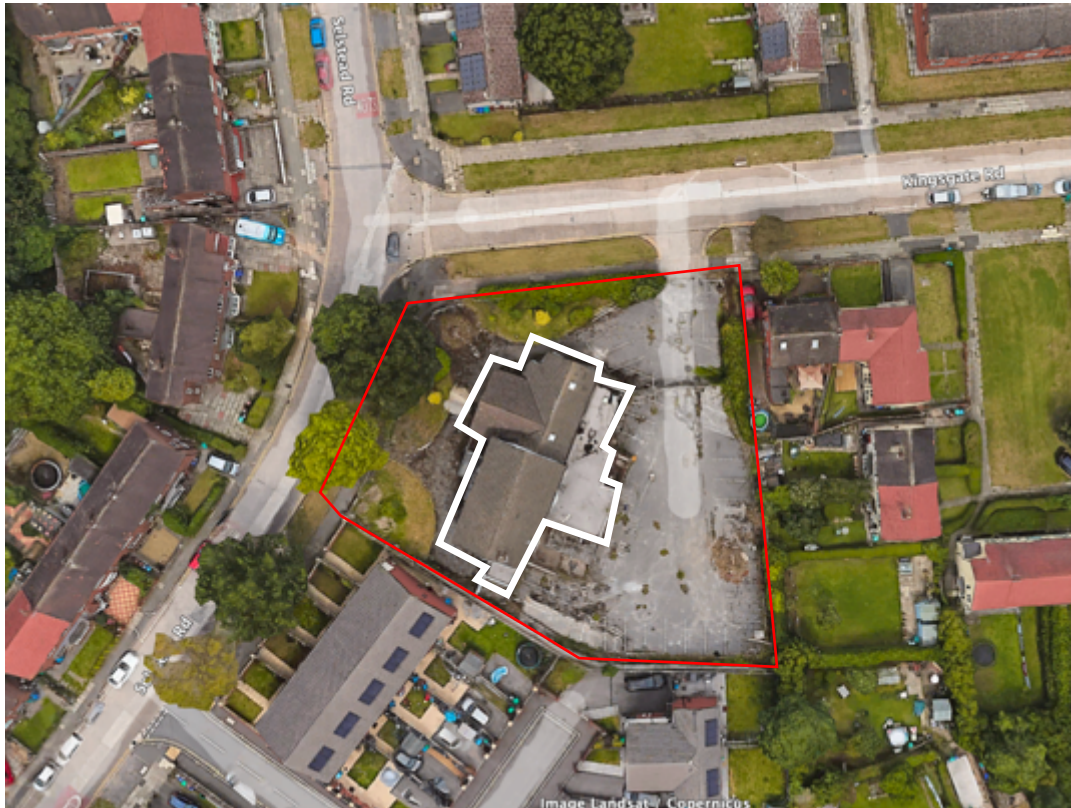
Figure 2.1; Site Location and Extent.

Leigh Ecology Ltd was commissioned by C P Property and Developments Ltd to undertake an Ecological Appraisal and Bat scoping survey of a building and land identified for a proposed development, named former Woodpecker Pub (approx. National Grid Reference (NGR) SJ820862); refer to redline boundary shown on Figure 2.1 below and the subject building extent (White line boundary).

The survey site covers the full extent of the land shown in **Fig 2.1**. The proposed development will see the demolition of the existing building on site, with the addition of several dwellings on the site footprint.

The proposed development (within the red line site boundary as shown in *Figure 2.1*) will consist of the demolition of the existing building to facilitate the development of several dwellings. Some amenity planted features and dense hedgerow feature on site and along the boundary.

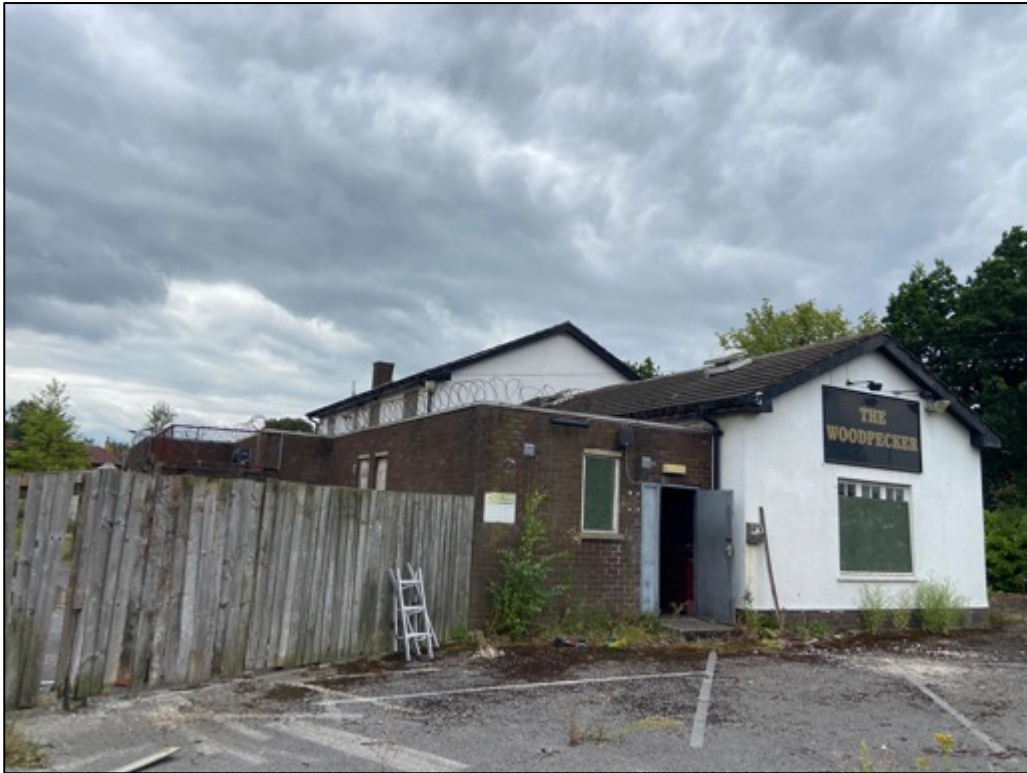
**Photograph 1;** A view of the subject building on site. Note the single-storey pitched roof section adjacent to a concrete flat topped roof section. Whitewash walls and wooden fascia linings feature across the building.

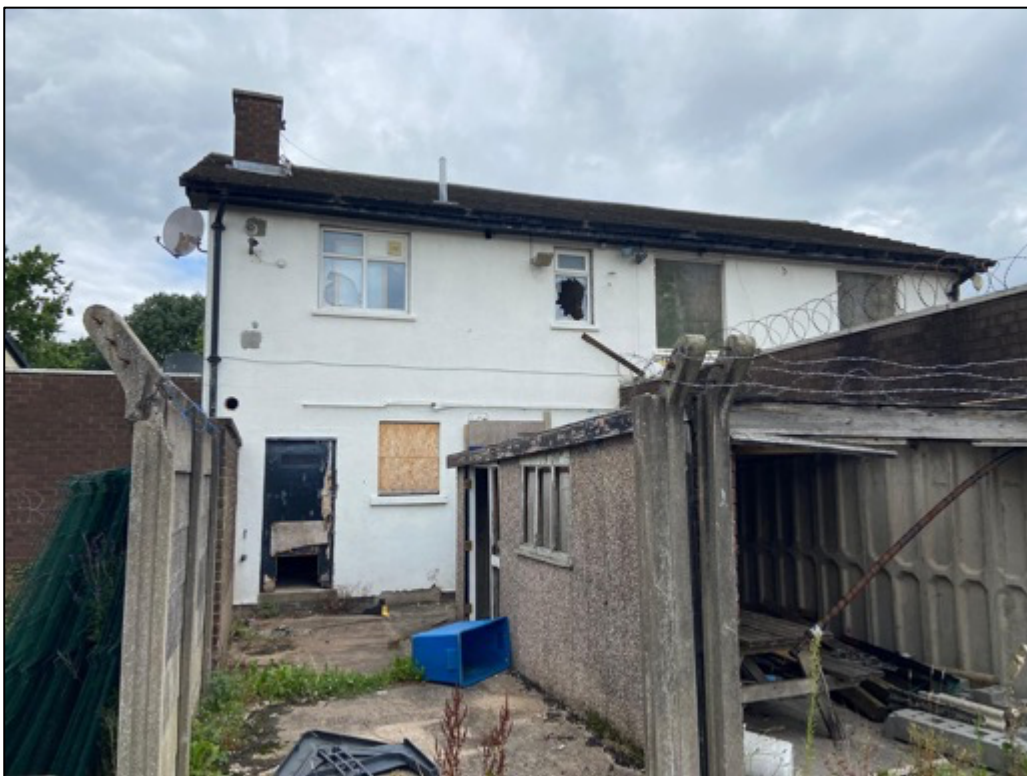
**Photograph 2;** A view of the rear of the subject building. Boarding and reinforcement has been added to most windows and external walls. Some upper windows are smashed. The roof can be seen in good condition, with no instances of tile displacement or damage.

No signs of bat usage were noted across the building, and the site offers **negligible bat roost potential**. The roof is in good condition internally and externally. No damage/displacement was found across the external roof along roof and ridge tiles and no damage to fascia and soffit linings was noted. Internally, the building features a well-structured felt lining and well-maintained internal walls.

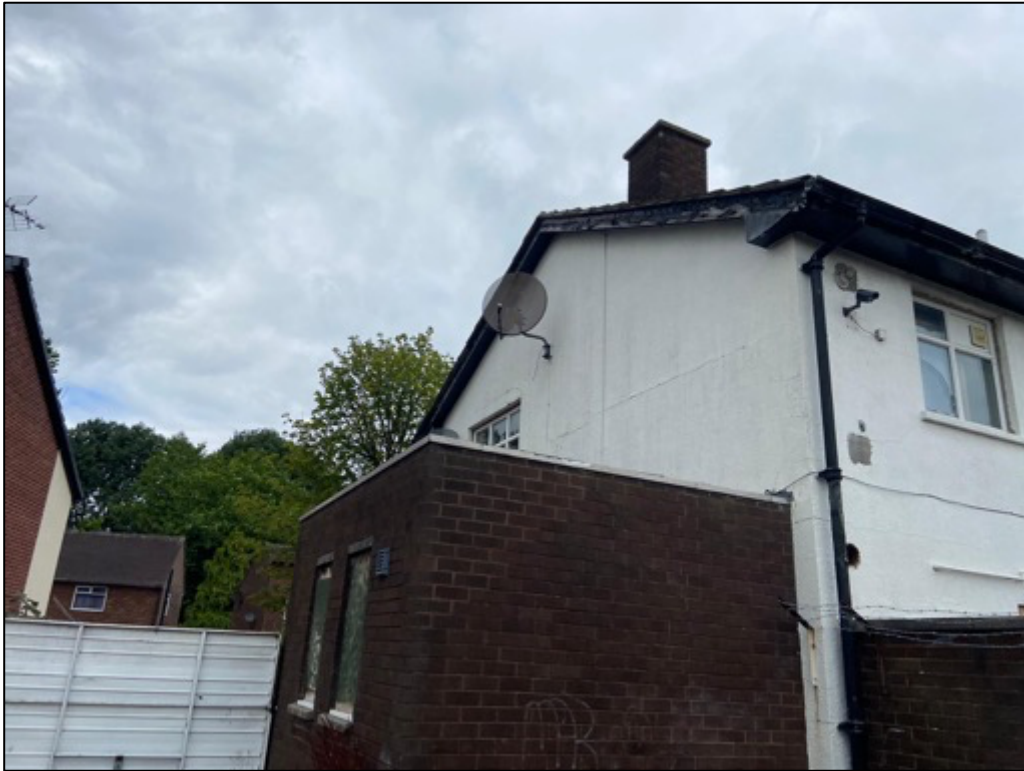
**Photograph 3;** The wooden fascia lining features some cosmetic damage due to age, but this does not affect the structural integrity of the roof and no openings were noted. Attached single-storey sections were more recently added and offer no ecological importance.

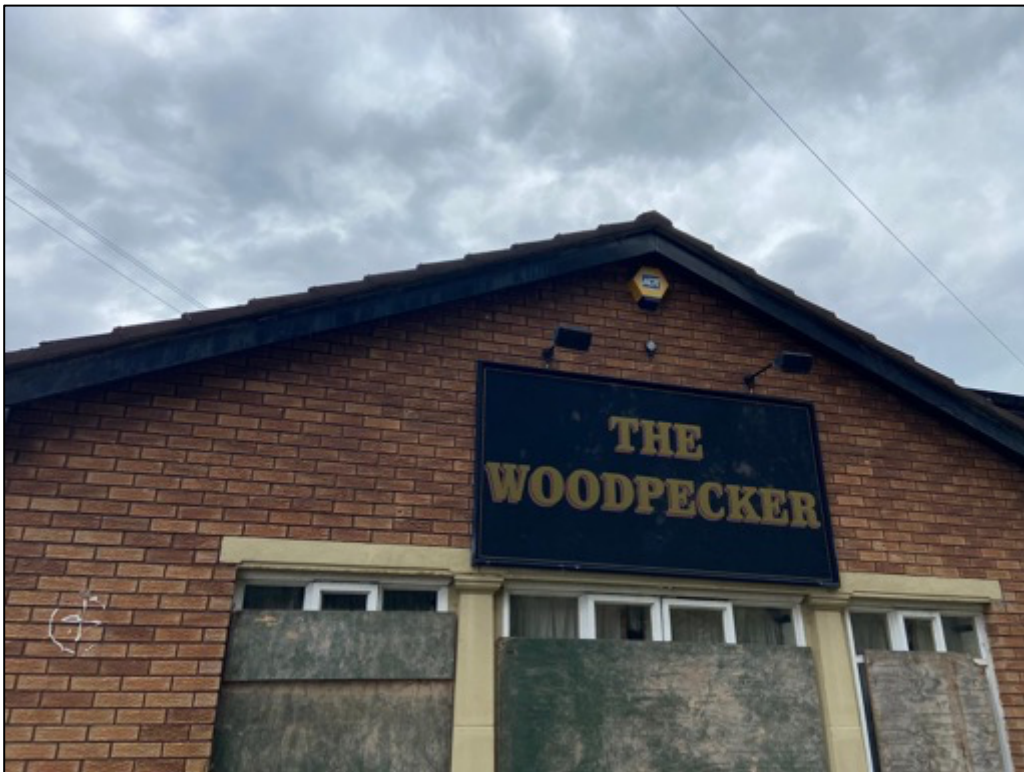
**Photograph 4;** A view of the front facing gable of the building. The newer brickwork again indicates this section has been more recently added. This section is in very good condition.

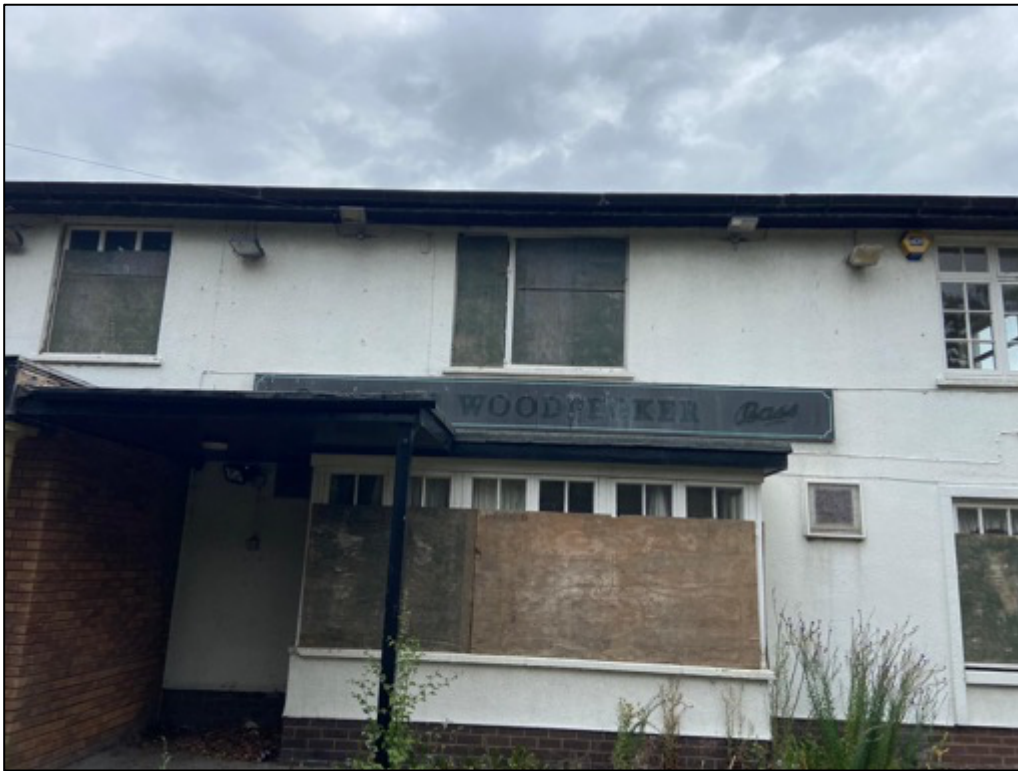
**Photograph 5;** The wooden soffit and fascia linings are in good condition across all faces of the building.

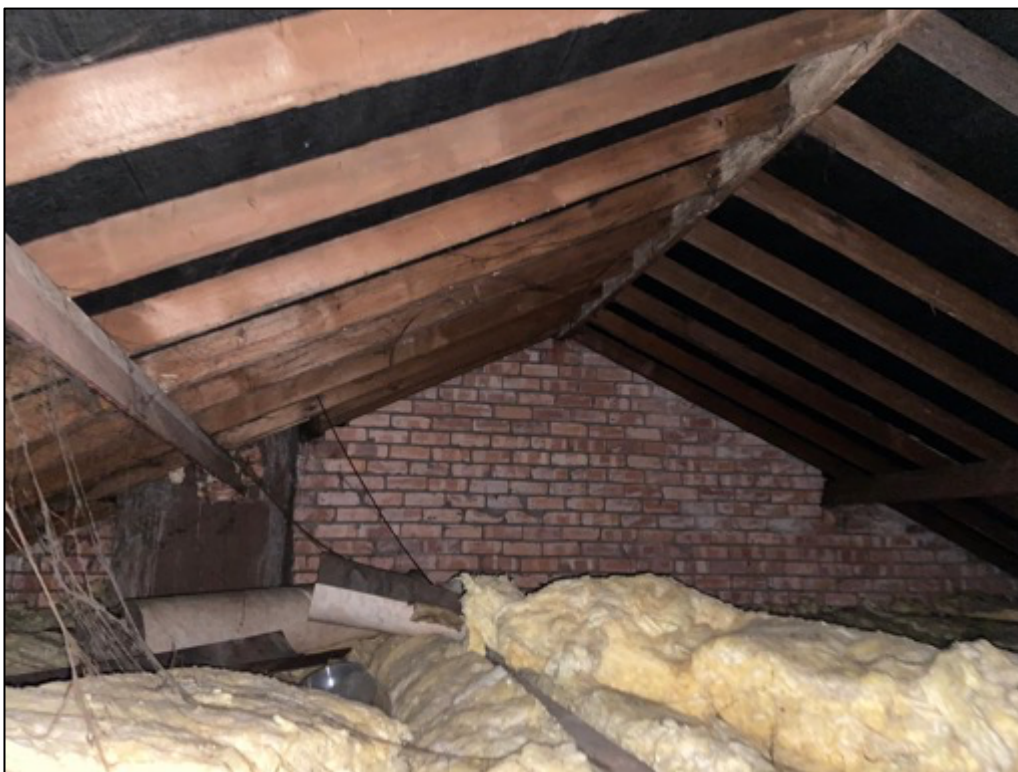
**Photograph 6;** An internal view of the building loft space. Standard insulation material is scattered across the loft floor, with no signs of previous bat usage or bird nesting noted during the survey.

The interior of the building was thoroughly checked for evidence of roosting bats, of which none was found. No signs of active or previous bird nesting were noted within the building.

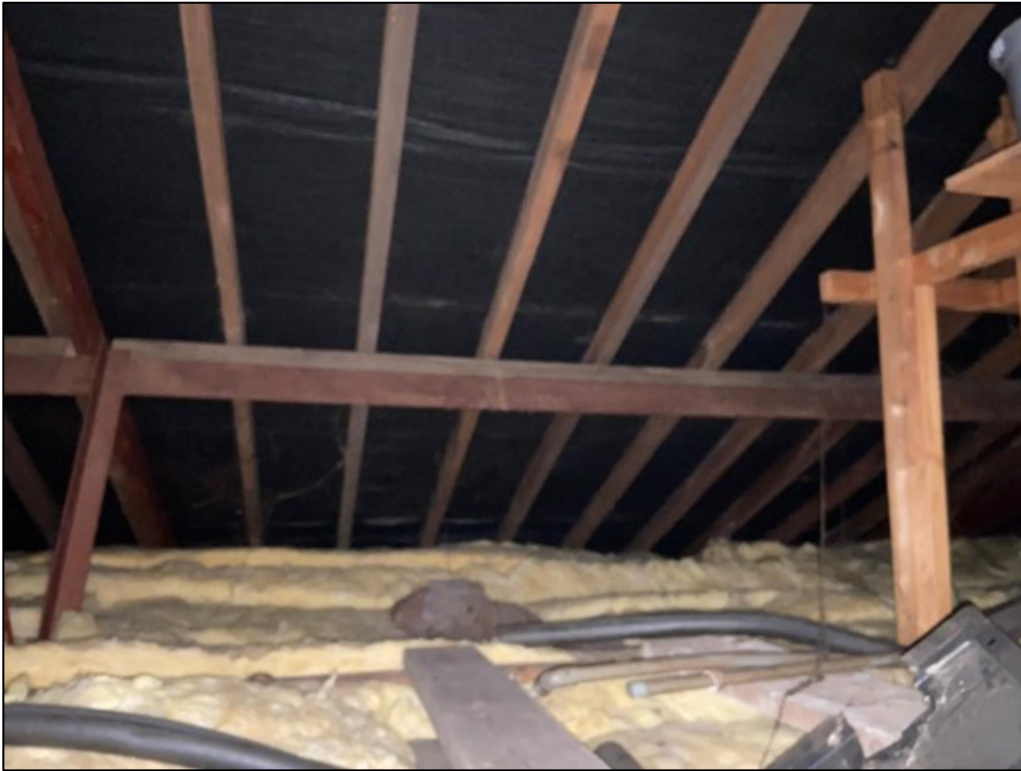
**Photograph 7;** Another view of the internal loft space. Wooden purlins and rafters support the roof, with some steel support beams also noted. The external roof features a felt membrane beneath; this membrane is in very good condition.

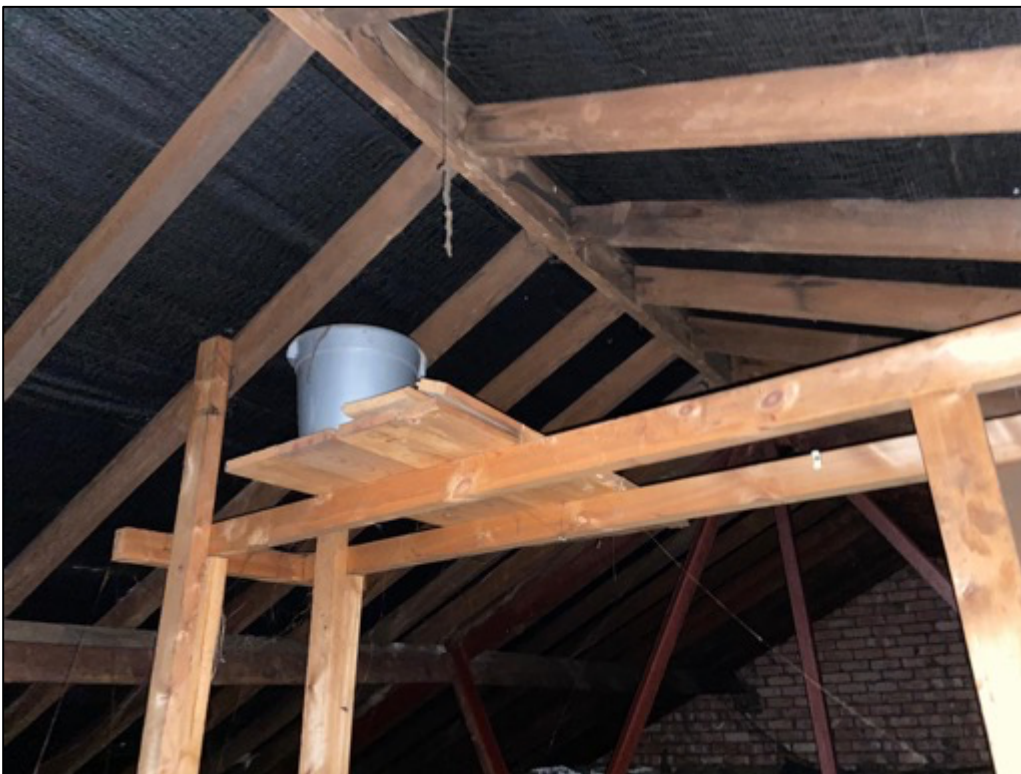
**Photograph 8;** Internal walls are in good condition also, with no displacement exposing cavities and sealed to intersecting purlins and rafters.

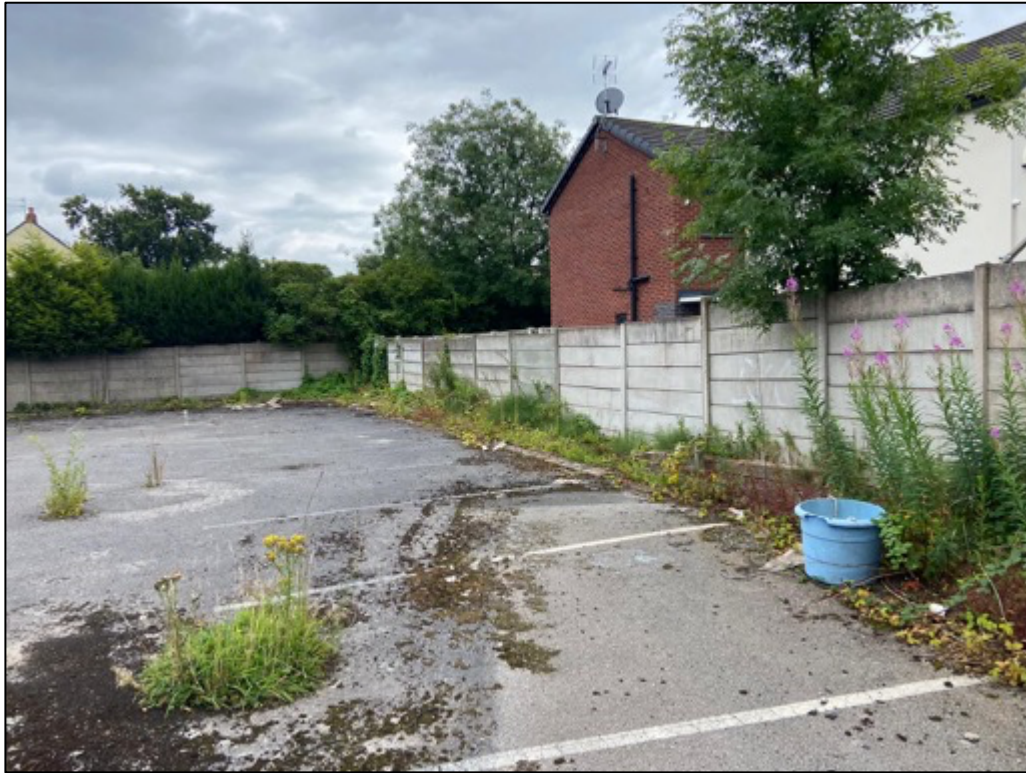
**Photograph 9;** The hard standing footprint that dominates the site is a former parking area for the pub. Standard hard standing fencing splits the site from an adjacent residential property. Some minor scrub features around the hard standing.

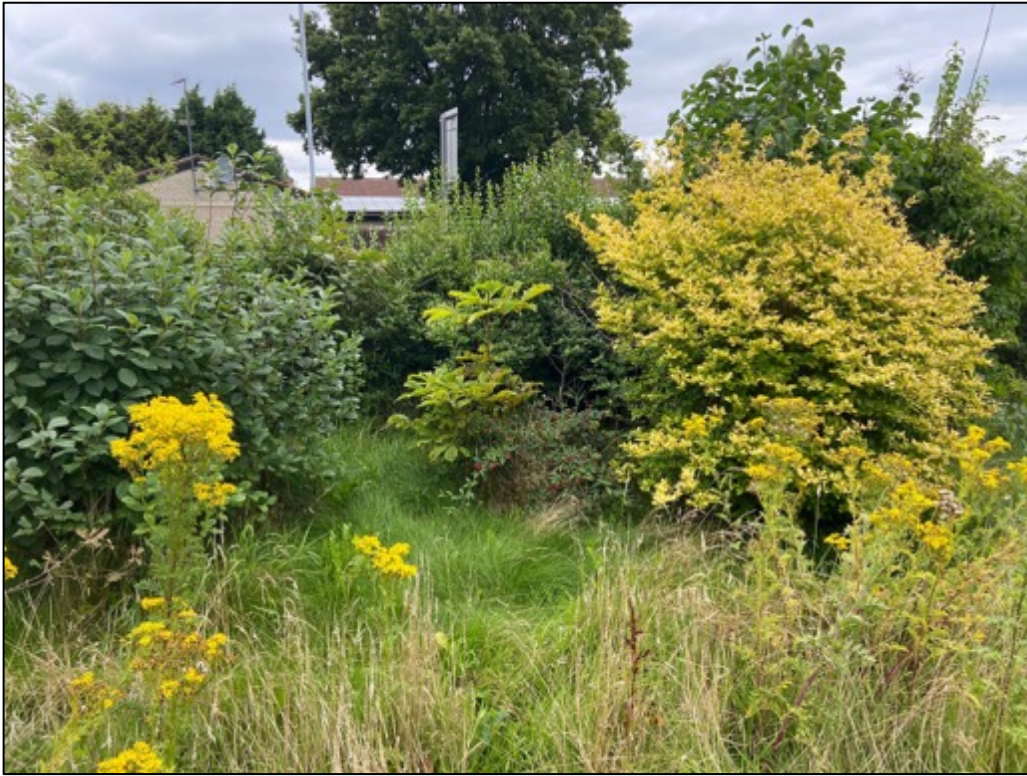
**Photograph 11;** Image shows a cluster of amenity planted bushes, acting as a buffer between the site and the adjacent Kingsgate road. These bushes sit atop previously maintained amenity grassland that has overgrown in the time since its closure.

The amenity bushes and dense hedgerow acting as a buffer from the adjacent main roads offer ideal bird nesting habitat. **it is recommended that the demolition and removal work be done outside of the bird nesting season (March-August) or after a thorough check for active nesting by a qualified ecologist directly prior to demolition work beginning.**

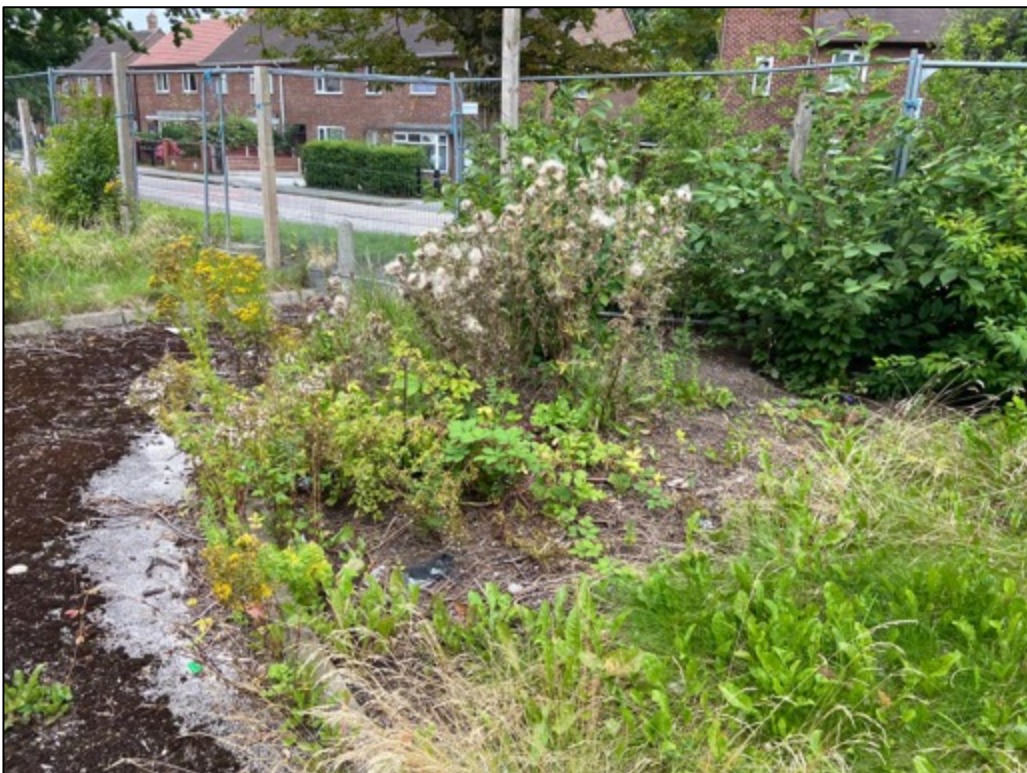
**Photograph 12;** Another section of planted bushes. These sections have developed due to their lack of management.

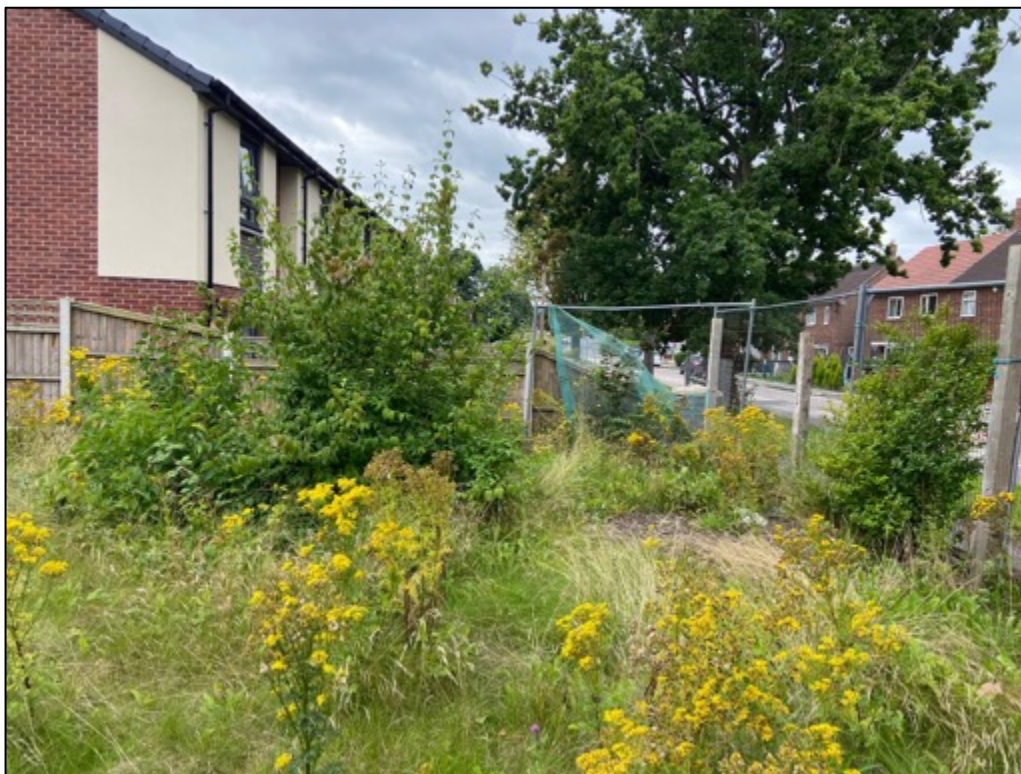
**Photograph 13;** Shows another overgrown section of amenity grassland bushes in the south western corner of the site.

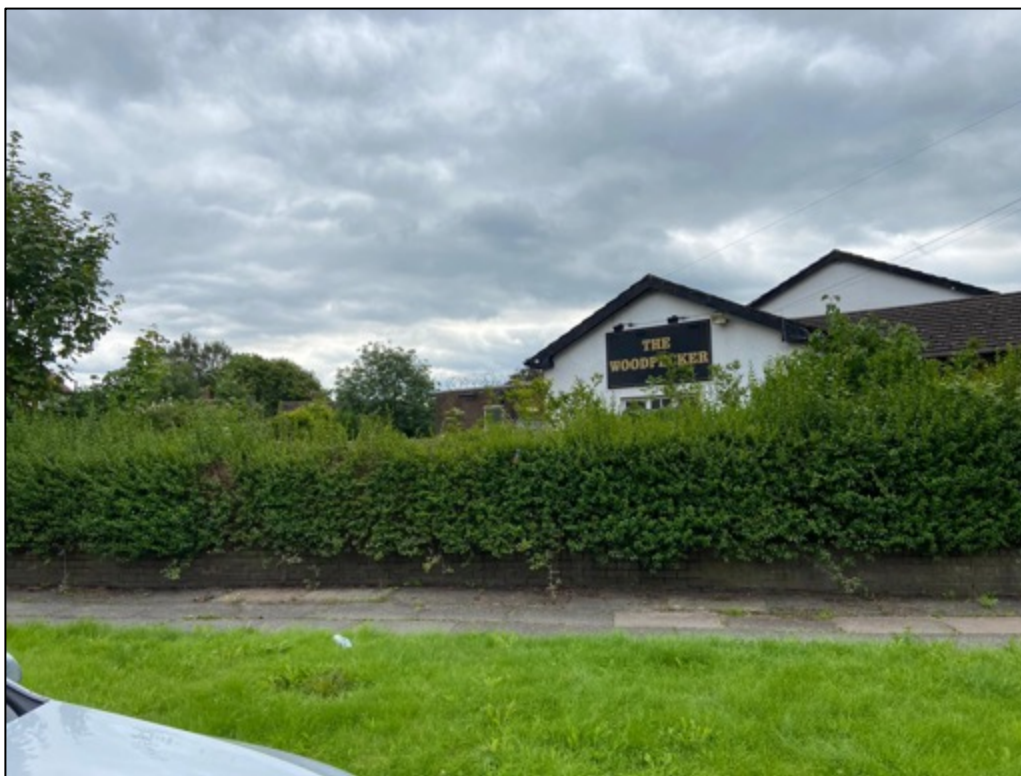
**Photograph 14;** A species-poor hedgerow found along the northern border of the site, comprising of mostly unmaintained laurel.
