117-119 Portland Street, Manchester  
Heritage Statement

April 2024

Appendix C - Detailed Architectural Significance Assessment  
and Photographic Record

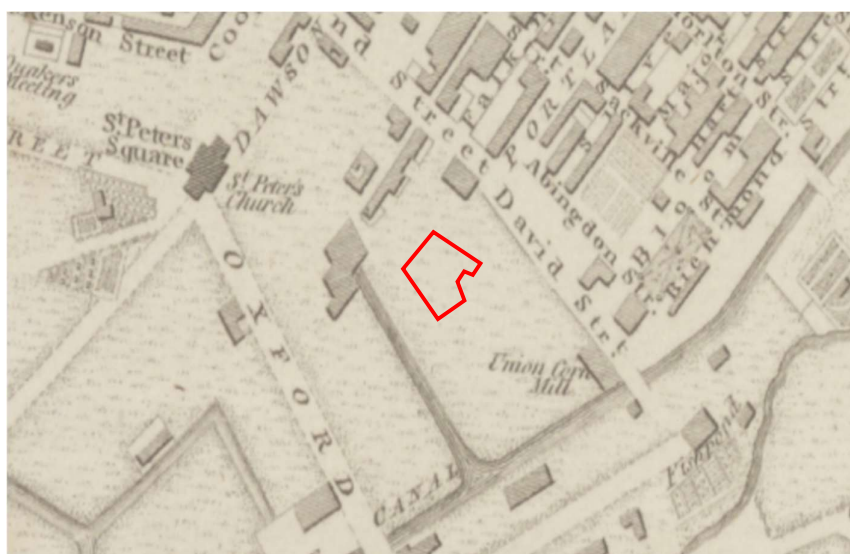
Figure 2 - Excerpt from Roper map 1807 with approximate area of the site indicated by a red line (Manchester Historical Maps accessed 6 February 2024<sup>11</sup>)

- 2.33. Figure 2 shows that the site was vacant in 1807 and development is concentrated towards the north and east of the site. Development around the site is limited to a few industrial buildings such as Union Corn Mill. The industrial building closest to the site can be seen having a canal arm connection from Rochdale Canal. St. Peter's Church which initially occupied St. Peter's Square is in close proximity. Portland Street and Faulkner Street which then ended at David Street have some development on either side. Oxford Road though defined as a major roadway has very little development surrounding it.

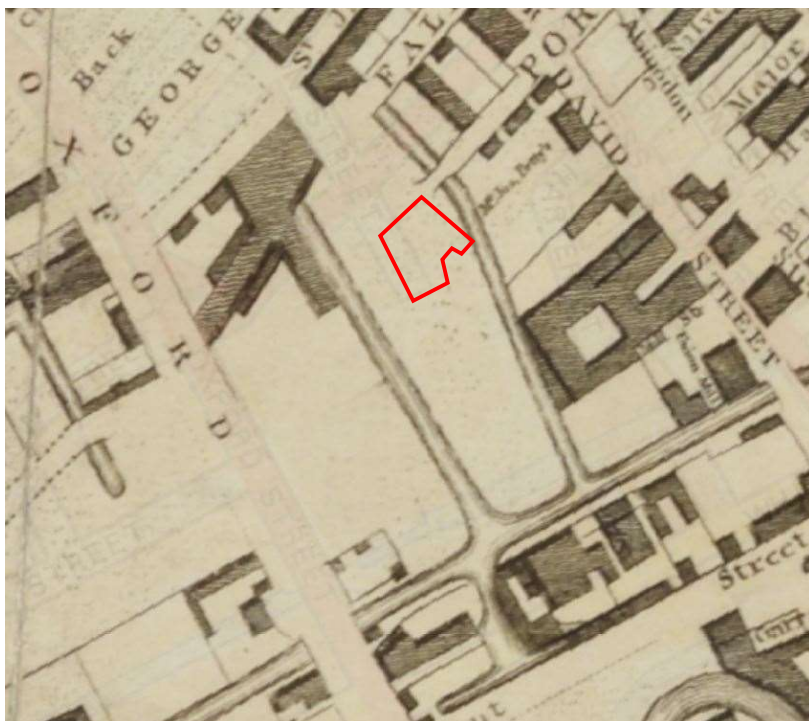
Figure 4 - Excerpt from A Plan of Manchester and Salford, surveyed 1821 by James Pigot with approximate area of the site indicated by a red line (Maps collection of the University of Manchester online accessed 24 January 2024<sup>13</sup>).

- 2.35. Figure 4 shows an increase in industrial development around the Site in 1821, which is still vacant. There is growing development around David Street and the Rochdale Canal to the south of the site. The site is now located between two canal arms drawn from Rochdale Canal to provide water to the growing industries, which would depend on them to run their steam powered engines.

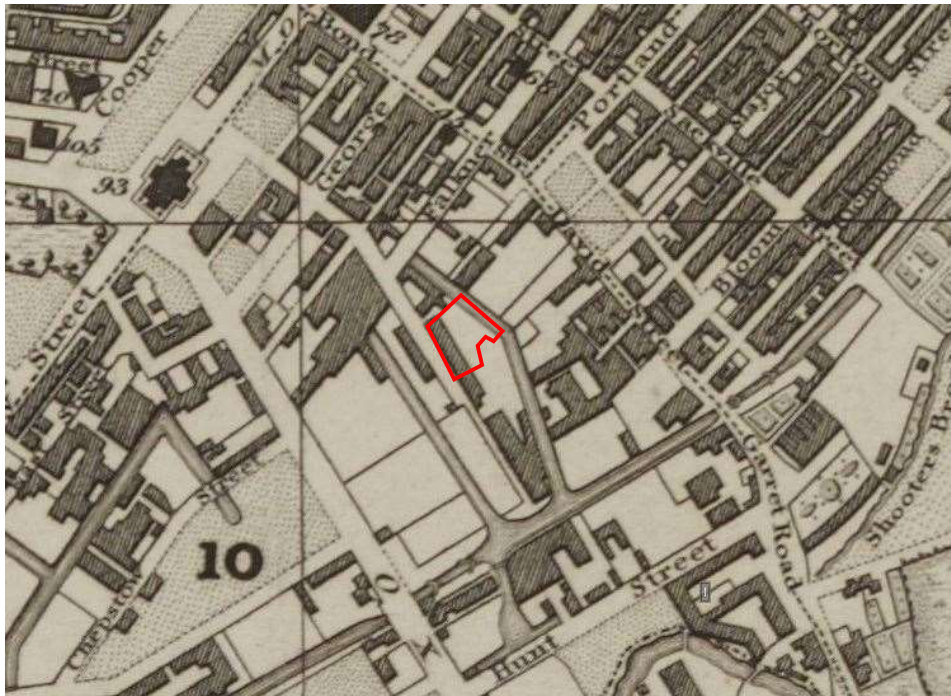
Figure 5 - Excerpt from Manchester and its Environs, surveyed in 1824 by William Swire with approximate area of the site indicated by a red line (Maps collection of the University of Manchester online accessed 24 January 2024<sup>14</sup>).

- 2.36. Figure 5 is the first map which shows industrial development on the site along the canal arm in 1824. The site is partially occupied by a linear building bounded by the new Dickinson Street and the canal arm to the east, which as seen in Figure 6 is part of a larger industrial development, Globe Ironworks. The canal arm to the west of the site can be seen servicing another industrial development on the opposite side of Dickinson Street. There has also been more development around St Peter's Church by this point and between David Street and the site.

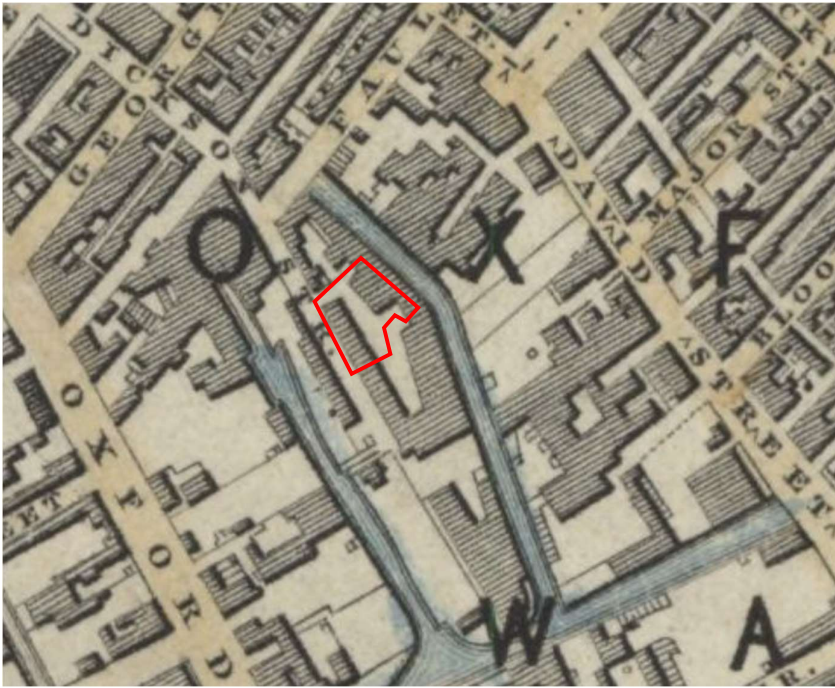
Figure 6 - Excerpt from Lancashire Sheet CIV Surveyed 1845 with approximate area of the site indicated by red line (National Library of Scotland accessed 24 January 2024<sup>15</sup>). The Site is occupied by the vast Globe Ironworks

- 2.37. The Globe Ironworks (shown in Figure 6 and identified in Figure 7), founded by Richard Roberts and various partners circa. 1821-1858, was established on the previously identified vacant area, covering a vast amount of space. Its northern end fronts onto Faulkner Street, eastern end onto canal arm, southern end onto the Dickinson Street Mill, and western front along Dickinson Street.

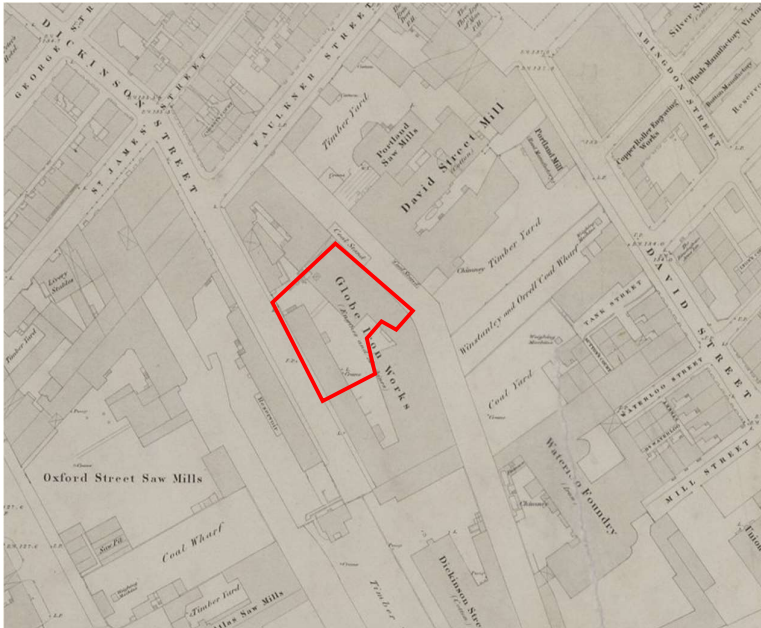
Figure 7 - Excerpt from Ordnance survey five feet to one statute mile. Manchester and Salford Surveyed 1851 with approximate area of the site indicated by red line (Maps collection of the University of Manchester online accessed 24 January 2024<sup>16</sup>).

- 2.38. Figure 7 suggests that by 1851 the Site was surrounded by major industrial developments such as David Street Mill, Oxford Street Saw Mills, Atlas Saw Mills, Waterloo Foundry, Portland Saw Mills and timber yards. The canal arms were used as reservoirs for these industries. While the areas north of the site around St James Street have regular grid patterns with worker housing, the area around the site and Rochdale Canal is interspersed with large industrial buildings.

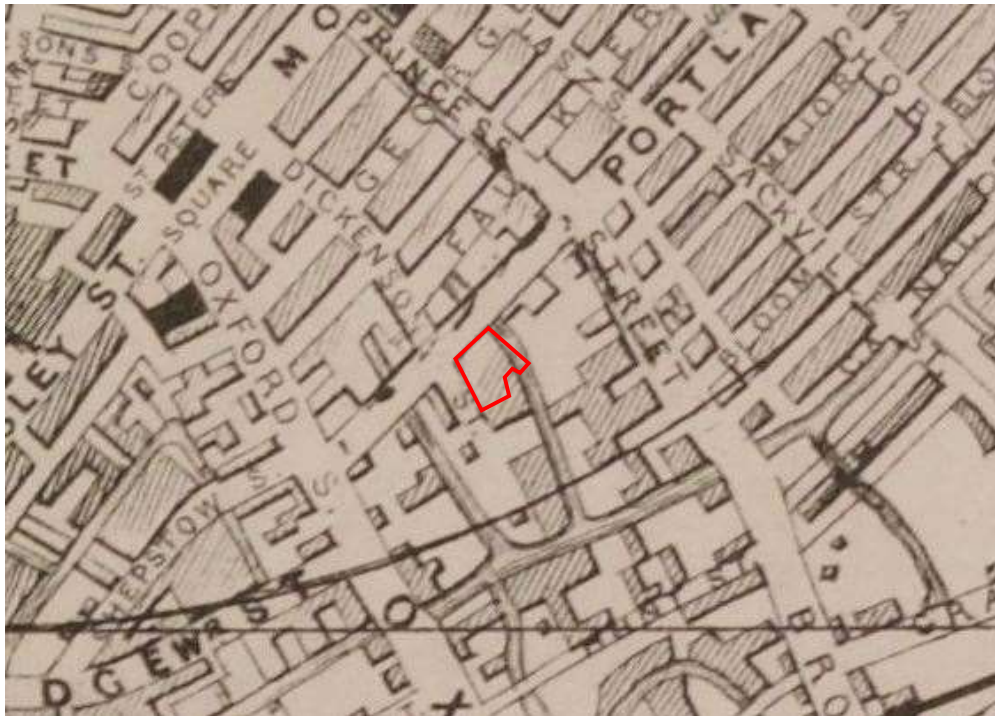
Figure 10 - Excerpt from Bacon Coloured map, surveyed 1878 with approximate area of the site indicated by red line (Manchester Libraries, Information and Archives, Manchester City Council<sup>19</sup>)

- 2.41. Between 1876 and 1878 David Street was renamed to Princess Street as seen in Figure 10. The map is at a block level and not very detailed and therefore it cannot be confirmed if the courtyard space seen within the block in Figure 9 still existed at this point.

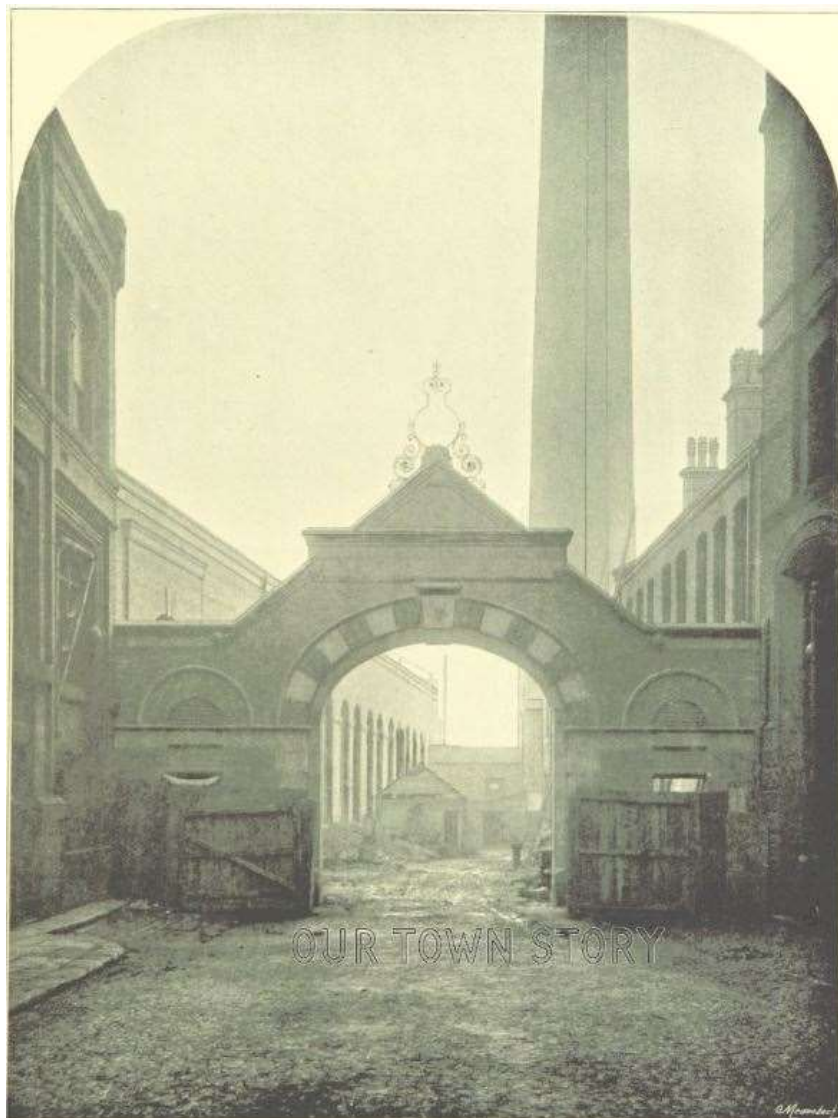
Figure 14- Dickinson street power station c.1890 with the lower section of 119 Portland Street just visible (Our Town Story, accessed 22 March 2024<sup>24</sup>).

- 2.46. Figure 14 shows an image of Dickinson Street power station and the now demolished building to the rear of 117-119 Portland Street. This was confirmed by correlating Figure 14 and the 1891 map on Figure 15. It was only two storeys tall and replicated the architectural details found in the rest of the building. This suggests that this building was a part of 117-119 Portland Street and would explain some of the remaining interior features in the rear of the extant building, including suggestion of a chimney breast. The gate to the power station between 117-119 Portland Street and 125 Portland Street as shown in Figure 14 has also now been demolished.

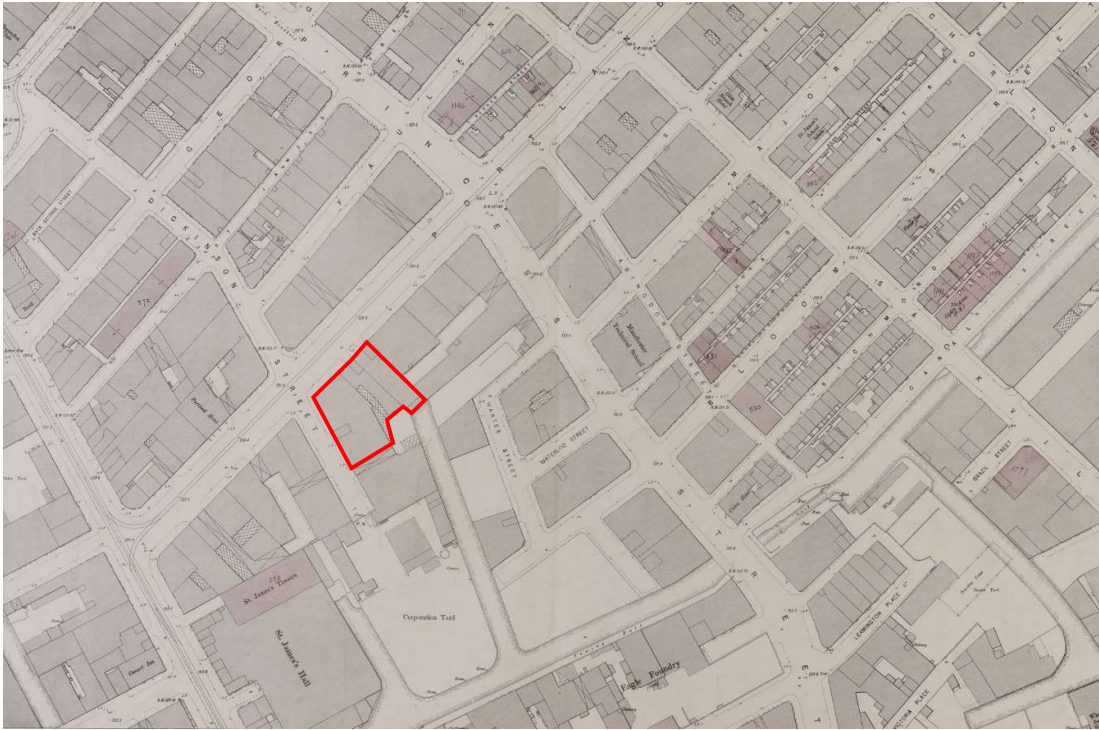
Figure 15 Excerpt from Ordnance Survey Map Surveyed 1891 with approximate area of the Site indicated by red (Maps collection of the University of Manchester online accessed 24 January 2024<sup>25</sup>).

- 2.47. Figure 12 and Figure 15 suggest that further beyond the site is the vacant Corporation Yard, while to the west is St James' Theatre. Slater's Directory also suggests that 111 Portland Street housed the Austrian and Hungarian Consulate. This shows the gradual shift in urban landscape around the site, from a heavy industrial character to an important trade, business and cultural area.

- 2.48. The building form in 1896 is as per shown in Figure 12 in 1886 and Figure 15 in 1891, albeit the atriums and rooflights are also more clearly visible on this plan on buildings across the area. The Corporation Electric Light Station building was built in 1893 on the site of the current Linley House, to the south of the site. This station served an area of up to half a square mile around it. While the canal arm north the the site has not undergone any change, the canal arm to the west of the site can be seen further truncated, giving way to more commercial and cultural floorspace.

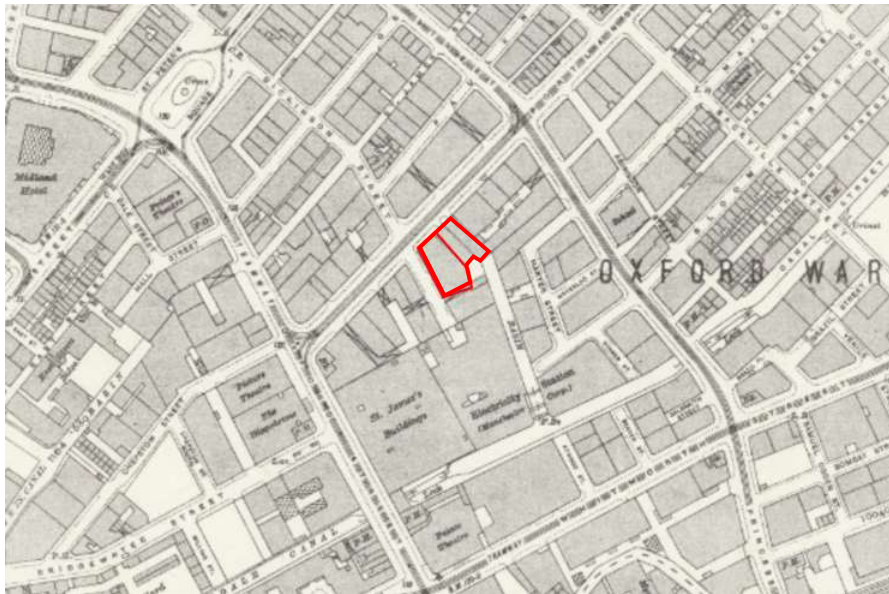
Figure 17 – Excerpt from Lancashire CIV.10 1915-1916 with approximate area of the Site indicated by red line (National Library of Scotland accessed 28 January 2024<sup>27</sup>).

- 2.49. By 1915 (Figure 17) due to increased demand of electricity, a second power station was built across the canal basin arm to the north of the Site, on the plot on Bloom Street. A footbridge close to the Rochdale canal had been built to facilitate movement between the two electricity stations. There has been further development on remaining vacant plots along Whitworth Street. While there were still some industrial buildings remaining in 1915 around the site such as the Chepstow Street mill, they were quickly being replaced by more cultural buildings. For instance, the Hippodrome and the Picture Theatre were developed along Oxford Road close to Chepstow Street mill and the Timber Yard block in the same area was also further developed.

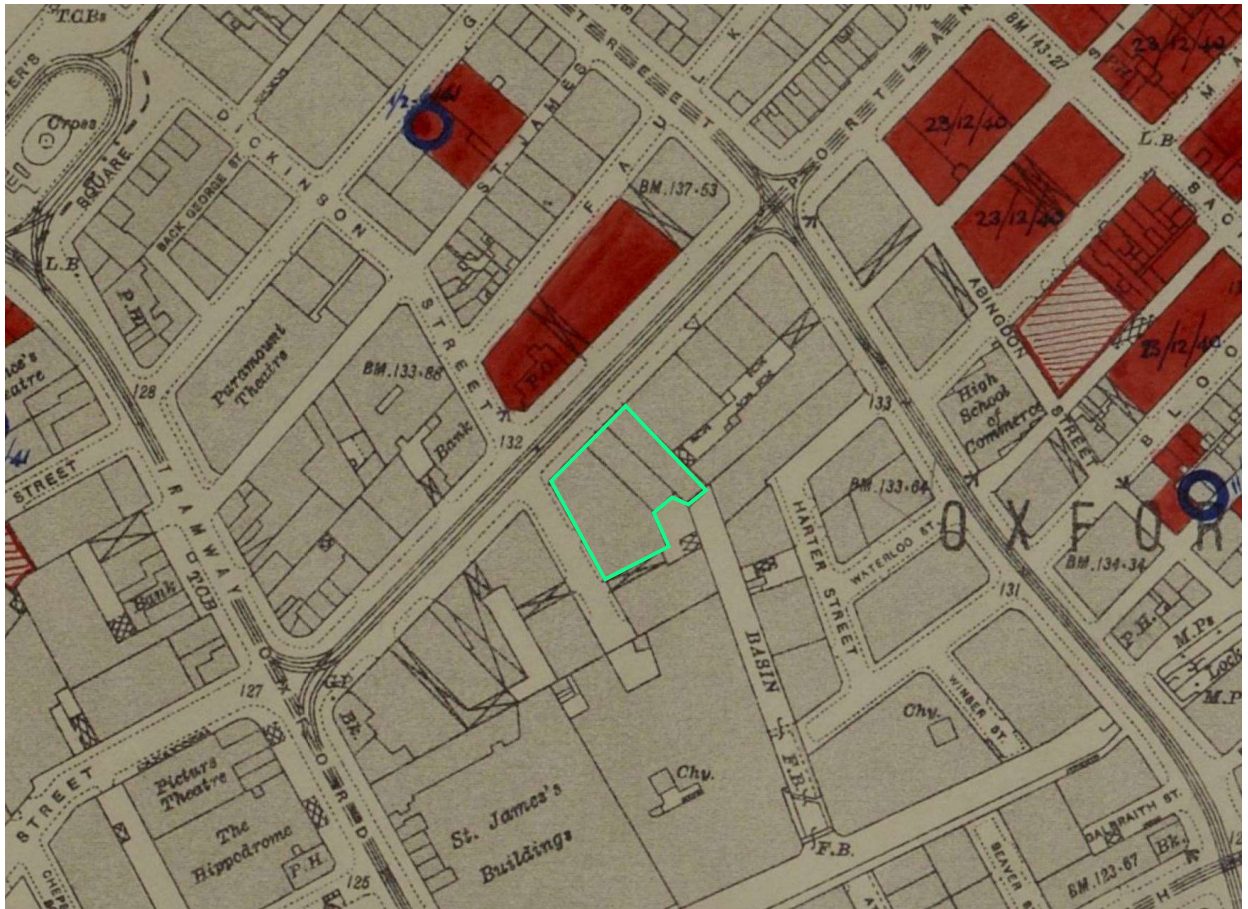
Figure 18- Excerpt from Manchester Bomb damage Map, surveyed 1940-1941 with approximate area of the Site indicated by green line. The areas hit by bombs are marked in red. (Maps collection of the University of Manchester online accessed 28 January 2024<sup>28</sup>).

- 2.50. The Site was unharmed in the Christmas Blitz in 1940 (Figure 18), however 21 Dickinson Street, 98 and 96 Portland Street opposite the Site sustained considerable damage. While the canal basin to the west of the site has been completely filled by 1940, the canal basin to the north of the site is still intact.

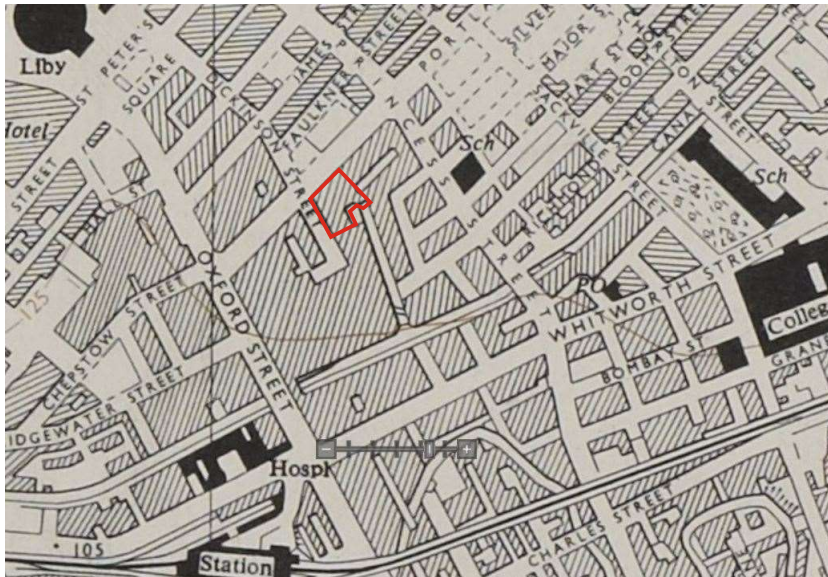
Figure 19- Excerpt from Ordnance survey map, National grid series, surveyed 1954 (SJ 89 NW) Site boundary marked in red. (Maps collection of the University of Manchester online accessed 28 January 2024<sup>29</sup>..

- 2.51. Figure 19 showing the map from 1954 shows that the canal basin arm and footbridge north of the site was still existing. The buildings along Portland Street Sackville Street and Oxford Street which were destroyed in the Christmas Blitz have not been rebuilt yet.

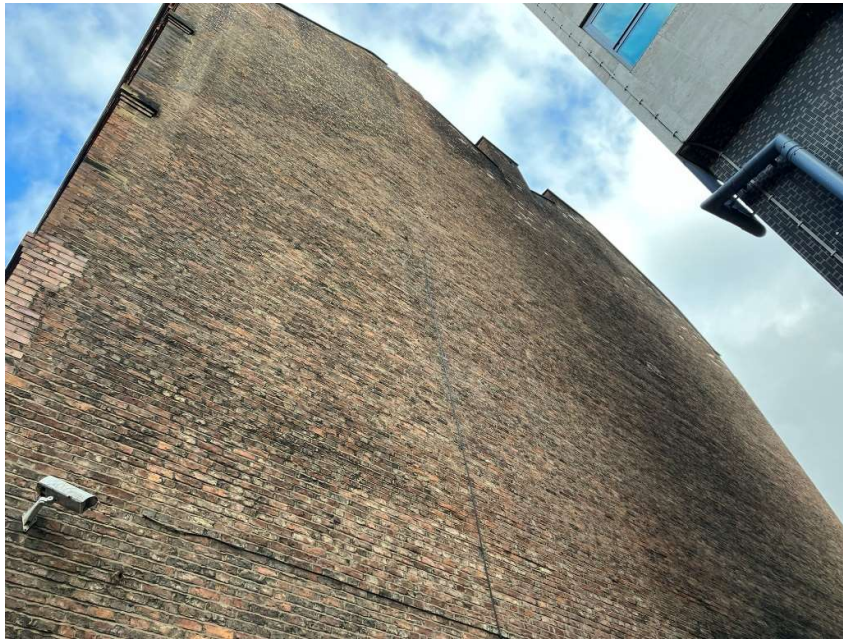
Figure 21- Exposed brick wall at the back of 117-119 Portland Street facing Linley House (Author's own image, 09 January 2024)

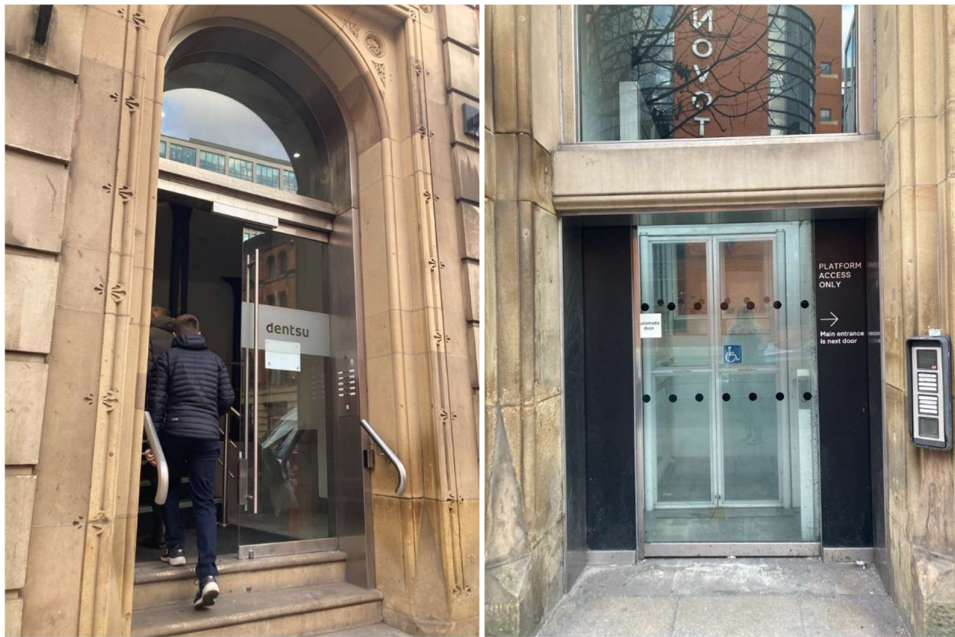
Figure 24 - Main entrance and disabled access from Portland Street. (Authors Own Image 09 Jan 2024)

- 5.9. The Site has an ornate entrance facing onto Portland Street that is located directly adjacent to the 113-115 Portland Street building. On the façade facing onto Portland Street, windows are allocated with “B-B-B-A” configuration ornated by detailed stone work, which evolve from one level to another. This is replicated on the façade facing onto Dickinson Street where windows are allocated with “A-B-B-B-B-C-B-B-B” configuration, ornated by different detailed stonework on different levels, same style to the façade facing onto Portland Street. This fenestration pattern presents an impressive experience at ground level as a pedestrian and shows high artistic interest. All stonework across the building is of high significance.

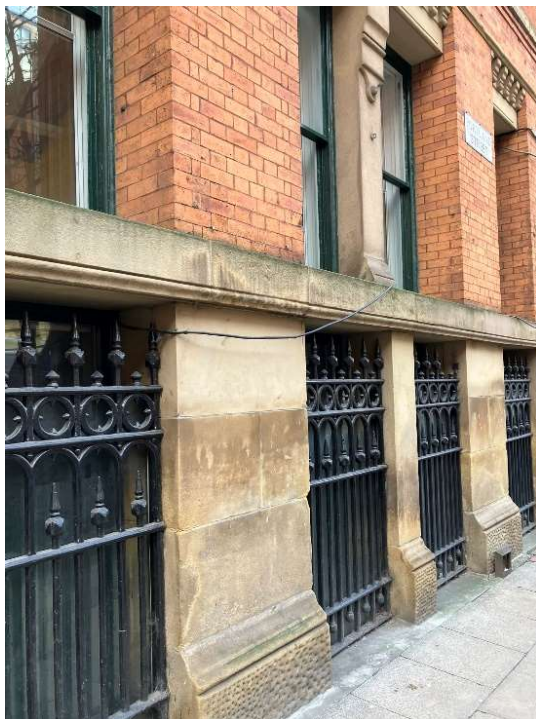
Figure 25 - Elaborate cast iron railings on Portland Street and Dickinson Street façades (Author's Own Image 09 Jan 2024)

- 5.10. Elaborate cast iron railings along the Portland Street and Dickinson Street façades that would have protected the basement windows are of high significance.

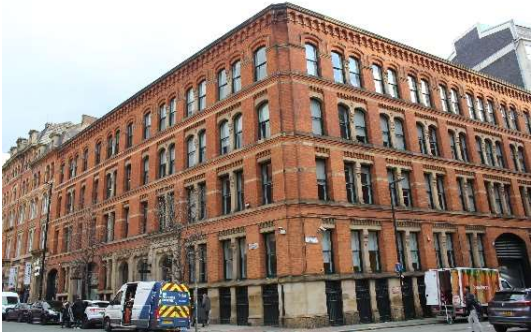
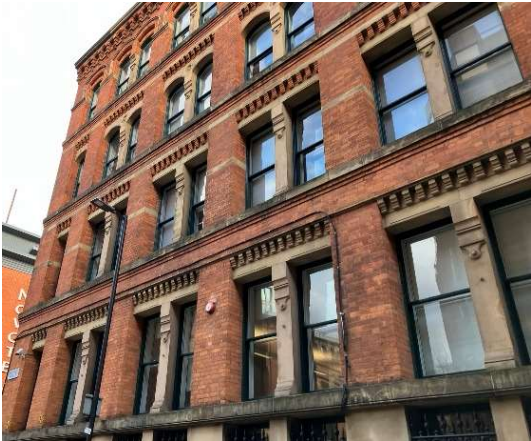
| Sr. no | Item | Description | Images (all author's own) |
|---|---|---|---|
| 1 | External walls | <p>External walls of the Site are constructed with red bricks laid out in Flemish bond, with sandstone and brick dressings. It has a rusticated stone base with arched entrances. Loosely based on the Italian Palazzo style, the external façade features Italian Renaissance and Gothic features.</p> <p>Each storey is boldly defined by a stone string-course, forming the sills of the recessed windows. An elaborate Lombard frieze runs along the top of the Portland Street and Dickinson Street facades, below the roof. Simpler brick friezes can also be found above the window openings on both the façades on the first and second floors while the ground floor has a sandstone frieze.</p> | <p>Figure 1- Facade of building along Portland Street and Dickinson Street</p> <p>Figure 2- Dickinson Street facade details</p> |

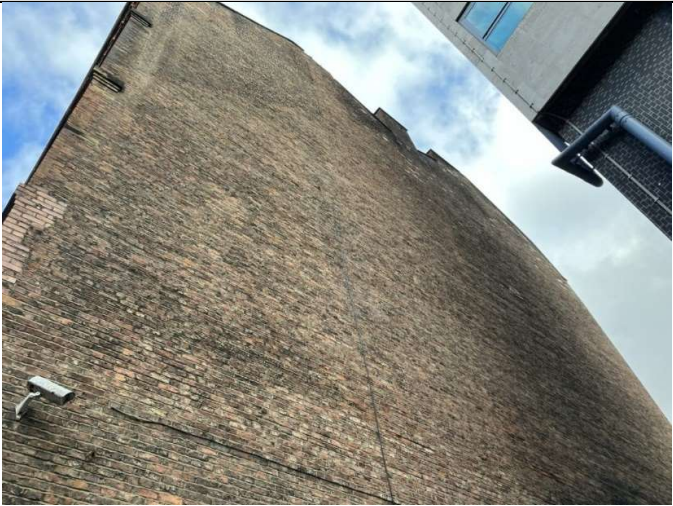
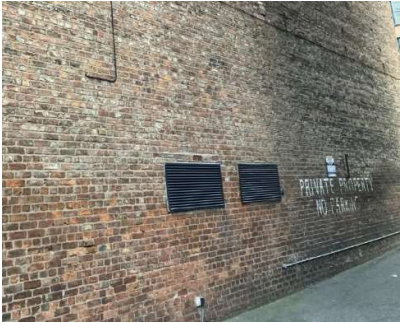
| Sr. no | Item | Description | Images (all author's own) |
|---|---|---|---|
| | | <p>The gable wall to the rear of the building is plain and was previously attached to another block, demolished around 1963.</p> <p>Louvres found at the bottom of the wall are modern interventions and of no significance</p> | <div><p>Figure 3- Rear gable wall</p><p>Figure 4- Louvers on rear gable wall</p></div> |

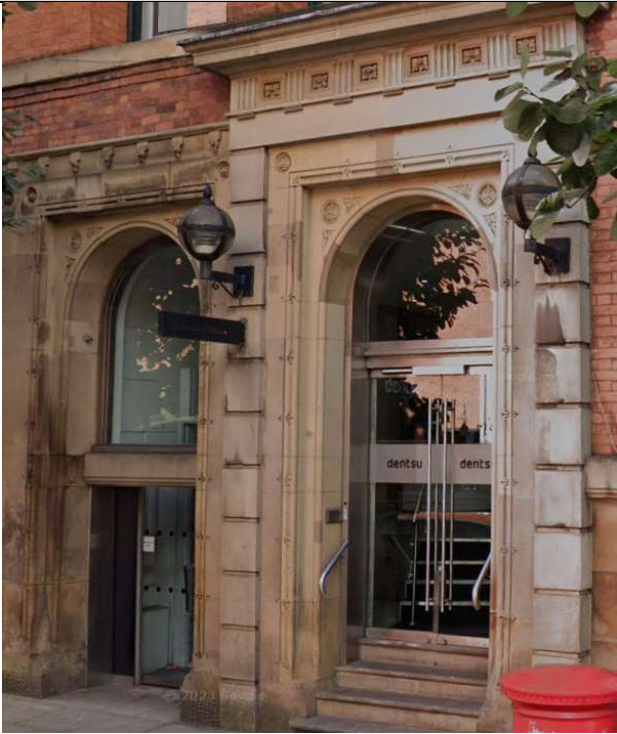
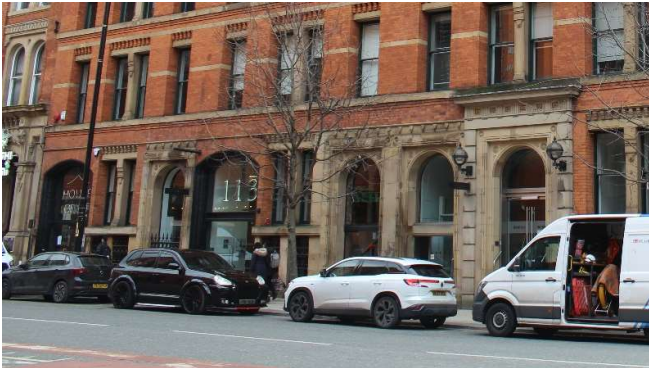
| Sr. no | Item | Description | Images (all author's own) |
|---|---|---|---|
| 2 | Entrance and exits | <p><b>Portland Street entrances</b></p> <p>Ornate main entrance on Portland Street with detailed sandstone work. The entrance to the raised ground floor has a semi-circular arch with stone masonry blocks framing the arches and decorative frieze. Glass entrance doors are a modern intervention and of no significance.</p> <p>Adjacent to this main entrance is a series of three secondary entrances and two loading bays. The one immediately adjacent to the main entrance also enters 117-119 and could have originally provided a separate entrance to this building. It is now utilised as a disabled access entrance with a modern platform lift inserted inside. The glazing and glass doors are of no significance.</p> | <div><p>Figure 5 - Entrances on Portland Street to 117-119</p><p>Figure 6 – Series of entrances on Portland Street to from 113-119, including loading bays</p></div> |

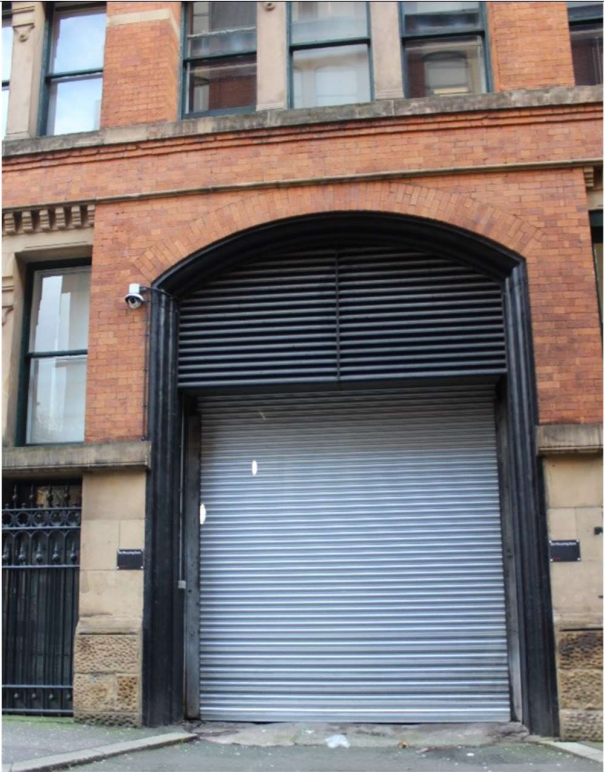
| Sr. no | Item | Description | Images (all author's own) |
|---|---|---|---|
| 3 | | <p><b>Dickinson Street: extant and former loading</b></p> <p>The loading bay is original to the building. There is no evidence of gates or an original barrier and the secure line was likely within the building. The loading bay has a modern roller shutter, which is of no significance.</p> <p><i>NB. Further inspection to be undertaken on site to confirm.</i></p> <p>There is also a fire exit door located immediately to the right, which has been placed in an original window opening and makes no contribution to the significance.</p> <p>Steel beams (outlined in red) can be seen at Figure 8 above and below the ground floor windows. There is also evidence of newer brick infills in between, which, along with the hoist in Figure 9, indicates these are likely to have been openings for loading goods into the building.</p> | <div><p>Figure 7- Loading bay entrance on Dickinson Street</p></div> <div><p>Figure 8- Fire exit and former loading areas, Dickinson Street</p></div> |

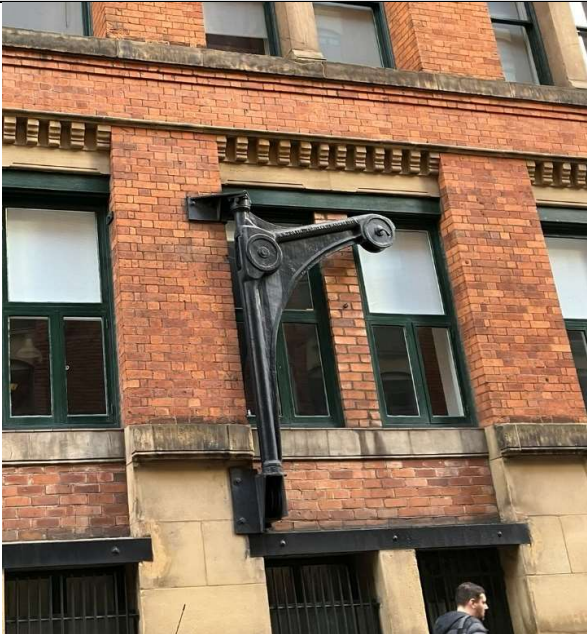
| Sr. no | Item | Description | Images (all author's own) |
|---|---|---|---|
| 4 | Hoist | <p>Cast iron hoist (now redundant) present on Dickinson Street shows this façade was used for loading and unloading. The hoist is of high significance as it relates back to the historic use of the building.</p> | <p>Figure 9- Cast iron hoist on Dickinson Street</p> |

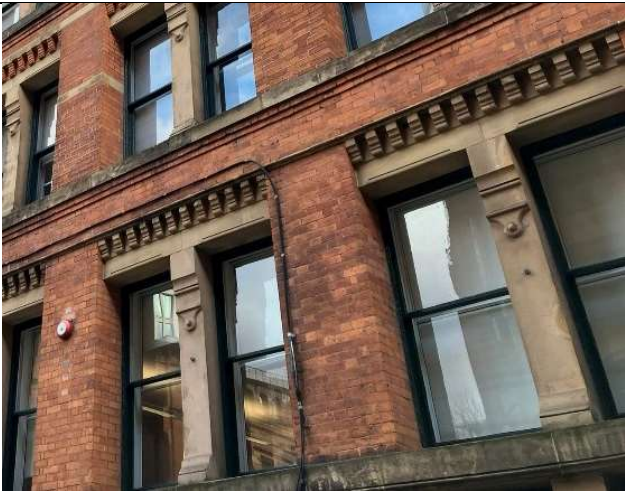
| Sr. no | Item | Description | Images (all author's own) |
|---|---|---|---|
| 5 | Windows and openings | <p>Window fenestrations are allocated with “B-B-B-A” configuration ornated by detailed stonework on the façade fronting Portland Street, whilst windows are allocated with “A-B-B-B-B-C-B-B-B-B” configuration on façade fronting onto Dickinson Street.</p> <p>The windows are slightly recessed from the brick facades and feature simple brick and sandstone friezes above them. Sandstone bands running across both</p> | <p>Figure 10- Rectangular windows with horizontal lintels on ground and first</p> |

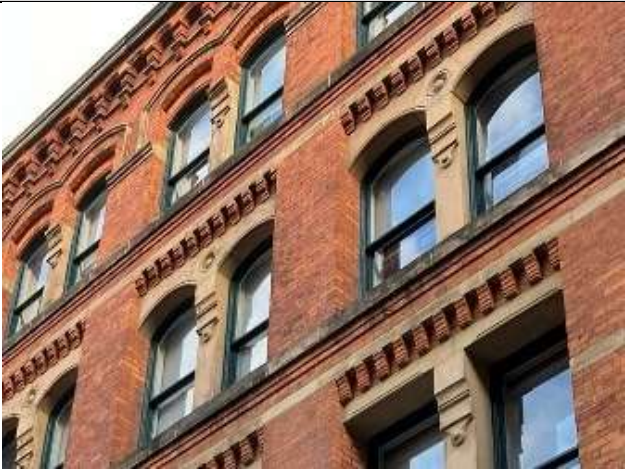
| Sr. no | Item | Description | Images (all author's own) |
|---|---|---|---|
| | | <p>facades form the sills of the windows on each floor. While the ground and first floors have rectangular windows, the second and third floors have windows with curved lintels.</p> <p>It is believed the windows are original and of high significance. They are top hung sash windows throughout, and have had a secondary glazing inserted, which is a modern intervention.</p> | <p>Figure 11- Windows with curved lintels on second and third floors</p> |

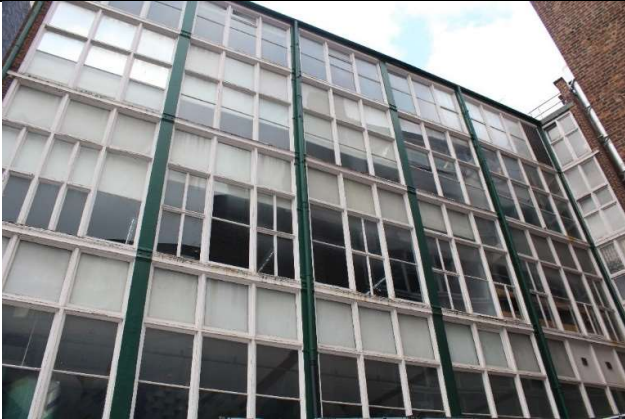
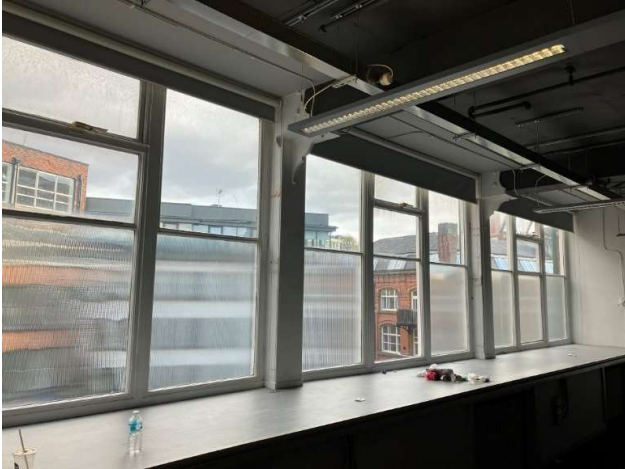
| Sr. no | Item | Description | Images (all author's own) |
|---|---|---|---|
| 6 | | <p>The rear eastern glazed (early) curtain wall, is of high architectural and historical significance. It was used to maximise light into the floors to facilitate better viewing of products on the adjacent tables.</p> <p>Some of the glass has been replaced over the years with privacy glass which is of less significance.</p> | <p>Figure 12- Rear (east) glazed facade of the Site</p> <p>Figure 13- Internal view of the rear (east) glazed façade showing the single glazed window, with modern interventions such as blinds and lighting.</p> |

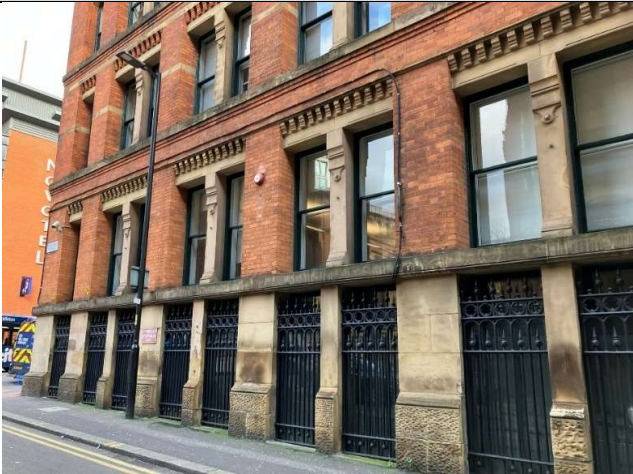
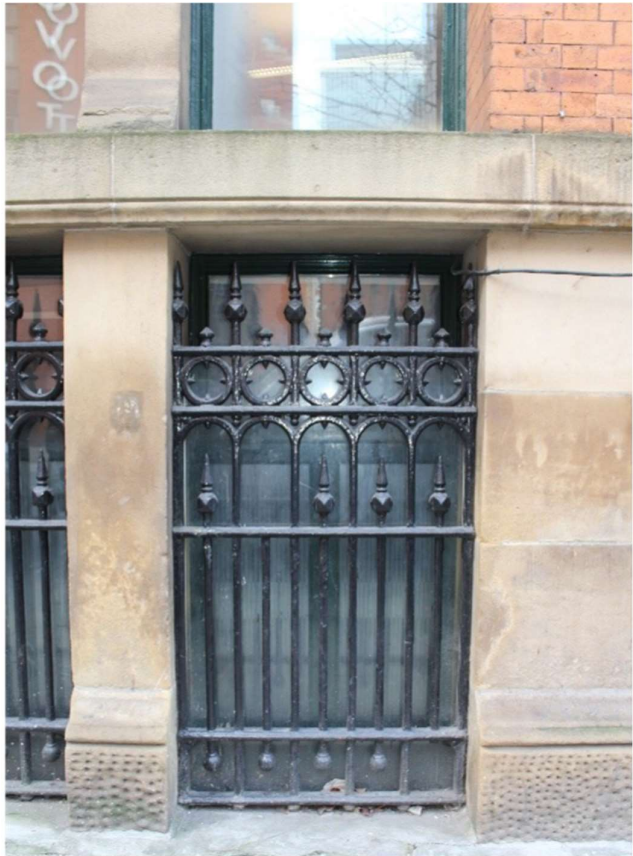
| Sr. no | Item | Description | Images (all author's own) |
|---|---|---|---|
| 7 | Cast Iron railing | <p>Elaborate Victorian cast iron railing with finials along the Portland Street and Dickinson Street façades that would have protected the basement windows are of high significance.</p> <p>They may have originally been painted green as during the Victorian times black paint took a considerable time to dry. It was only after alkyd resin fast drying black paints became commercially available post WWII, there was a trend of painting railings black as they also masked the dirt built up from the polluted air.</p> | <div><p>Figure 14- Cast iron railings, fronting onto Dickinson Street</p></div> <div><p>Figure 15- Detail of cast iron railing, fronting onto Portland Street (north) facade</p></div> |

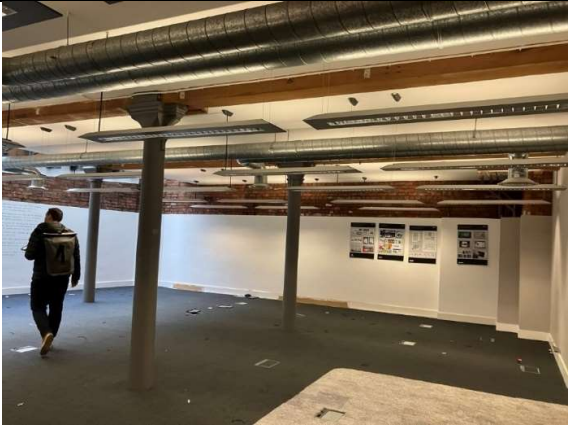
| Sr. no | Item | Description | Images (all author's own) |
|---|---|---|---|
| 9 | Internal structure | Original timber beam and cast iron columns are present throughout this floor; of high significance together with various exposed brick walls; of medium significance. | <p>Figure 17- Original structural elements clearly visible on the lower ground floor</p> |

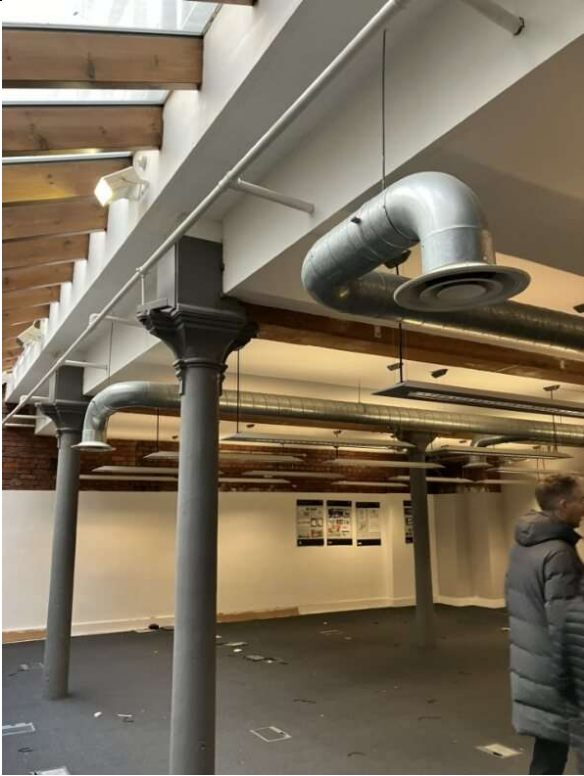
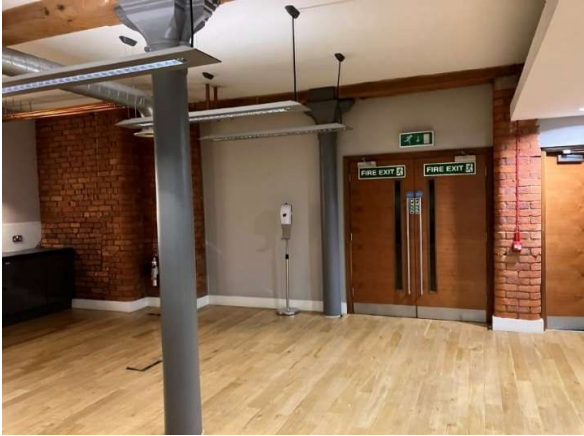
| Sr. no | Item | Description | Images (all author's own) |
|---|---|---|---|
| | | | <div><p>Figure 18- Original cast iron column connected to original timber beam</p><p>Figure 19- Example of exposed brick wall on lower ground floor of medium significance. Modern lighting and later fit out of no significance.</p></div> |

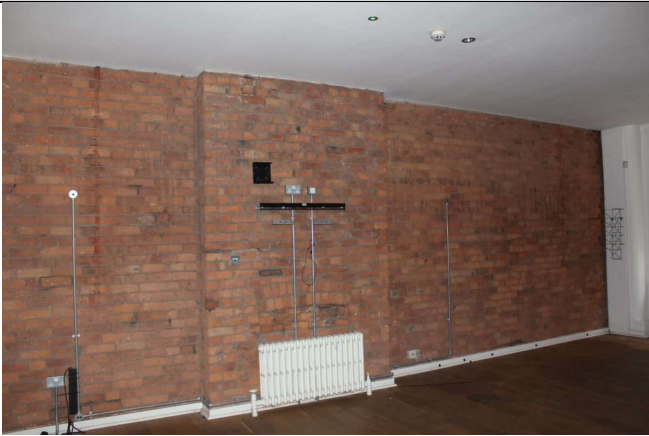
| Sr. no | Item | Description | Images (all author's own) |
|---|---|---|---|
| | | Original brick wall with chimney protrusion. Modern heater has covered up original fireplace which has cambered brickwork on top of it. While the wall is of high significance, the modern fitting is of no significance and has affected the significance of the fireplace. | <p>Figure 20- Original brick wall with chimney protrusion (Author's own image 09 Jan 2024)</p> |

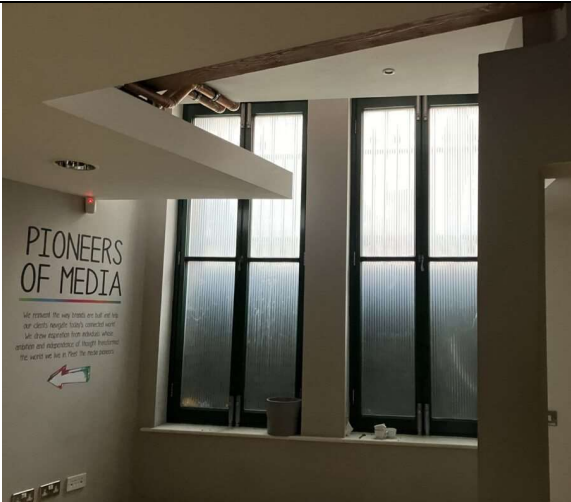
| Sr. no | Item | Description | Images (all author's own) |
|---|---|---|---|
| 10 | Windows and openings | Windows and window fittings in the basement are low quality modern replacements protected by cast iron railing at Street level. The windows are of low significance | <p>Figure 21- Window openings on lower ground floor (Author's own image 09 Jan 2024)</p> |

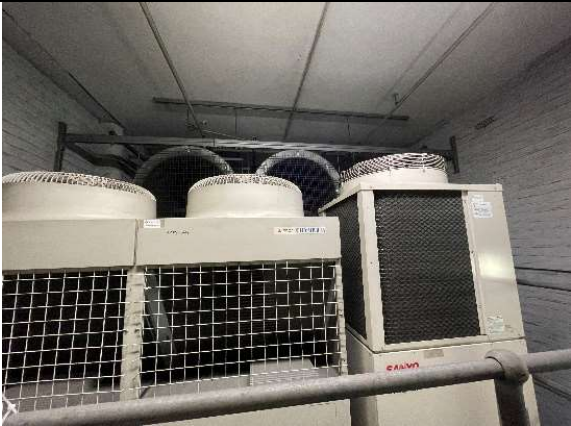
| Sr. no | Item | Description | Images (all author's own) |
|---|---|---|---|
| 12 | Loading bay | <p>Loading bay on lower ground floor off Dickinson Street. Currently used for AC units and bin store. Painted brick walls of medium significance.</p> <p>The bay also has modern features such as ventilation pipes covered in silver insulation material.</p> | <p>Figure 23- AC units (Author's own image 09 Jan 2024)</p> |

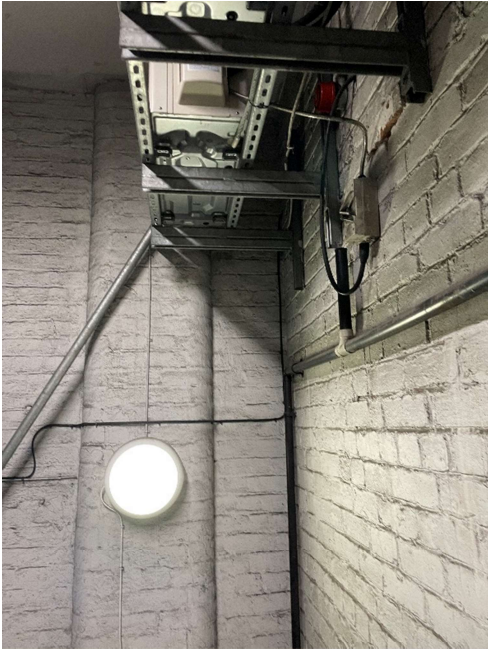
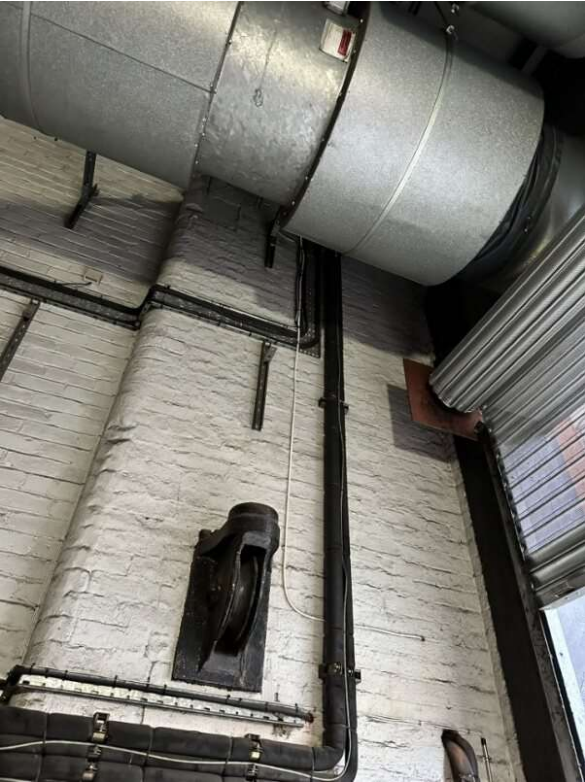
| Sr. no | Item | Description | Images (all author's own) |
|---|---|---|---|
| | | | <div></div> <p>Figure 24- Original brick walls painted white (Author's own image 09 Jan 2024)</p> <div></div> <p>Figure 25- Modern ventilation pipe in loading bay</p> |

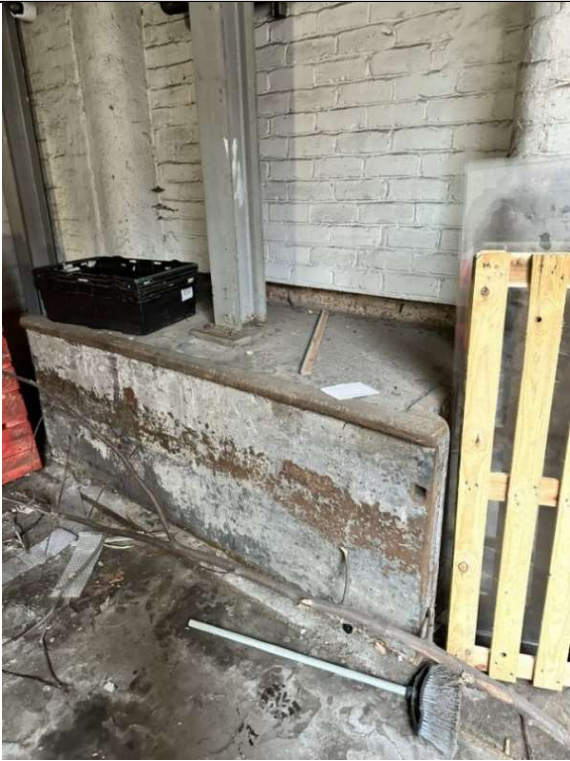
| Sr. no | Item | Description | Images (all author's own) |
|---|---|---|---|
| | | <p>Iron framed box filled with concrete in the loading bay thought to potentially have provided a surface level with the bed of a horse-drawn cart to facilitate the loading and unloading of cloth and safeguarded the internal walls of the loading bay from any potential damage from the carts. The iron framing could have been further reinforcement for the concrete. The marking on the concrete could potentially suggest contact with the carts.</p> <p>The feature is now used as a robust base for modern steel columns supporting the AC units.</p> | <p>Figure 26- Iron framed box (Intrusive investigation 25 March 2024)</p> |

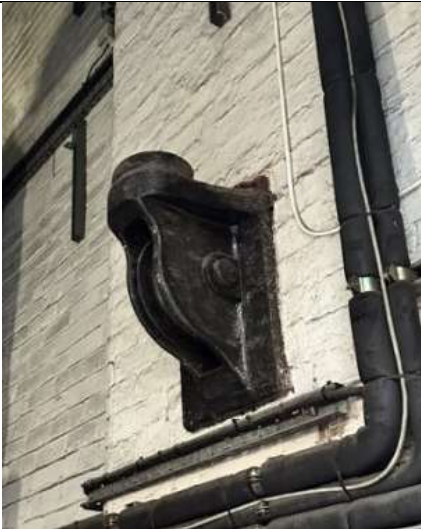
| Sr. no | Item | Description | Images (all author's own) |
|---|---|---|---|
| | | <p>Iron device thought to be to facilitate loading and unloading of cloth/ goods</p> | <p>Figure 27- Probably loading and unloading device</p> |

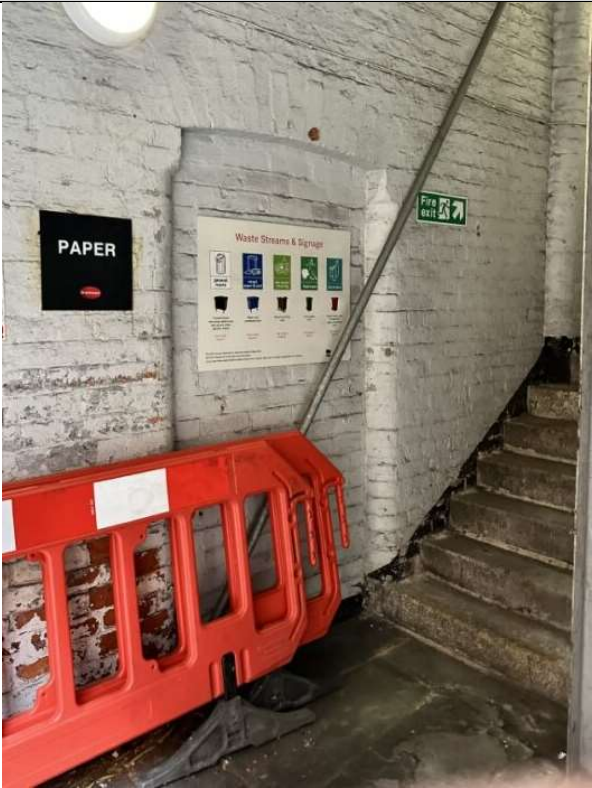
| Sr. no | Item | Description | Images (all author's own) |
|---|---|---|---|
| | | The loading bay features a bricked up original opening next to the stone staircase. It has cambered bricks at the lintel and painted white along with the rest of the walls. | <p>Figure 28- Bricked up opening in loading bay</p> |

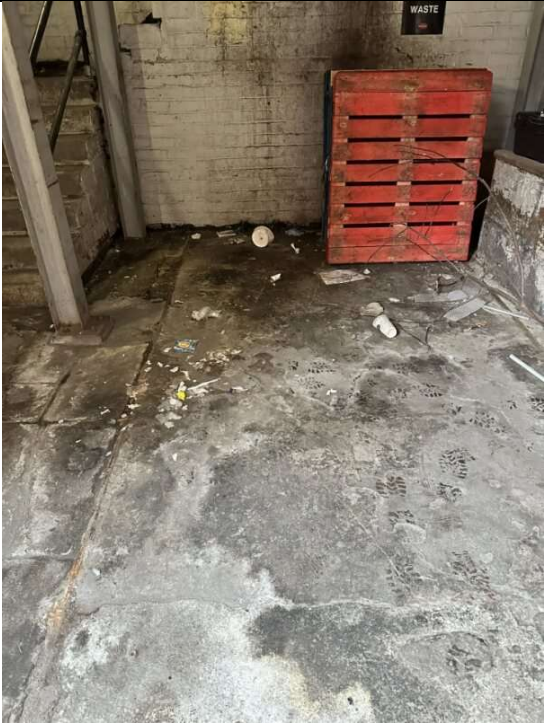
| Sr. no | Item | Description | Images (all author's own) |
|---|---|---|---|
| | | The loading bay features original stone flooring and stone steps. The flooring has some marks which could be due to the movement of goods. | <p>Figure 29- Original stone flooring</p> |
