117-119 Portland Street, Manchester  
Heritage Statement

April 2024

Appendix C - Detailed Architectural Significance Assessment  
and Photographic Record

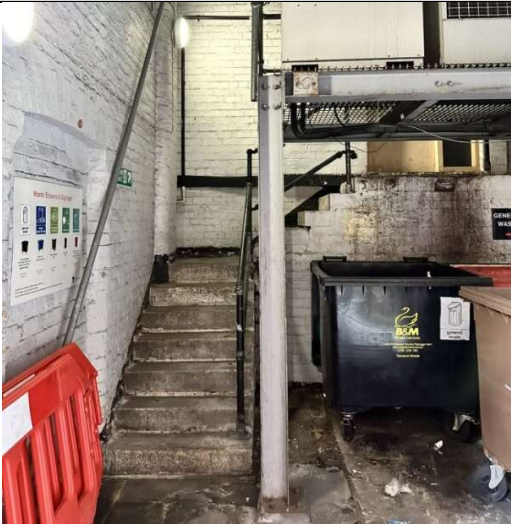
| Sr. no | Item | Description | Images (all author's own) |
|---|---|---|---|
| | | | <div></div> <div>Figure 30- Original stone steps</div> |

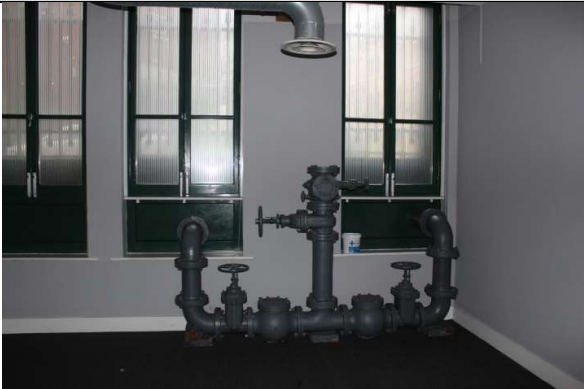
| Sr. no | Item | Description | Images (all author's own) |
|---|---|---|---|
| | | <p><b>Early sprinkler system</b></p> <p>Part of early sprinkler system. This is of medium significance.</p> | <p>Figure 35- Intake for early sprinkler system (Author's own image 09 Jan 2024)</p> |

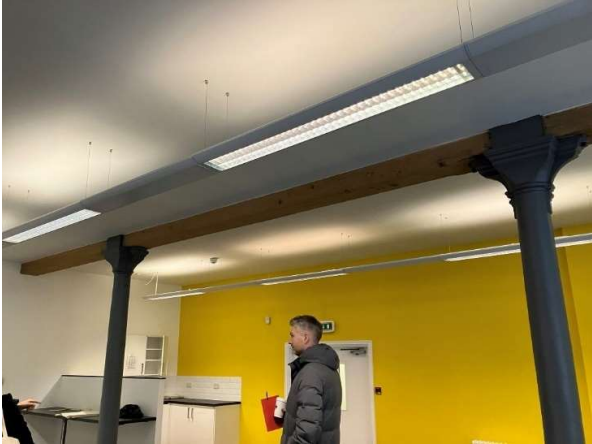
| Sr. no | Item | Description | Images (all author's own) |
|---|---|---|---|
| 14 | Internal Structure | <p>Original timber beams and cast iron columns are present throughout; of high significance.</p> <p>The cast iron columns are clamped to the original timber beams.</p> | <p>Figure 36- Original timber beams and cast iron columns on ground floor (Author's own image 09 Jan 2024)</p> |

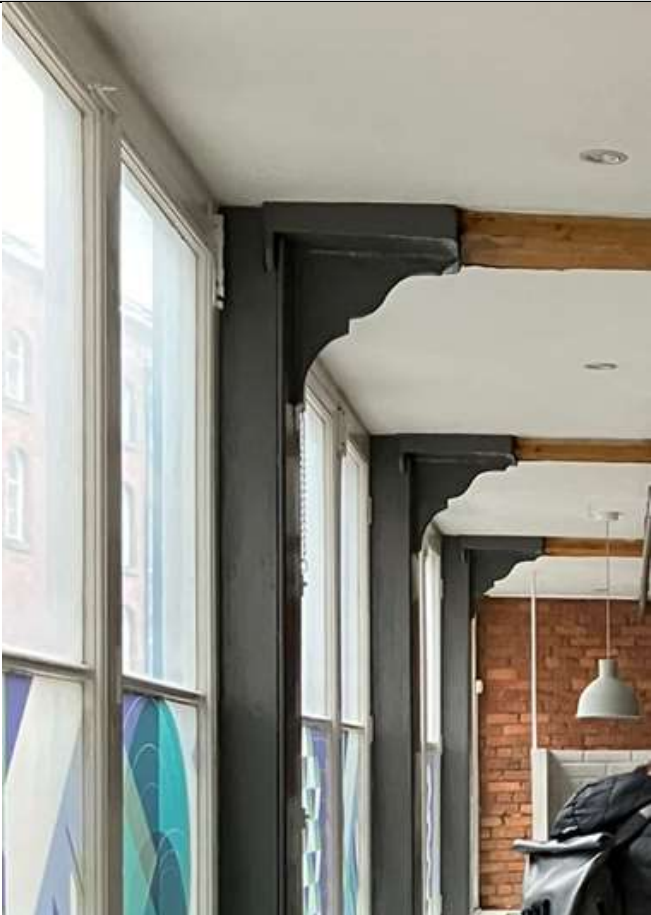
| Sr. no | Item | Description | Images (all author's own) |
|---|---|---|---|
| | | <p>Original cast iron brackets to hold the timber beams in place which have been painted black connect to the external wall structure of the eastern rear glazed curtain wall façade.</p> | <p>Figure 37- Original cast iron brackets (Author's own image 09 Jan 2024)</p> |

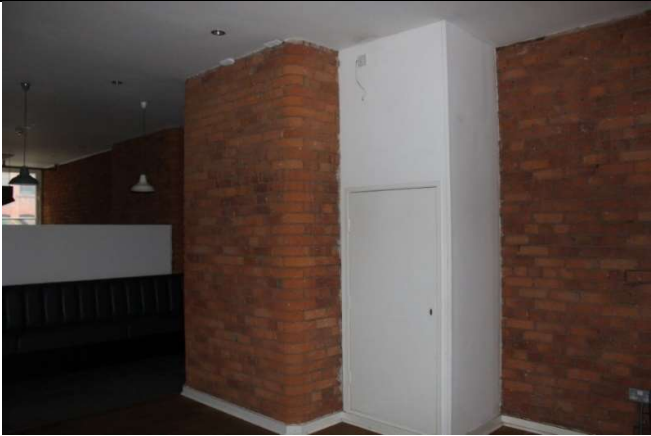
| Sr. no | Item | Description | Images (all author's own) |
|---|---|---|---|
| | | <p>There are exposed brick walls throughout this floor. These are of medium significance.</p> <p>A small room of modern construction has been incorporated on the exposed rear wall which is of no significance.</p> | <p>Figure 38- Exposed brick wall to south façade, on ground floor (Author's Own Image 09 Jan 2024)</p> |

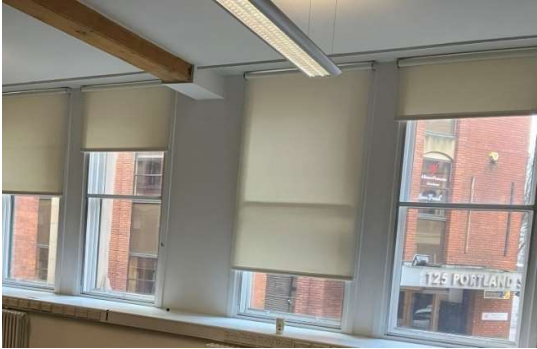
| Sr. no | Item | Description | Images (all author's own) |
|---|---|---|---|
| 15 | Windows and openings | <p>The windows on the ground floor are rectangular shaped with straight lintels.</p> <p>They are believed to be original top hung sash windows which is of high significance. Modern secondary glazing on Portland Street and Dickinson Street facades added later are of no significance, albeit relatively sympathetically installed.</p> | <div><p>Figure 41- Window openings (Author's own image 09 Jan 2024)</p></div> |

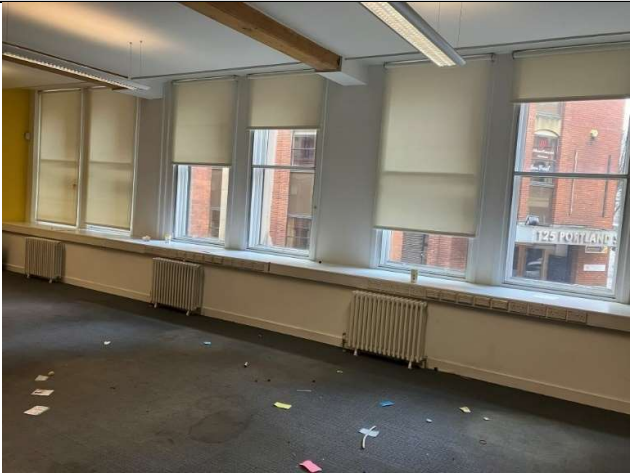
| Sr. no | Item | Description | Images (all author's own) |
|---|---|---|---|
| 17 | 'Cotton Tables' | <p>'Cotton table' (present on this façade only) has been boxed in on Dickinson Street façade. Due to historic use of building these were likely used for all material products, not specifically cotton. Unknown whether original 'cotton tables' remain under later boxing in (intrusive investigations underway to this floor). Boxing in has some moderate significance due to indication of historic layout and use of the building.</p> | <p>Figure 44- Cotton table (Author's own image 09 Jan 2024)</p> |

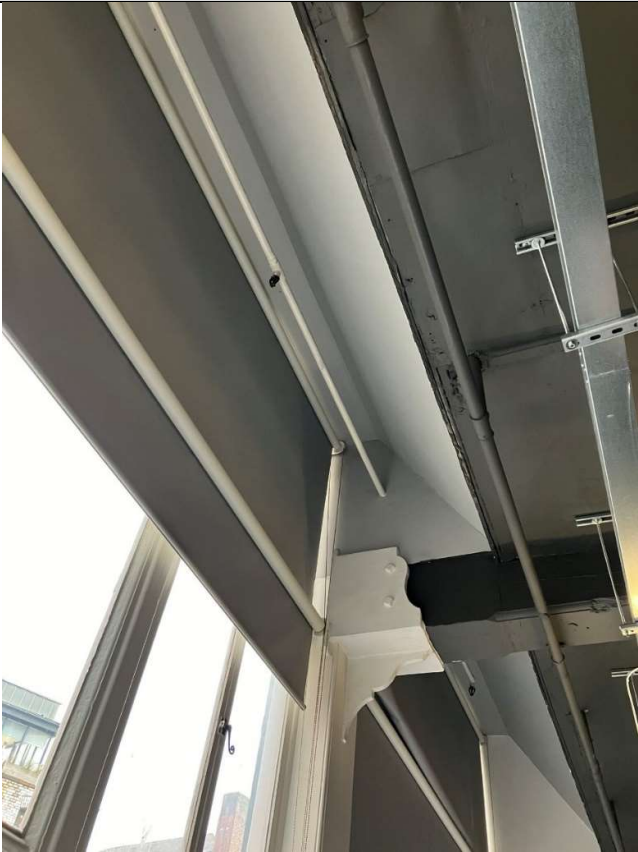
| Sr. no | Item | Description | Images (all author's own) |
|---|---|---|---|
| | | Original cast iron bracket for original timber beams | <p>Figure 50- Cast iron bracket on first floor (Author's Own Image 09 Jan 2024)</p> |

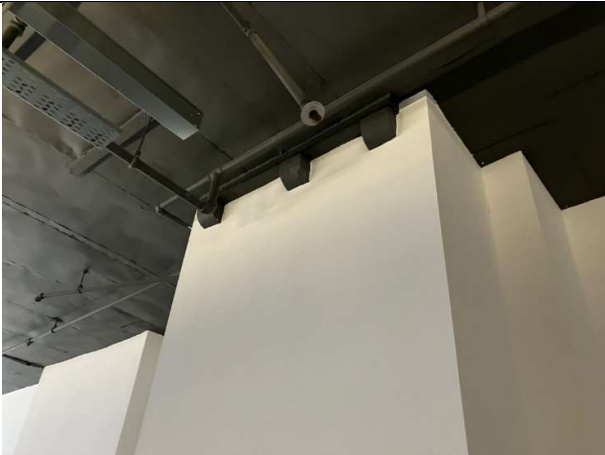
| Sr. no | Item | Description | Images (all author's own) |
|---|---|---|---|
| 21 | Ceiling | Metal ceiling present across the floorplate area, possibly covering timber beams or ceiling joints. Appears to potentially be an early form of fireproofing, popular as a cheap alternative to full fireproof construction in the early 19 <sup>th</sup> century. Pressed metal ceilings were also common in North America during this era, but largely for decorative reasons. No decoration present here. These are of medium significance. | <p>Figure 51- Original fireproofing (Author's Own Image 09 Jan 2024)</p> |

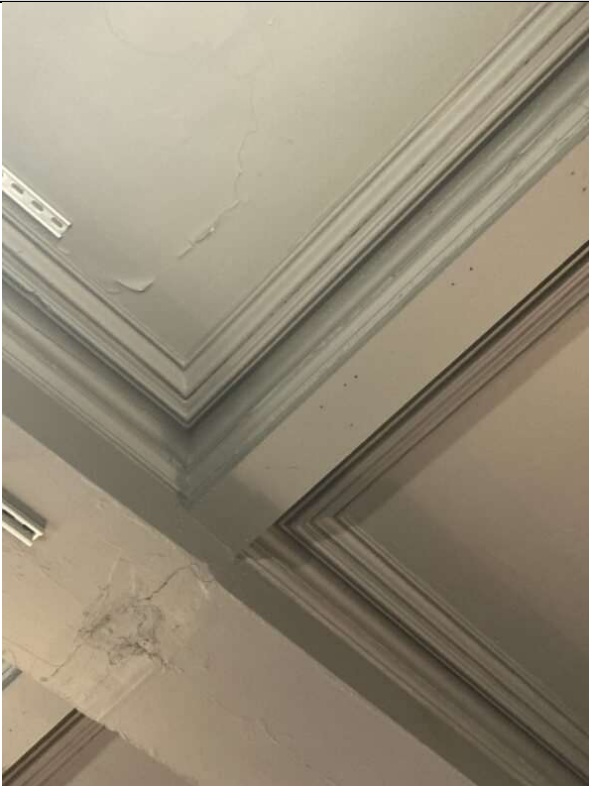
| Sr. no | Item | Description | Images (all author's own) |
|---|---|---|---|
| | | Original detailing on ceiling of medium significance | <p>Figure 52- Detailing on ceiling (Author's Own Image 09 Jan 2024)</p> |

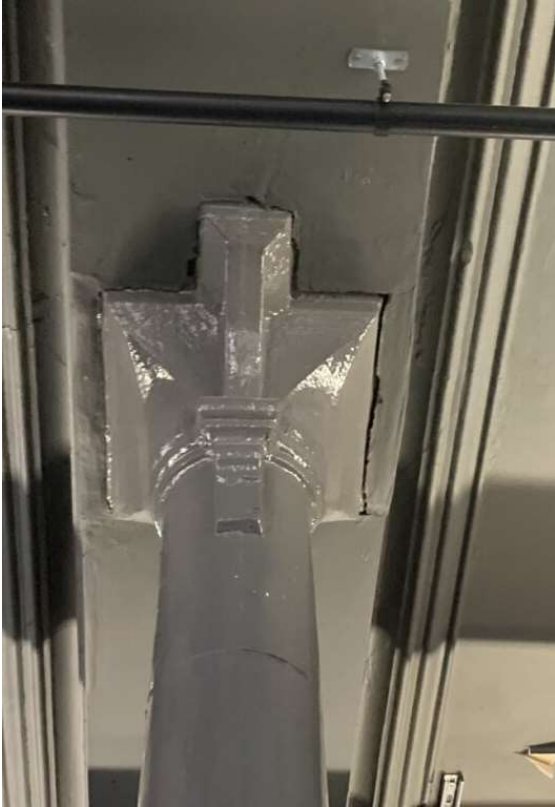
| Sr. no | Item | Description | Images (all author's own) |
|---|---|---|---|
| | | There are instances on this floor of the original columns being embedded into modern panelling around services. | <p>Figure 53- Original column embedded into panelling</p> |

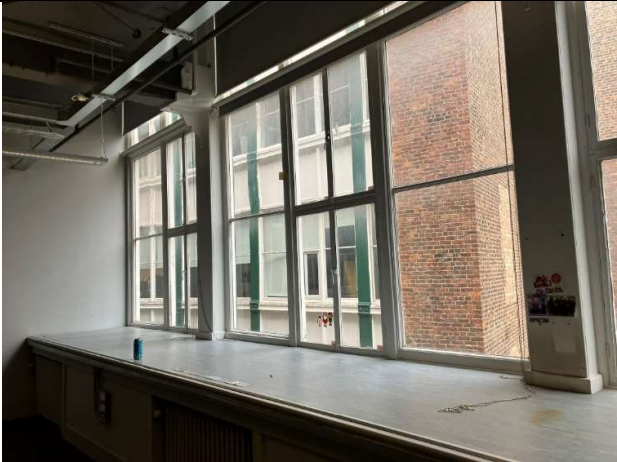
| Sr. no | Item | Description | Images (all author's own) |
|---|---|---|---|
| 23 | 'Cotton Table' | <p>'Cotton table' present along rear eastern façade has been boxed in. Due to historic use of building these were likely used for all material products, not specifically cotton. Unknown whether original 'cotton tables' remain under later boxing in (intrusive investigations underway to this floor). Boxing in has some moderate significance due to indication of historic layout and use of the building.</p> <p>To maximise light on to the tables the ceiling slopes upwards as it reaches the window to maximise the glazing.</p> | <p>Figure 55- Cotton Table with Glazed Wall on First Floor</p> |

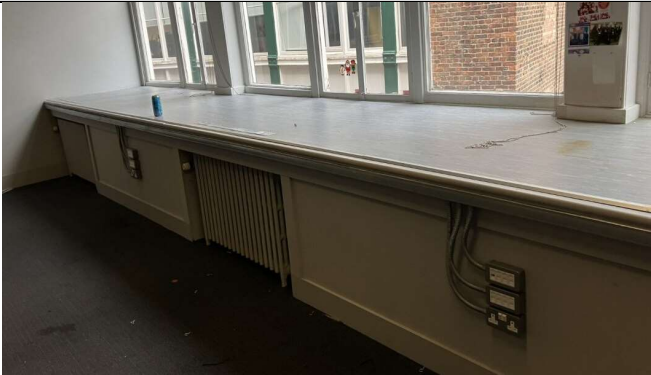
| Sr. no | Item | Description | Images (all author's own) |
|---|---|---|---|
| | | Modern heating equipment such as radiators and electricity sockets are also of low significance. | <div><p>Figure 57- Modern radiators and sockets (Author's own image 09 Jan 2024)</p></div> <div><p>Figure 58- Modern seating as part of modern interventions on the floor (Author's own image 09 Jan 2024)</p></div> |

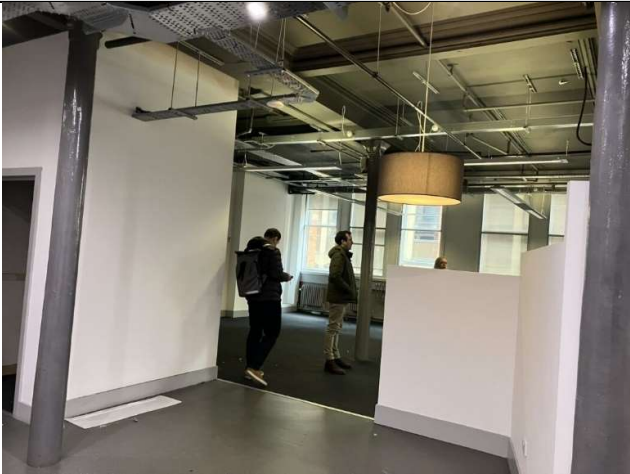
| Sr. no | Item | Description | Images (all author's own) |
|---|---|---|---|
| | | The level has modern carpeting and modern vinyl flooring which are of no significance | <p>Figure 59- Modern carpeting and vinyl flooring (Author's own image 09 Jan 2024)</p> |

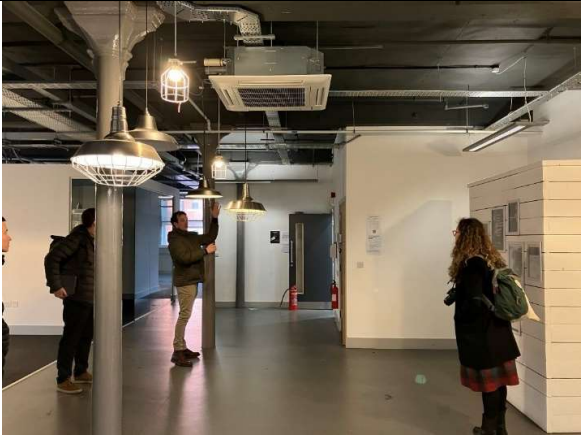
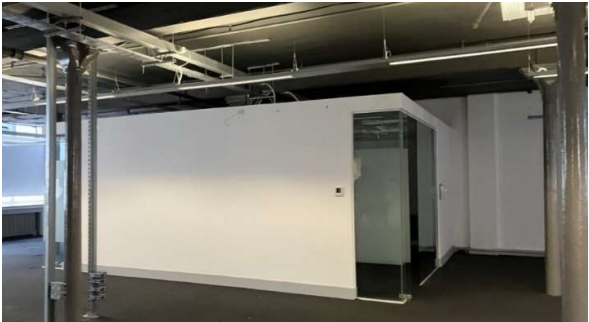
| Sr. no | Item | Description | Images (all author's own) |
|---|---|---|---|
| 25 | Internal Structure | <p>Original cast iron columns and timber beams (painted) present on this floor; of high significance. Some of the columns have been embedded in the walls (see plan ref 20820-AXI-00-ZZ-02-DR-A-00002_002)</p> <p>Modern plasterboard walls, partitions and glass partitions present; of no significance</p> | <p>Figure 60- Original cast iron columns on second floor (Author's Own Image 09 Jan 2024)</p> <p>Figure 61- Modern intervention in the form of a meeting room</p> |

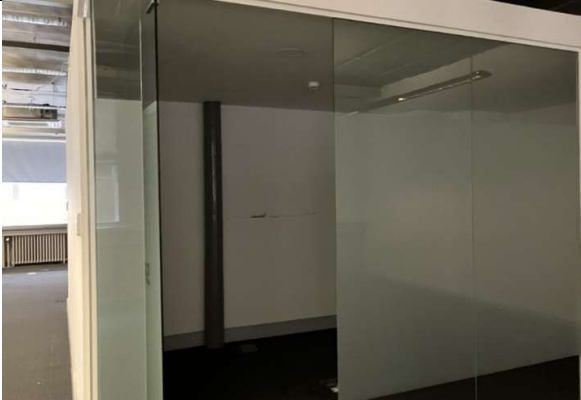
| Sr. no | Item | Description | Images (all author's own) |
|---|---|---|---|
| | | | <div></div> <div>Figure 62- Original column along wall (see plan ref 20820-AXI-00-ZZ-02-DR-A-00002_002)</div> |

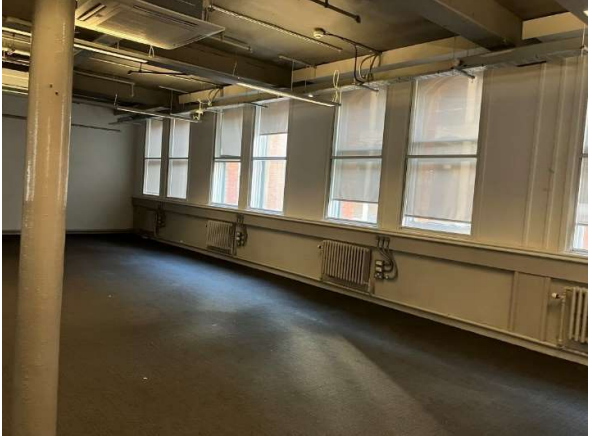
| Sr. no | Item | Description | Images (all author's own) |
|---|---|---|---|
| 26 | Windows and openings | <p>The windows on the second floor are rectangular shaped with straight lintels. They are believed to be original top hung sash windows of high significance.</p> <p>Modern secondary glazing on Portland Street and Dickinson Street facades added later which is of no significance, albeit relatively sympathetically installed.</p> | <div></div> <div>Figure 63- Secondary glazing on second floor on Dickinson Street facade</div> |

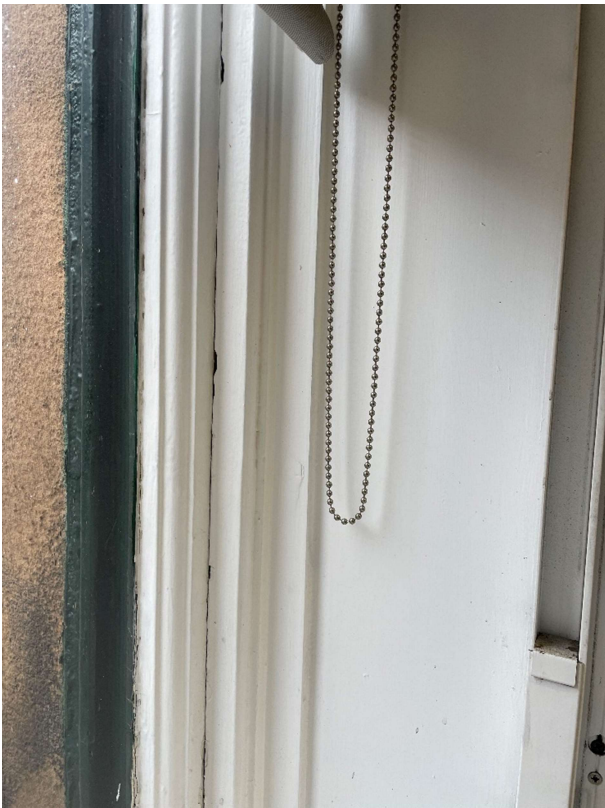
| | | | <p>Figure 64- Rear glazed wall on second floor (Author's Own Image 09 Jan 2024)</p> <p>Figure 65- Detail of original windows with modern secondary glazing just visible on the right of the photo (Author's Own Image 09 Jan 2024)</p> |

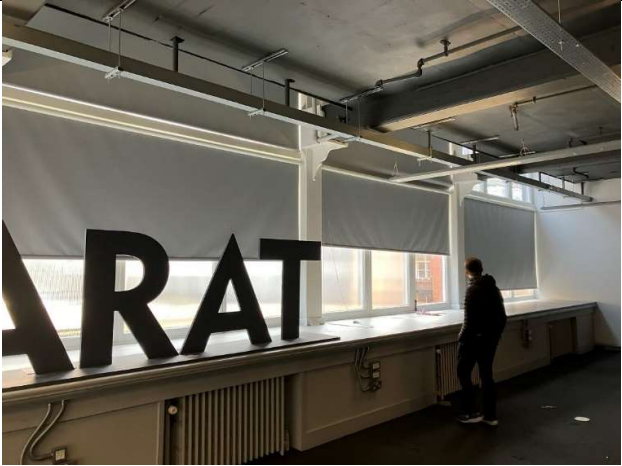
| Sr. no | Item | Description | Images (all author's own) |
|---|---|---|---|
| 27 | 'Cotton Tables' | <p>'Cotton table' present along rear eastern façade has been boxed in. Due to historic use of building these were likely used for all material products, not specifically cotton. Intrusive investigations have taken place that indicate there is little to no surviving historic fabric underneath this stretch of table. Boxing in has some moderate significance due to indication of historic layout and use of the building.</p> <p>To maximise light on to the tables the ceiling slopes upwards as it reaches the window to maximise the glazing.</p> | <p>Figure 66- Cotton table with glazed wall on second floor (Author's Own Image 09 Jan 2024)</p> |

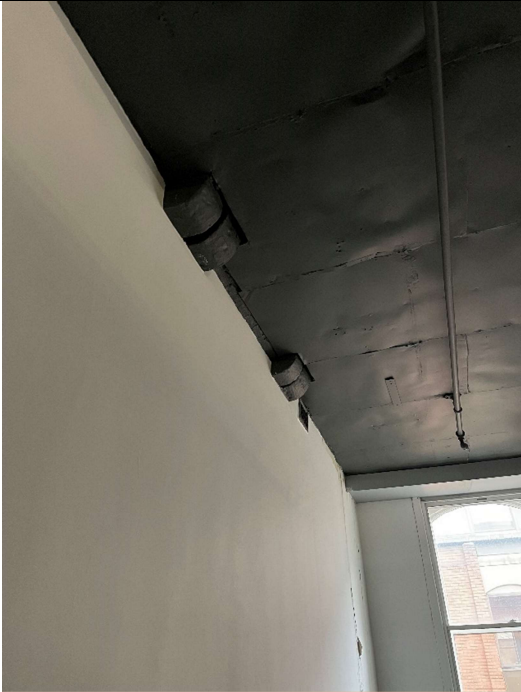
| Sr. no | Item | Description | Images (all author's own) |
|---|---|---|---|
| 28 | Ceiling | <p>Metal ceiling present across the floorplate area, possibly covering timber beams or ceiling joints. Appears to potentially be an early form of fireproofing, popular as a cheap alternative to full fireproof construction in the early 19<sup>th</sup> century. Pressed metal ceilings were also common in North America during this era, but largely for decorative reasons. No decoration present here. These are of medium significance.</p> | <p>Figure 67- Metal ceiling</p> |

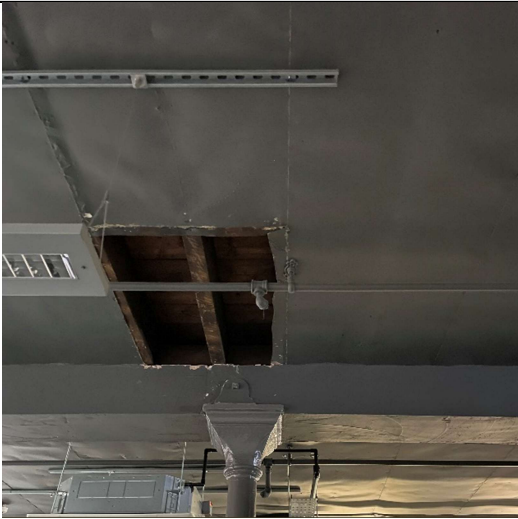
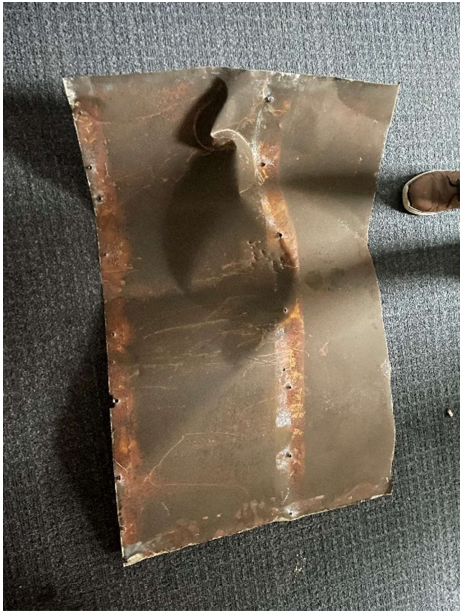
| Sr. no | Item | Description | Images (all author's own) |
|---|---|---|---|
| | | | <div><p>Figure 68- Intrusive survey done on ceiling (Author's Own Image 09 Jan 2024)</p></div> <div><p>Figure 69- Metal ceiling panel (Author's Own Image 09 Jan 2024)</p></div> |

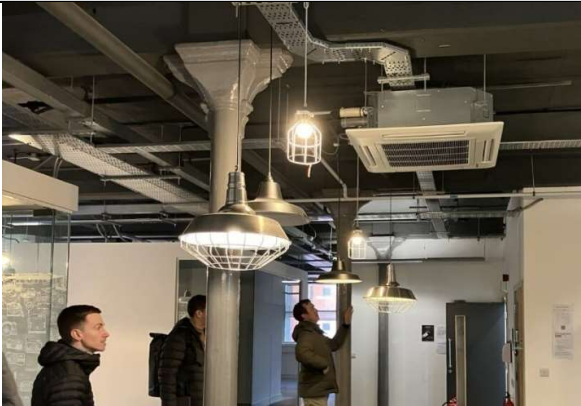
| Sr. no | Item | Description | Images (all author's own) |
|---|---|---|---|
| 29 | Fixtures and fittings | <p>Modern light fixtures and ventilation fittings are of low significance.</p> <p>The floor has modern toilets and a kitchenette which are of no significance.</p> <p>Early fire sprinkler system present at ceiling height is of medium significance.</p> | <p>Figure 70- Light fixtures and ventilation fittings</p> |

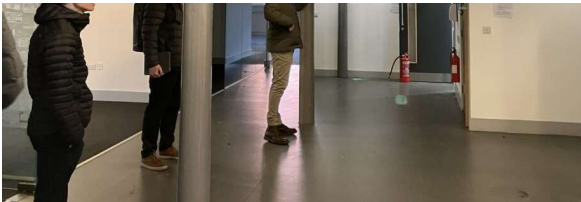
| Sr. no | Item | Description | Images (all author's own) |
|---|---|---|---|
| | | <p>The level has modern carpeting and vinyl flooring which are of low significance</p> | <p>Figure 71- Modern carpeting (Author's Own Image 09 Jan 2024)</p> <p>Figure 72- Modern vinyl flooring (Author's Own Image 09 Jan 2024)</p> |

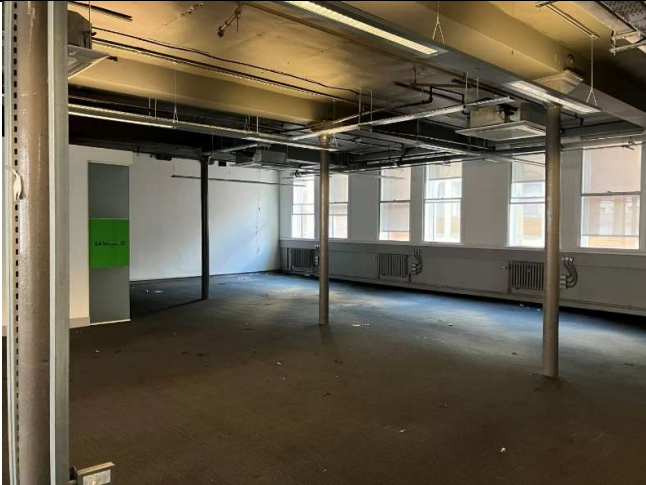
| Sr. no | Item | Description | Images (all author's own) |
|---|---|---|---|
| 30 | Internal Structure | <p>Original cast iron columns and timber beams (painted) are present throughout the floor; of high significance.</p> <p>Sprinkler system present at ceiling height is of medium significance.</p> <p>Some presence of columns being embedded or partitions being unsympathetically constructed immediately adjacent (see plan ref 20820-AXI-00-ZZ-03-DR-A-00003_003) – this negatively impacts the (limited) internal significance.</p> <p>Modern plasterboard walls, partitions and glass partitions present; of no significance.</p> | <div></div> <p>Figure 73- Original cast iron columns (Author's Own Image 09 Jan 2024)</p> <div></div> <p>Figure 74- Original cast iron column (Author's Own Image 09 Jan 2024)</p> |

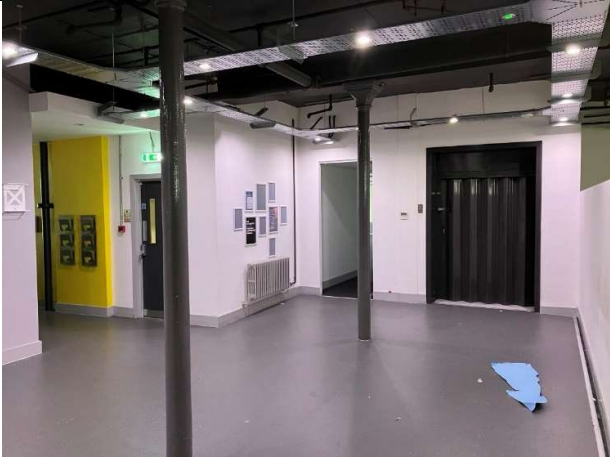
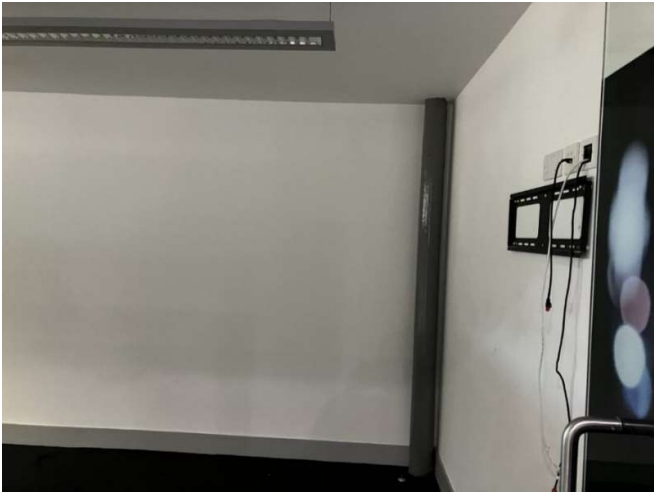
| Sr. no | Item | Description | Images (all author's own) |
|---|---|---|---|
| | | | <div></div> <div><p>Figure 75- Original cast iron columns (Author's own image 09 Jan 2024)</p></div> <div><p>Figure 76- Original cast iron column at the corner of room (see plan ref 20820-AXI-00-ZZ-03-DR-A-00003_003) (Author's own image 09 Jan 2024)</p></div> |

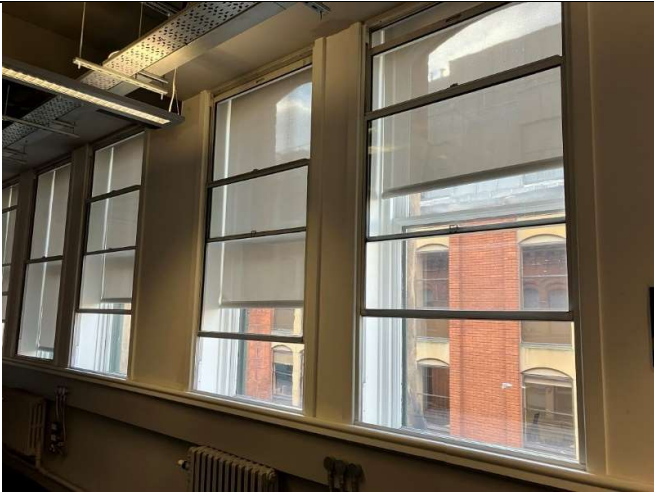
| Sr. no | Item | Description | Images (all author's own) |
|---|---|---|---|
| 31 | Windows and openings | <p>The window openings on third floor have slightly arched window lintels. Though it is believed to be an original top hung sash window of high significance, a secondary glazing has been incorporated on Portland Street and Dickinson Street facades; detrimental to significance here due to inability to read the original window detail and design.</p> <p>There are original glazing windows on each floor</p> | <div></div> <div><p>Figure 77- Secondary glazing on Dickinson Street façade (Author's own image 09 Jan 2024)</p></div> |

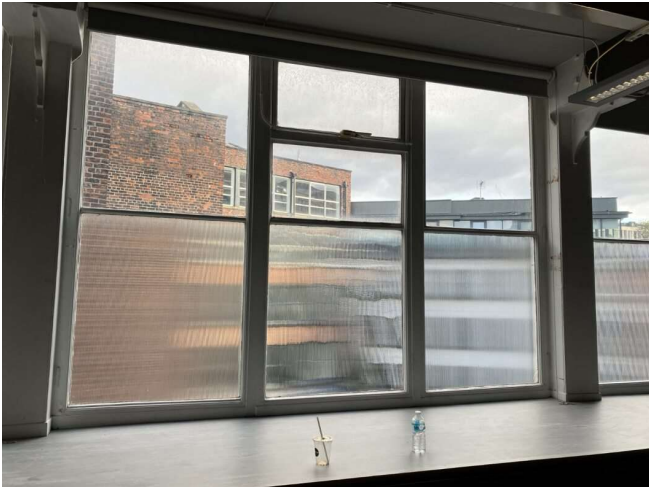
| Sr. no | Item | Description | Images (all author's own) |
|---|---|---|---|
| | | facing the courtyard which are of high significance. | <p>Figure 78- Original glazing window facing courtyard</p> |

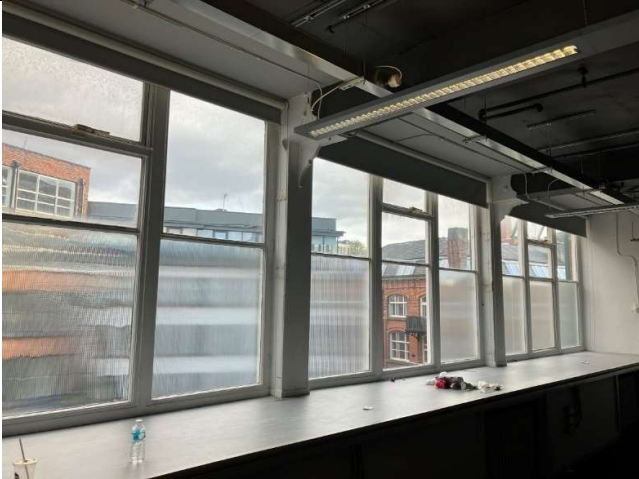
| Sr. no | Item | Description | Images (all author's own) |
|---|---|---|---|
| 32 | 'Cotton Tables' | 'Cotton table' present along rear eastern façade has been boxed in. Due to historic use of building these were likely used for all material products, not specifically cotton. Unknown whether original 'cotton tables' remain under later boxing in (intrusive investigations conducted on this floor). Boxing in has some moderate significance due to indication of historic layout and use of the building. | <p>Figure 79- Boxed in cotton table on eastern rear façade</p> |

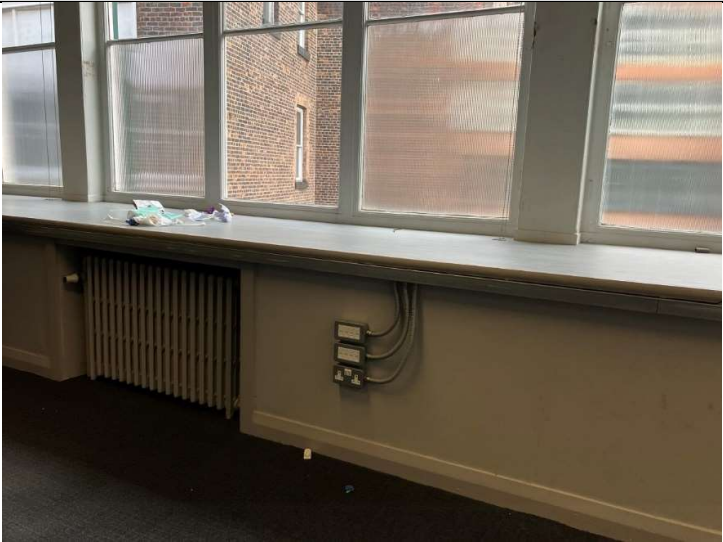
| Sr. no | Item | Description | Images (all author's own) |
|---|---|---|---|
| | | | <p>Figure 80- Boxing in of 'cotton table' (Author's own image 09 Jan 2024)</p> |

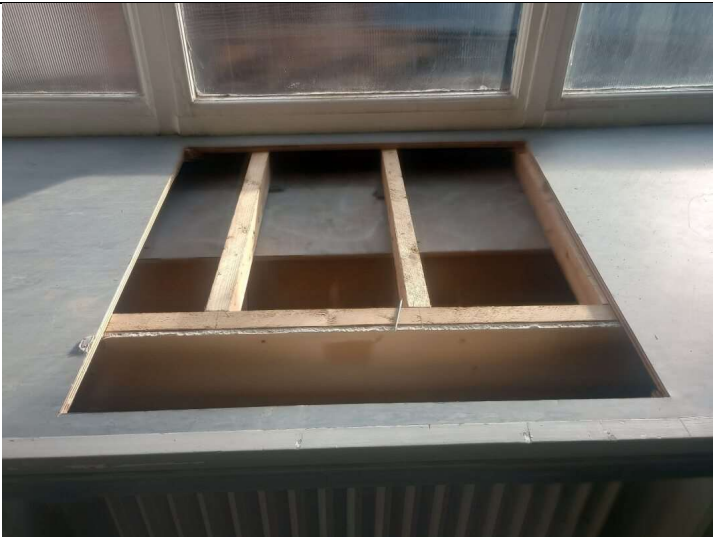
| Sr. no | Item | Description | Images (all author's own) |
|---|---|---|---|
| | | <p>Intrusive investigations revealed an underlying timber support below the cotton table above the modern heater insertions. The space underneath is otherwise empty.</p> <p>There seems to be slanting internal concrete wall beneath the cotton table throughout.</p> | <p>Figure 81- Underlying supporting timber structure beneath cotton table (intrusive investigation pictures March 2024)</p> |

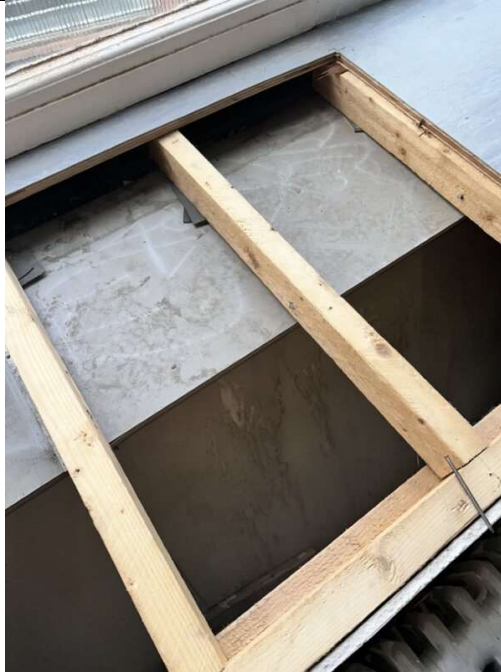
*Figure 82- Underlying structure below cotton table (intrusive investigation pictures March 2024)*

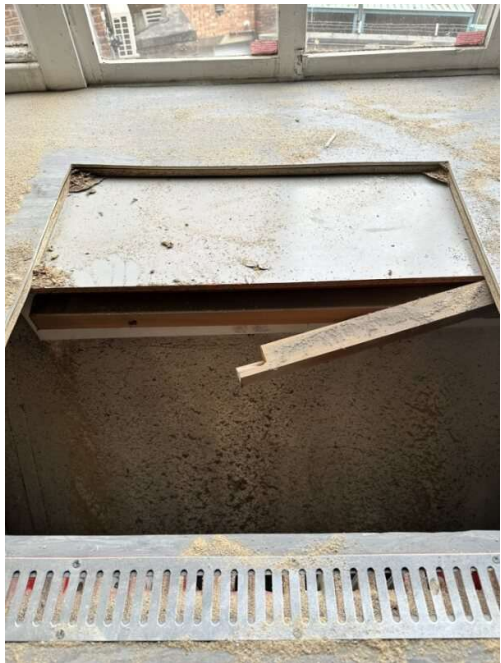
*Figure 83- Below the cotton table (intrusive investigation pictures March 2024)*

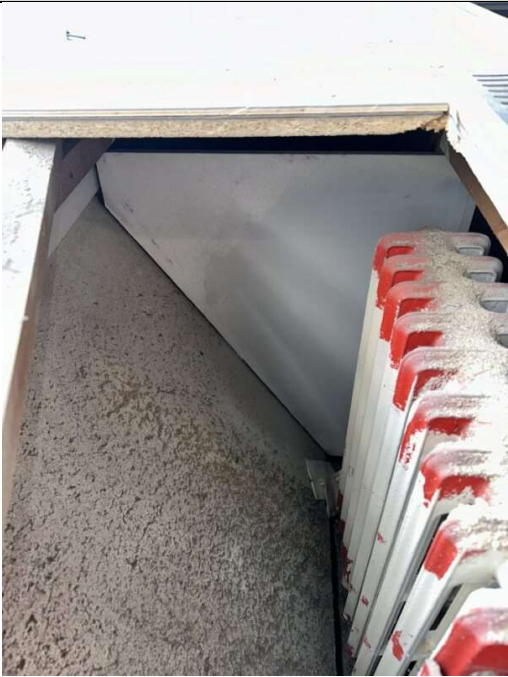
| Sr. no | Item | Description | Images (all author's own) |
|---|---|---|---|
| | | | <div></div> <p>Figure 84- Modern heater fitted into space below cotton table (intrusive investigation pictures March 2024)</p> |

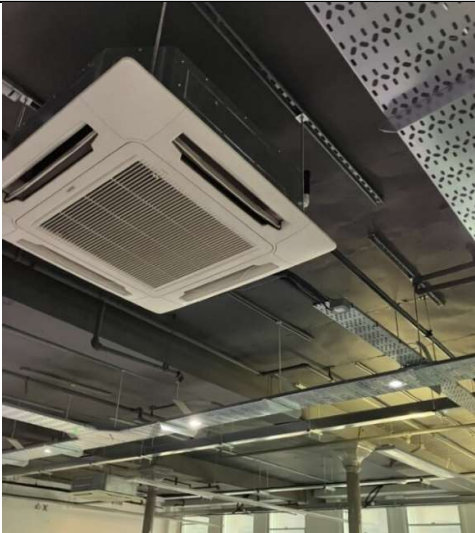
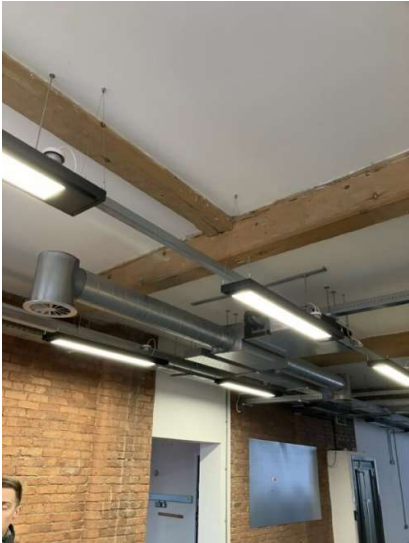
| Sr. no | Item | Description | Images (all author's own) |
|---|---|---|---|
| 34 | Fixtures and fittings | <p>Modern interventions are found throughout this floor, including office fit-outs, M&amp;E equipment, power points, modern doors. These are of no significance.</p> <p>The floor has modern toilets and kitchenette which are of no significance.</p> | <div><p>Figure 86- Modern ventilation fittings (Author's own image 09 Jan 2024)</p></div> <div><p>Figure 87- Modern light fittings (Author's own image 09 Jan 2024)</p></div> |

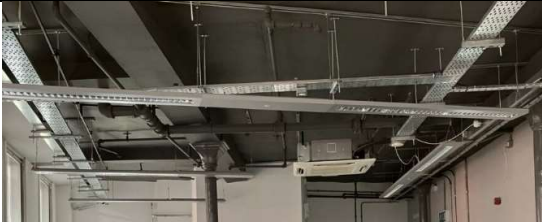
| Sr. no | Item | Description | Images (all author's own) |
|---|---|---|---|
| | | <p>Early fire sprinkler system on ceiling is of moderate significance</p> | <div><p>Figure 88- Early fire sprinkler system (Author's own image 09 Jan 2024)</p></div> |

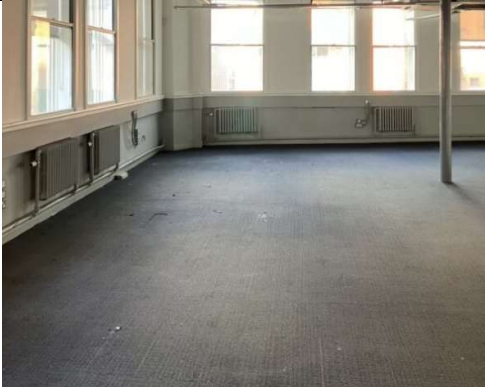
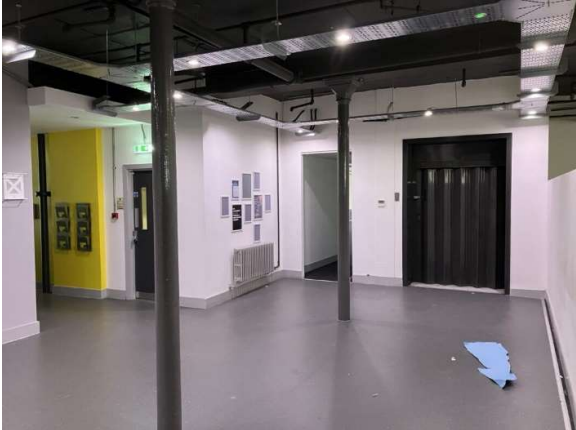
| Sr. no | Item | Description | Images (all author's own) |
|---|---|---|---|
| | | The level has modern carpeting and vinyl flooring which are of no significance | <div><p>Figure 89- Modern carpeting (Author's own image 09 Jan 2024)</p></div> <div><p>Figure 90- Modern vinyl flooring (Author's own image 09 Jan 2024)</p></div> |

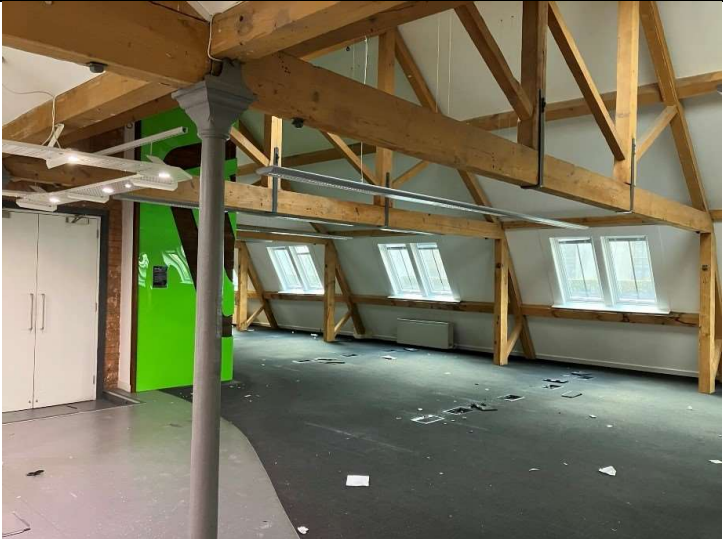
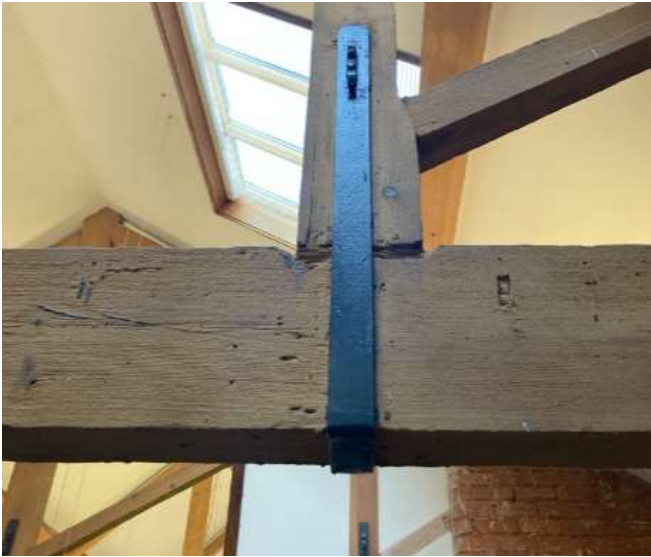
| Sr. no | Item | Description | Images (all author's own) |
|---|---|---|---|
| 35 | Internal Structure | <p>The fourth floor (top floor) of the Site boasts a system of original timber beams / roof king post truss and original cast iron columns; of high significance.</p> <p>Some of the timber beams have been 'blasted' clean. In some areas, this was too rigorous and as such has eroded the significance of the beams.</p> <p>Modern plasterboard walls, partitions and glass partitions present; of no significance, including small storage room adjacent to lift, shown within green modern structure in Figure 62.</p> | <p>Figure 91- King post truss timber roof structure with cast iron columns</p> <p>Figure 92- King post truss roof – impact of cleaning on timber beams</p> |

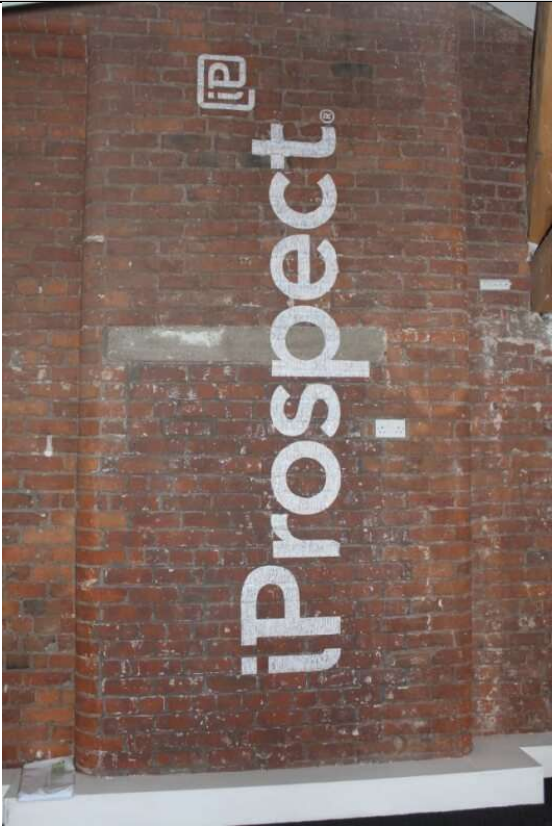
| Sr. no | Item | Description | Images (all author's own) |
|---|---|---|---|
| | | <p>Along the north-eastern corner of the Site, the wall bordering the Site and 113-115 Portland Street, is an early brick wall which is of medium significance.</p> <p>Protrusion in the wall is likely to be the chimney which can be seen in the roof.</p> | <div></div> <p>Figure 93- Illustration of original brick wall, between the Site and 113-115 Portland Street, likely chimney breast with fire place (Author's own image 09 Jan 2024)</p> |

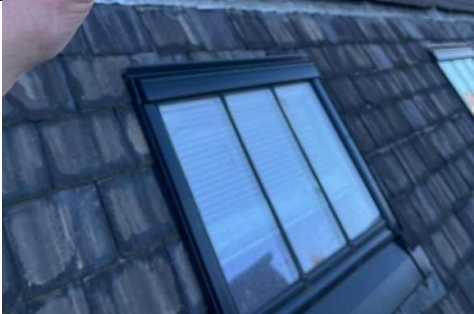
| Sr. no | Item | Description | Images (all author's own) |
|---|---|---|---|
| 36 | Windows and openings | <p>The fourth floor has original skylights with modern glass and fixtures.</p> | <div></div> <p>Figure 94- Skylights with modern glass (Inspection pictures 12 Feb 2024)</p> |

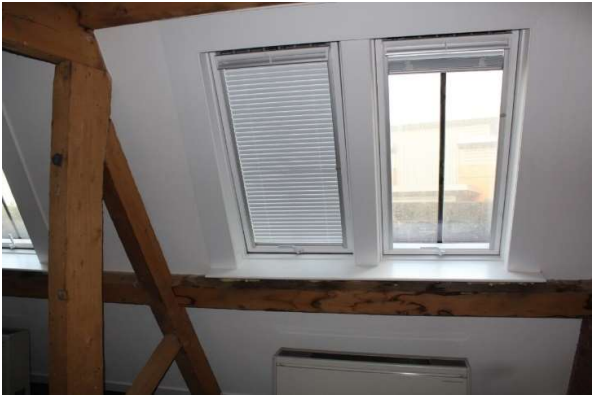
| Sr. no | Item | Description | Images (all author's own) |
|---|---|---|---|
| | | | <div><p>Figure 95- Modern blinds on skylights- internal view (Inspection pictures 12 Feb 2024)</p></div> <div><p>Figure 96- Modern window fixtures</p></div> |

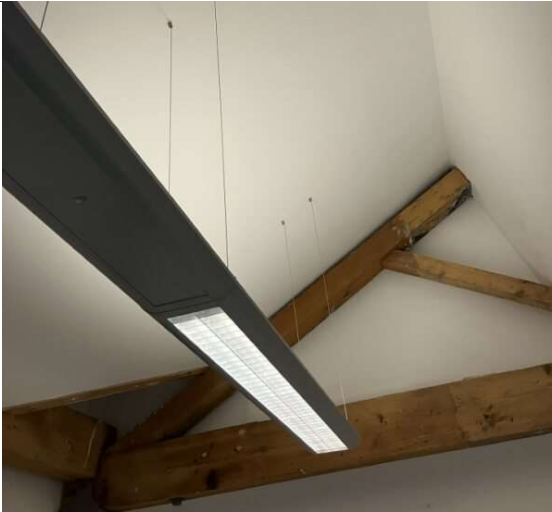
| Sr. no | Item | Description | Images (all author's own) |
|---|---|---|---|
| 37 | Fixtures and fittings | <p>Modern light fixtures are of no significance</p> <p>Sprinkler system present at ceiling height is of medium significance.</p> | <div><p>Figure 97- Modern light fittings (Author's own image 09 Jan 2024)</p></div> |

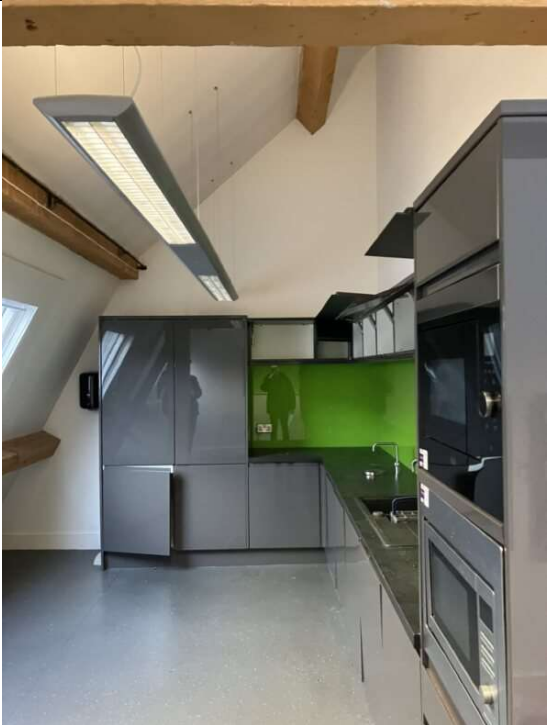
| Sr. no | Item | Description | Images (all author's own) |
|---|---|---|---|
| | | The floor has modern toilets and a modern modular kitchenette which are of low significance | <div></div> <p>Figure 98- Modern kitchenette (Author's own image 09 Jan 2024)</p> |

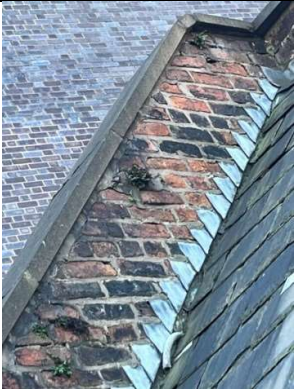
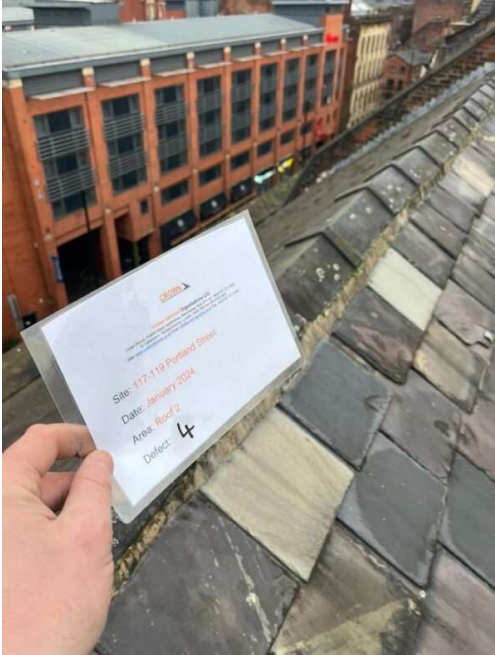
| Sr. no | Item | Description | Images (all author's own) |
|---|---|---|---|
| 38 | Roof | The building has an original slate roof. | <div><p>Figure 99- Original slate roofing (Inspection pictures 12 Feb 2024)</p><p>Figure 100- Original slate roof tiles (Inspection pictures 12 Feb 2024)</p></div> |

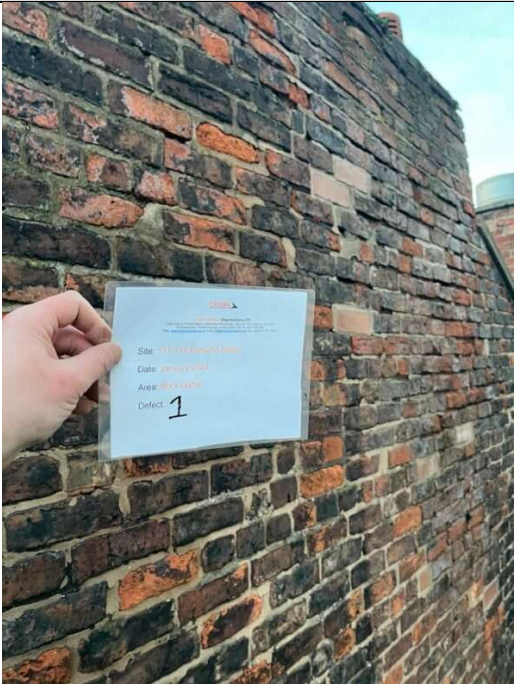
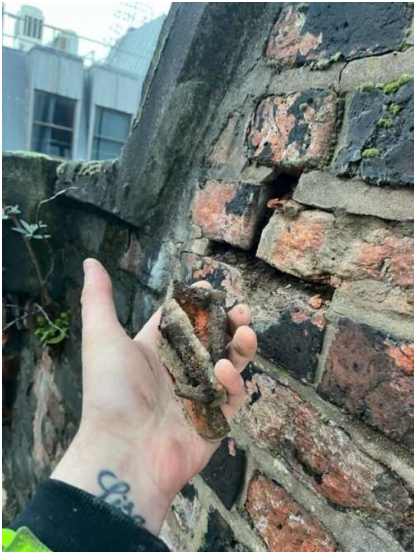
| Sr. no | Item | Description | Images (all author's own) |
|---|---|---|---|
| | | <p>Original gable wall to the south elevation made of handmade bricks. It is of high significance</p> <p>Investigation reveals that the mortar joints have perished and need to be replaced.</p> | <div></div> <p>Figure 103- Original gable wall end in south elevation (Inspection pictures 12 Feb 2024)</p> <div></div> <p>Figure 104- Crumbling original mortar joints (Inspection pictures 12 Feb 2024)</p> |

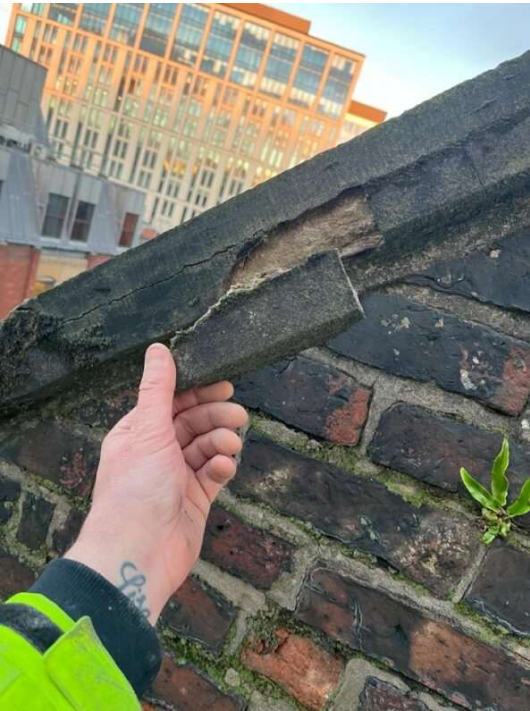
| Sr. no | Item | Description | Images (all author's own) |
|---|---|---|---|
| | | | <div><p>Figure 105- Part of the original timber used (Inspection pictures 12 Feb 2024)</p></div> |

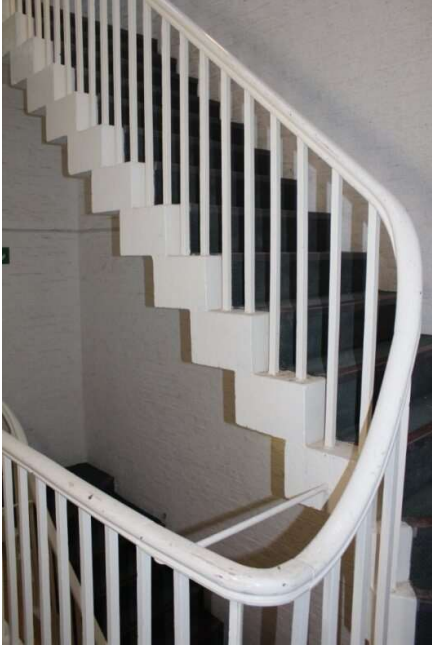
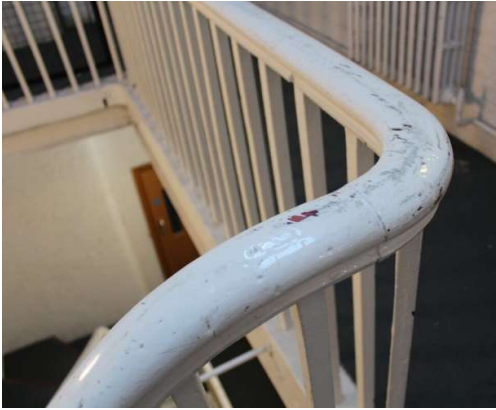
| Sr. no | Item | Description | Images (all author's own) |
|---|---|---|---|
| 39 | Original staircase | <p>Original rectangular timber escape staircase painted white close to former goods lift (see plan ref 20820-AXI-00-ZZ-02-DR-A-00002_002). It connects the lower ground floor with the fourth floor.</p> <p>The walls are white painted brick. The brick itself is of medium significance. A paint sample analysis is underway to assess the paint.</p> <p>Of medium significance.</p> | <div><p>Figure 107- Original timber staircase, taken on floor 2</p></div> <div><p>Figure 108- Chipped white paint on original staircase, appears to have been painted red at one point. Taken on floor 4.</p></div> |

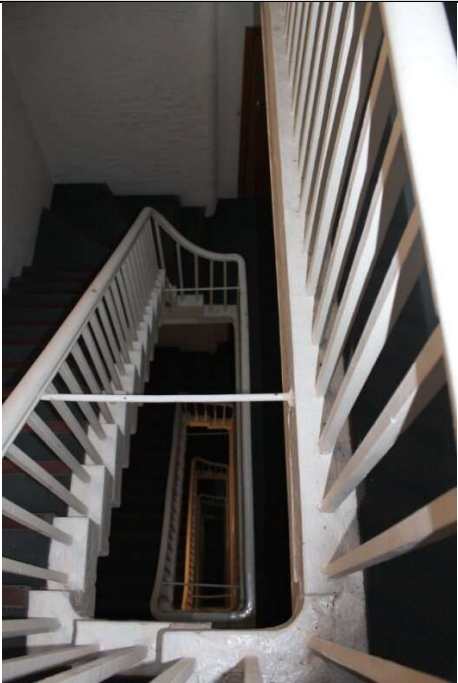
| Sr. no | Item | Description | Images (all author's own) |
|---|---|---|---|
| | | | <div></div> <div>Figure 109- View from top of staircase, taken on the 4<sup>th</sup> floor</div> |

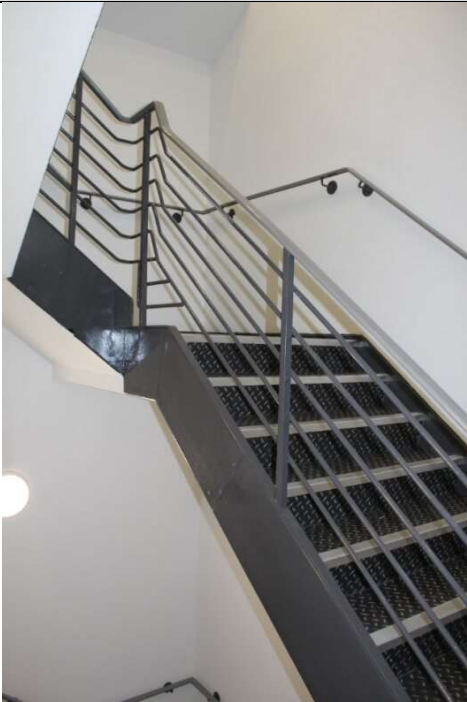
| Sr. no | Item | Description | Images (all author's own) |
|---|---|---|---|
| 41 | Modern staircase | <p>Modern metal staircase (20820-AXI-00-ZZ-03-DR-A-00003_003) inserted in original circulation core which also has a modern bank of lifts. From review of plans provided by Manchester Local archives, it is clear that the circulation core containing these stairs and one lift existed in 1974.</p> <p>Modern metal staircase is of no significance.</p> | <p>Figure 111- Modern staircase, taken on XX floor</p> |
