117-119 Portland Street, Manchester  
Heritage Statement

April 2024

Appendix C - Detailed Architectural Significance Assessment  
and Photographic Record

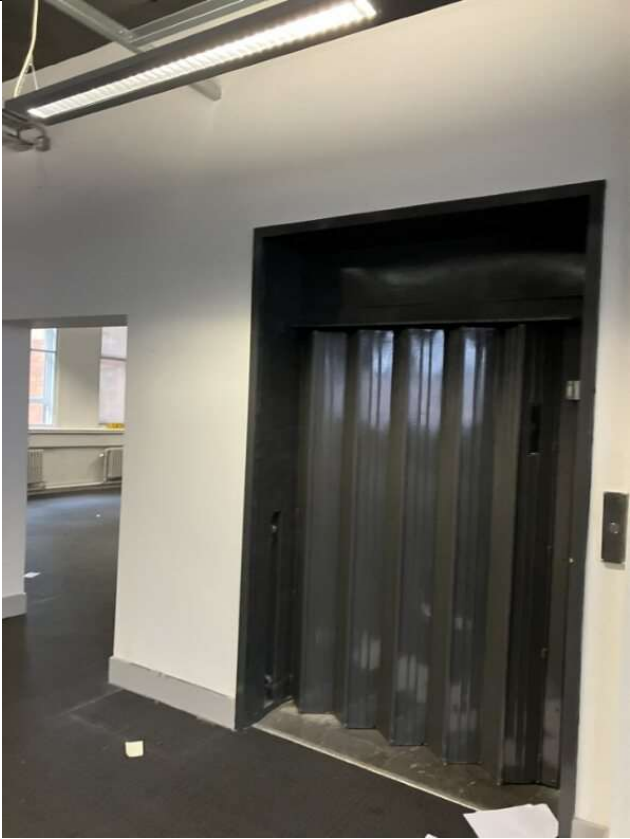
| Sr. no | Item | Description | Images (all author's own) |
|---|---|---|---|
| 42 | Goods Lift | <p>Original lift shaft on the ground floor (see plan ref (20820-AXI-00-ZZ-03-DR-A-00003_003). While the shaft and some of internal structure is of medium significance, the later metal doors are of low significance.</p> | <p>Figure 112- Original lift with later door</p> |
