| Project Name<br>ST. MICHAELS DEVELOPMENT,<br>MANCHESTER |

| Drawing Title<br>BUILDING ENCLOSURE -<br>HOTEL PODIUM |

| Project No<br>Scale @ A0<br>As indicated | Drawing No<br>S73-511 | Revision<br>P03 |

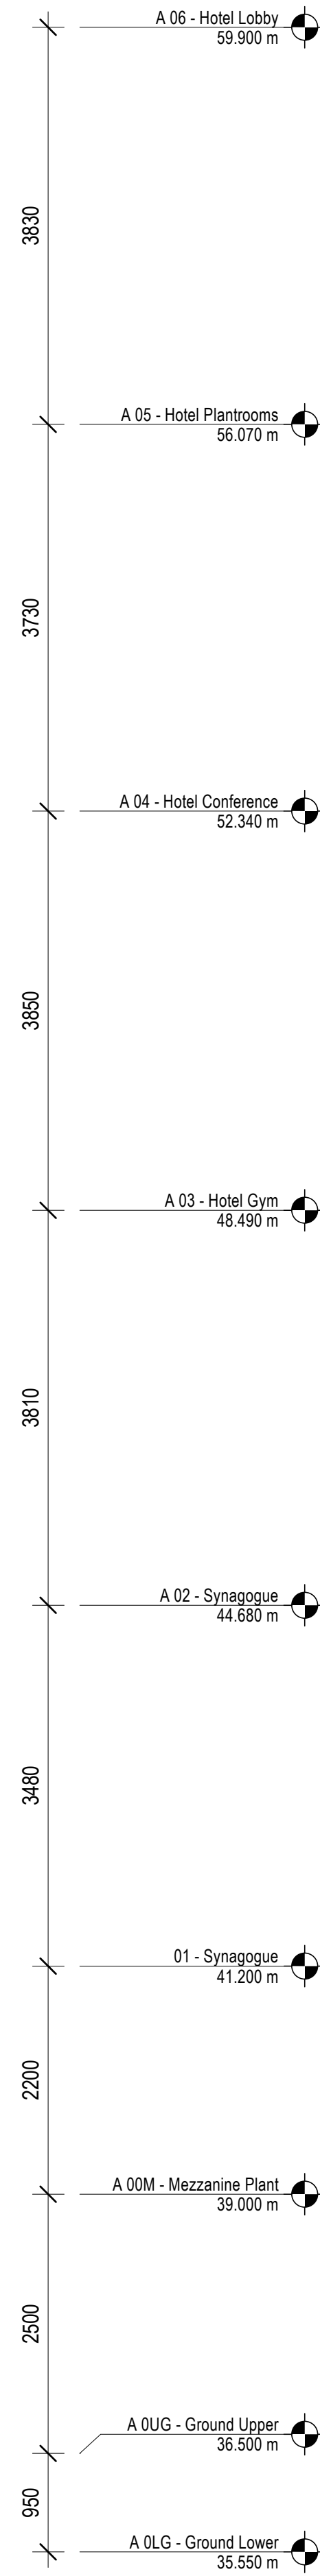
A7

TYP ENCLOSURE ELEVATION - HOTEL PODIUM

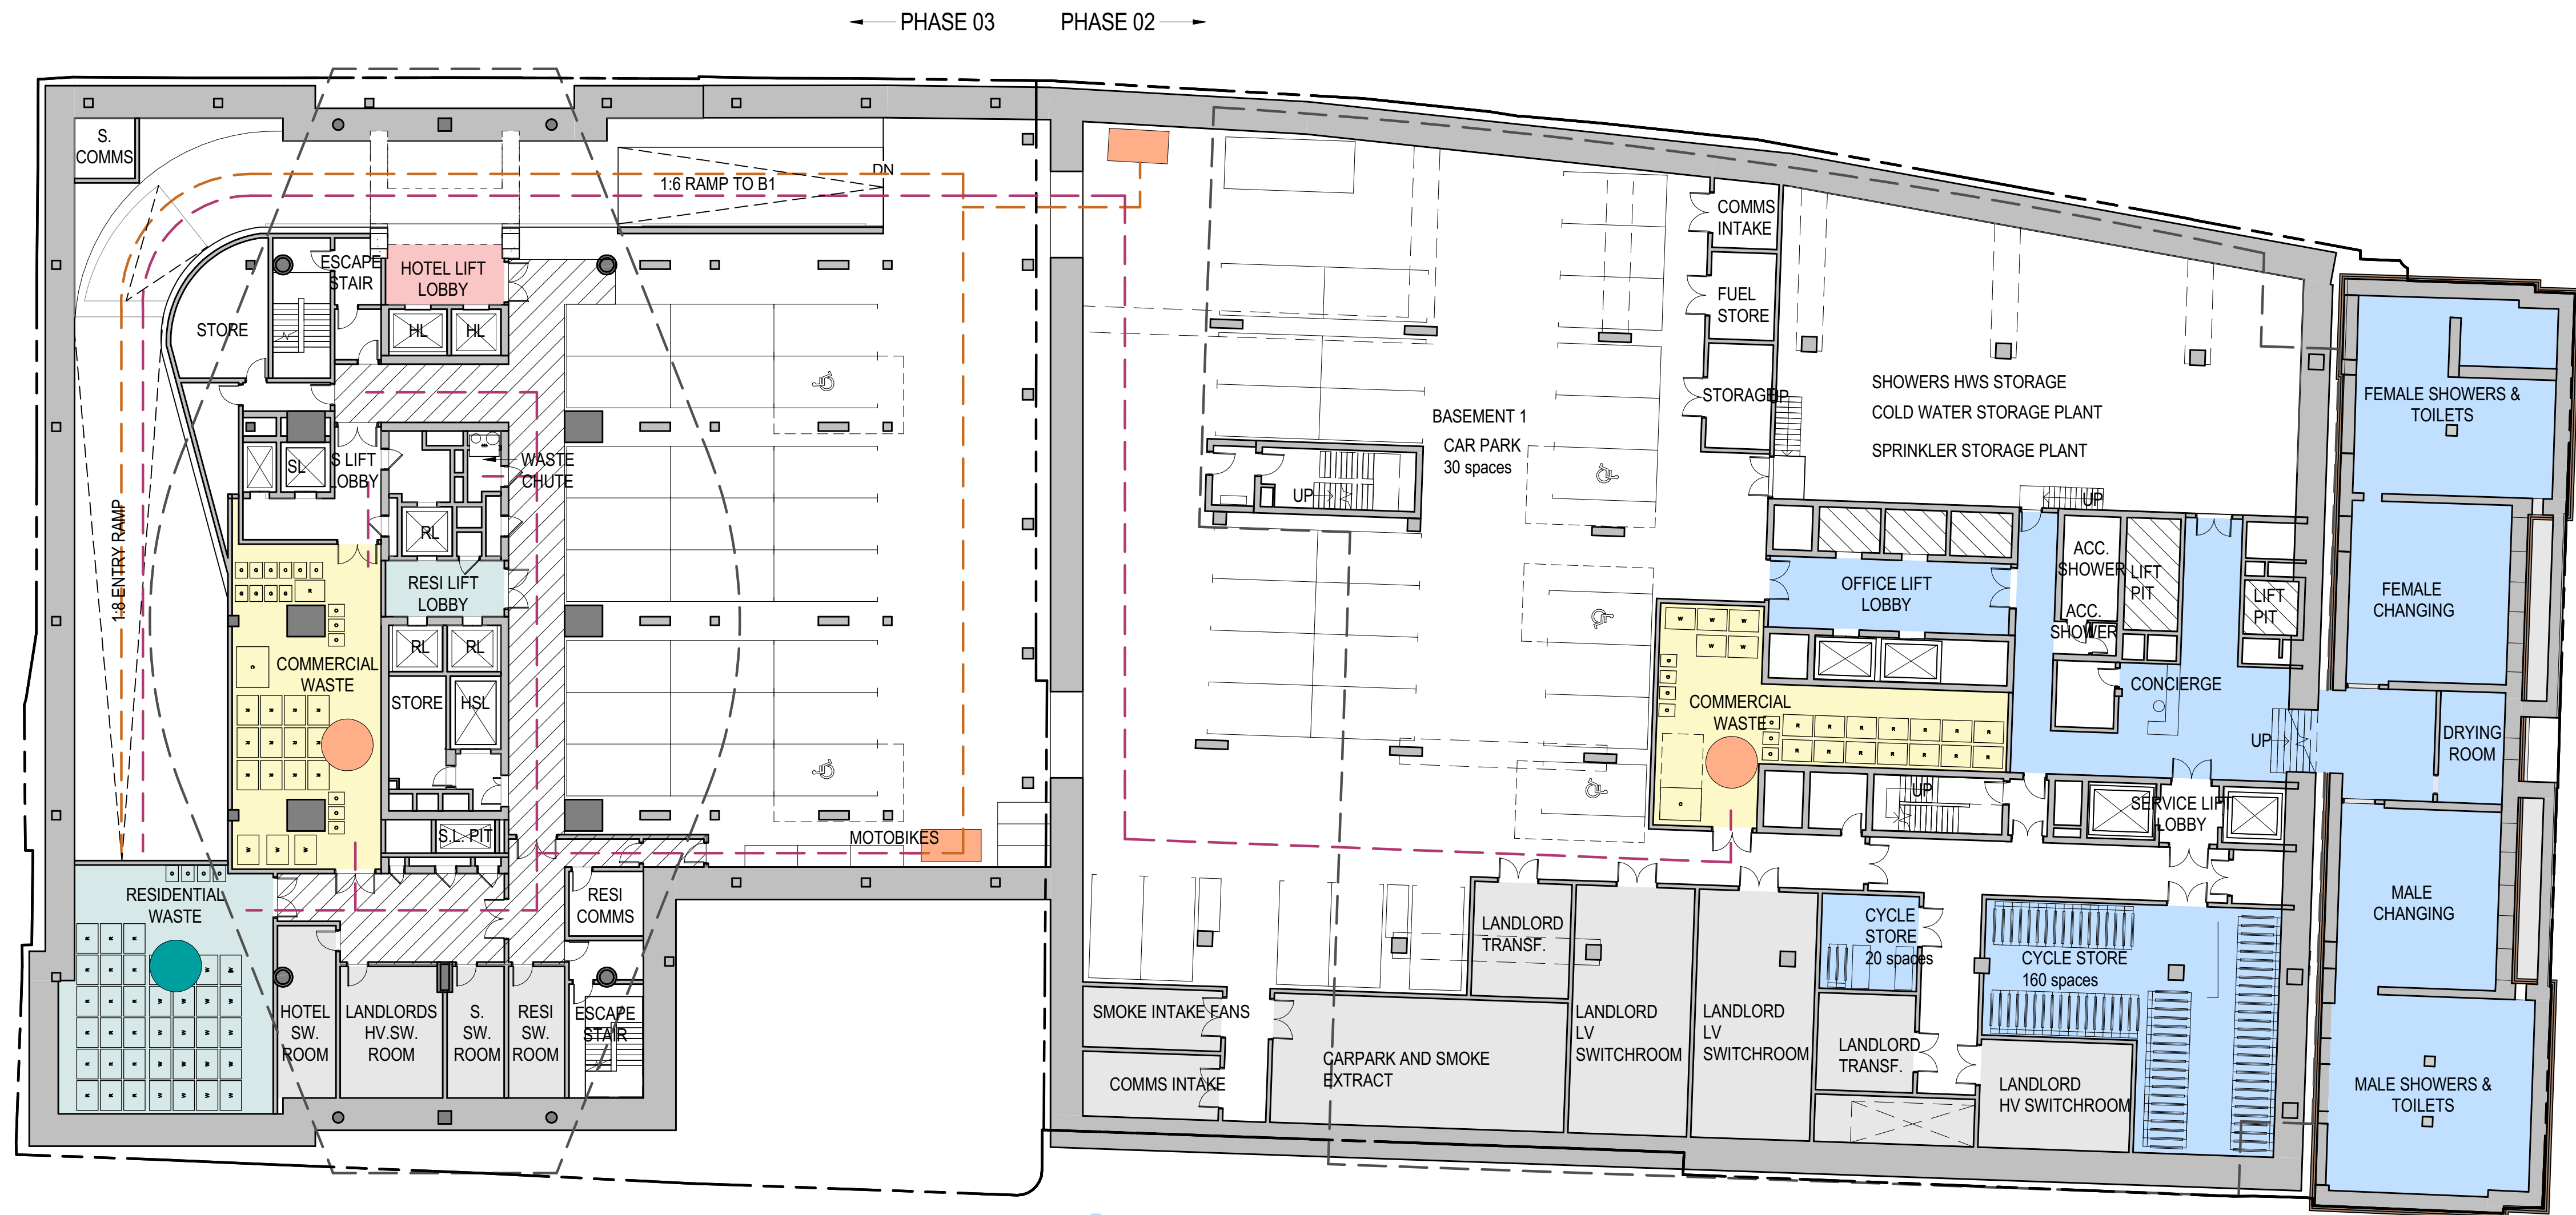
LEVEL B1 PLAN

- COMMERCIAL BIN STORE
- RESIDENTIAL BIN STORE
- BIN PRESENTATION COLLECTION POINT
- BLOCK A RETAIL AND PUB WASTE STORE
- BLOCK A RETAIL AND PUB WASTE STORE
- BIN TUG ROUTE
- PEDESTRIAN ACCESS
