## **Plot 8 First Street, Manchester**

### **Geotechnical and Geoenvironmental Assessment**

**For: Ask Property Developments Ltd**

Doc Ref: 1011906.RPT.GL.004

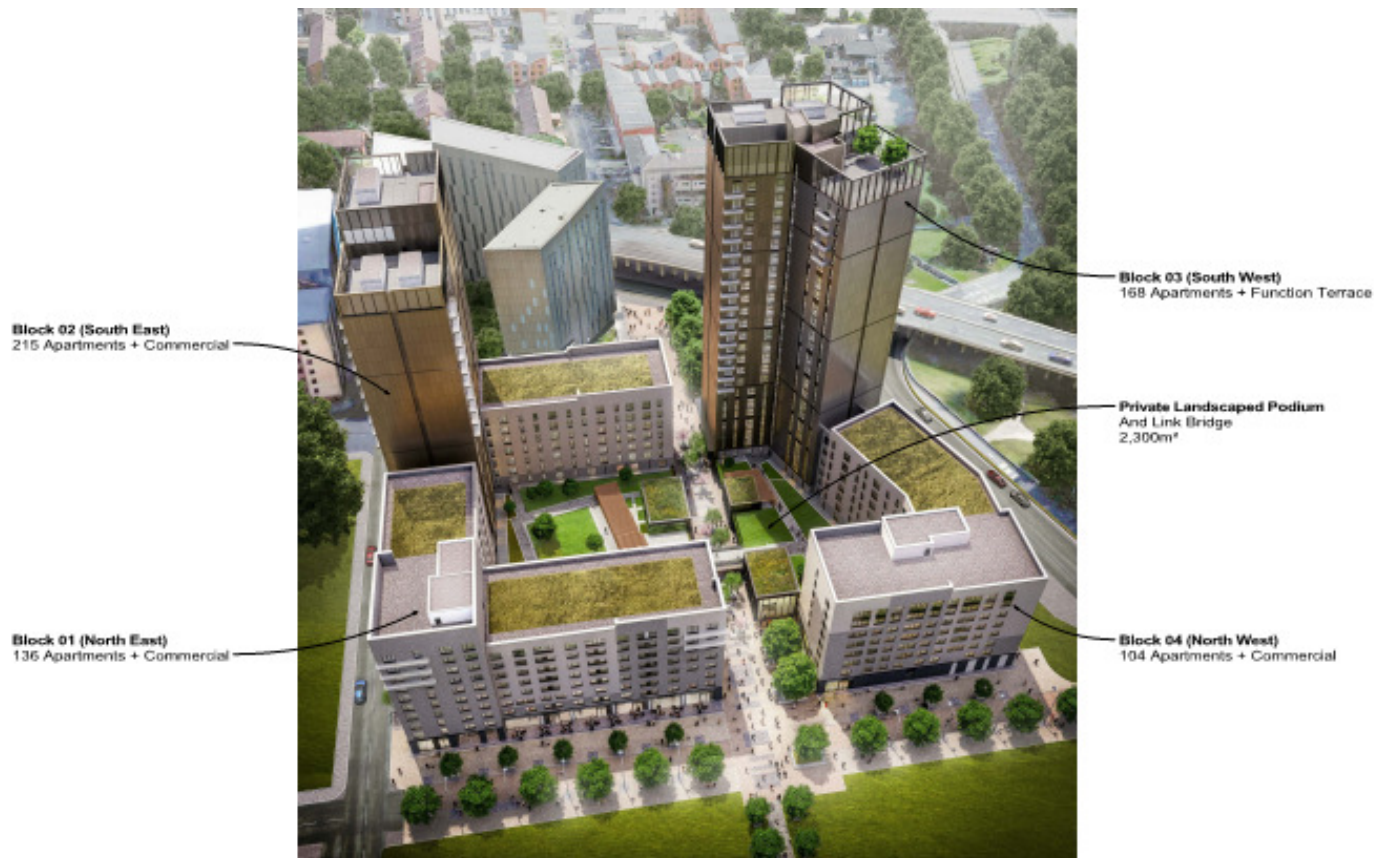
*Figure 2 – Architects Representation of Development Scheme*

Current schematic proposals for the site are illustrated as Figure 2 and comprise the following:

- The inclusion of some retail / commercial use at ground level within the residential complex.
- Landscaping within the development is proposed to include limited green spaces (soft landscaping) within the centre of the complex constructed on a raised podium slab, as well as paved access routes and hard-surfaced public realm.
