| Project: | MBS East Refurbishment | | | | | | |
| Drawing: | Existing Roof Plan | | | | | | |
| 8405-NGB-01-R-DR-A-0306 | | | | | | | P2 |

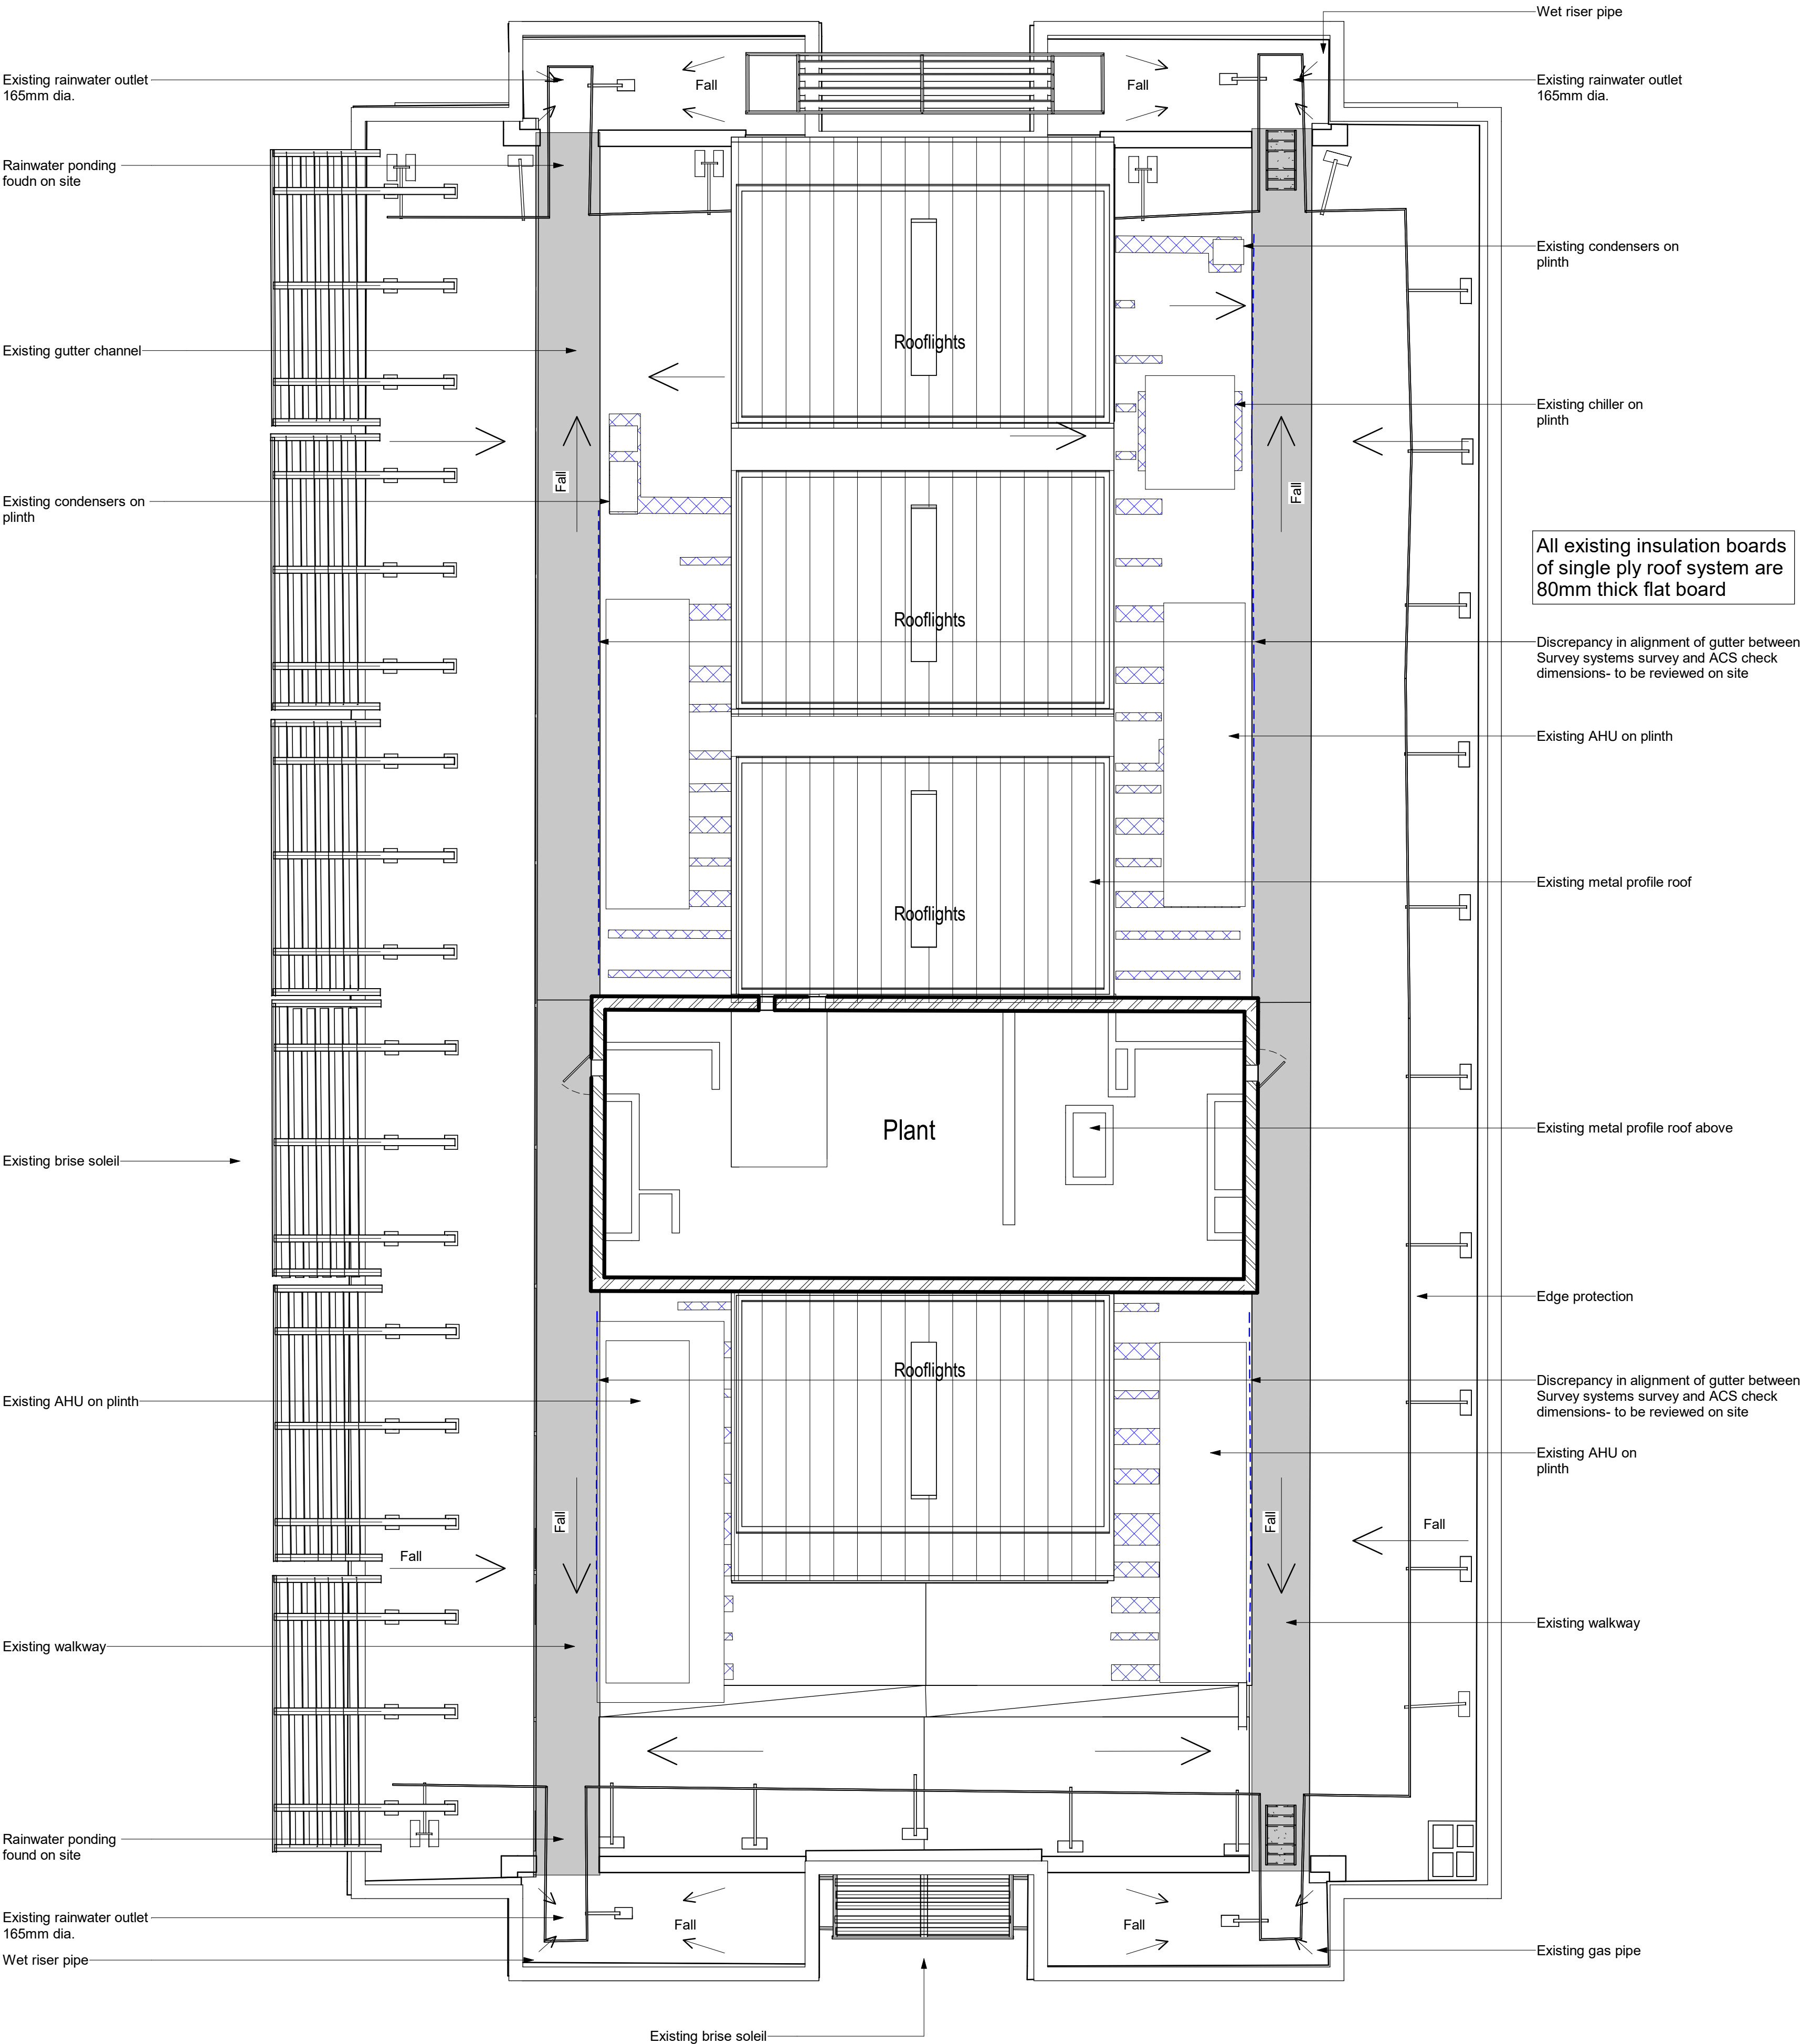
Existing Roof Plan

The sizes and positions of existing plinths are based on post strip out survey of plinth by ACS. Discrepancies on alignment with original roof survey by Survey Solutions.

Alignment of gutter from ACS check dims.

Discrepancy in alignment of gutter between Survey systems pre strip out survey and ACS check dimensions to cladding line. To be checked on site prior to installation of M&E plant equipment.

- Setting out of plinths and external cladding line of roof based on survey information from Survey Solutions and post strip out survey of plinth locations by ACS. There are discrepancies between alignment of surveys. All setting out to be checked on site prior to manufacture/ construction.
