**EASTLANDS ARENA LTD**

**COOP LIVE WALKING ROUTE**

**ECOLOGICAL INSPECTION FOR BATS AND BIRDS**

15<sup>th</sup> March 2024

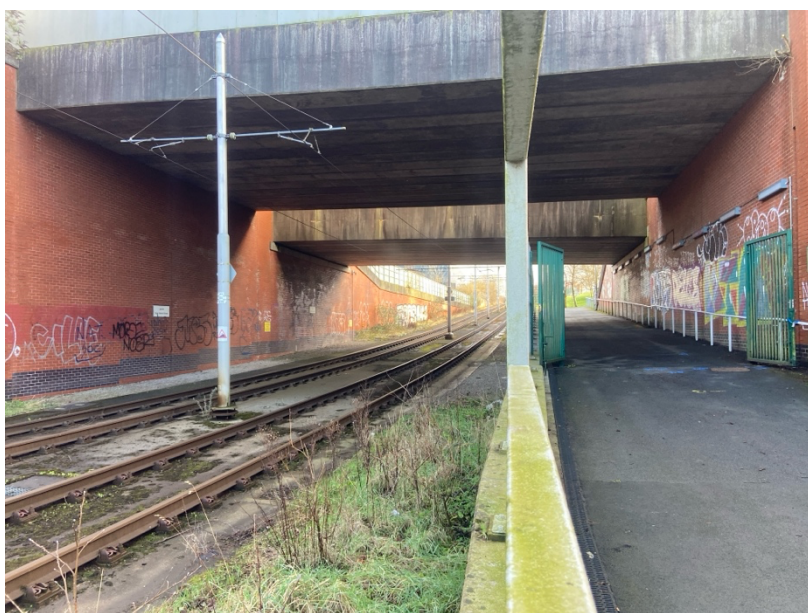
**Figure 2 CWT\_006 New Viaduct Street (Near) and Rail Bridge (Far)**

- 3.3 Figure 2 illustrates this location, which is spanned by two bridges running south to north; the New Viaduct Street road bridge to the west, and the rail bridge to the east.

- 3.4 The New Viaduct Street Bridge had no gaps on the underside where the piers meet the span, either to the north or the south. There is no bat roost potential on its underside.

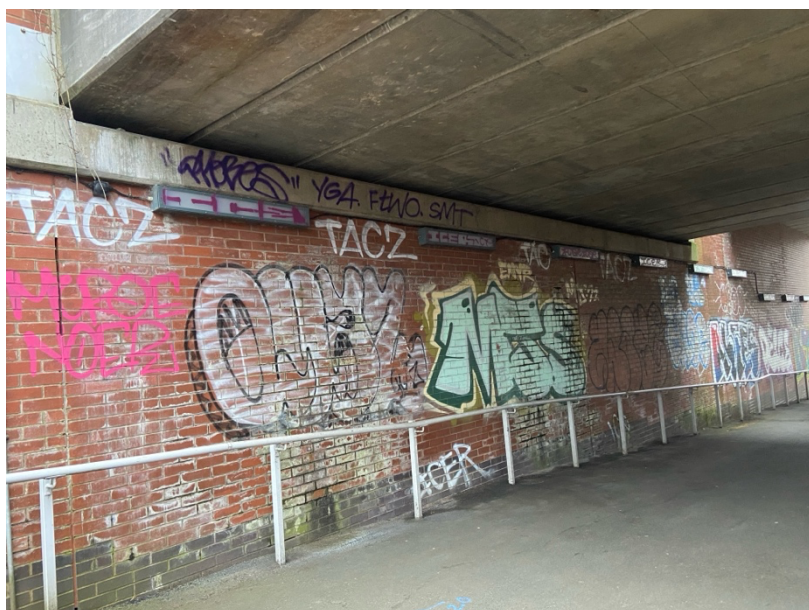
**Figure 3 Rail Bridge South Side with Existing Artificial Lighting at Night**

- 3.5 On the south side of the rail bridge, gaps were inspected from the footpath (left side of Figure 2, Figure 3) and no evidence of bats found. The section is actively lit at night (all night) and there are some gaps with low potential to the rear of a concrete shelf. If present, bat evidence here would be easy to see and would collect and be protected from weathering, but none was visible. Both corners had accessible voids but there was evidence of bird nesting material (possible pigeon or jackdaw) in both corners making bat use unlikely (Figure 4). The bird nesting material did not look recently accumulated – probably from previous seasons.

- 4.5 The vertical wall and underside of the span on the south side of the Rail Bridge were inspected using MEWP and no evidence of bats found. The structure was such that potential was also low and it is not considered likely that a bat roost, is located in this area. The whole footpath area is strongly lit at night which is likely to further discourage bats from roosting here. There was also no evidence of recent breeding bird activity in this area.

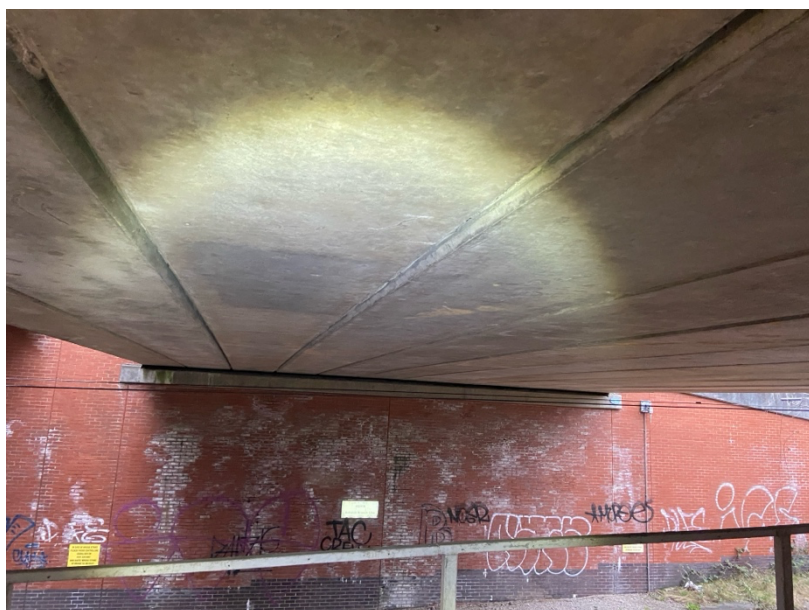
**Figure 5 Rail Bridge North Side, Not Accessible**

- 3.6 On the north side of the rail bridge, similar structure was visible across the tram tracks (Figure 5) but could not be inspected due to accessibility issues.

- 4.6 It was not possible to search the north side of the bridge due to access for the MEWP over the tram tracks. Due to darker ambient night-time conditions, the bat roost is more likely to be situated over here.

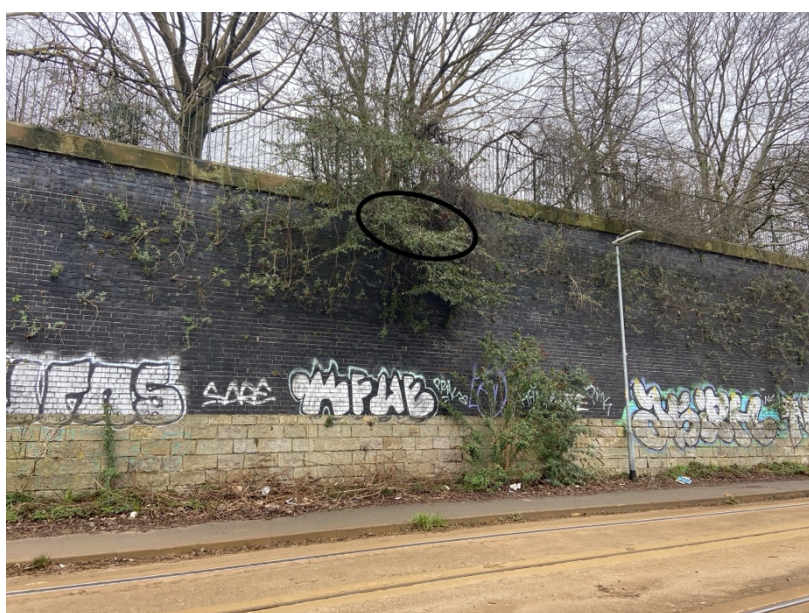
**Figure 6 Bush Containing Bird Nest**

- 3.8 The vegetation along the CWT\_002A section was predominantly thin plants of buddleia (*Buddleia davidii*) growing directly out of the mortar along the wall, with some wisps overhanging from the park above. Mostly, this vegetation was not suited to bird nesting and no nests or breeding behaviour was noted.
- 3.9 A single denser bush was present (Figure 6) which appeared to contain a nest, possibly from 2023 season.

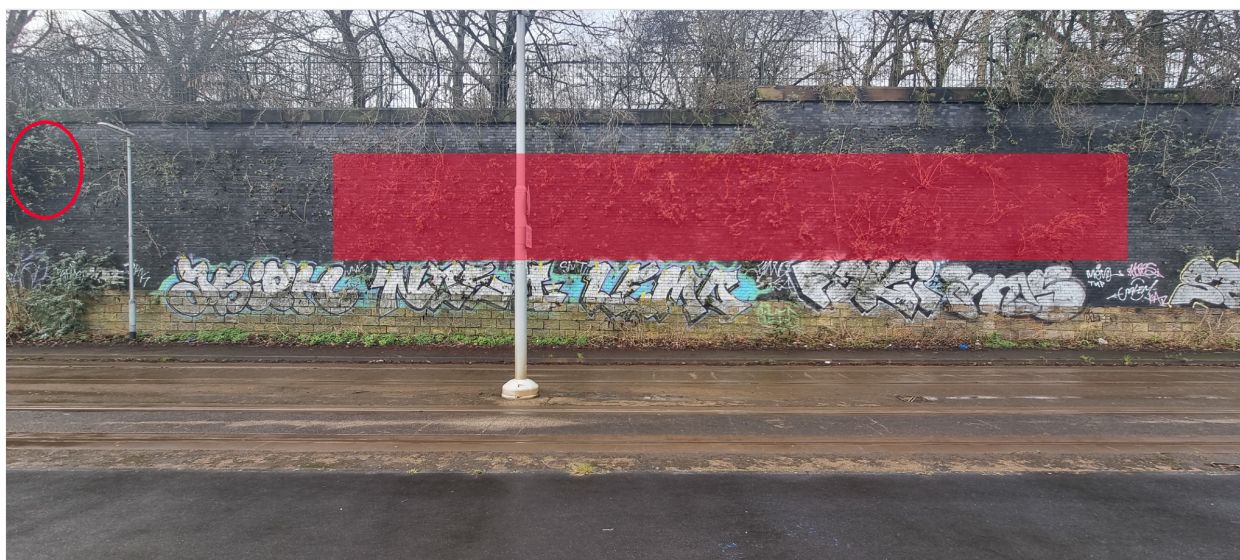
**Figure 7 Location of CWT\_002A Installation and bird nest**

- 4.1 The elevated inspection using MEWP found no potential for or evidence of bats at this location.
- 4.2 An old and possibly active bird nest was located in a bush overhanging the wall, to left of Figure 7. No bird activity was noted in relation to this nest, but at this time of year a precautionary approach is advisable. However, the area from which vegetation needs to be removed, also shown in Figure 7, lies at least 5m away from the works area and will not be affected. Thus, no further action is necessary during localised vegetation removal and installation of the content wall within the rectangle indicated in Figure 7.

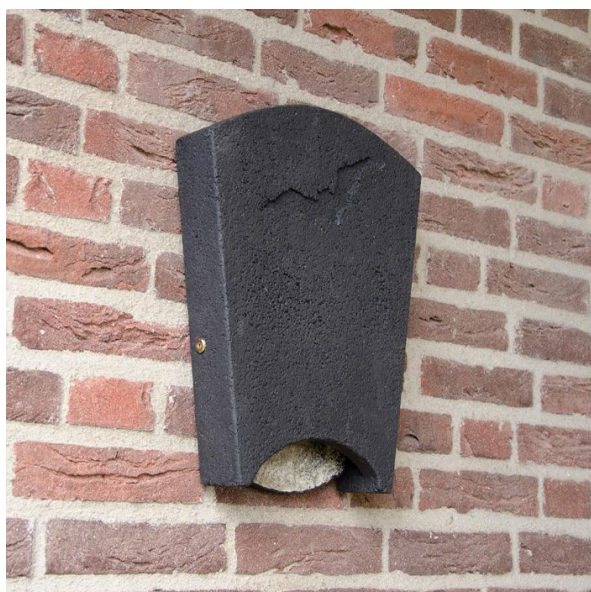
## APPENDIX 2 EXAMPLE BAT BOX LOCATIONS ★

## E.G. Beaumaris WoodStone Bat Box Midi

- 4.10 Possible negative impacts upon bats could be further reduced by a sympathetic lighting programme, which results in reduced lighting levels outside of key periods such as matches or events. In fact, reductions in overall lighting at times of low traffic could potentially deliver a benefit for bats.
- 4.11 Further benefits for bats could be achieved by:
- Respecting the dark zones identified in the Ecological Update Report Feb 2024 (Appendix 1).
  - Installation of suitable bat boxes on the bridge north side at CWT\_006, as suggested in Appendix 2, or with similar locations and types. Such installation should be advised by an ecologist.
- 4.12 Taking all these into account a net benefit for bats could be achieved from this scheme.
