# ASBESTOS SAMPLING REPORT

LOCATION: Cheetham Hill Site, Herbert Street, Manchester, M8 0DG

SURVEYED ON: 20 Feb 2024

OUR REF: PR12547

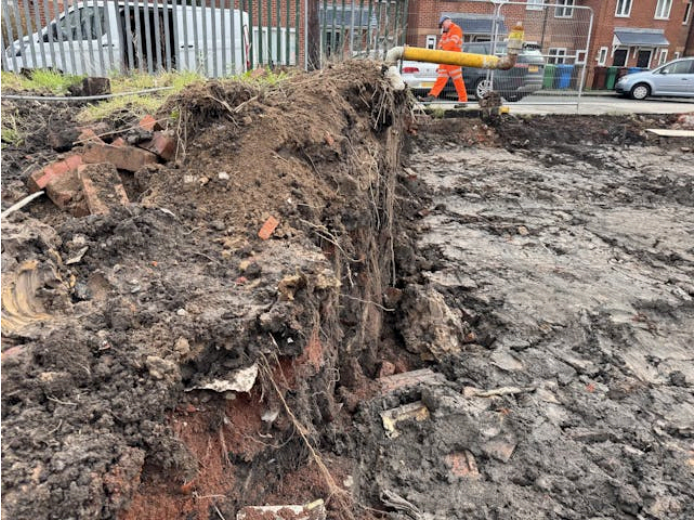
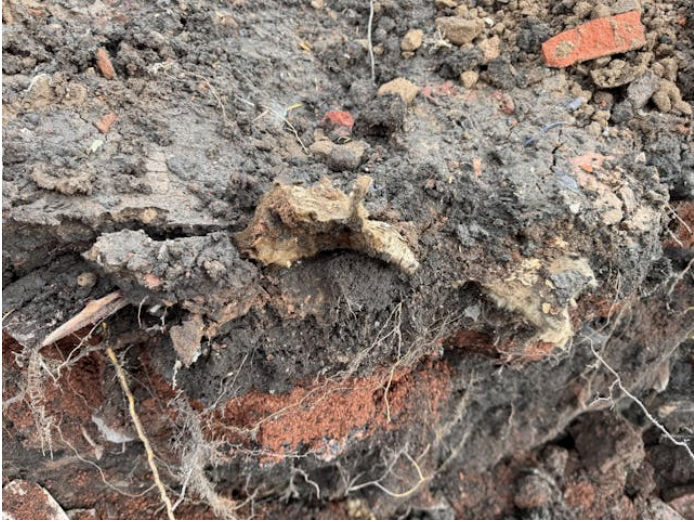
**Cheetham Hill Site > External > Development Land > Sample Point 1**

| Material | Debris | Extent | 0.1M <sup>2</sup> |
| Strategy / Sample Id | Sample / ISO1 | Fibre Type | NADIS |
| General Comments | Inspection of area identified insulation type material amongst general demolition rubble and risings. | | |

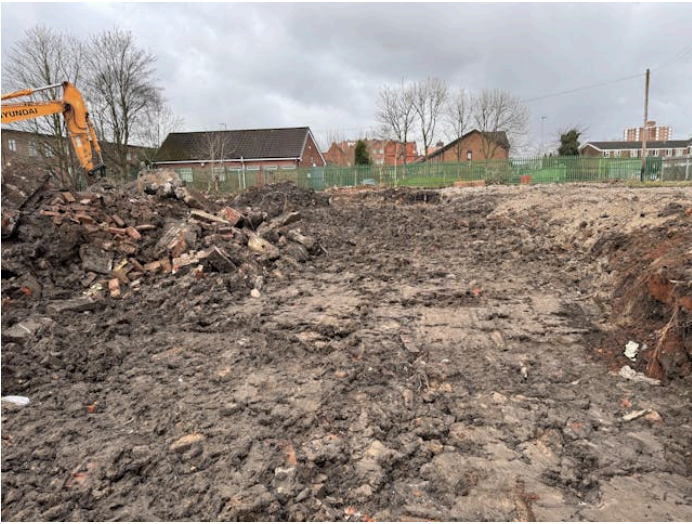
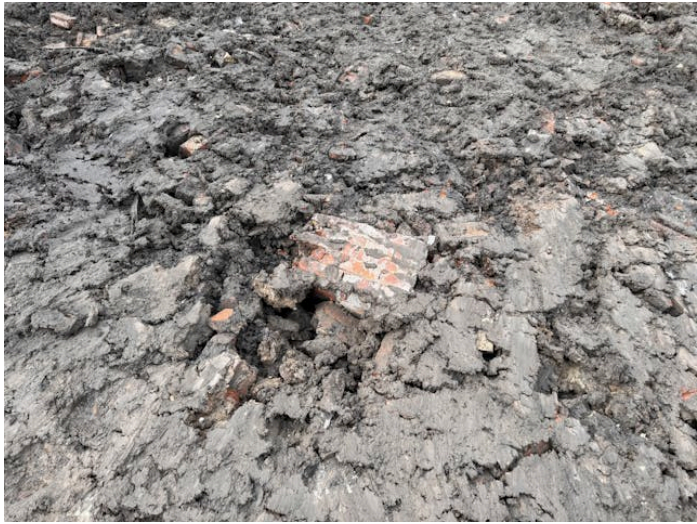
**Cheetham Hill Site > External > Development Land > Sample Point 2**

| <b>Strategy / Sample Id</b> | Sample / ISO2 | <b>Fibre Type</b> | NADIS |
| <b>General Comments</b> | Inspection of area identified cement type fragments amongst general demolition rubble and risings. | | |

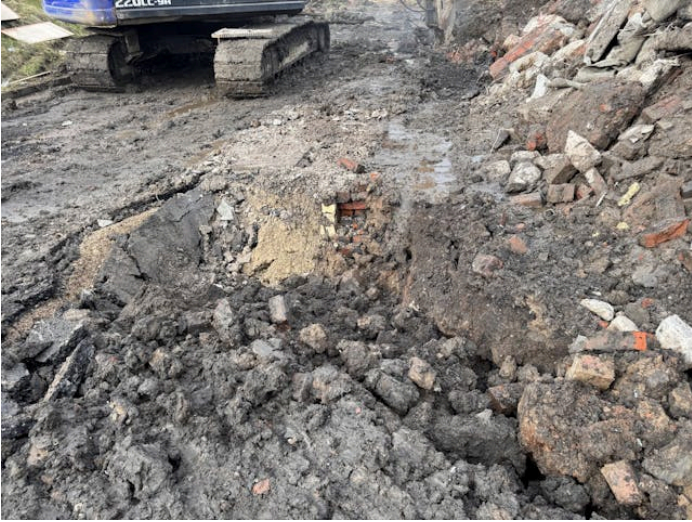
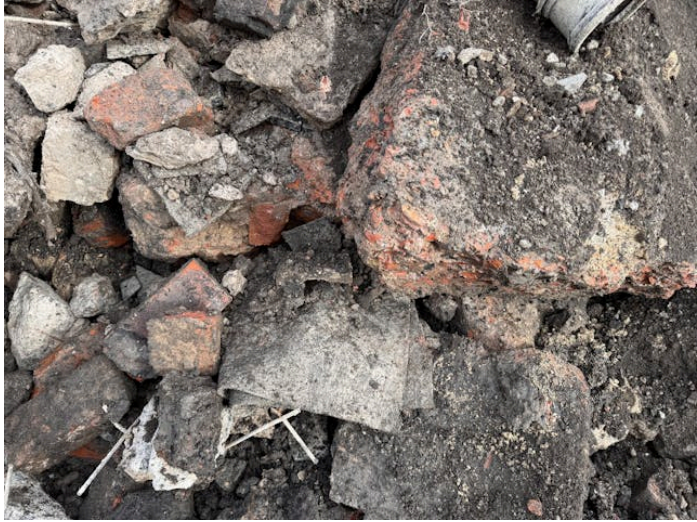
**Cheetham Hill Site > External > Development Land > Sample Point 3**

| Strategy / Sample Id | Sample / ISO3 | Fibre Type | NADIS |
| General Comments | Inspection of area identified felt and cement type materials amongst general demolition rubble and risings. | | |

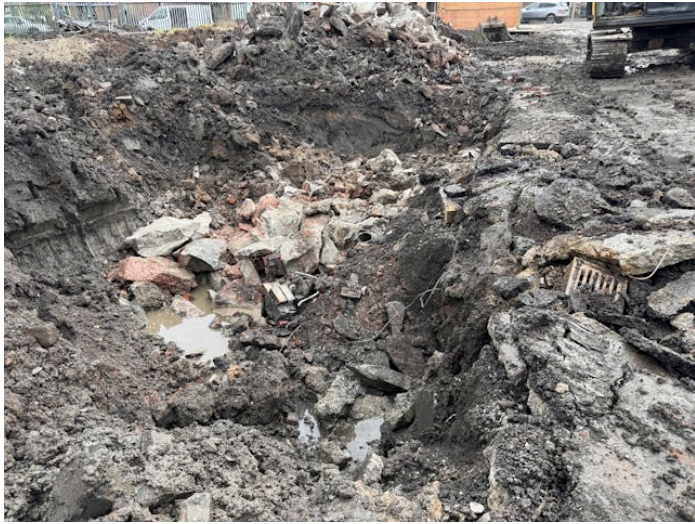
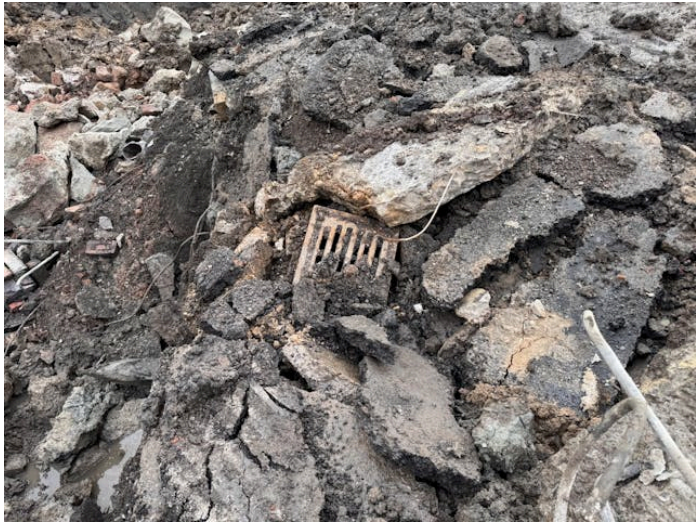
## Cheetham Hill Site > External > Development Land > Sample Point 4

| Material | Debris | Extent | <0.1M <sup>2</sup> |
| Strategy / Sample Id | Sample / ISO4 | Fibre Type | Chrysotile |
| General Comments | <p>Inspection of area identified a small section of bitumen felt wrap amongst general demolition rubble and risings. The small fragment was removed in entirety as a sample.</p> <p>Further inspections did not identify any recurrence of the asbestos containing bitumen felt material.</p> | | |

| Product Type (or Debris from Product) | 1 | Extent of Damage / Deterioration | 3 |
| Surface Type / Treatment | 0 | Asbestos Type | 1 |
| Material Score | 5 / Low | | |

| Recommendation | Remove | | |

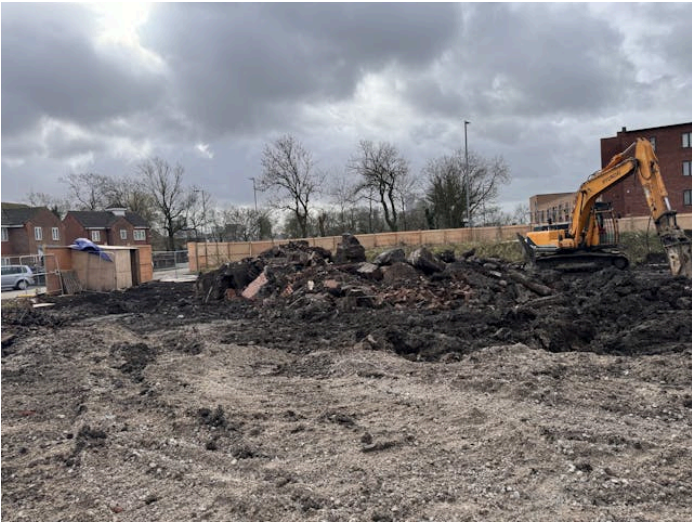
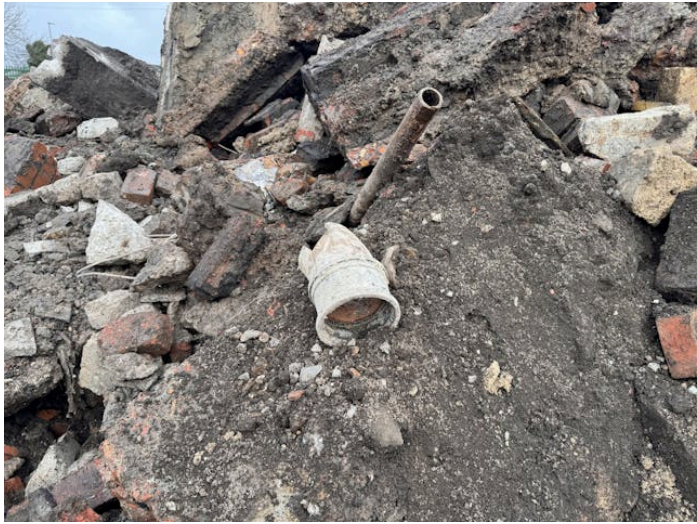
**Cheetham Hill Site > External > Development Land > Sample Point 5**

| <b>Strategy / Sample Id</b> | Sample / ISO5 | <b>Fibre Type</b> | NADIS |
| <b>General Comments</b> | Inspection of area identified vinyl floor tile, insulation and cement type materials amongst general demolition rubble and risings. | | |
