# Remediation Strategy Bignor Street Park, Cheetham Hill

## Prepared for Conlon Construction Ltd

**10/2204/003 Rev. 03**

## Remediation Strategy Report Bridge Street Park (Olive School), Cheetham Hill

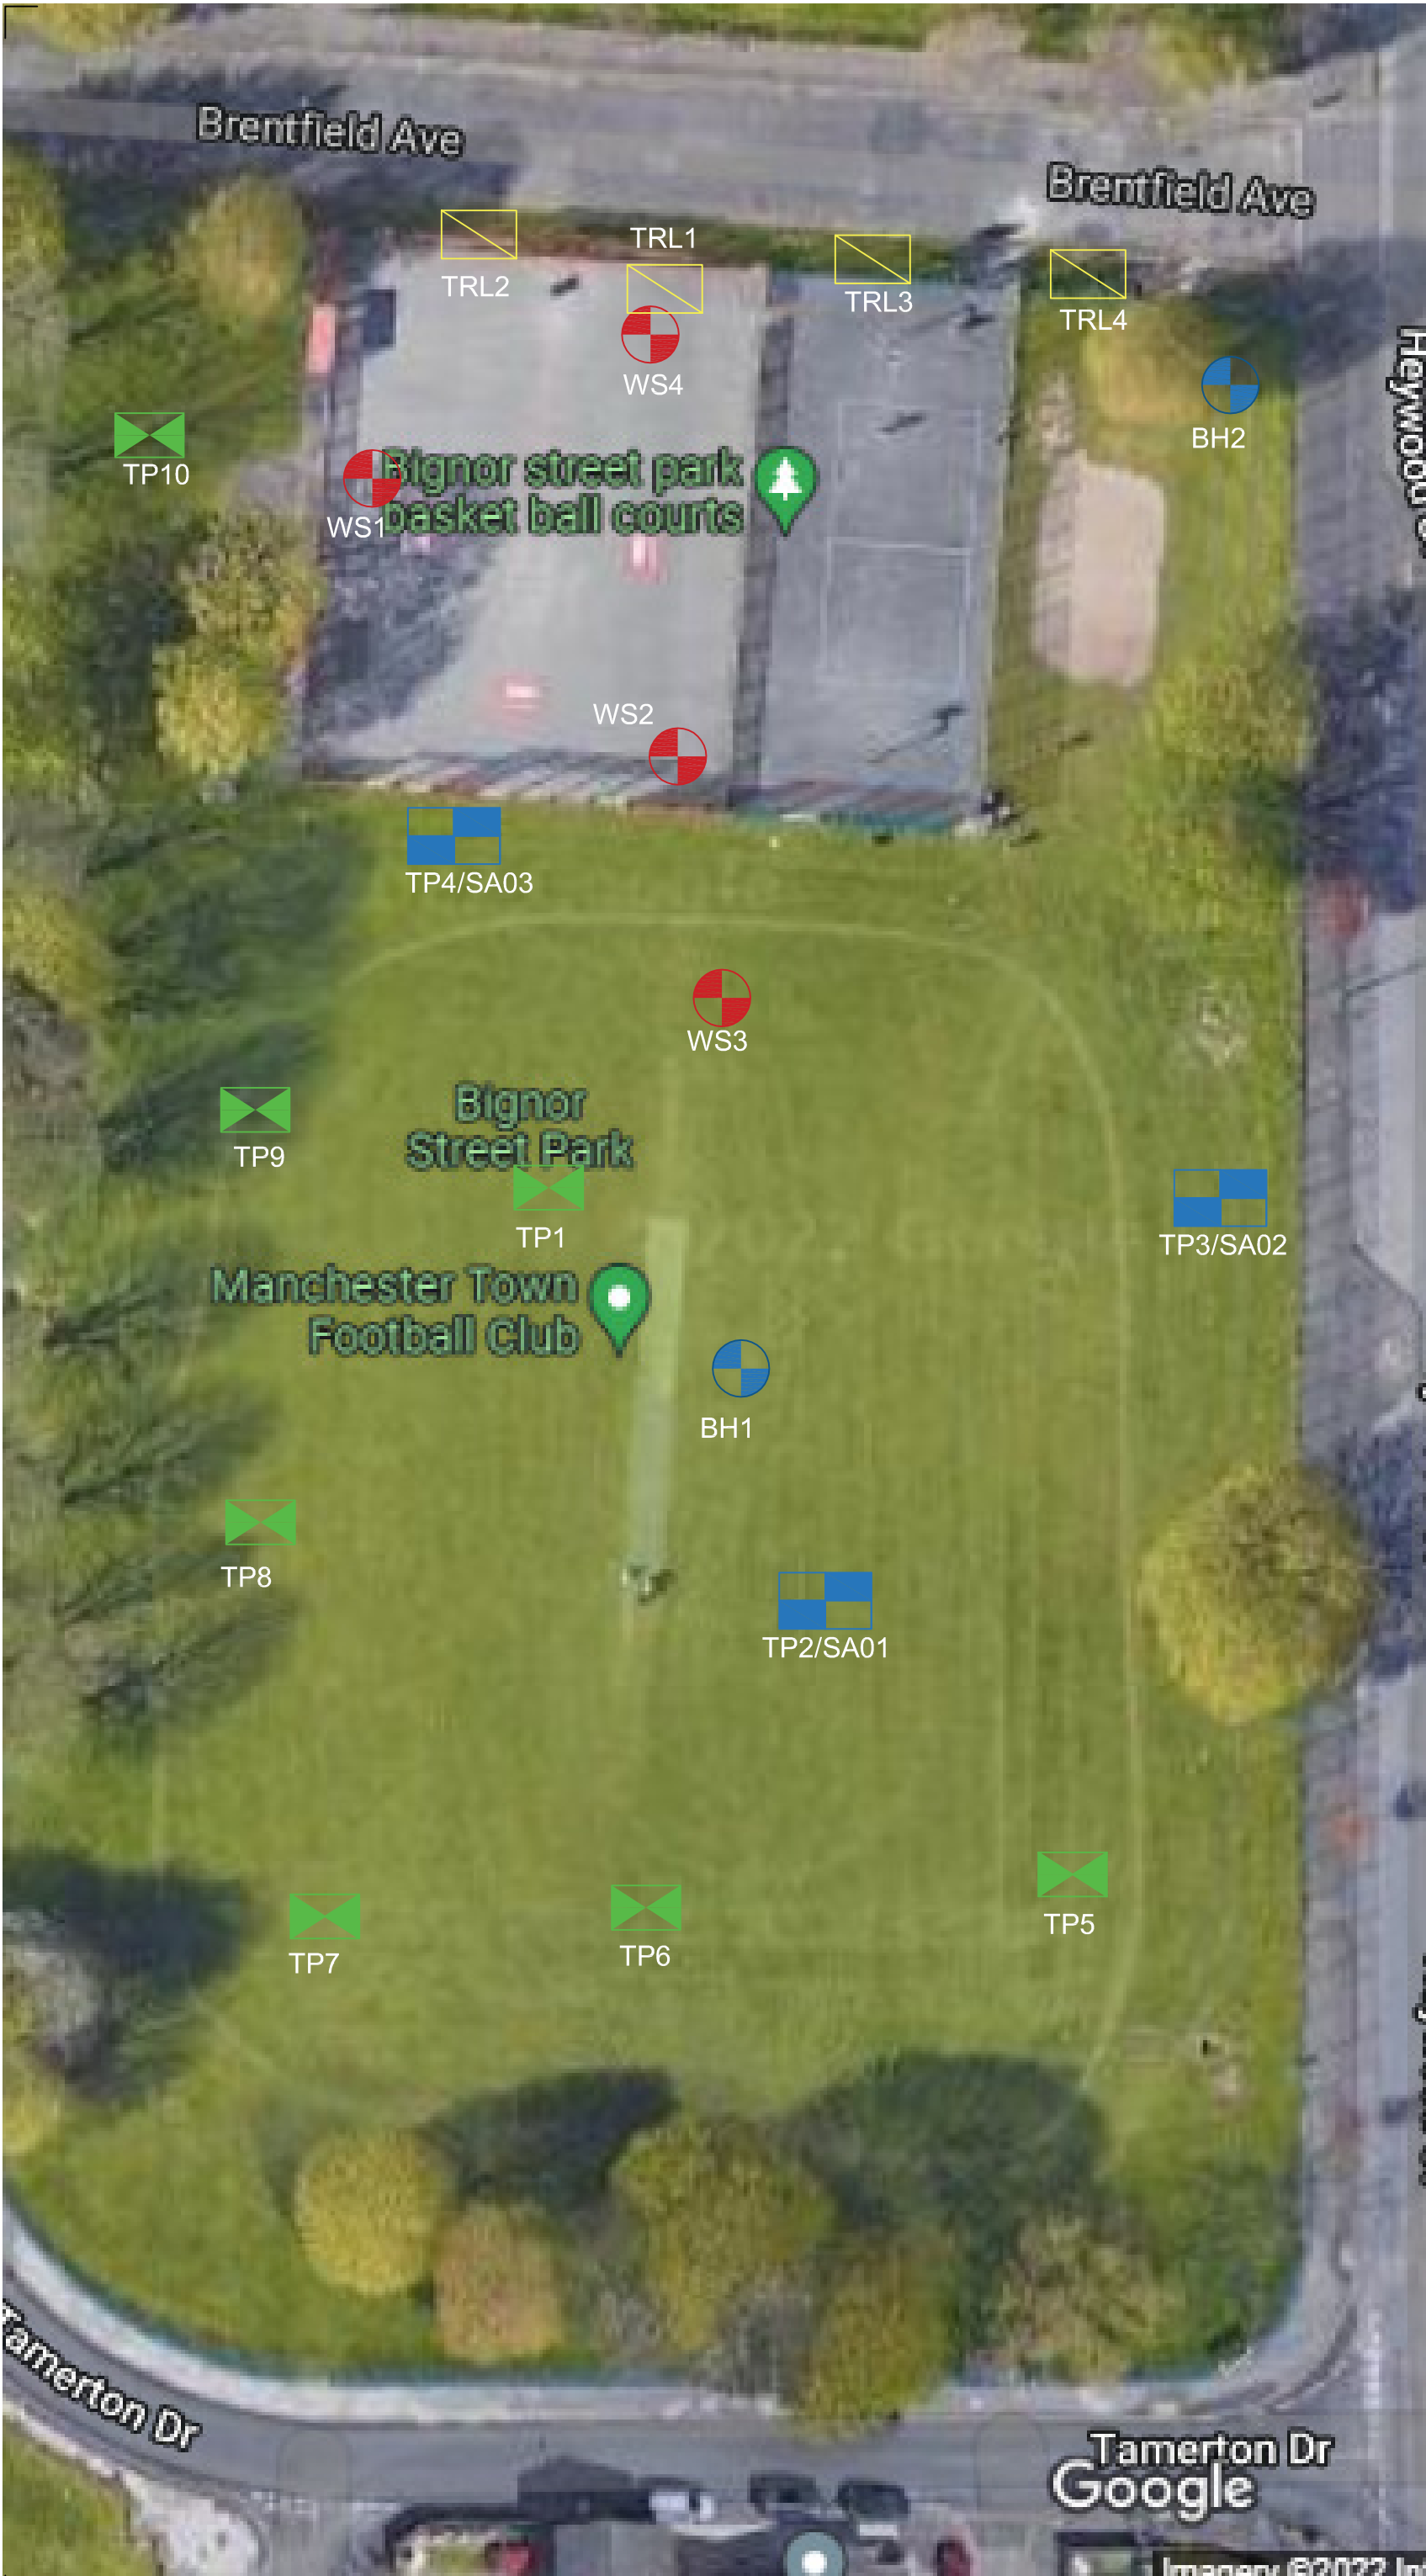
| Title | Exploratory Hole<br>Location Plan | | |

The site investigation comprised two cable percussion boreholes (BH1 and BH2) to depths of approximately 20.00m bgl, four window sampler boreholes (WS1 to WS4) to depths up to 5.45m bgl and ten machine excavated trial pits (TP1 to TP10) to depths of up to approximately 3.10m bgl.

Groundwater and ground gas monitoring wells were installed in boreholes BH1, BH2, WS1 and WS2 and SPTs were undertaken throughout the depth of each borehole. In addition, soakaway tests were carried out in three trial pits (TP1 to TP3) to assist with drainage design and four DCP tests (DCP1 to DCP4) were carried out in areas of proposed hardstanding to provide indicative CBR values. A copy of the exploratory hole location plan is attached.

Made Ground was recorded in all exploratory locations to depths between 1.00m and 1.90m bgl underlain by Glaciofluvial Sheet Deposits, comprising interbedded soft to stiff cohesive soils and very loose to medium dense granular deposits. This was in turn underlain by Devensian Till from circa 16.30m bgl comprising stiff and very stiff clay to a maximum proven depth of 20.45m bgl.

Concentrations of benzo(a)pyrene, benzo(b)fluoranthene, naphthalene and beryllium were recorded in samples of Made Ground collected from TP3, TP6 and TP10, in excess of their adopted AC. As such it is recommended that a 300mm thickness of clean capping layer, comprising at least 100mm thickness of topsoil, be placed in areas of soft landscaping to form a barrier between recorded contaminants of concern and future site users.

In the location of TP3 significantly elevated concentrations of naphthalene were recorded. Whilst it is possible the elevated concentrations are related to slag and clinker recorded in the sample analysed, given the sensitive nature of the proposed development and environmental setting (Secondary A and Principal Aquifers beneath the site) it is considered prudent for the contaminated Made Ground soils in the vicinity of TP3 to be locally excavated and disposed off site to ensure the protection of site end users and controlled waters receptors.

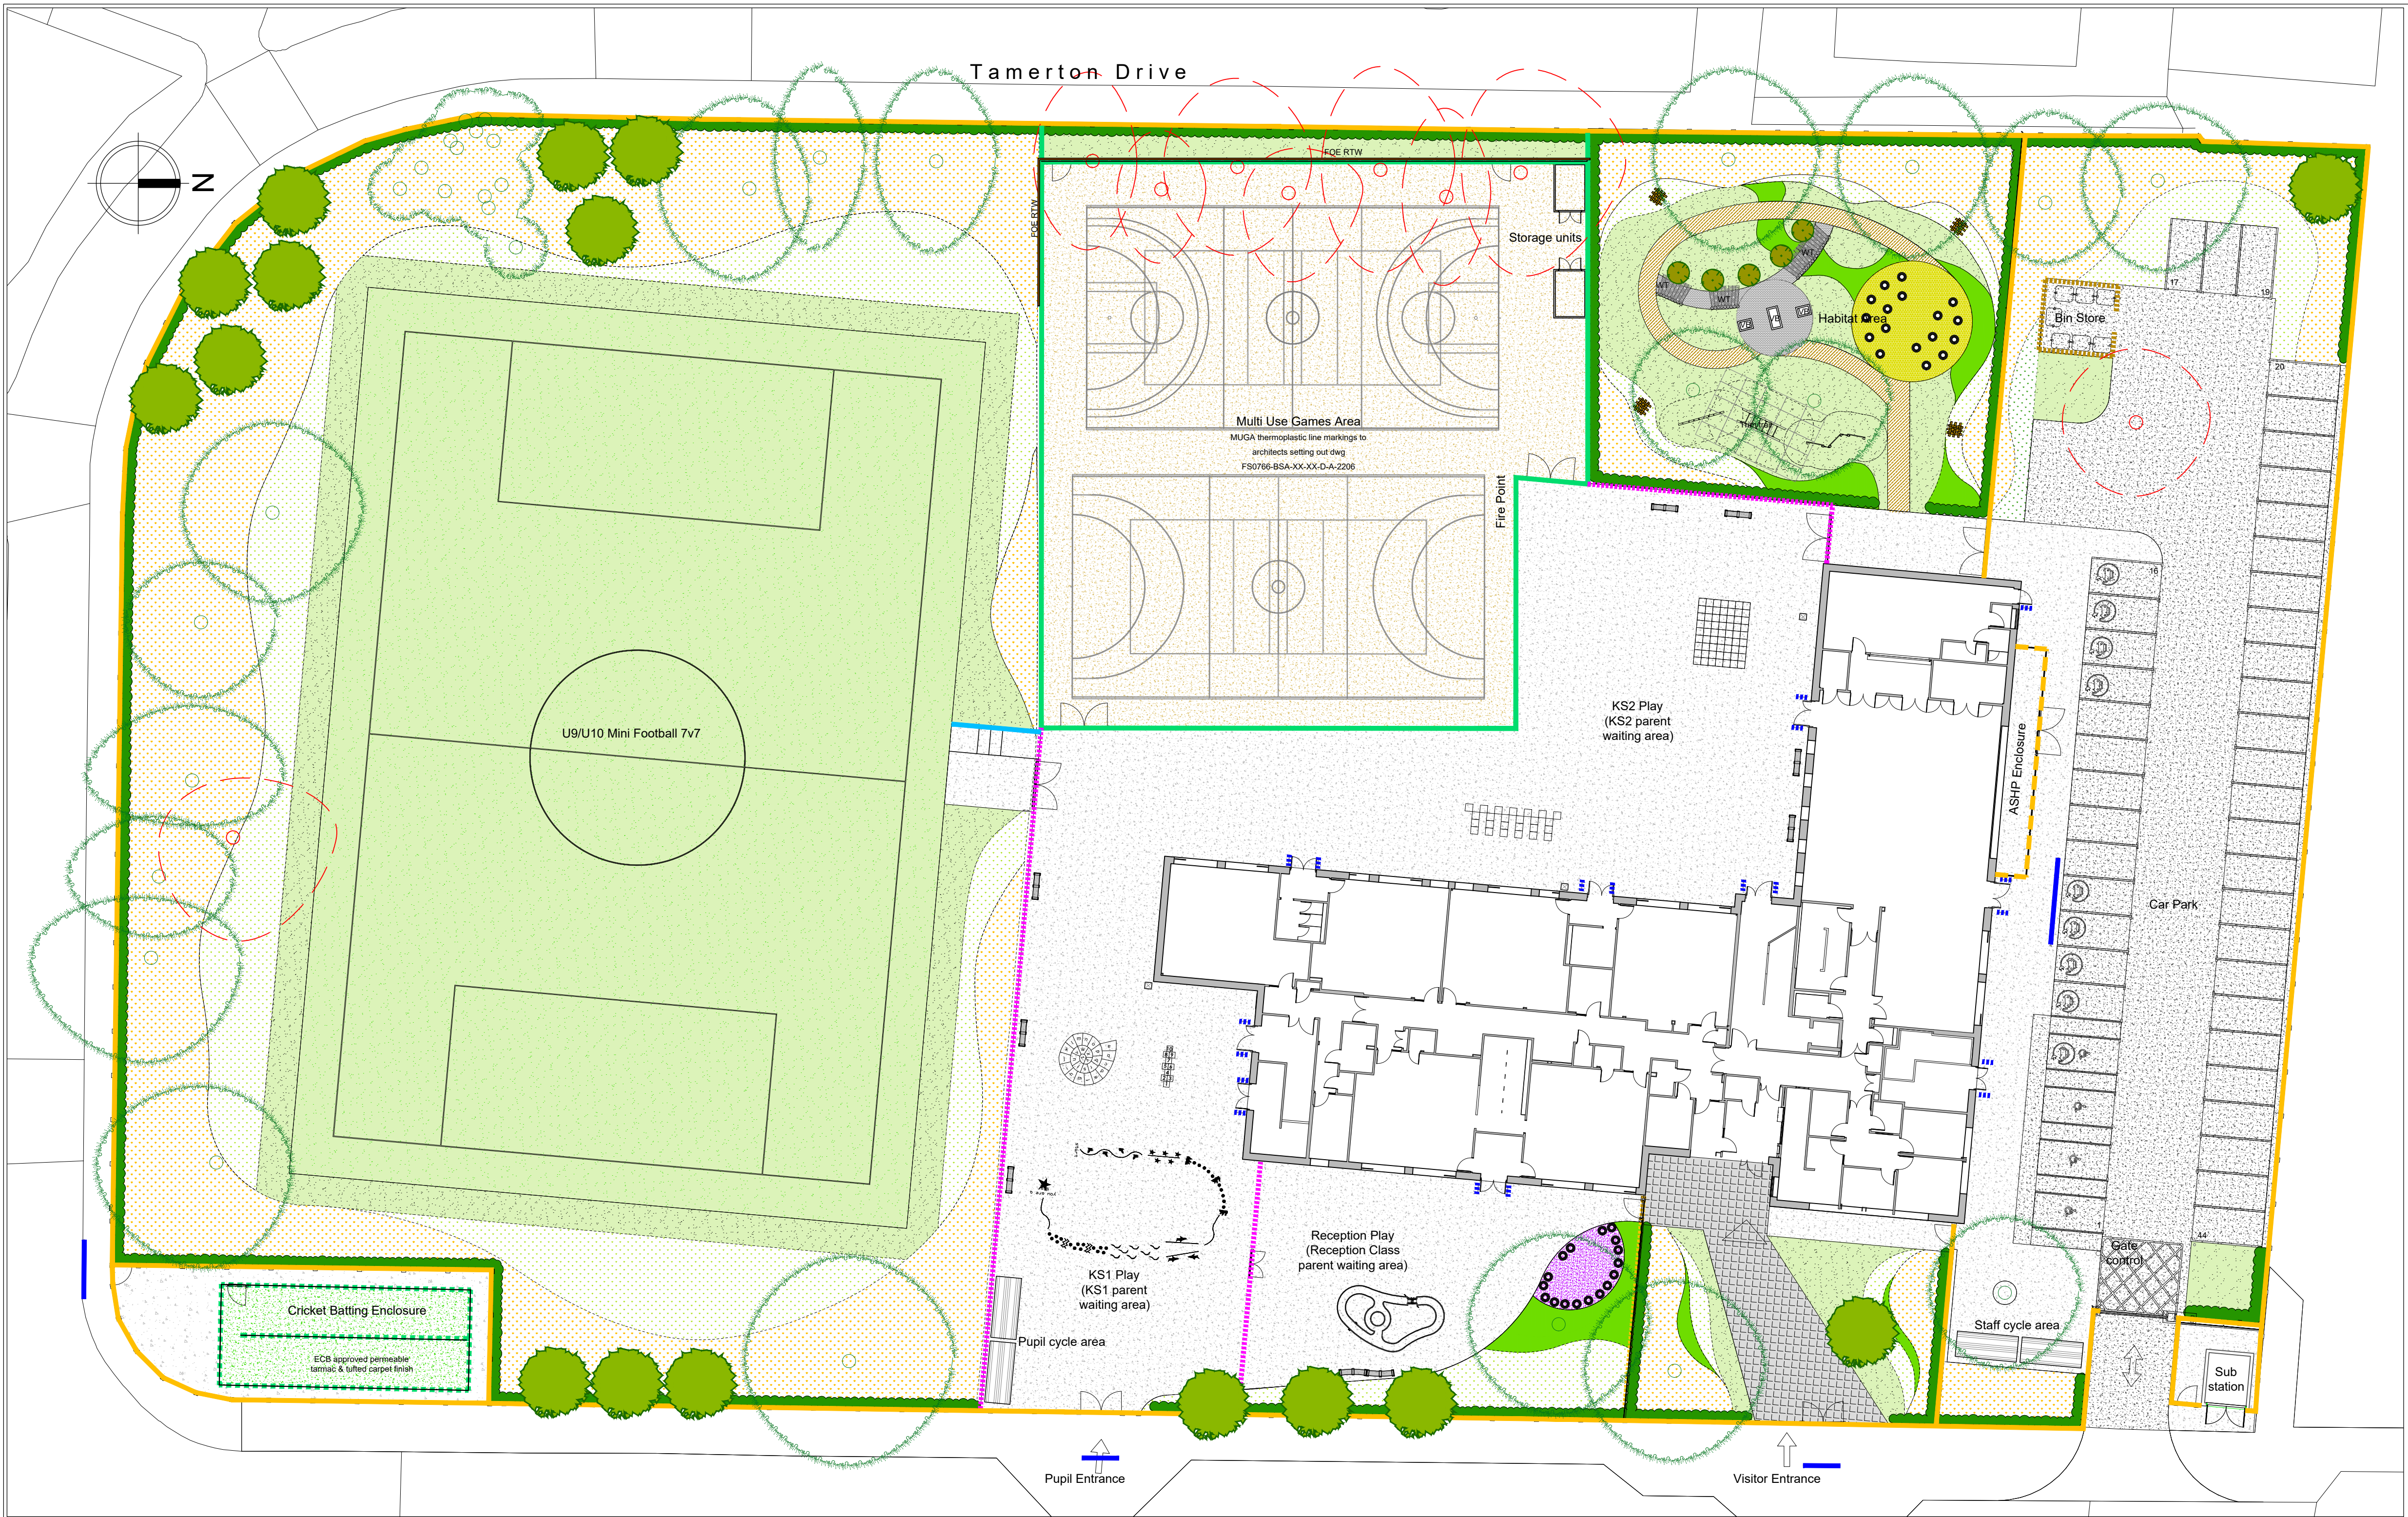
DRAWING TITLE  
Landscape Masterplan

The areas requiring clean soil cover are shown on the Landscape Masterplan drawing in Appendix. In particular this relates to areas of landscaping annotated as Amenity Turf, Sports Turf and Ornamental Shrub Planting. As previously mentioned, areas of wildflower seeding and tree protection zones are excluded given these areas will remain largely inaccessible and to avoid potential damage to the protected tree root systems.

Given the nature of the Made Ground soils and presence of elevated soil contaminant concentrations some form of remediation is required. In the location of the mini football field, habitat area and general soft landscaping a 300mm layer of verified clean soil cover should be provided, including a minimum 100mm thickness of topsoil and 200mm subsoil in accordance with guidance set out in the NHBC Technical Standards 2022. The clean cover layer will form a barrier between recorded contaminants of concern and future site users, thus breaking the pollutant linkage.
