# St Margaret Mary's Roman Catholic Primary School, New Moston

## Bat Survey Report

14<sup>th</sup> June 2023

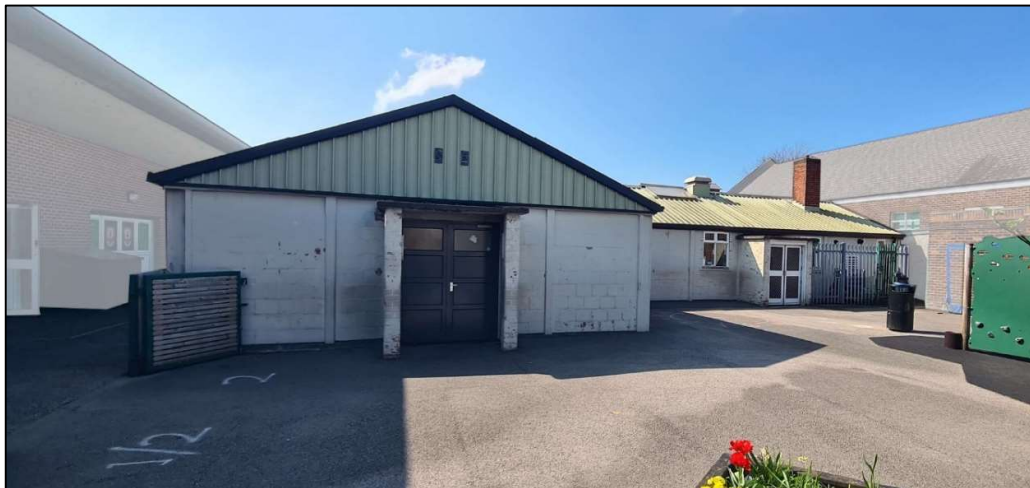
**Plate 1. The north aspect of the building (adjacent buildings greyed out)**

5.2.4 The single-storey building was constructed from a single skin of concrete blocks with concrete pillars. The hall and the kitchen had separate pitched roofs covered with sheet metal. The top half of the four gable ends were also clad with sheet metal (Plate 1). At the southern end the building was linked to the rest of the school via a brick-built corridor with a flat roof (Plate 2). Some of the original wooden framed windows were present (on the eastern aspect), others had been replaced with UPVC framed windows.

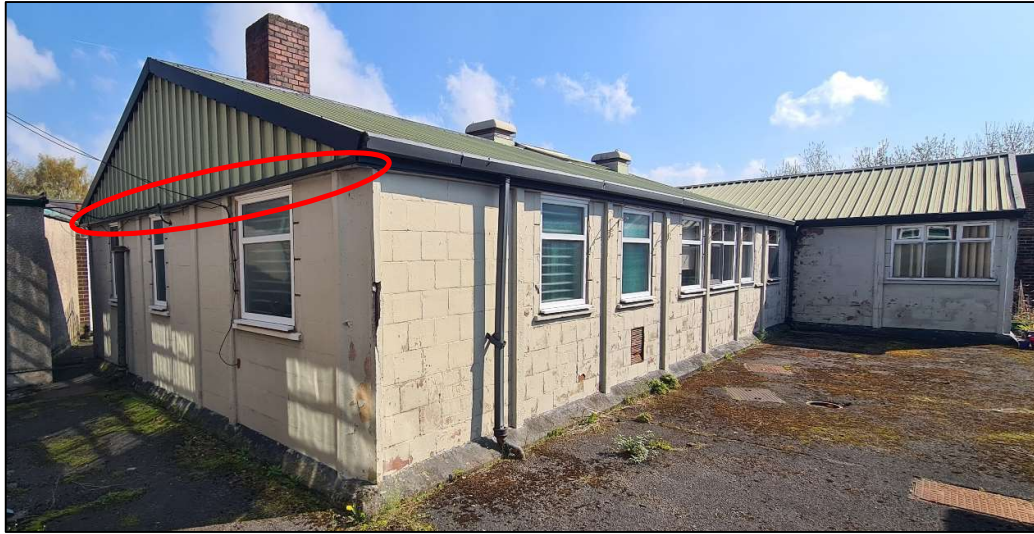
**Plate 4. Location of PRF-A circled red on the western gable end**

- 5.2.5 A potential roost feature (PRF) was noted behind the metal trim at the bottom of the cladding on the western gable end (PRF-A, Plate 4). A second potential bat roost feature was present at the wall top on the eastern aspect of the building (Plate 5). One of the two access points to this location was located above one of the wooden framed windows (Plate 6). The locations of the PRFs identified are shown in Figure 3.

- 5.2.6 The PRFs were inspected with a high-powered torch and endoscope but were too large to be exhaustively checked. No bats or signs of bats were present. It is expected that signs of bat use would have been present internally near the openings if they were historically well used as bat roosts.

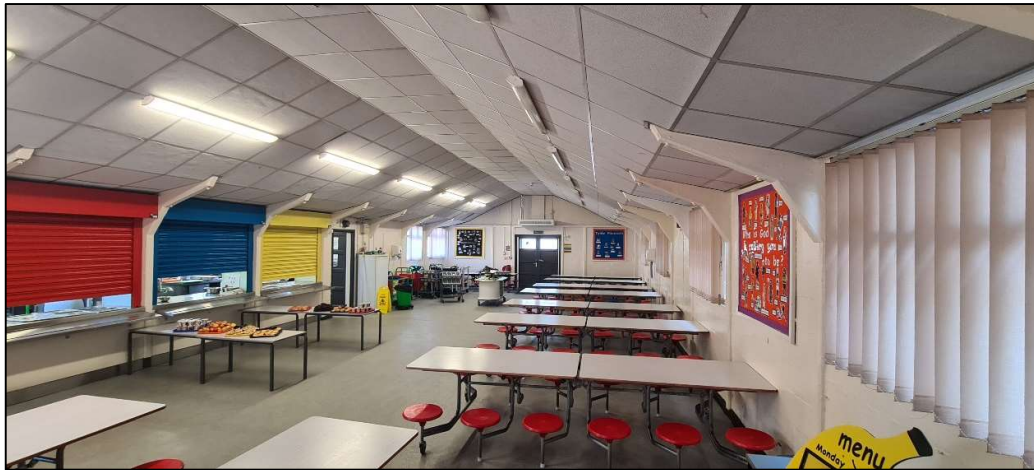
**Plate 7. The dining hall**

- 5.2.7 The building was divided into two main areas, the dining hall (Plate 7) in the north-south oriented section and the kitchen (Plate 8) in the east-west section. The kitchen area also contained a boiler room, WC, and a room used as an office and store (Plate 9). A small loft space/ water tank cupboard (Plate 10) was located in the ceiling of a corridor between the store and the boiler room. The internal layout is shown in Figure 4.

5.2.8 The metal sheet roof was backed by insulated boarding above purlins which were, in turn, supported by rafters. The roof was vaulted but a suspended ceiling followed the pitch of the roof (Plates 7 and 8). The space between the suspended ceiling and the roof is shown in Plate 11.

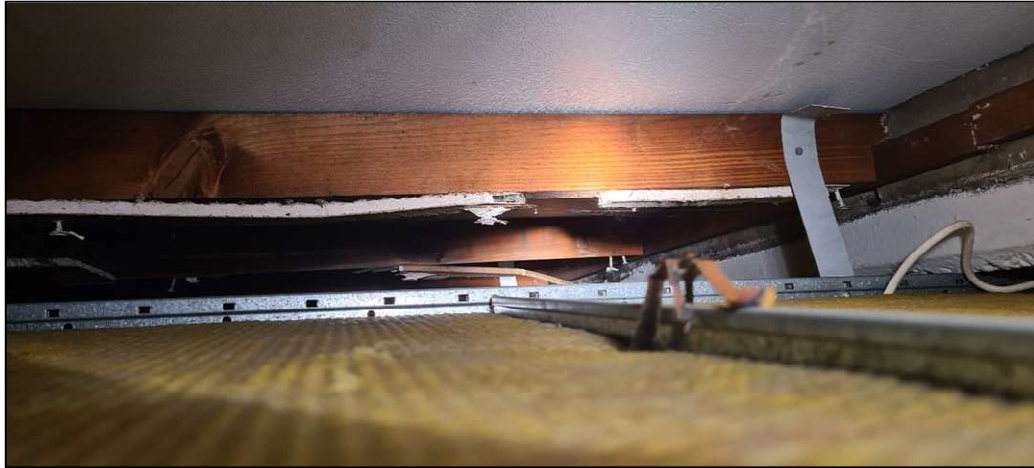
**Plate 11. Space between the suspended ceiling and the insulated board under the sheet metal roof**

5.2.9 No signs of bats were present within any of the internal spaces or voids.
