**2&3 Angel Square**  
**Ground Engineering Summary Report**  
**043434-BH-XX-XX-RP-GE-0001**

30 March 2023

Revision P04

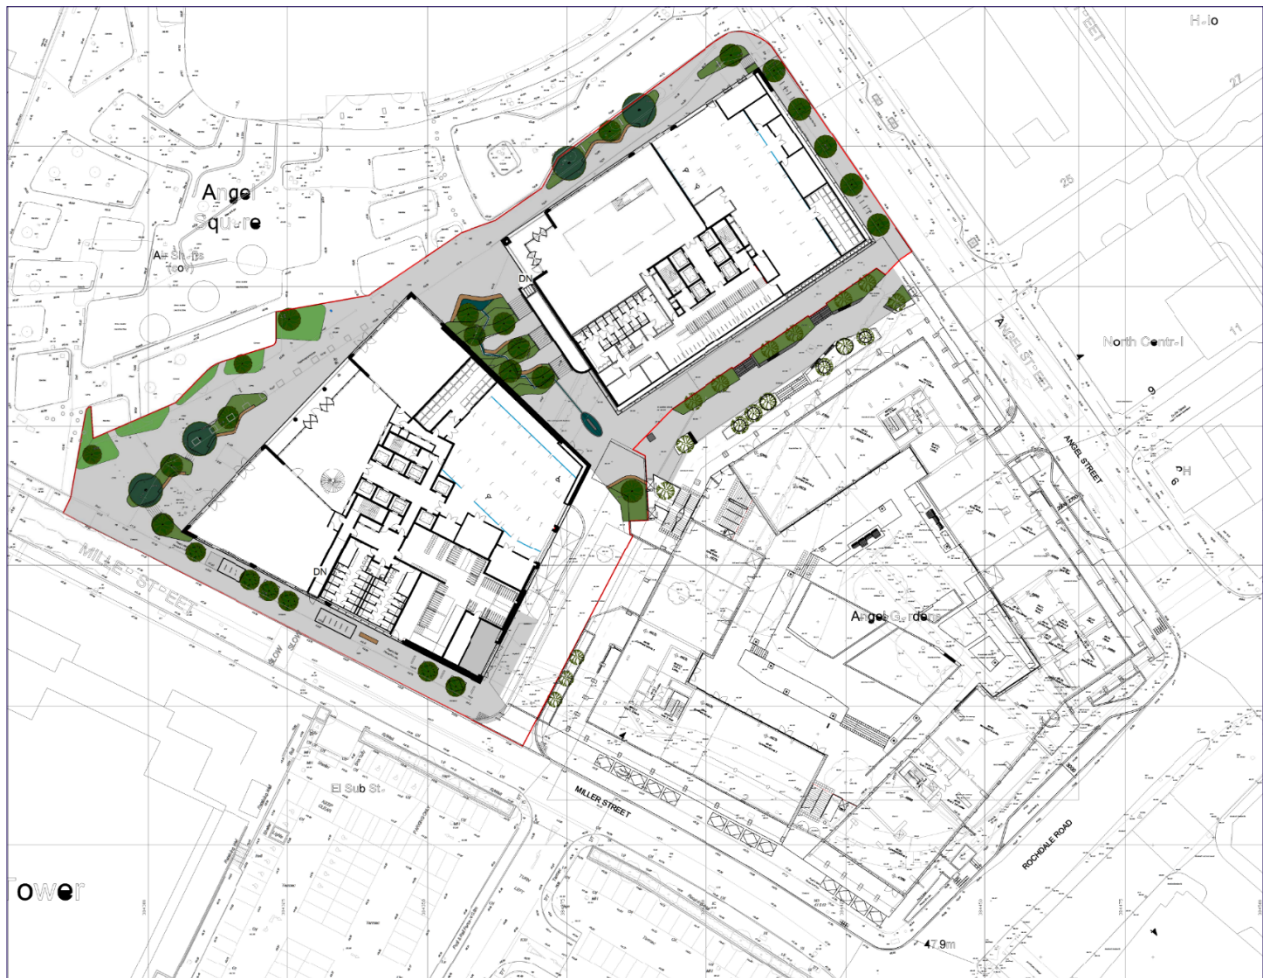
Figure 2—2 2&3 Angel Square with redline boundary

The Proposed Development is for offices (Use Class B1a), with ground floor retail and commercial units, external terraces at upper levels, car parking and cycle facilities. The Proposed Development will comprise two buildings, one of lower and upper ground plus 14 storeys (2 Angel Square), and one of lower and upper ground plus 13 storeys (3 Angel Square) and will also include a comprehensive public realm scheme with hard and soft landscaping, car parking, and highways and other associated works (Figure 2—2 refers). In advance of works starting on 2 & 3 Angel Square, the NMS is proposed to be erected on site as a temporary building in the southwestern corner of the Site and will consist of a single storey building with associated car parking and public realm. The NMS has been constructed and is currently in use by the client (Figure 2—3 refers).

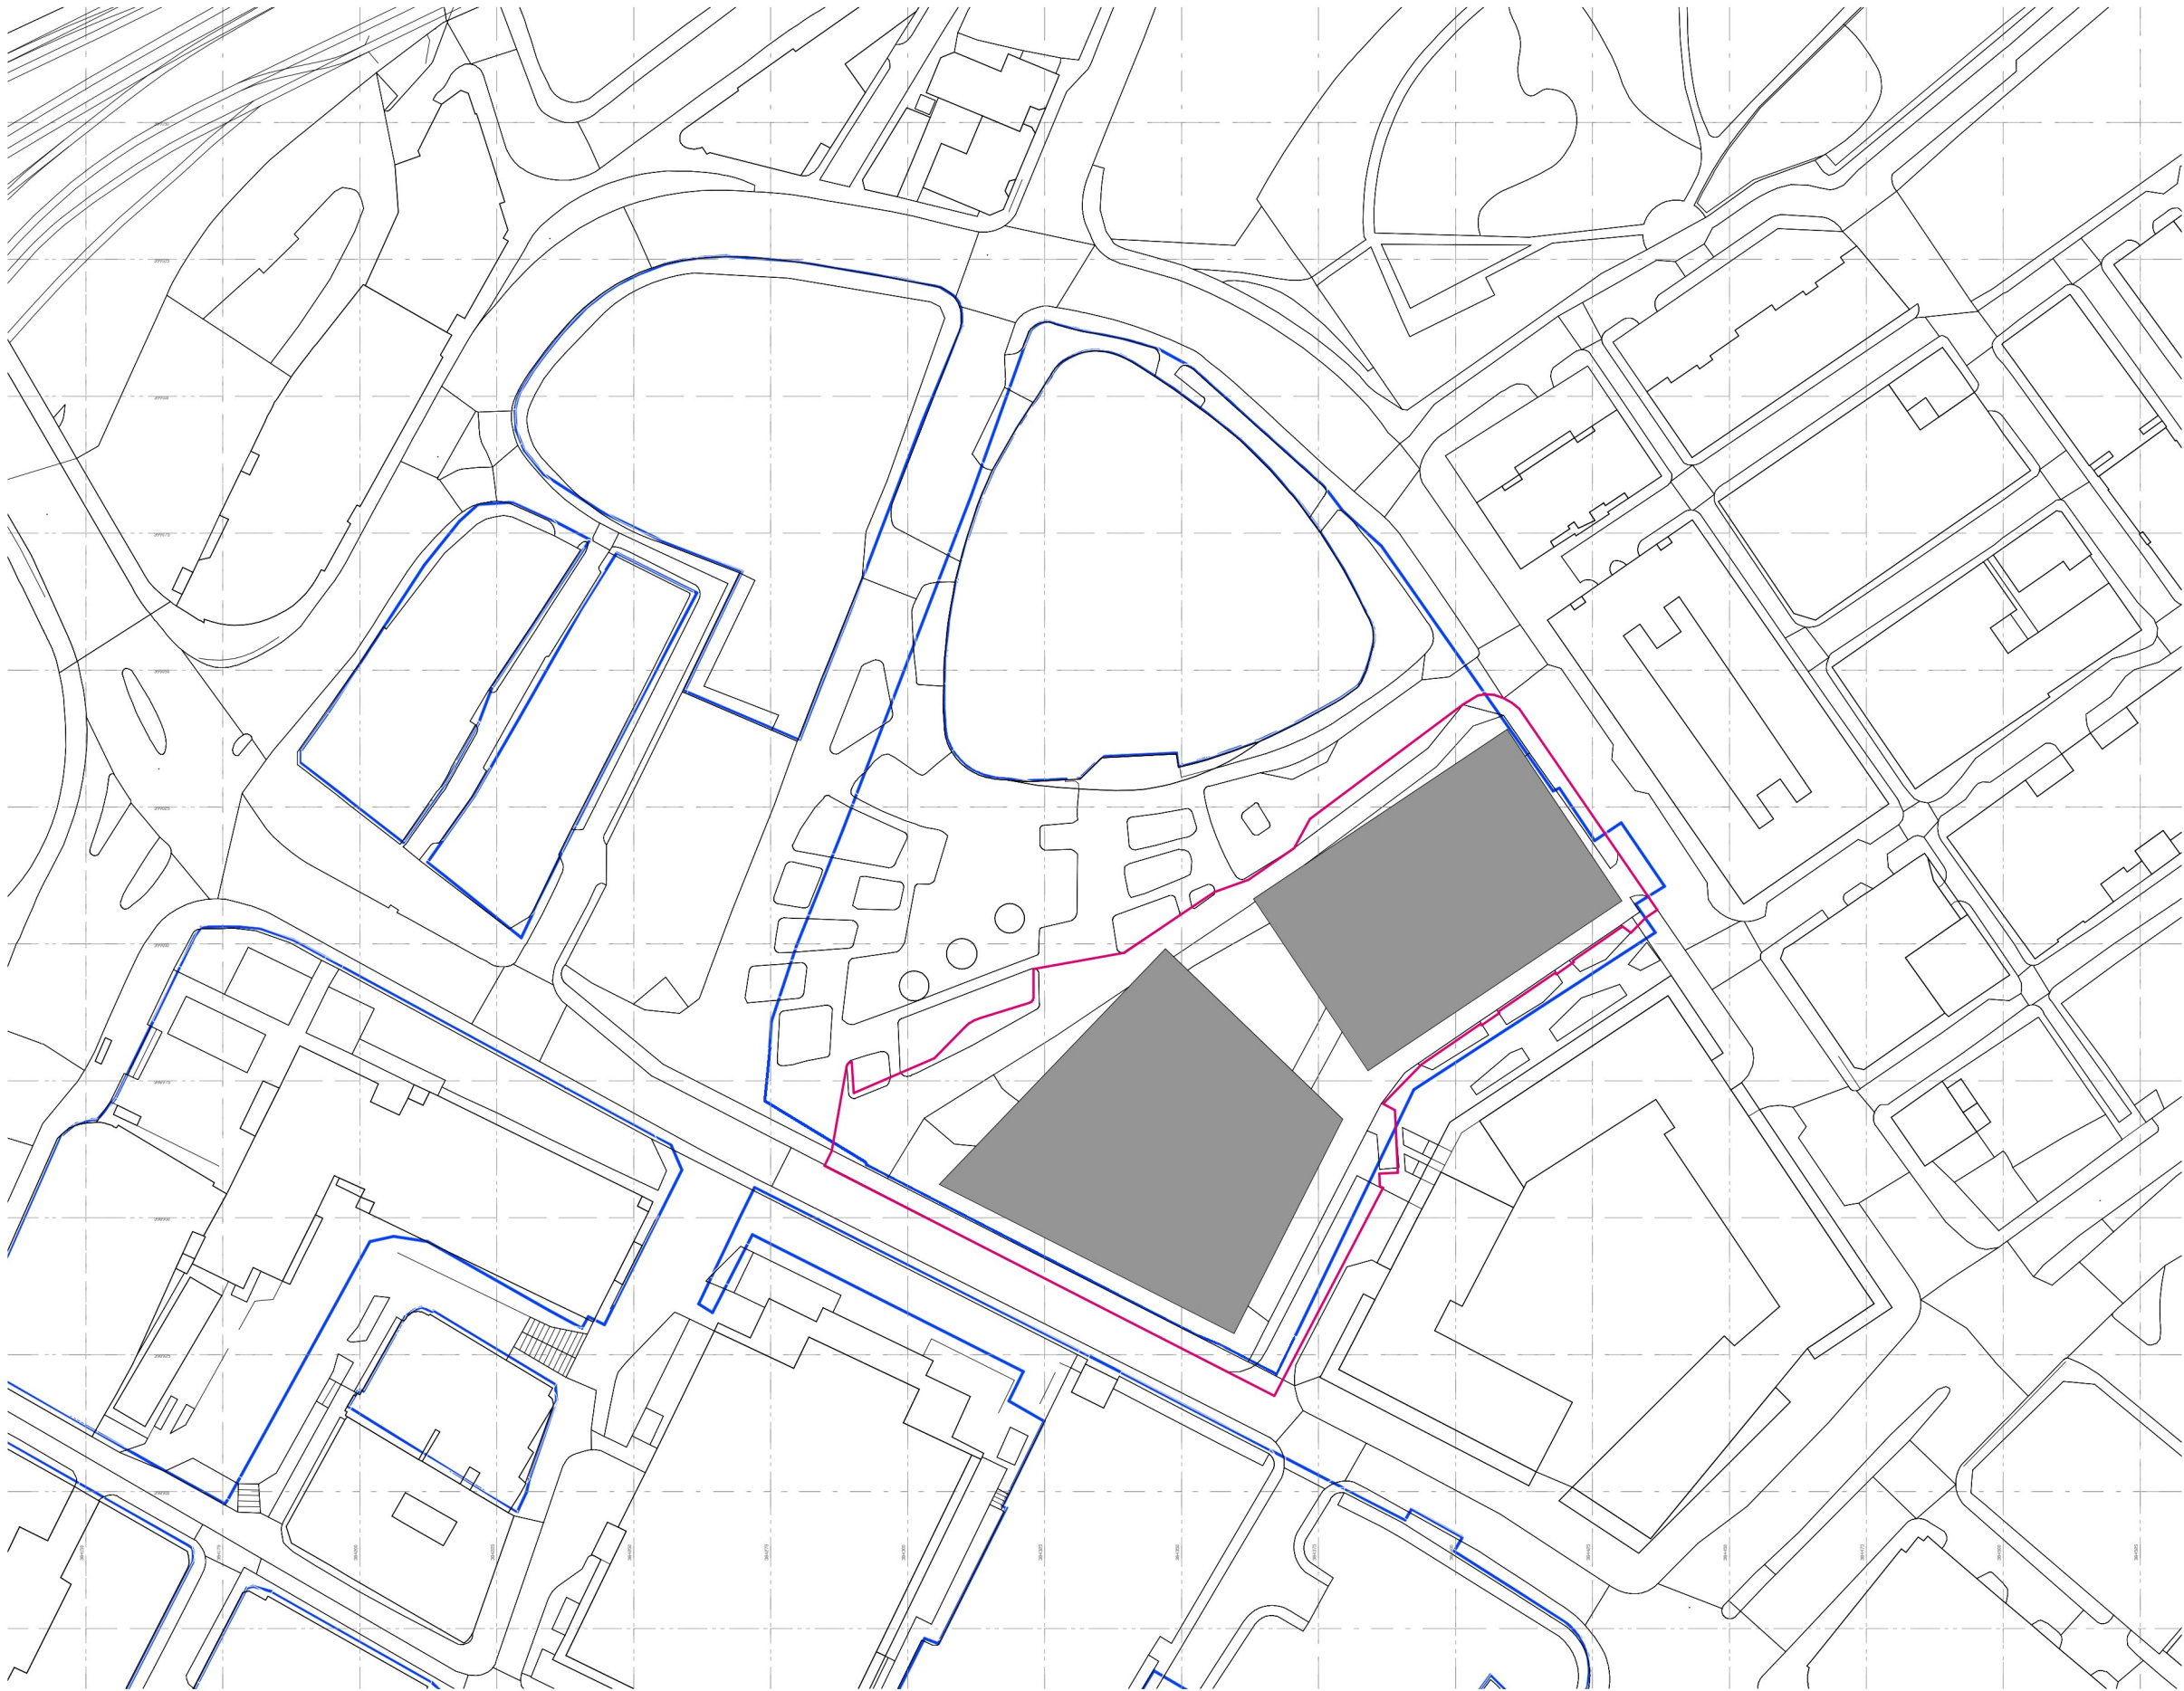
### **A.1 Exploratory Hole Location Plan**

Please note, this drawing shows the final red line planning boundary (March 2023). The exploratory hole location plans within this appendix show different boundaries, however, they are the same site for the purposes of this report.

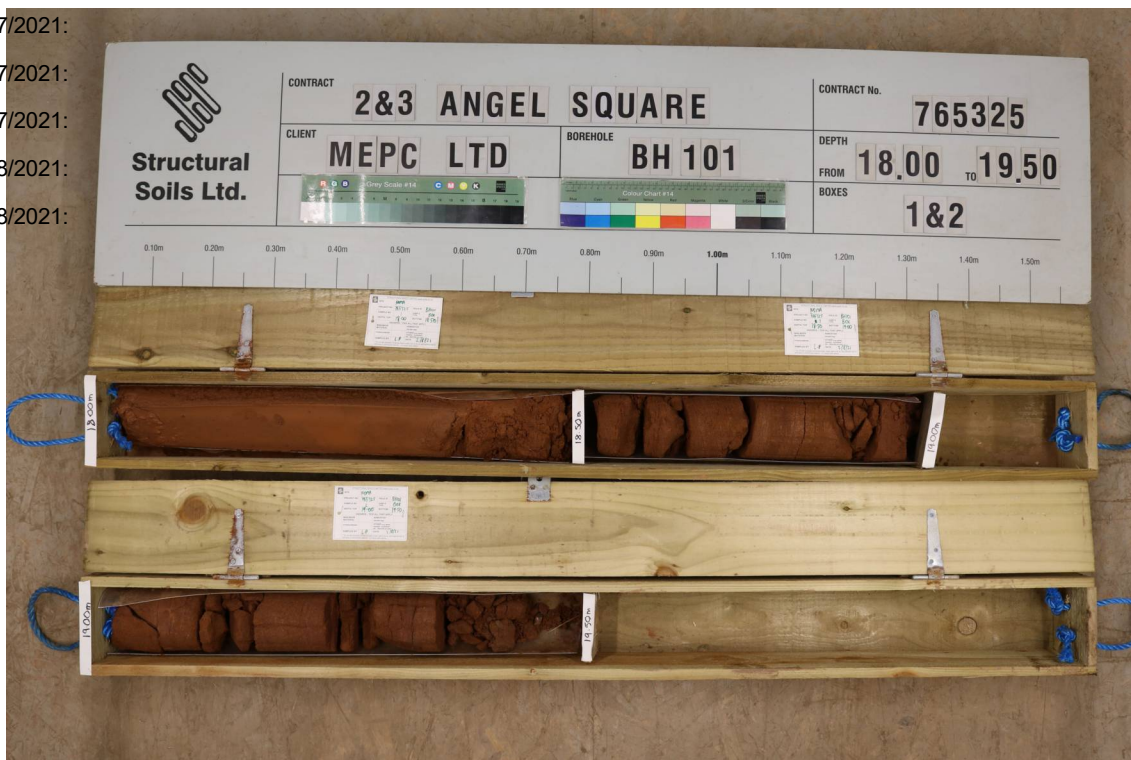
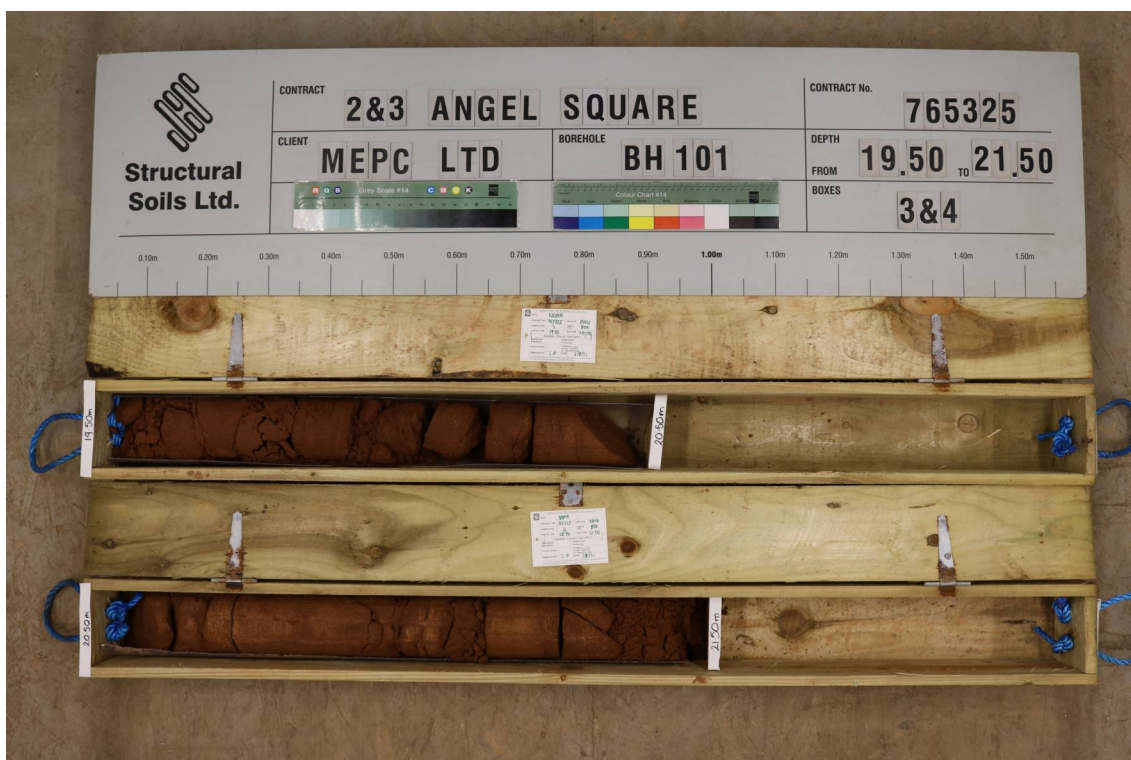
## BH101 19.50-21.50m

A total of 31 No. point load tests (PLT) were undertaken on rock core samples obtained during the ground investigation. Rock strength varied from 0.24 MPa (BH101 at 18 m bgl (29.52 m AOD)) to 20 MPa (BH104 at 28 m bgl (16.20 m AOD)). The PLT indicate that the sandstone is very weak (UCS between 1-5 MPa) between 30.00 and 17.00 m AOD (~13.00 to 29.00 m bgl) and becomes weak (UCS between 1-25 m MPa) below 17.00 m AOD (>24.00 m bgl). This also correlates to the borehole records that frequently record non-intact rock core recovery.

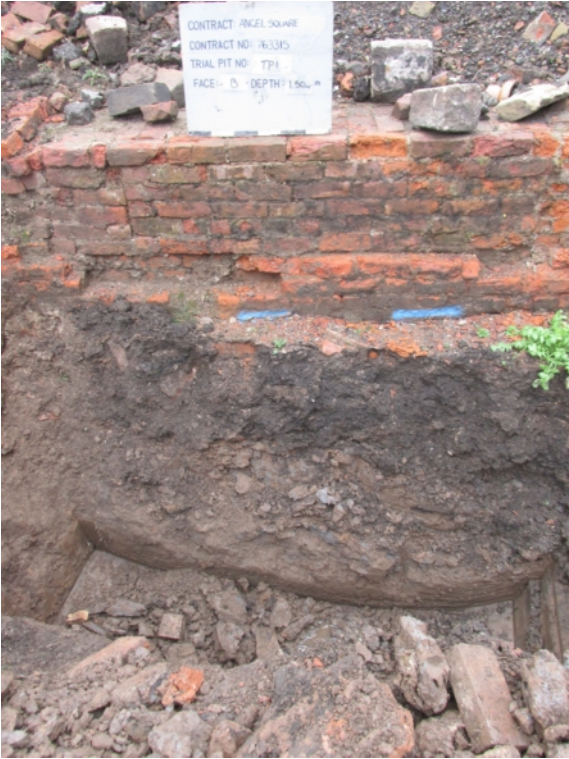
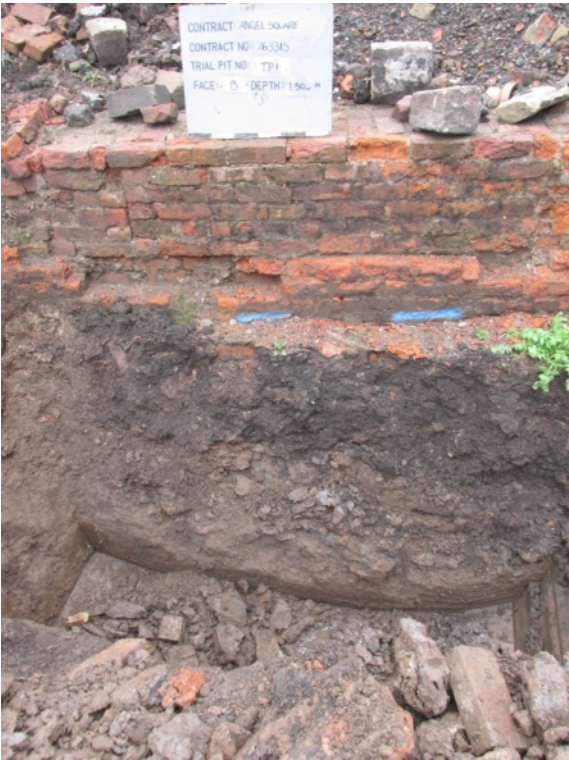
TP1 Face A

TP1 Face B
