# DOMIS CONSTRUCTION LTD

Fusion, Manchester

Remediation Validation Report

NS/C5511/12505

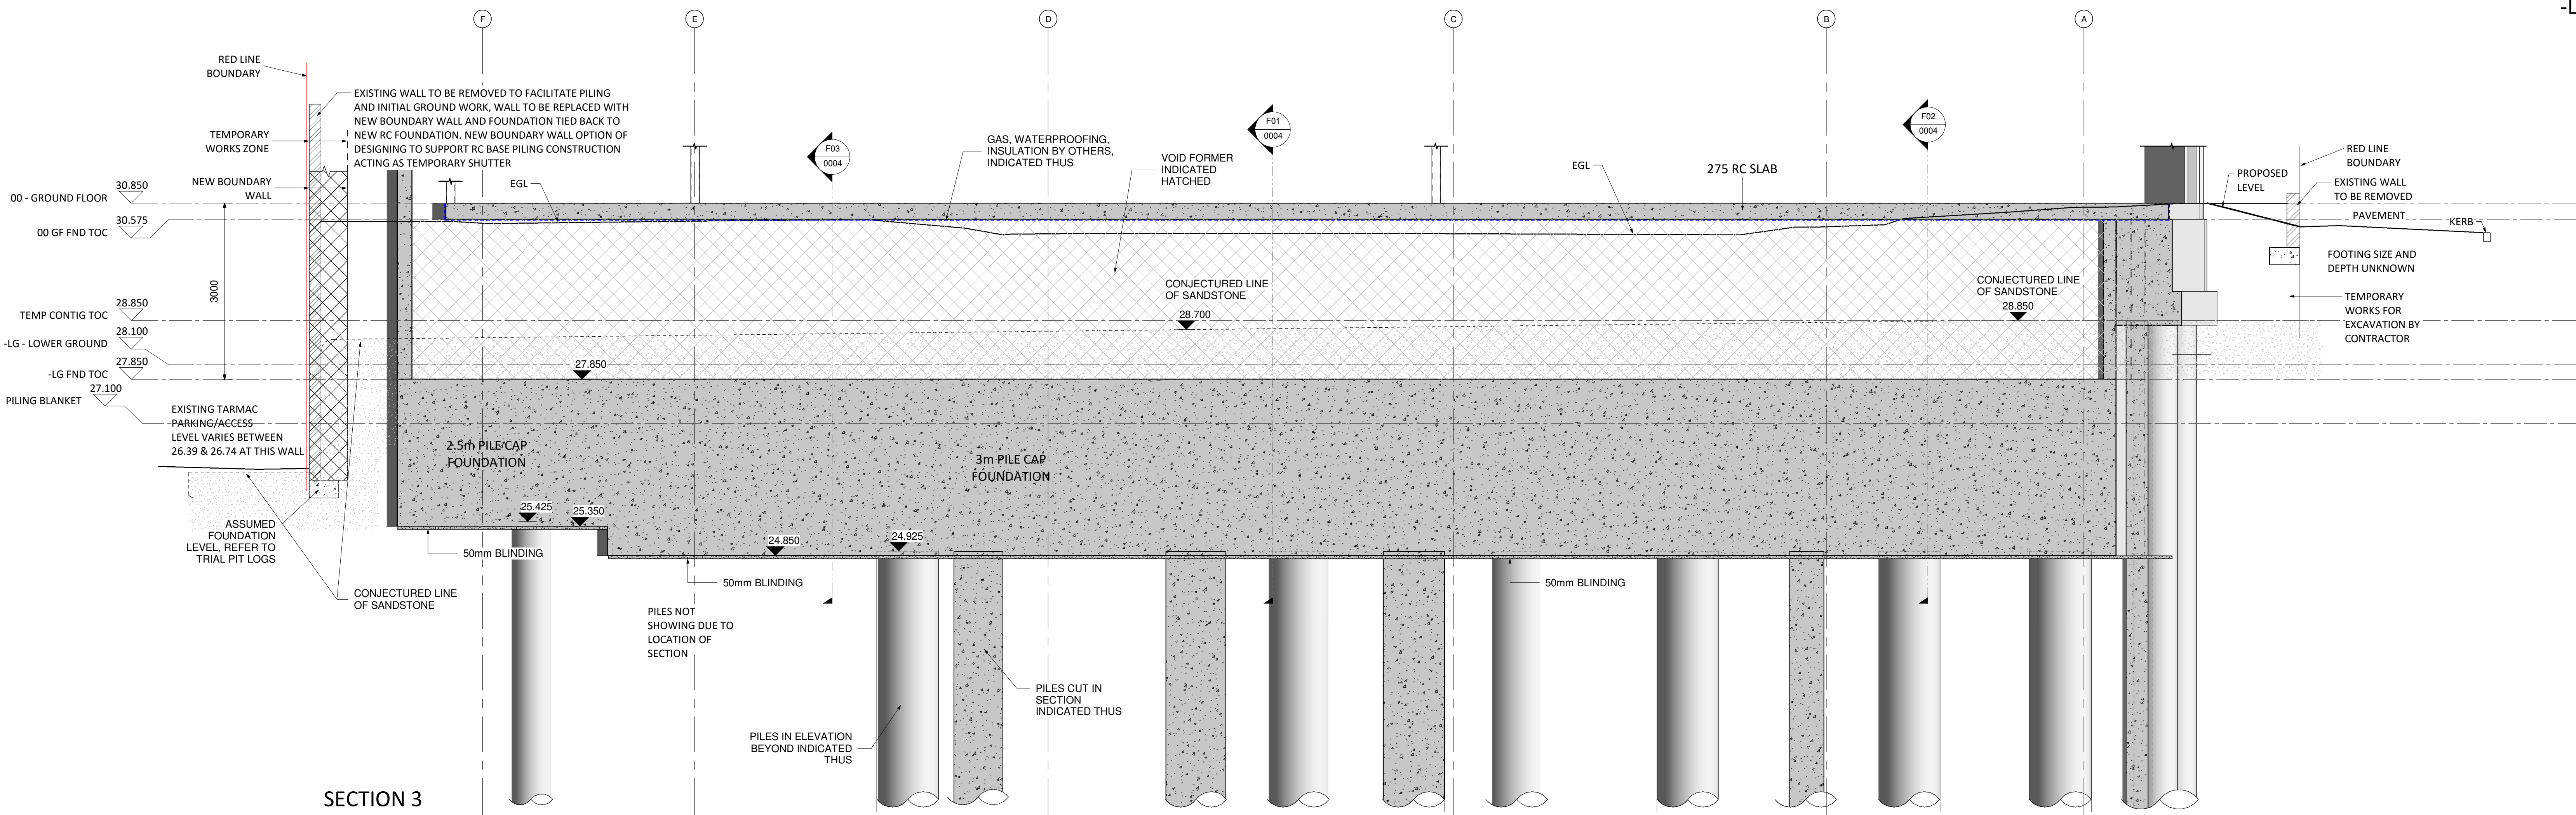
SECTION 3  
1 : 50

NOTE! DPM  
DPM/DPC AND TANKING DETAILS BY OTHERS

The above is demonstrated on the General Arrangement Foundation Sections for the site (ref. DSM-SDL-ZZ-FX-DR-ST-0091 P03 and DSM-SDL-ZZ-FX-DR-ST-0092 P03).

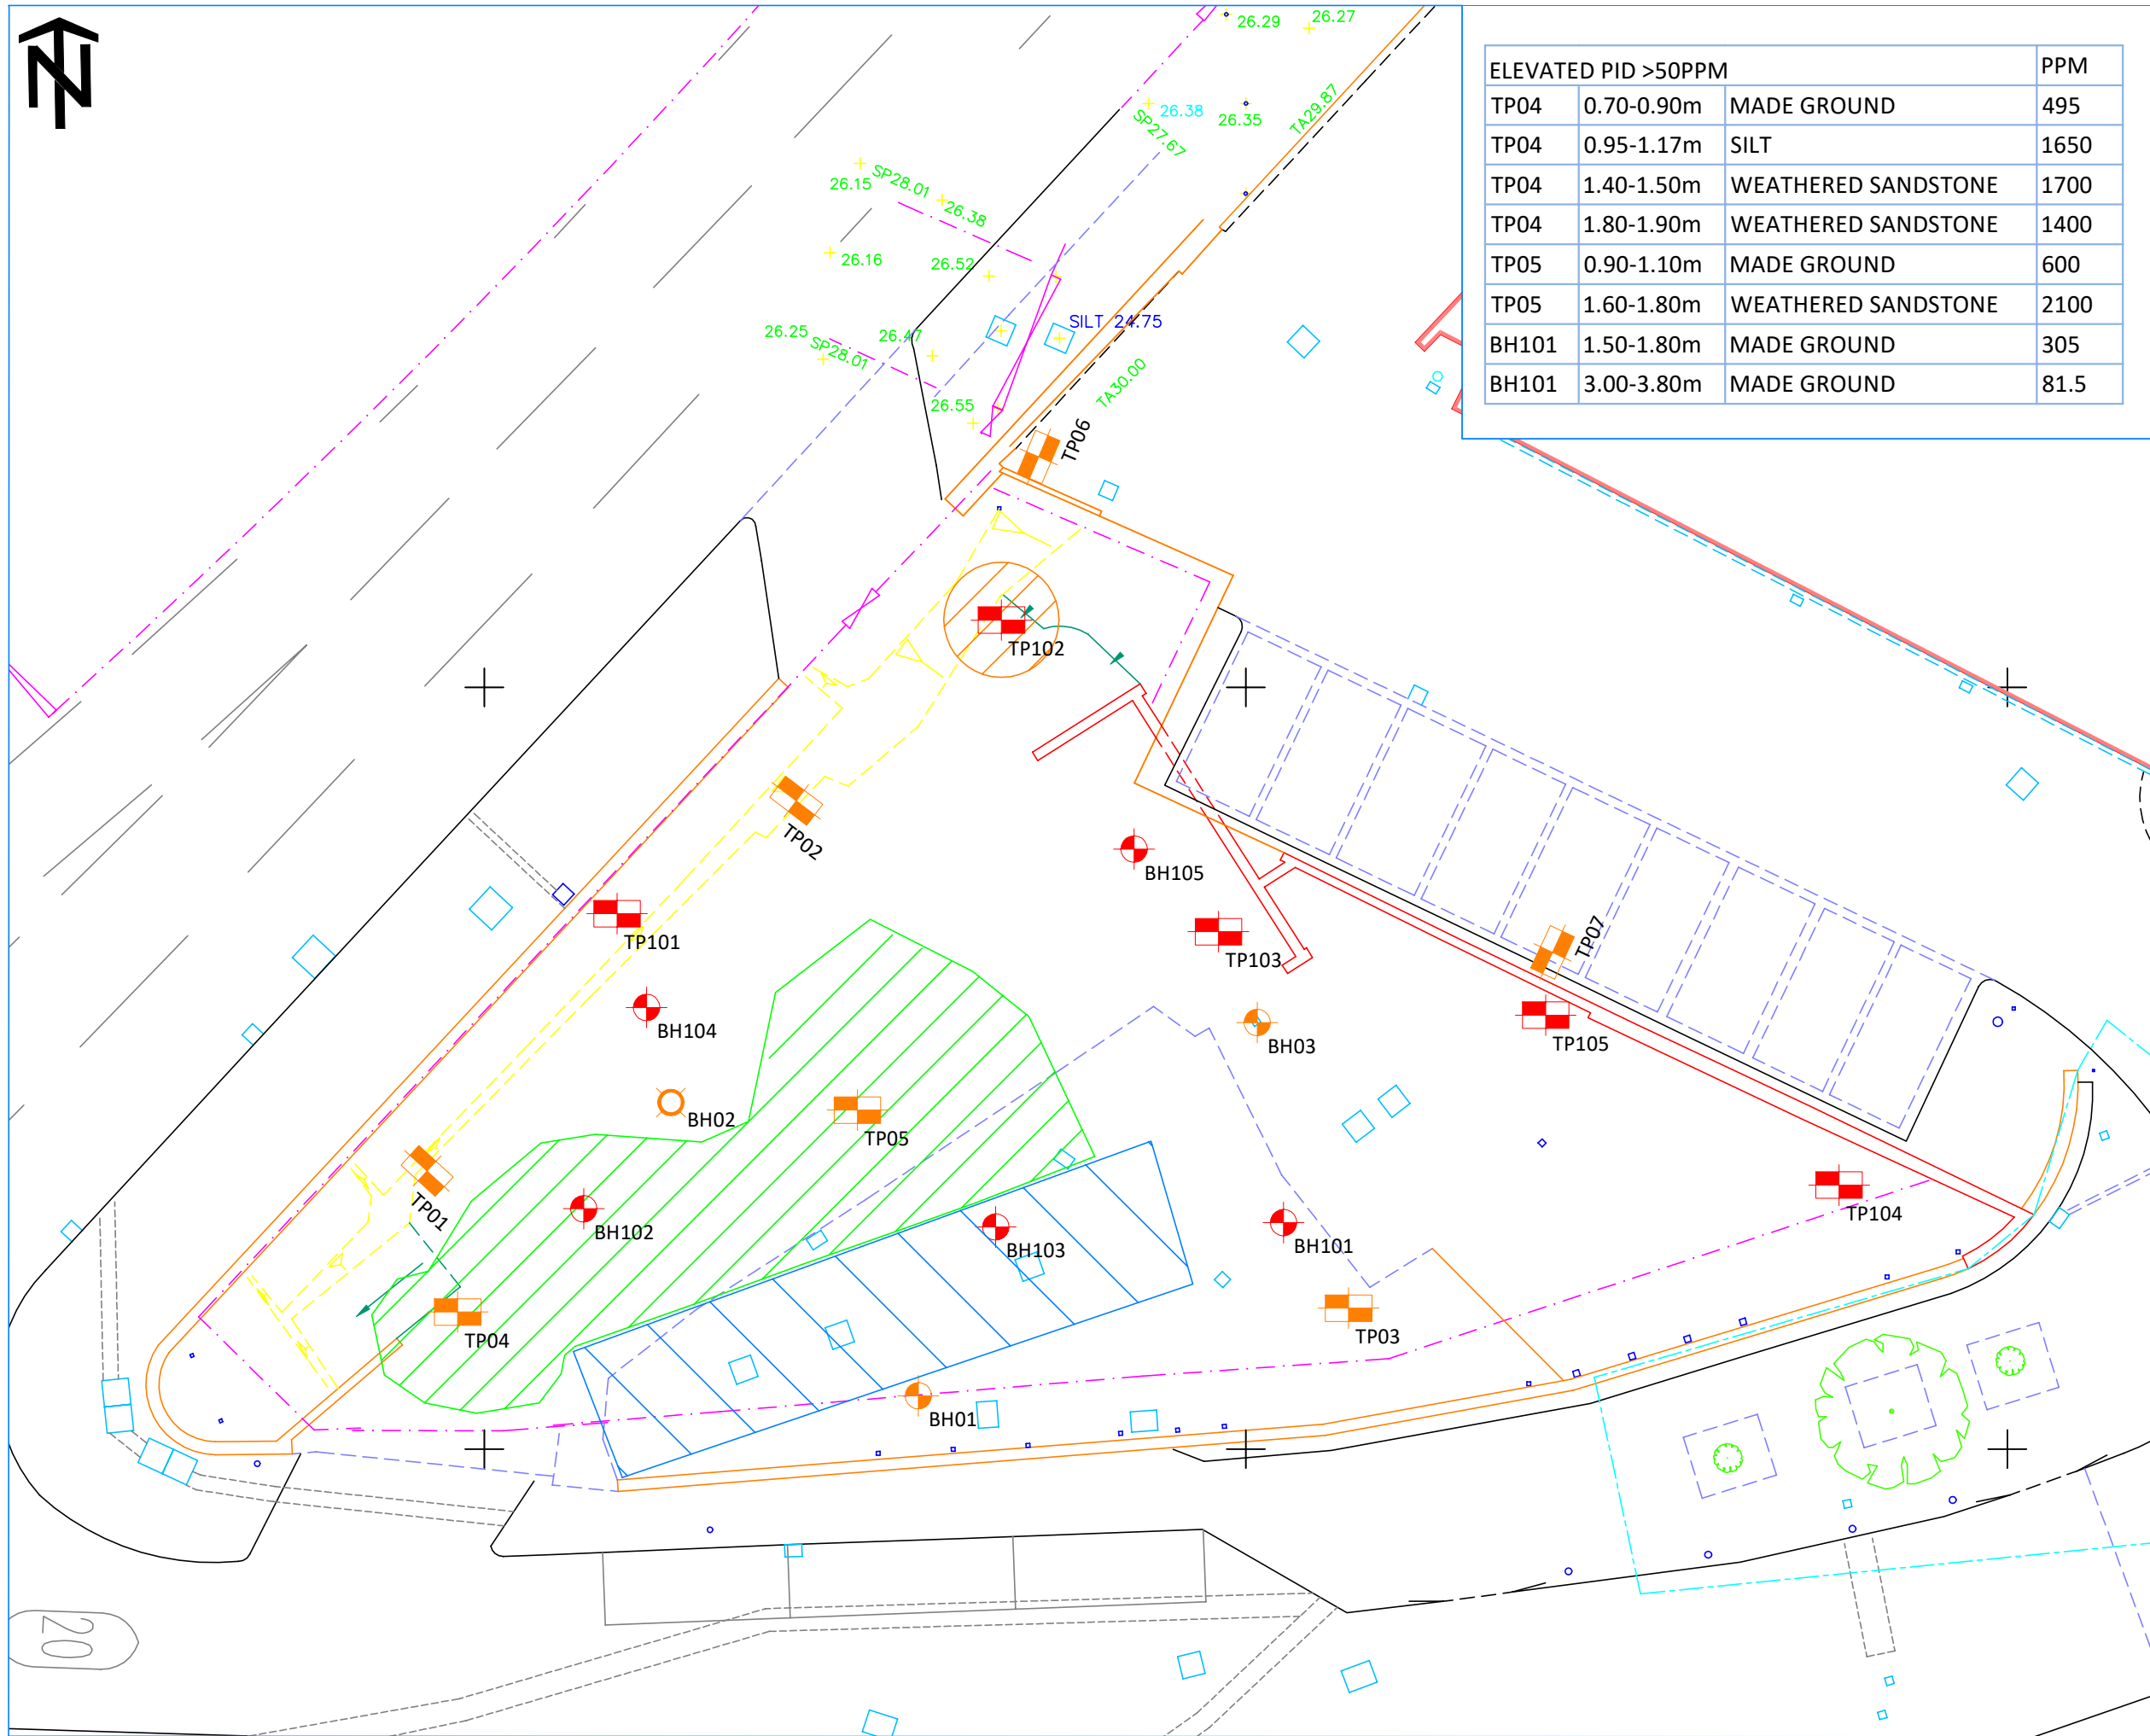
| DRAWING No. | REVISION | SCALE | DATE |
|---|---|---|---|
| C5511/03 | - | NTS | 06/10/23 |

| ELEVATED PID >50PPM | | | PPM |
| TP04 | 0.70-0.90m | MADE GROUND | 495 |

It should be noted that all locations with elevated PID readings (>50 ppm) were in close proximity to the 4No. tanks on site. The above PID readings and the exceedances within TP04 and TP05, as well as groundwater contamination in BH102 were utilised to generate an indicative Hotspot Location Plan (ref. C5511/03) for targeting remediation and validation of the hydrocarbon impacted site soils.
