## Intrusive Geoenvironmental and Geotechnical Site Assessment

Crabtree Lane, Manchester  
Former Walkers Site  
Crabtree Lane  
Manchester  
M11 4GU

July 2023

Chancerygate Manchester Limited  
12a Upper Berkeley Street  
London  
England  
W1H 7QE

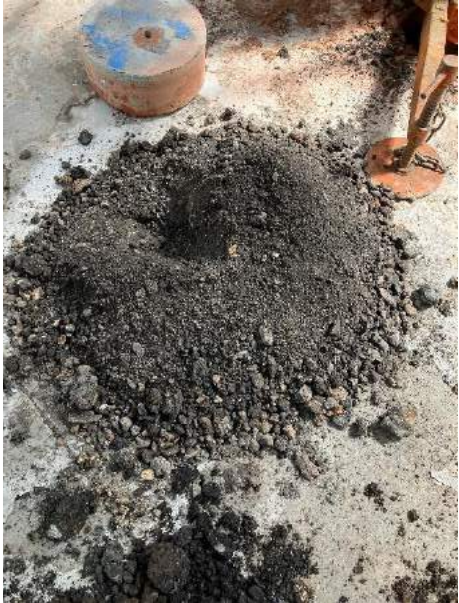
| Photo No.<br>1 | Date | | | | |

| Description:<br>WS101 | | | | | |

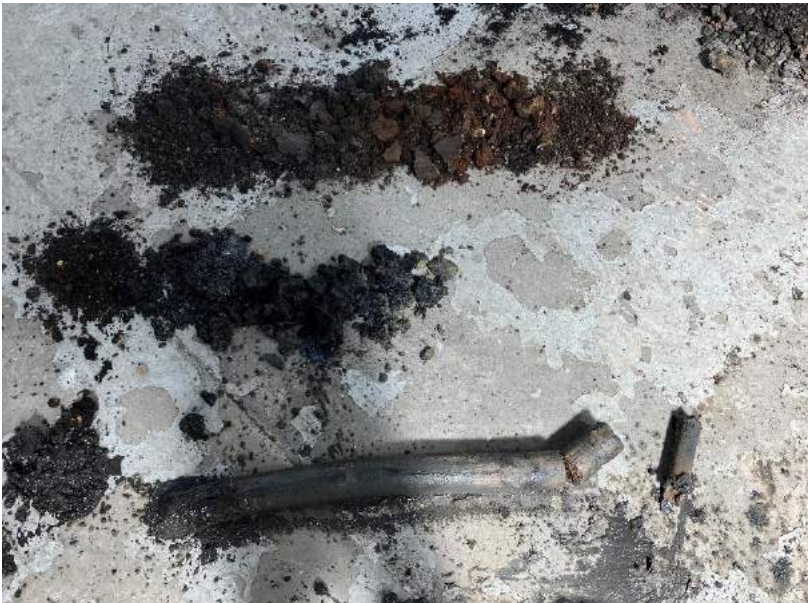
| Photo No.<br>2 | Date | | | | |

| Description:<br>WS101<br>1 – 4.45m | | | | | |

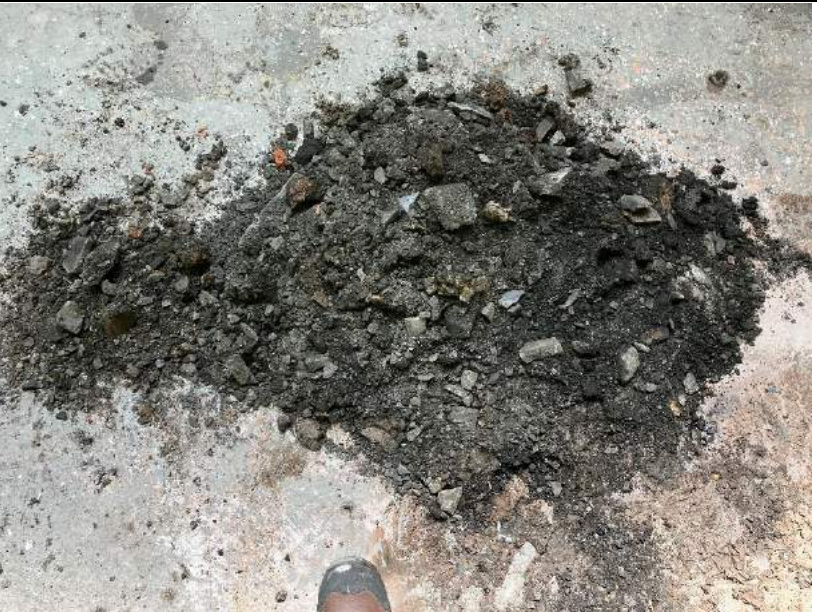
| Photo No.<br>3 | Date | | | | |

| Description:<br>WS102 | | | | | |

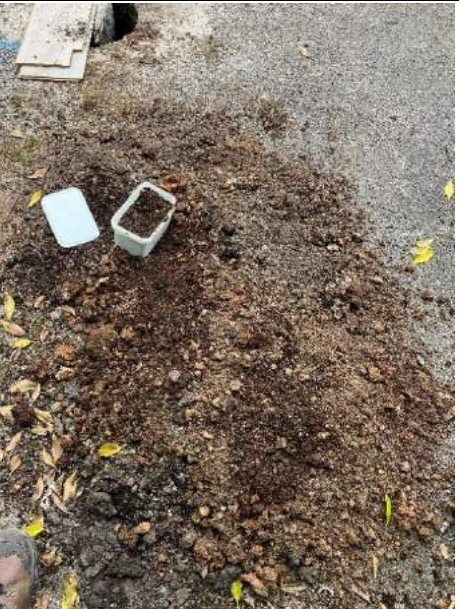
| Photo No.<br>4 | Date | | | | |

| Description:<br>WS103 | | | | | |

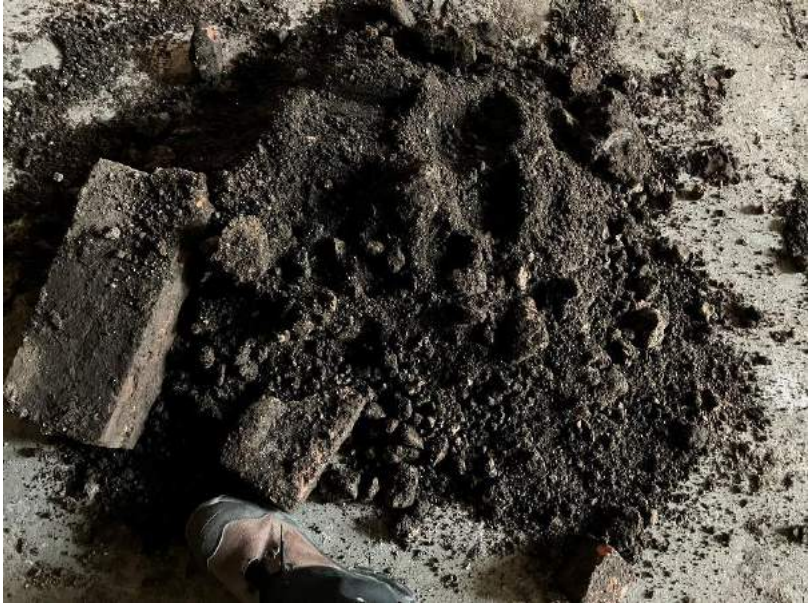
| Photo No.<br>5 | Date | | | | |

| Description:<br><br>WS104 | | | | | |

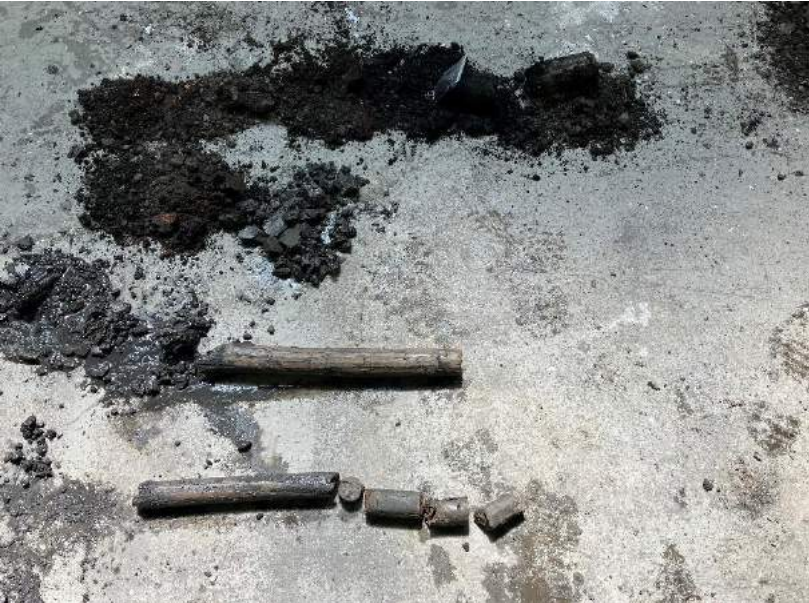
| Photo No.<br>6 | Date | | | | |

| Description:<br><br>WS104<br>1 – 5.45m | | | | | |

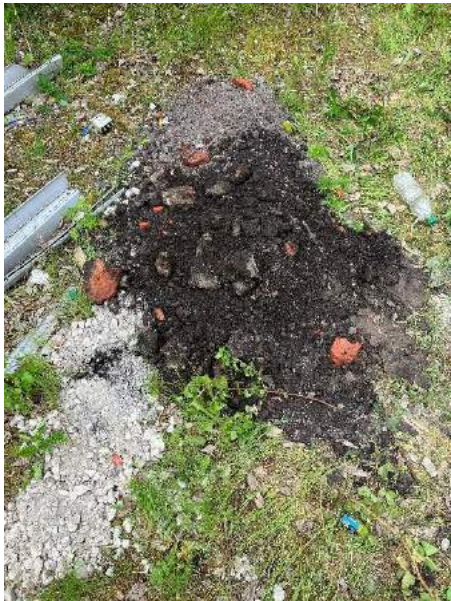
| Photo No.<br>7 | Date | | |

| Description:<br><br>WS105 | | | |

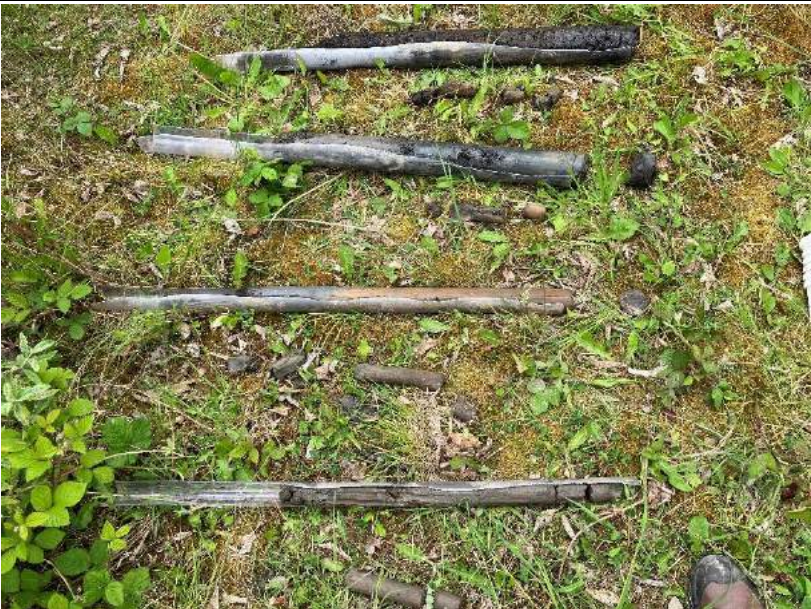
| Photo No.<br>8 | Date | | |

| Description:<br><br>WS105 | | | |

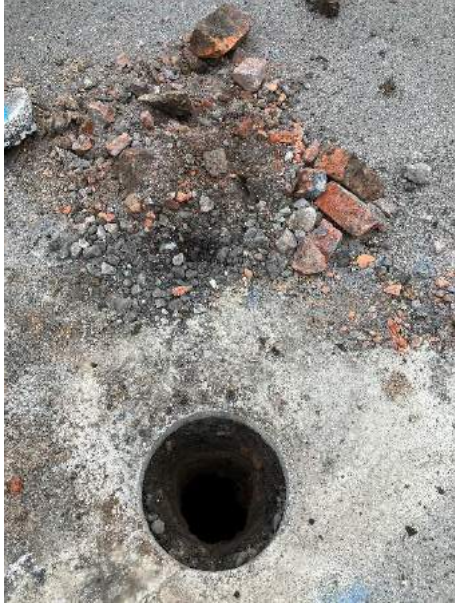
| Photo No.<br>9 | Date | | | | |

| Description:<br>WS106 | | | | | |

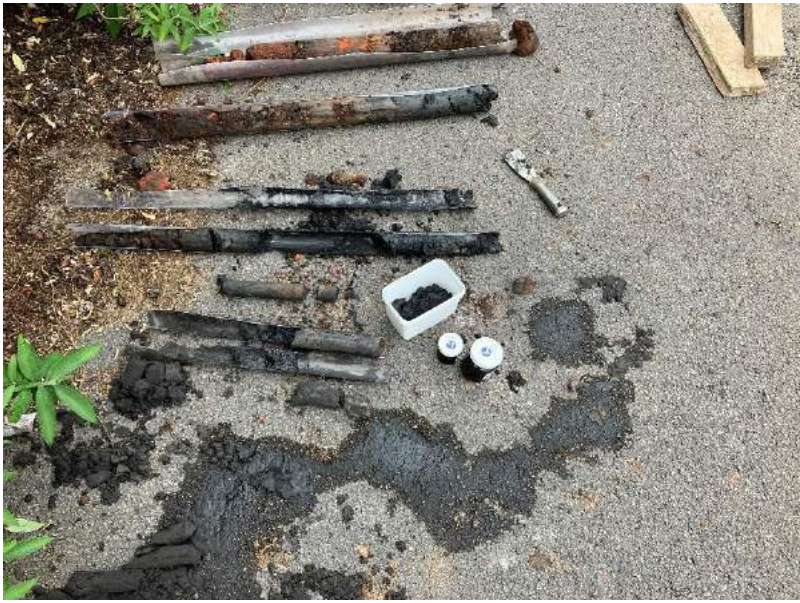
| Photo No.<br>10 | Date | | | | |

| Description:<br>WS106 | | | | | |

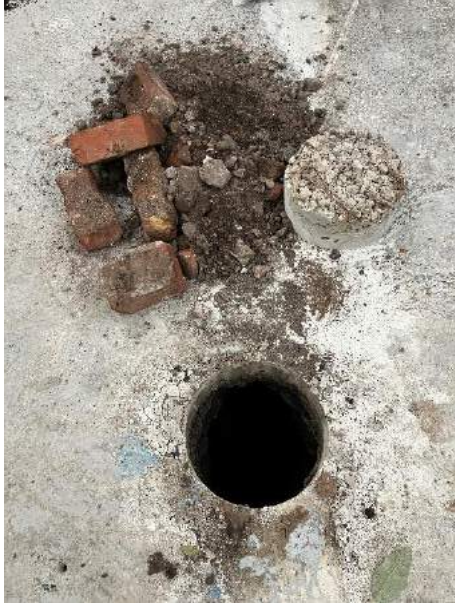
| Photo No.<br>11 | Date | | | | |

| Description:<br>WS107 | | | | | |

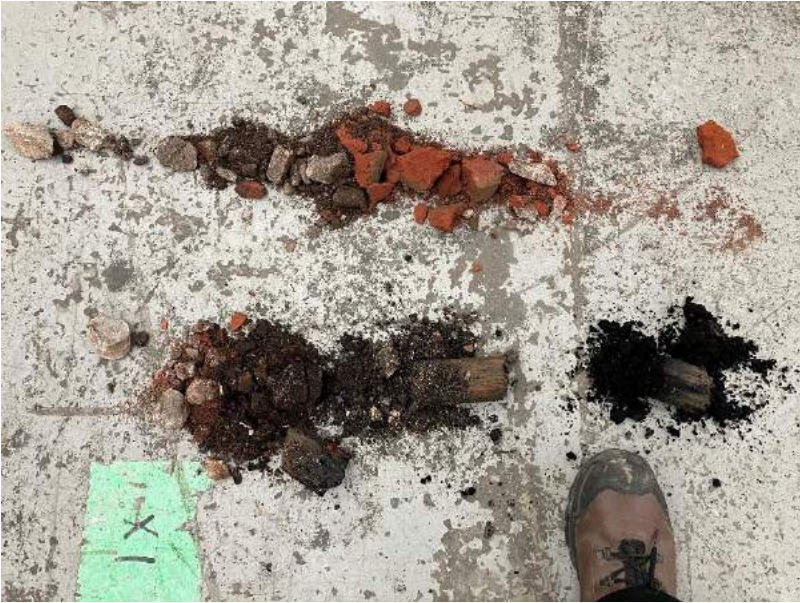
| Photo No.<br>12 | Date | | | | |

| Description:<br>WS107 | | | | | |

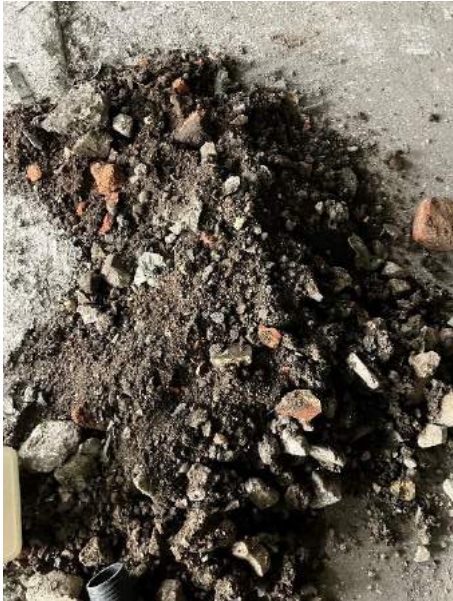
| Photo No.<br>13 | Date | | | | |

| Description:<br>WS108 | | | | | |

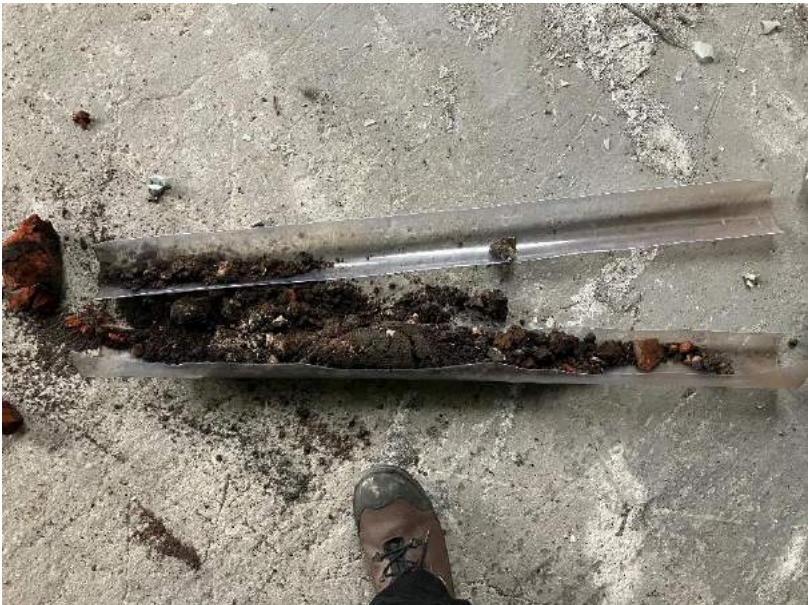
| Photo No.<br>14 | Date | | | | |

| Description:<br>WS108 | | | | | |

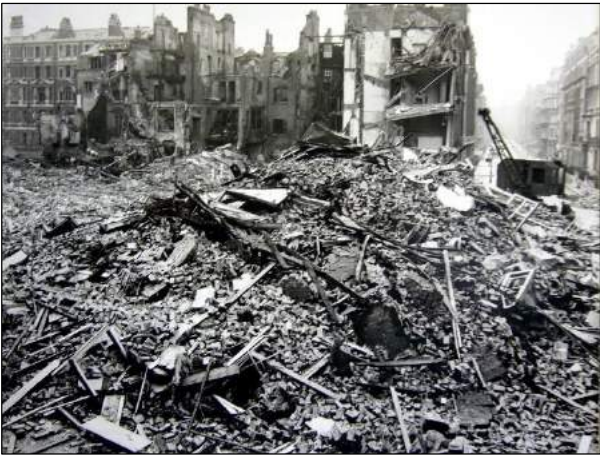
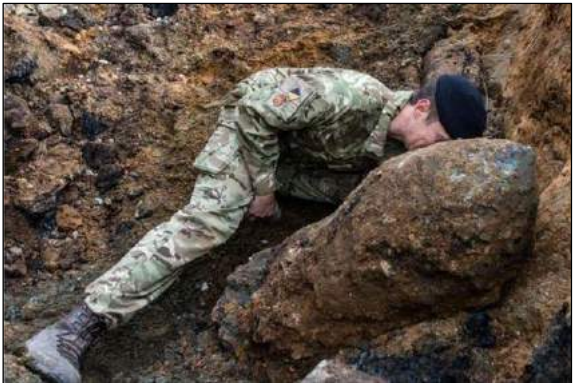
**Top:** J-curve Effect - Due to angle of entry, unexploded bombs would often end their trajectory at a lateral offset from point of entry, often ending up beneath adjacent extant structures/sites. The photograph above shows a 250kg unexploded bomb found in Bermondsey in 2015, pointing upwards, demonstrating ‘J-curve’.

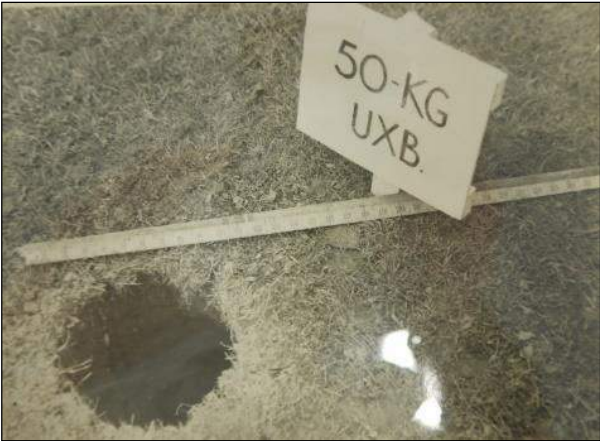
One of the most common scenarios for UXO going unnoticed was when a UXB fell into a ‘bomb site’ (such as the area shown **Top Left**), the entry hole of the bomb obscured by any debris and rubble present. Note that the entry hole of a 50kg UXB could be as little as 20cm in diameter (**Left**).
