VALLEY GUTTER: EXISTING TYPICAL DETAIL OVER BRICK CROSS WALL 1:5 @ A1 / 1:10 @ A3

| JOB TITLE<br>Essential Repair, 1830 Warehouse,<br>Science & Industry museum M3 4FP | JOB NO.<br>275 | DRWG. TITLE<br>Valley Gutter: Existing typical<br>detail over brick cross wall | STATUS<br>Planning |
| | | DRWG. NO.<br>275 / PD / 122<br>(A1 ORIGINAL FORMAT) | REV:<br>1:5@A1<br>1:10@A3 |

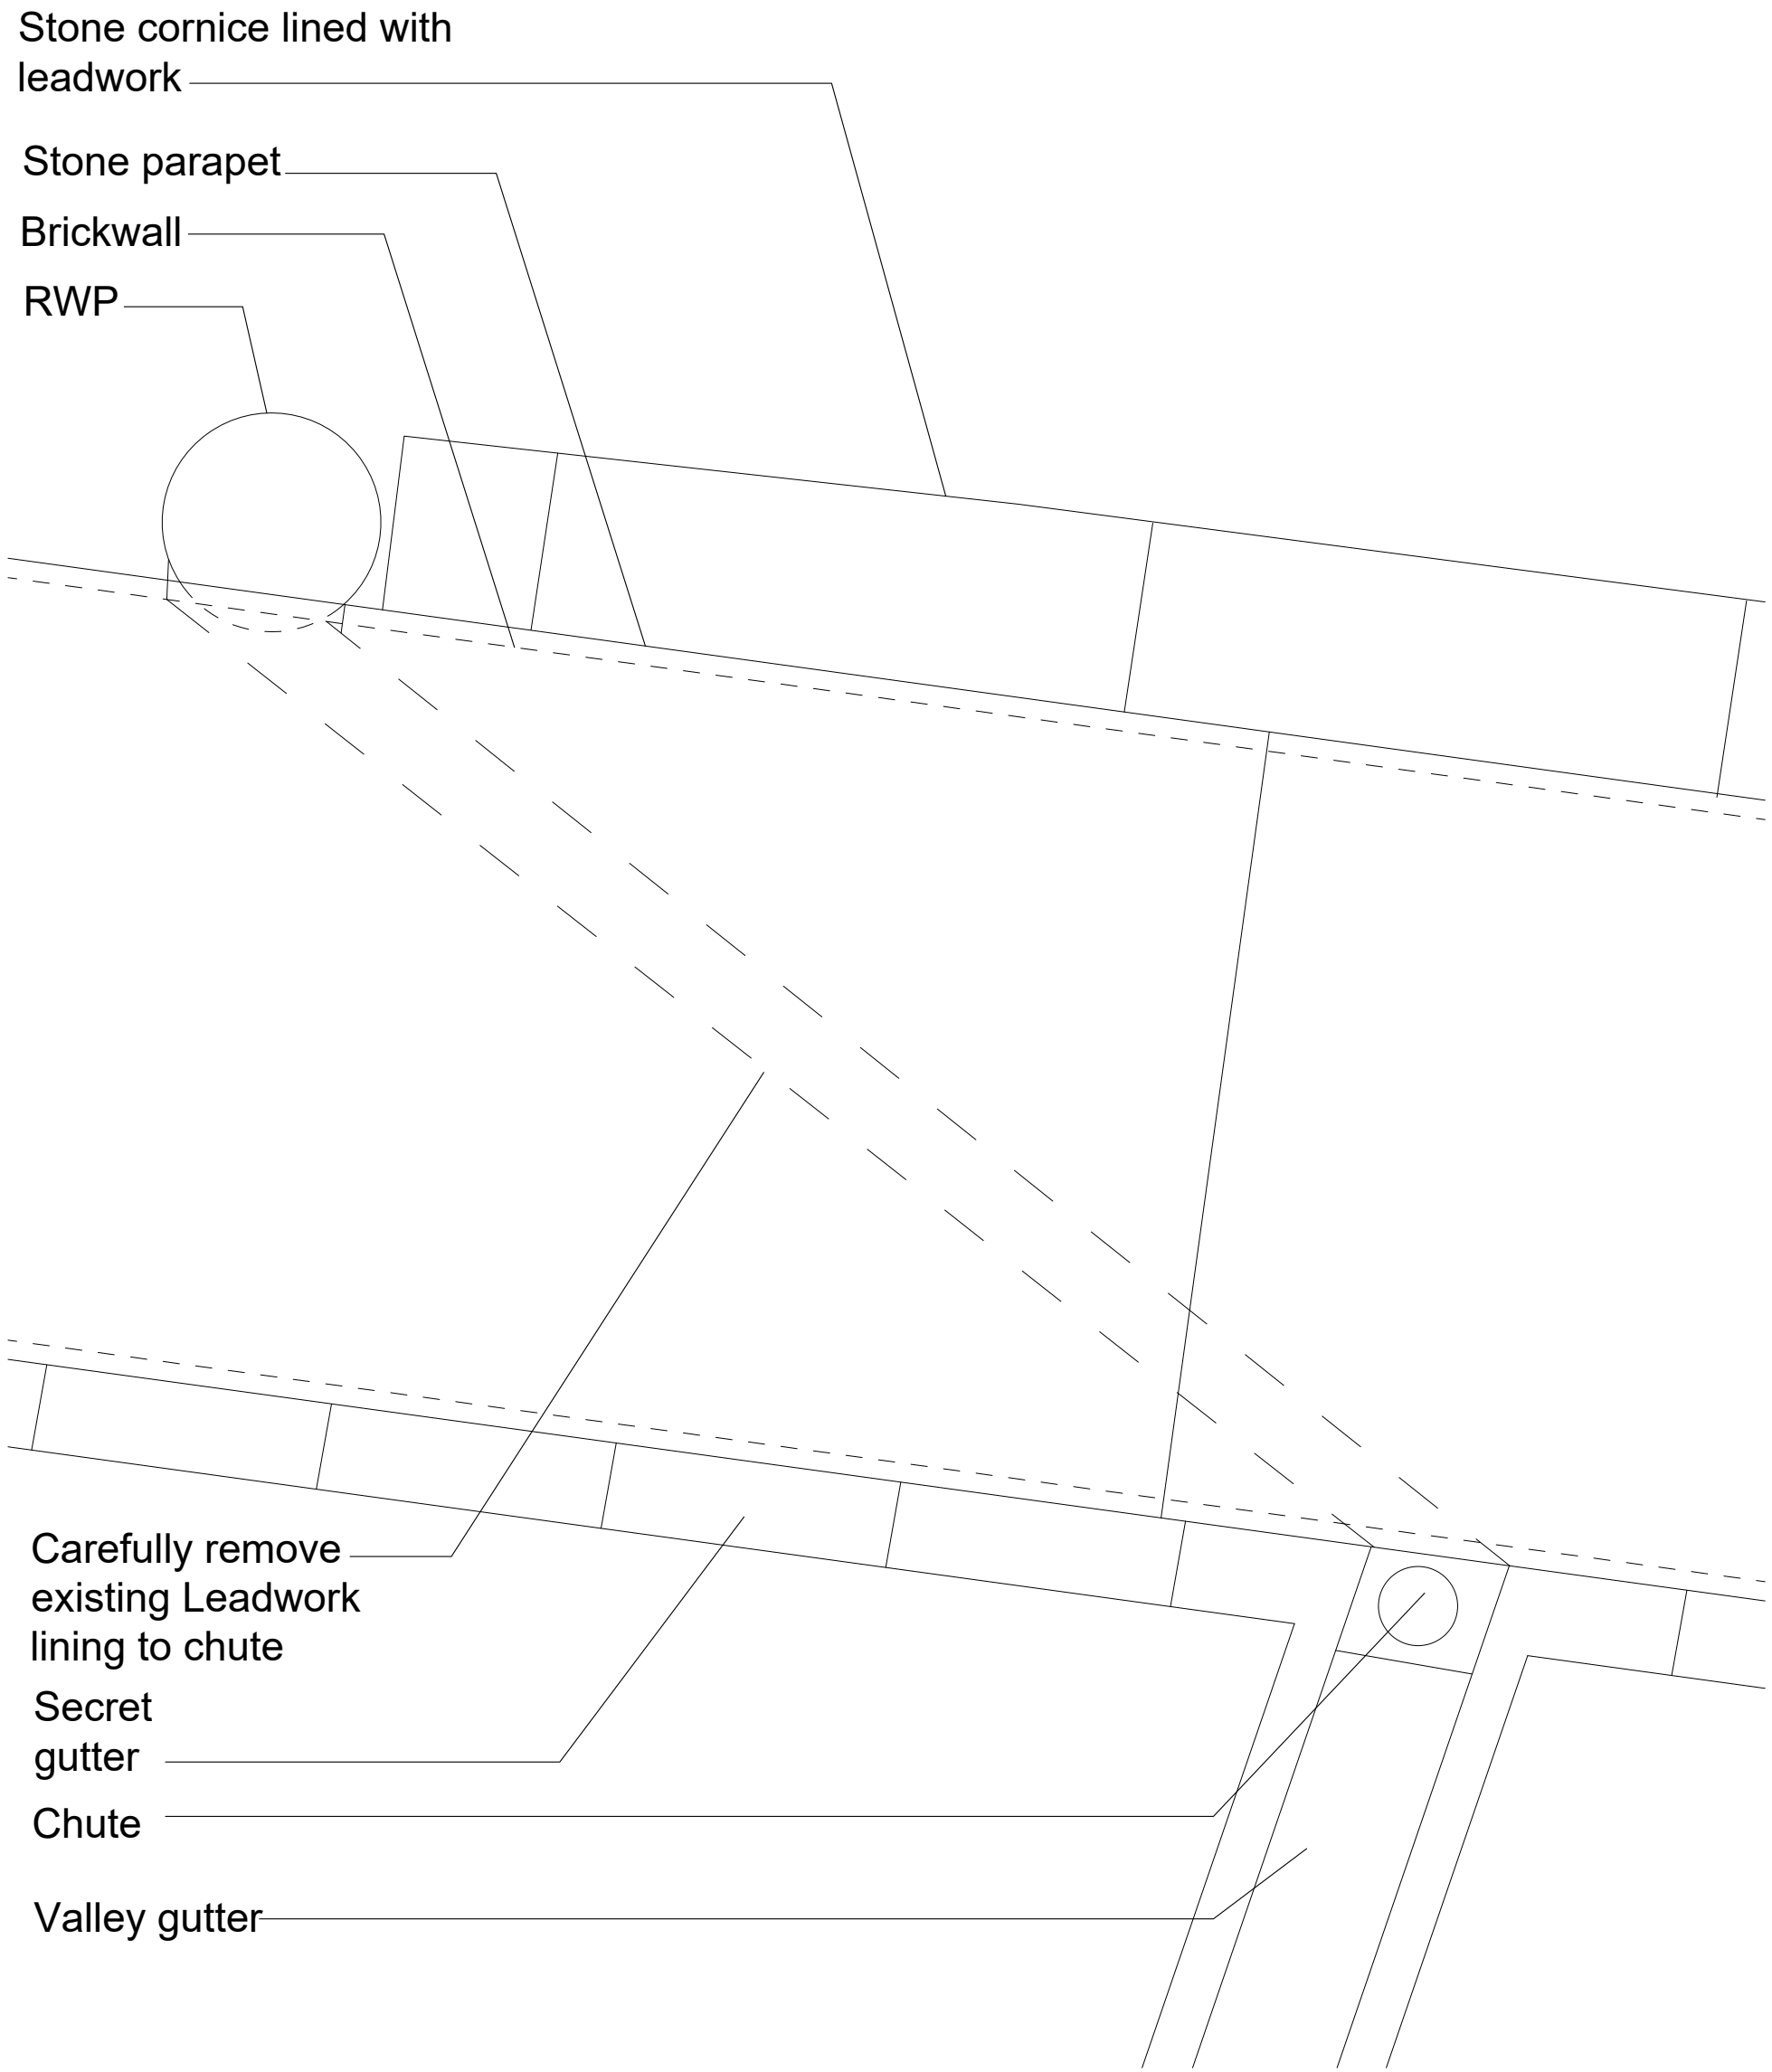
DETAIL 3: ROOF PLAN

MC to survey existing roof and to carefully remove and salvage for re-use existing slate tiles and to remove existing leadwork and substrate to enable new valley gutter installation as per SDA Drwg Nos. 275/PD/320-322 .
