Cube Homes Limited

# Chorlton High School

Supplementary Phase 2 Geo-environmental and Geotechnical  
Site Investigation

11884-R01(00)

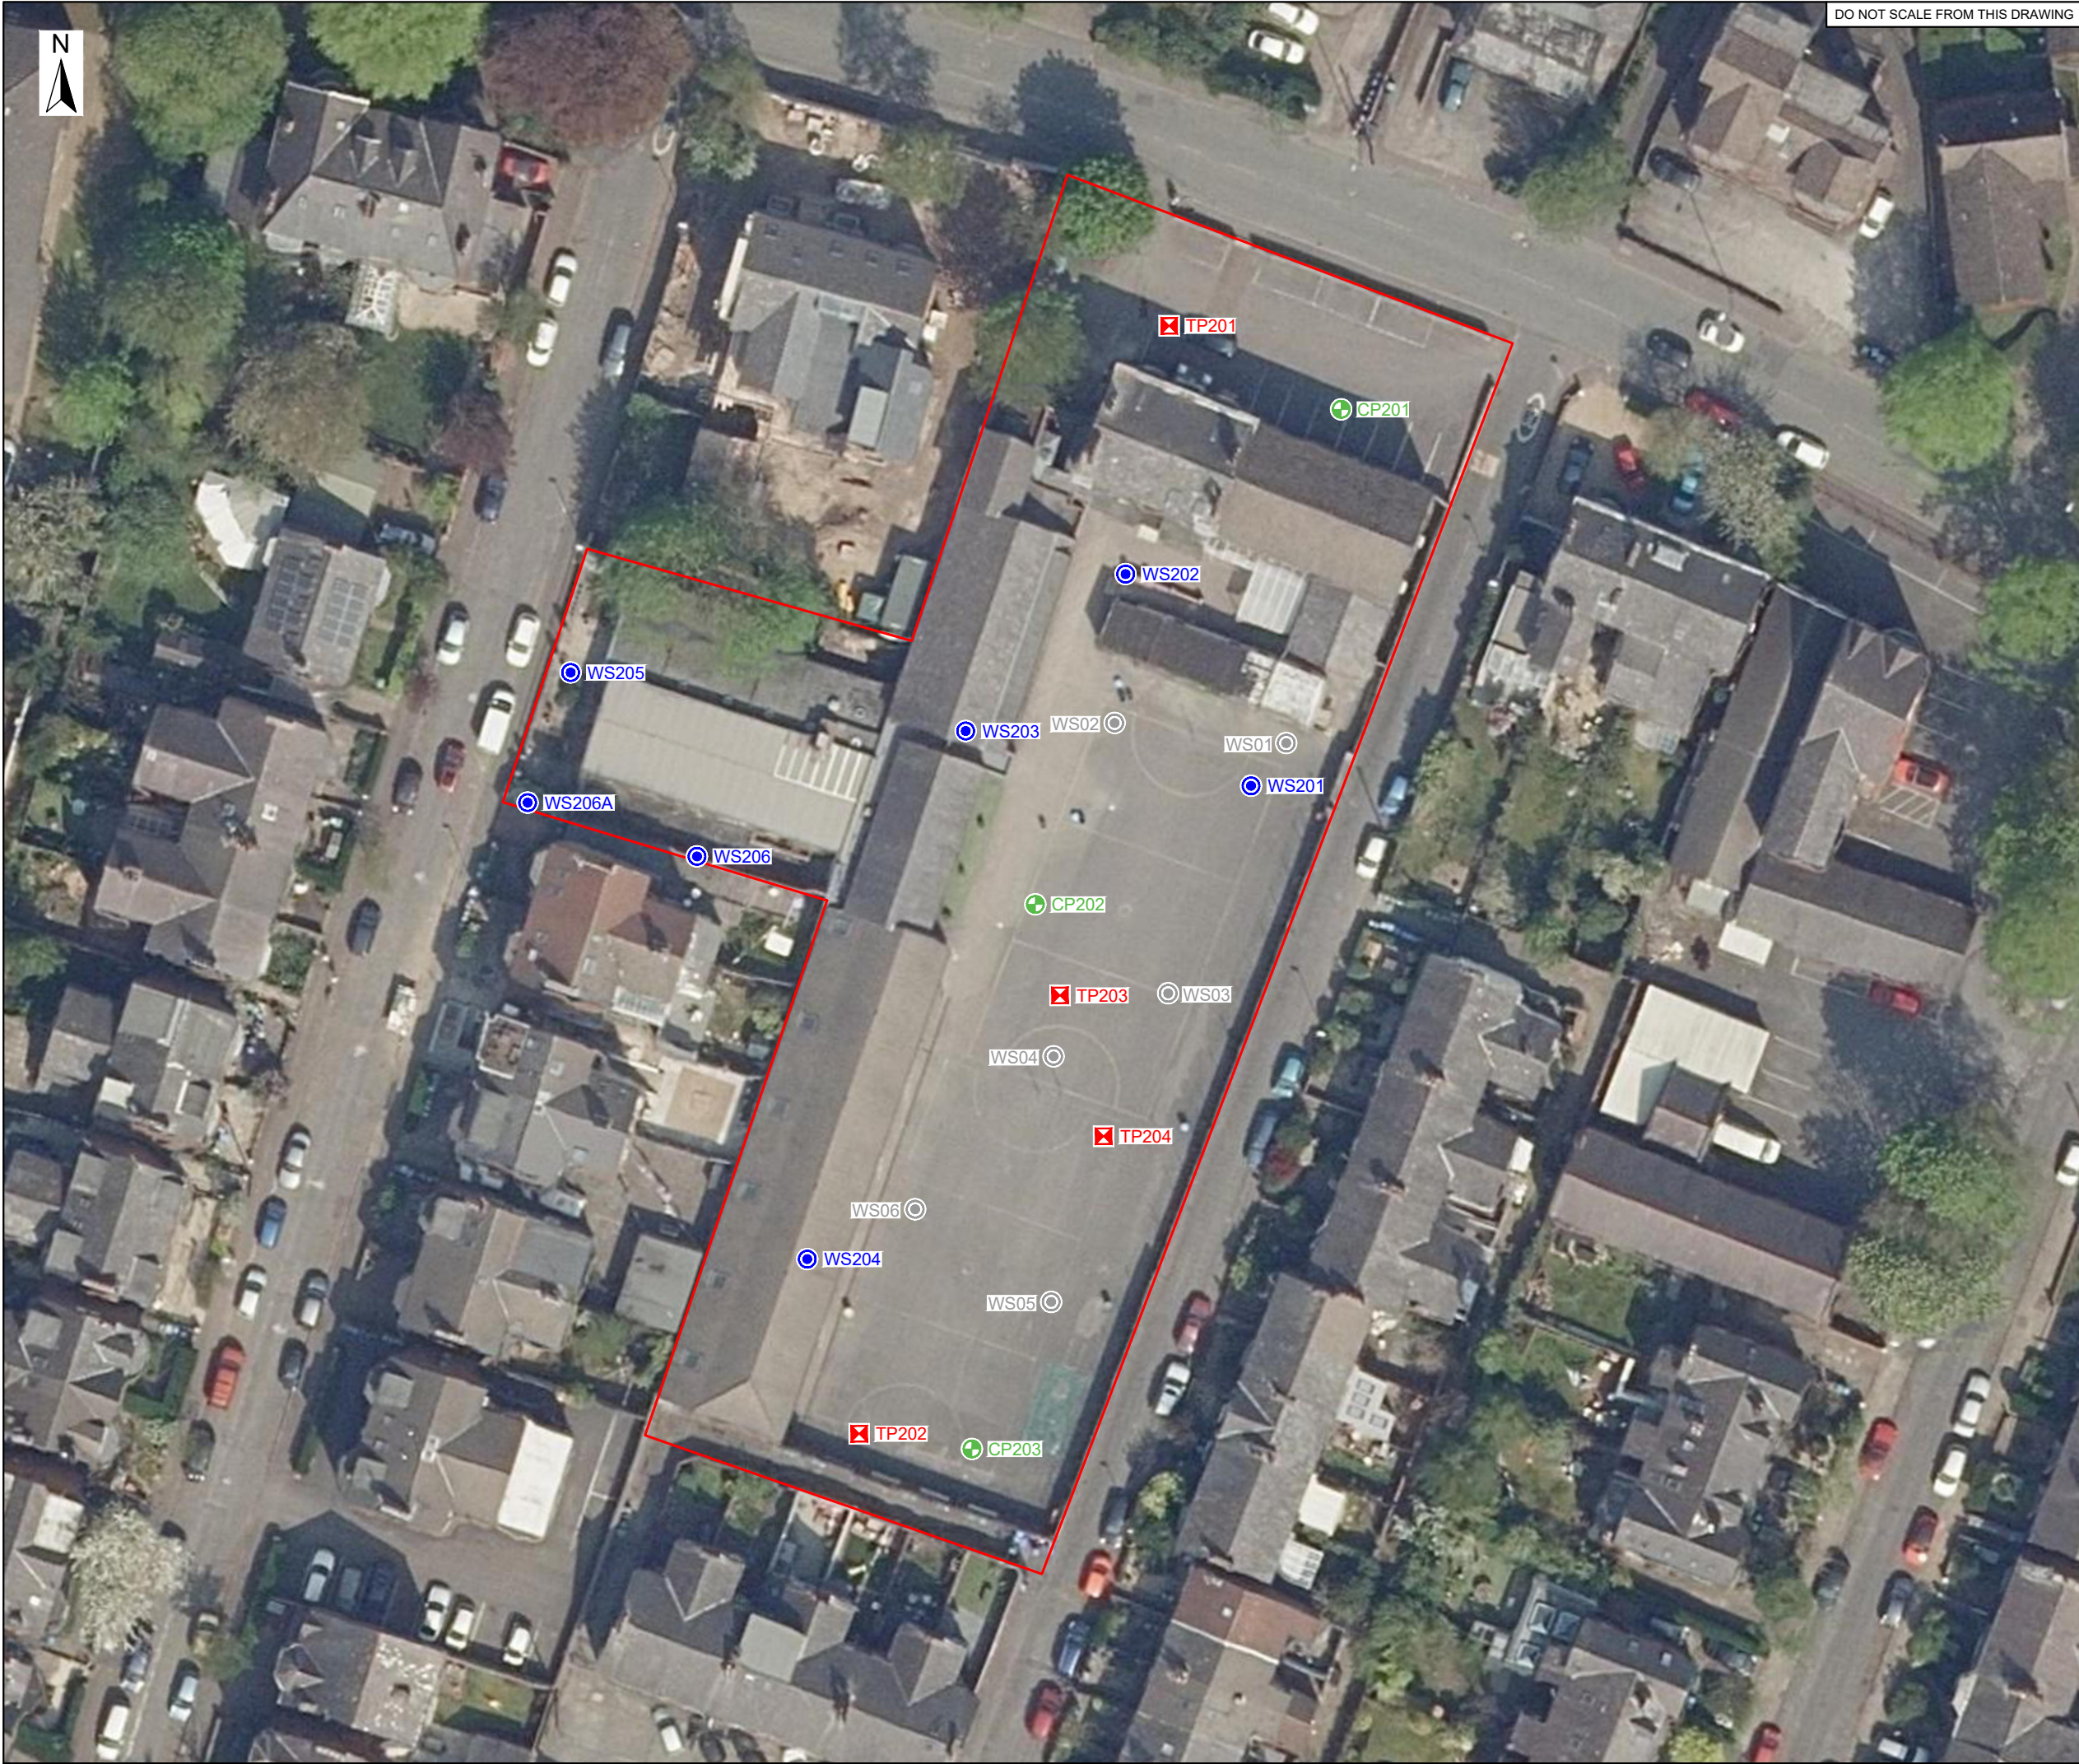
## **Figure 2 EXPLORATORY HOLE LOCATION PLAN**

- LEGEND**
- Site boundary
  - Cable percussive borehole location
  - Window sample location
  - Trial pit location
  - Window sample location (RSK Site Investigation October 2022)

Mechanically excavated trial pitting were also carried out at a number of investigation locations to achieve greater visibility of the made ground and delineate the extent of the area previously found to have exceedances in metals (WS04). Two of the trial pits located to the north and south areas of site underwent soakaway testing.
