# BAT SURVEY REPORT

**OCTOBER 2023**

**Plant Hill Road**

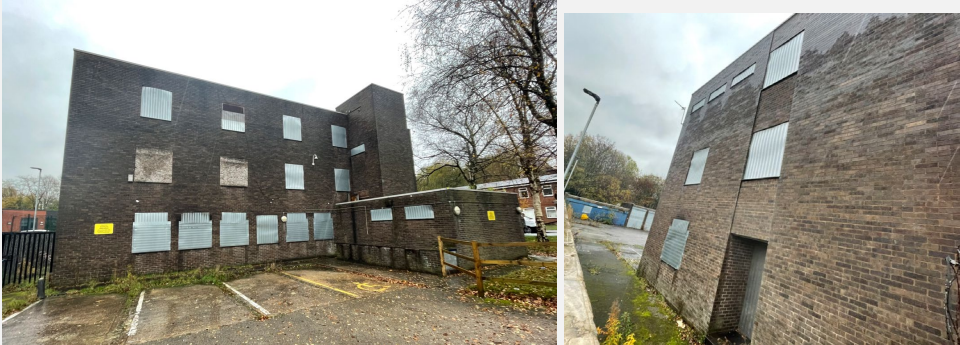
| Building Reference | Description | Evidence | Category of Suitability |
|---|---|---|---|
| B1 | B1 was a flat roofed building, featuring a staggered elevation between 1-3 storeys. All windows were covered by PVC boarding or metal panelling, with all areas appearing well sealed, with no obvious crevices or PRFs present across the building's extent. | | Negligible |

B1 was assessed as having negligible bat roosting potential and no further surveys are required on B1 for the proposed development to proceed.

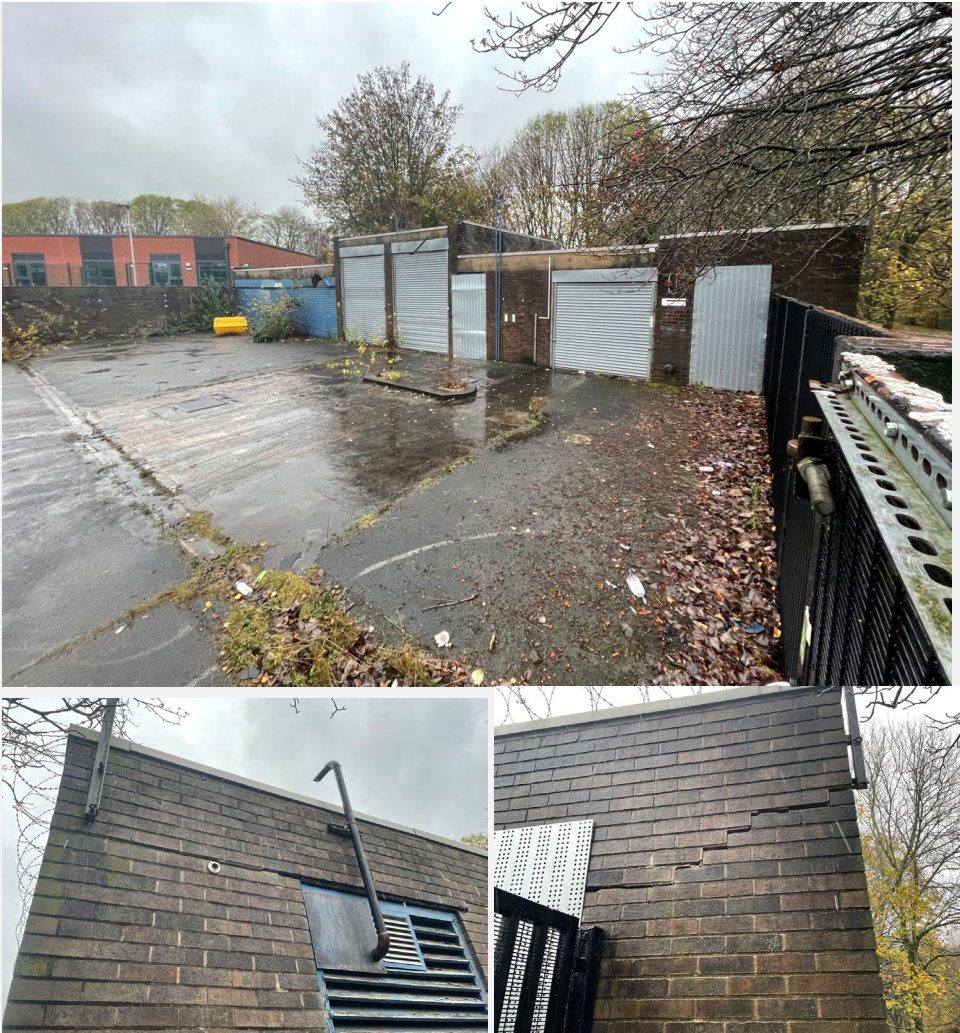
| Building Reference | Description | Evidence | Category of Suitability |
|---|---|---|---|
| B2 | <p>B2 was a single storey flat roofed building, featuring a number of corrugated metal garage door entrances along the western aspect. The building had a generally well-sealed façade with the exception of a single PRF consisting of a mortar crack extending along the southwestern aspect.</p> | | Low |

No emergence activity was recorded, and no bat roosts were identified at any PRFs on B2 during the survey.

No bat roosts were identified at any of the PRFs during the survey, as no bats were identified interacting with B2. As such, it is anticipated that the site is solely used for commuting and foraging purposes.

No bat roosts were identified onsite, but activity was present in the form of foraging and commuting. As such, no further surveys or mitigation relating to roosting bats is required to facilitate development.
