### DETAIL 02 PLANT BED/THRESHOLD DETAIL

### DETAIL 04 RAMPS/PLANTING BED DETAIL

**DETAIL 08B Typical Gate-Service Gate-Single  
leaf-Front (outside) elevation-manually operated**

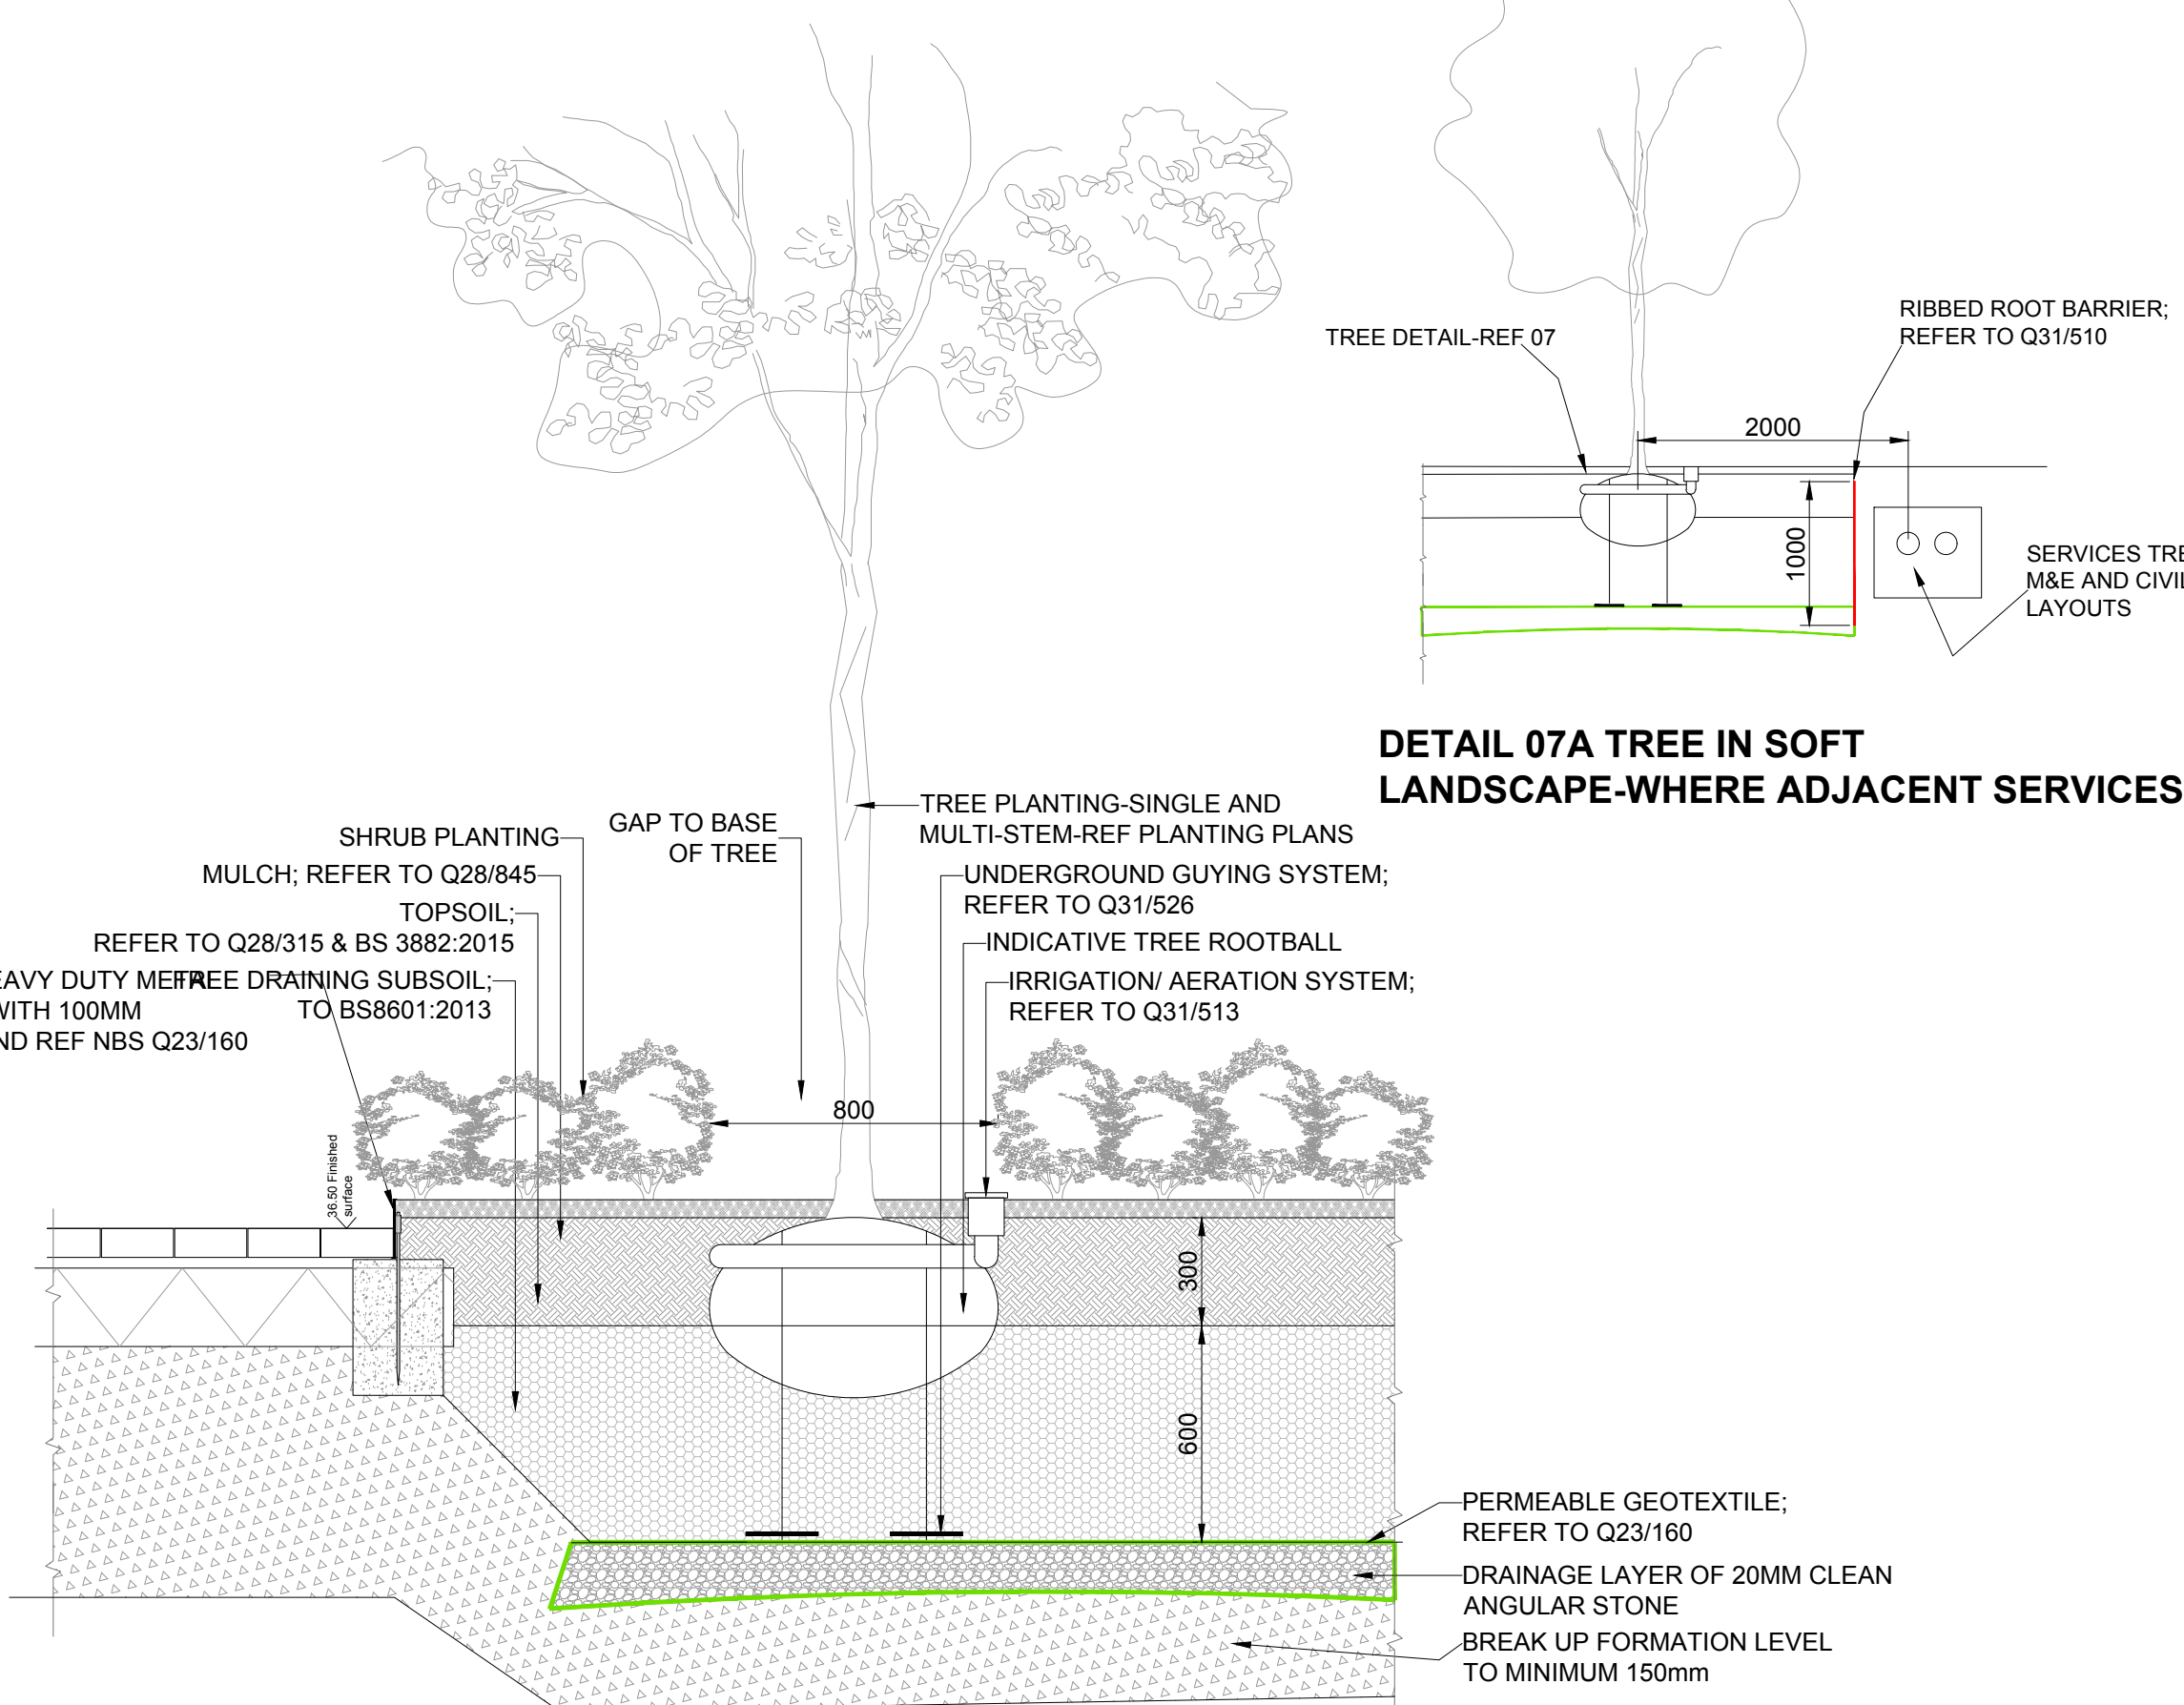
**DETAIL 07A TREE IN SOFT  
LANDSCAPE-WHERE ADJACENT SERVICES**

**DETAIL 05 TREE IN SOFT LANDSCAPE/RAISED KERB**

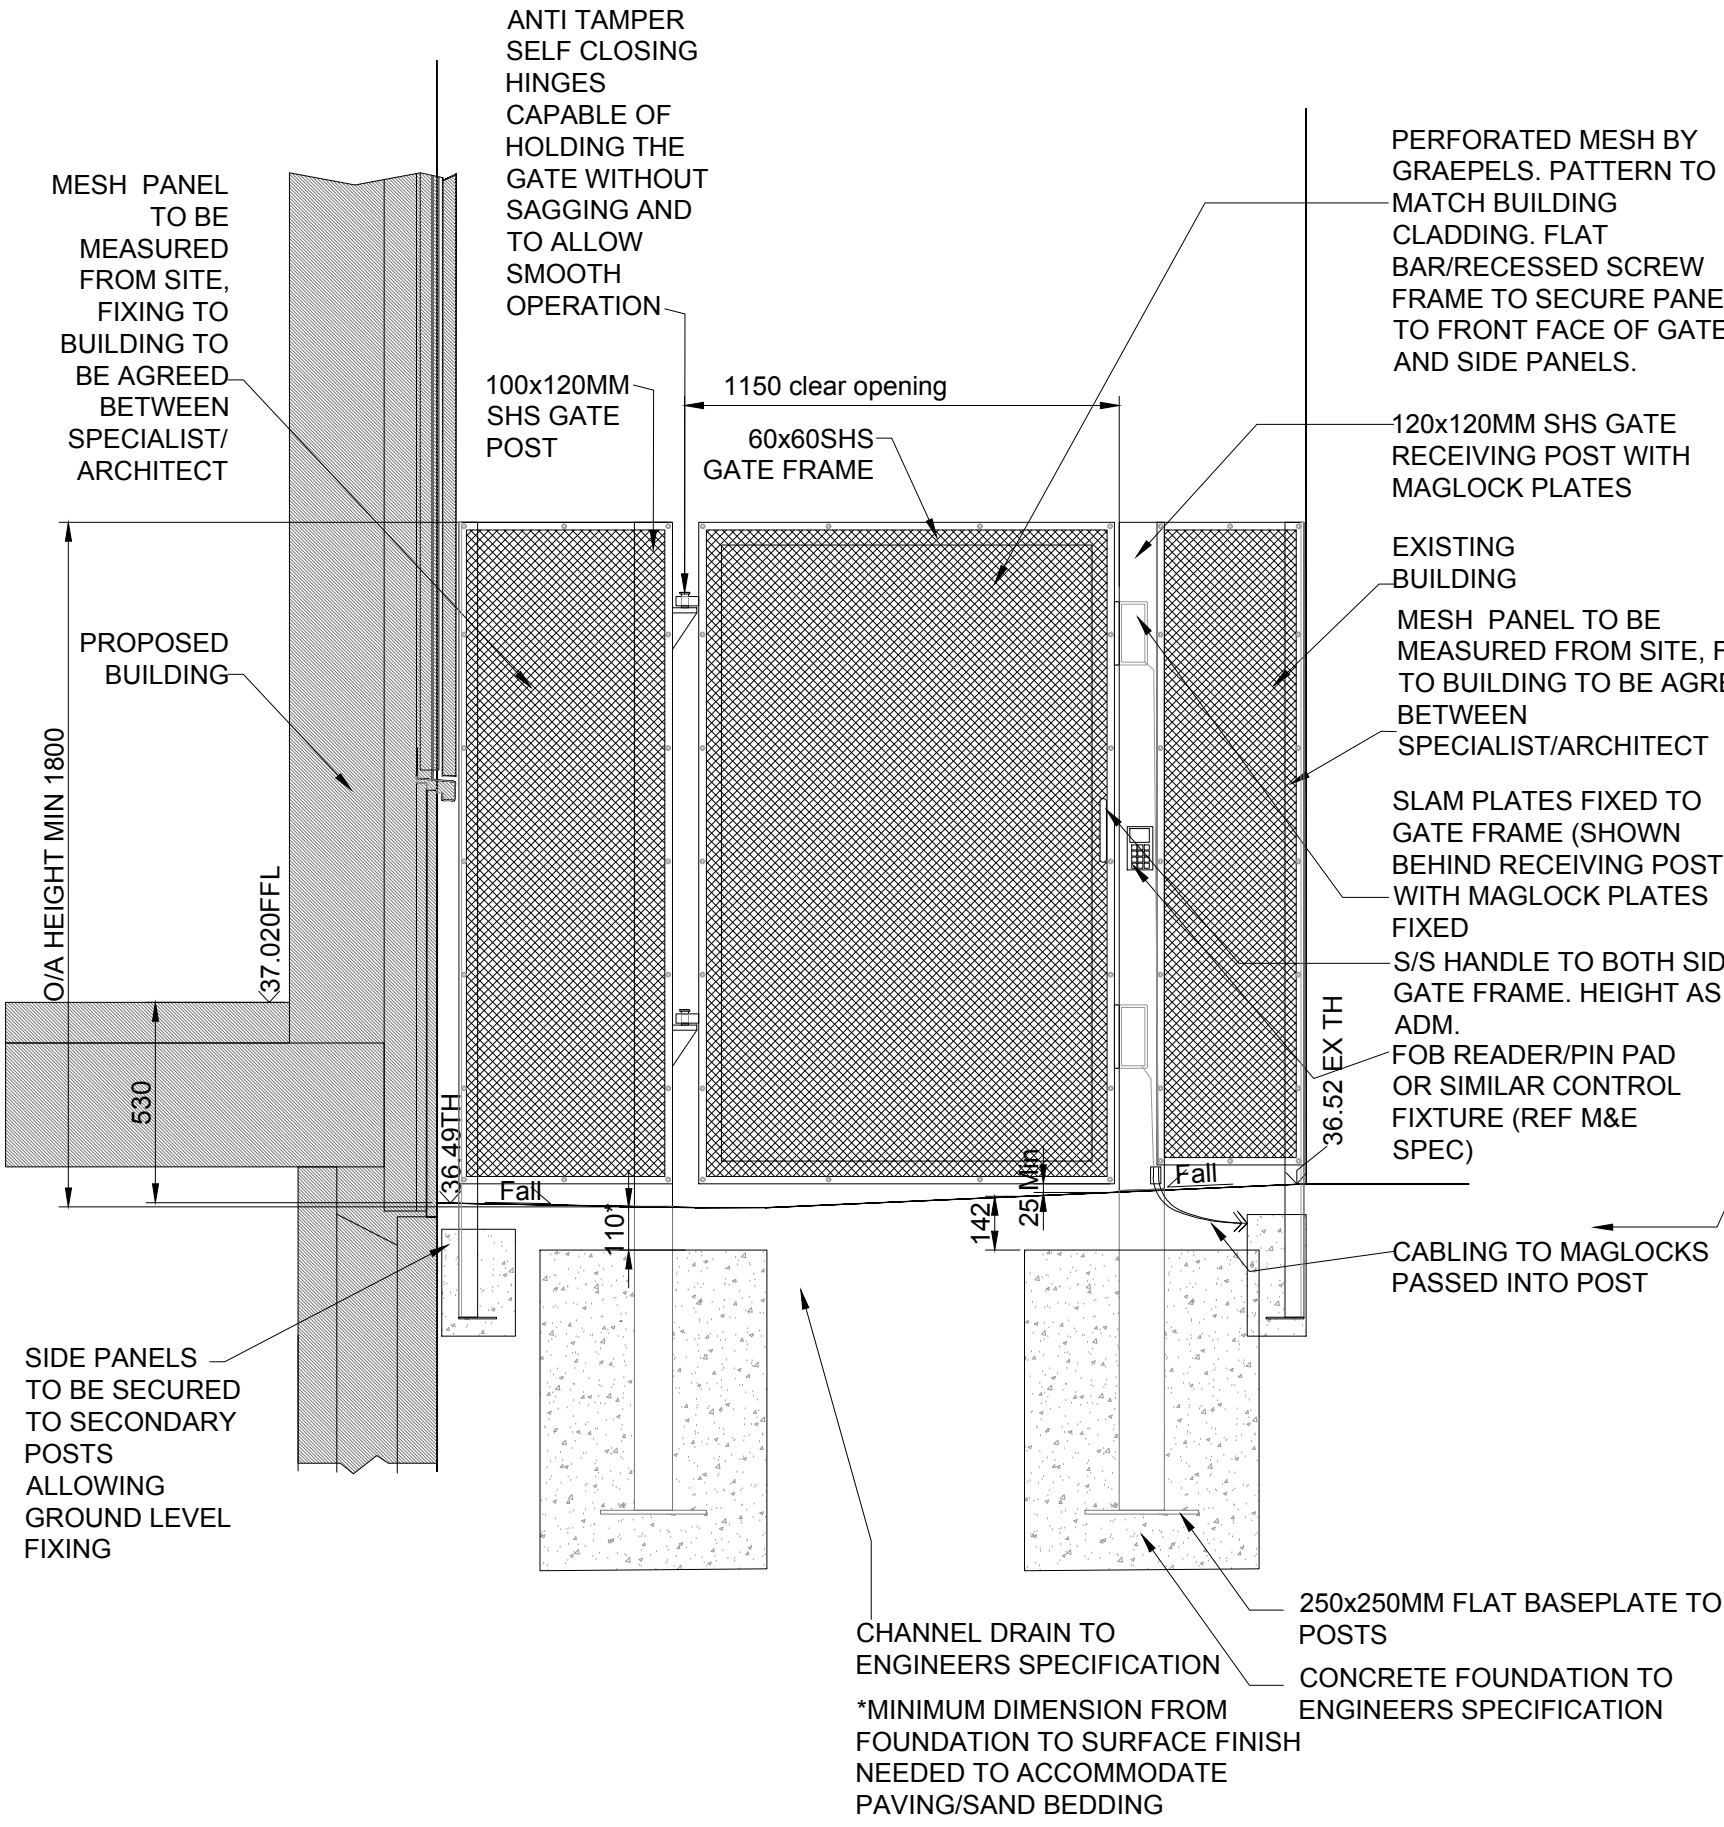
**DETAIL 08 Typical Gate-Single leaf-maglock  
operated-Front (outside) elevation**

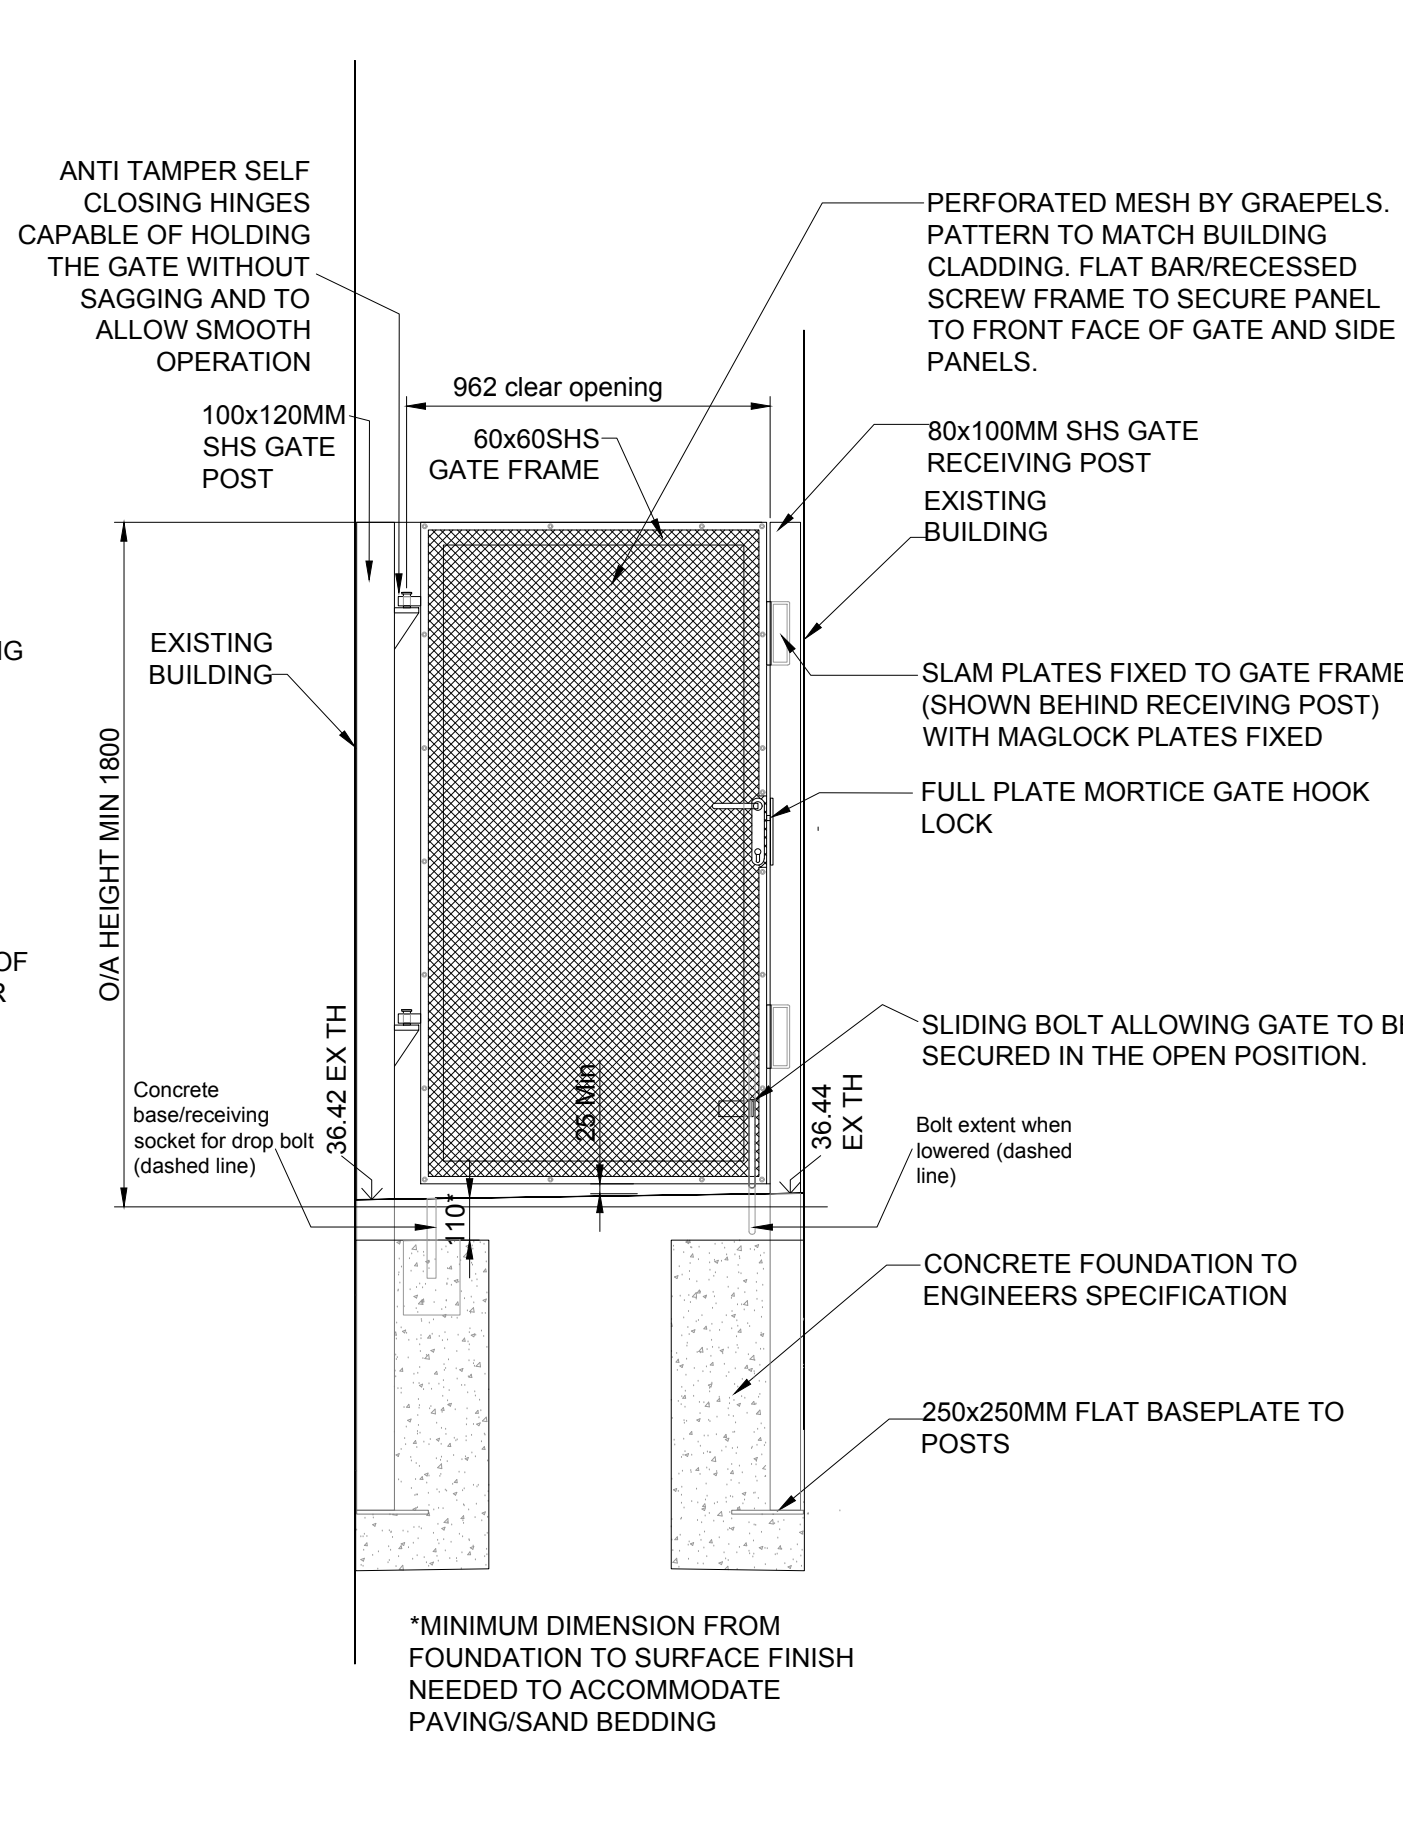
**DETAIL 08A Typical Gate-Single leaf-Front (outside)**  
elevation: To end of Ginnel-manual operation

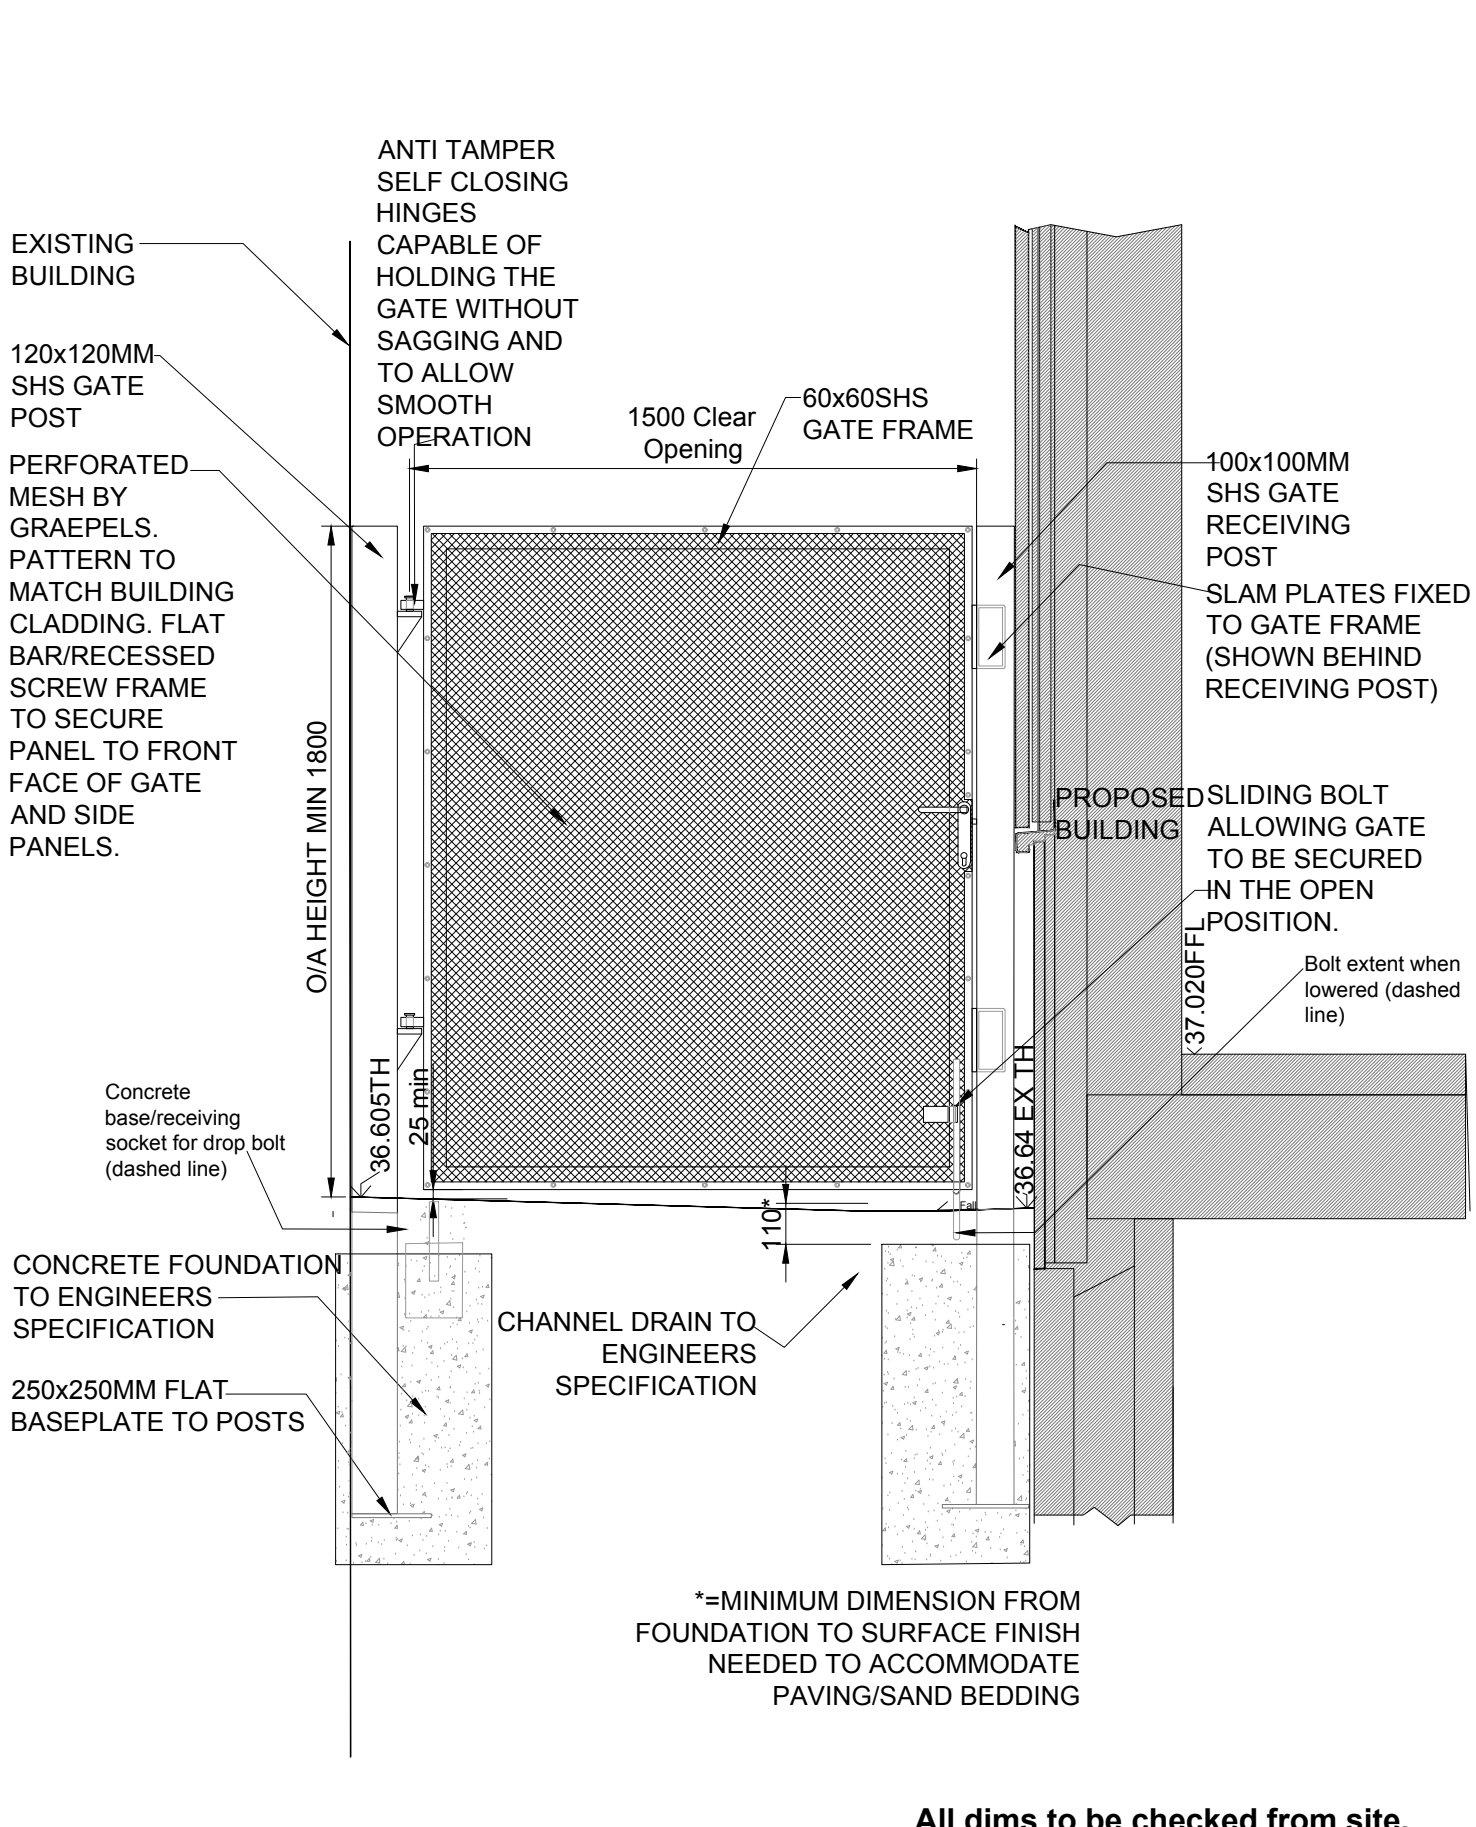
**DETAIL 08B Typical Gate-Service Gate-Single  
leaf-Front (outside) elevation-manually operated**
