# GROUND INVESTIGATION REPORT- INTERPRETATIVE

St Gabriel's, Manchester

PREPARED FOR: McLaren Living

Concept: 23/3814-GIR-GIR

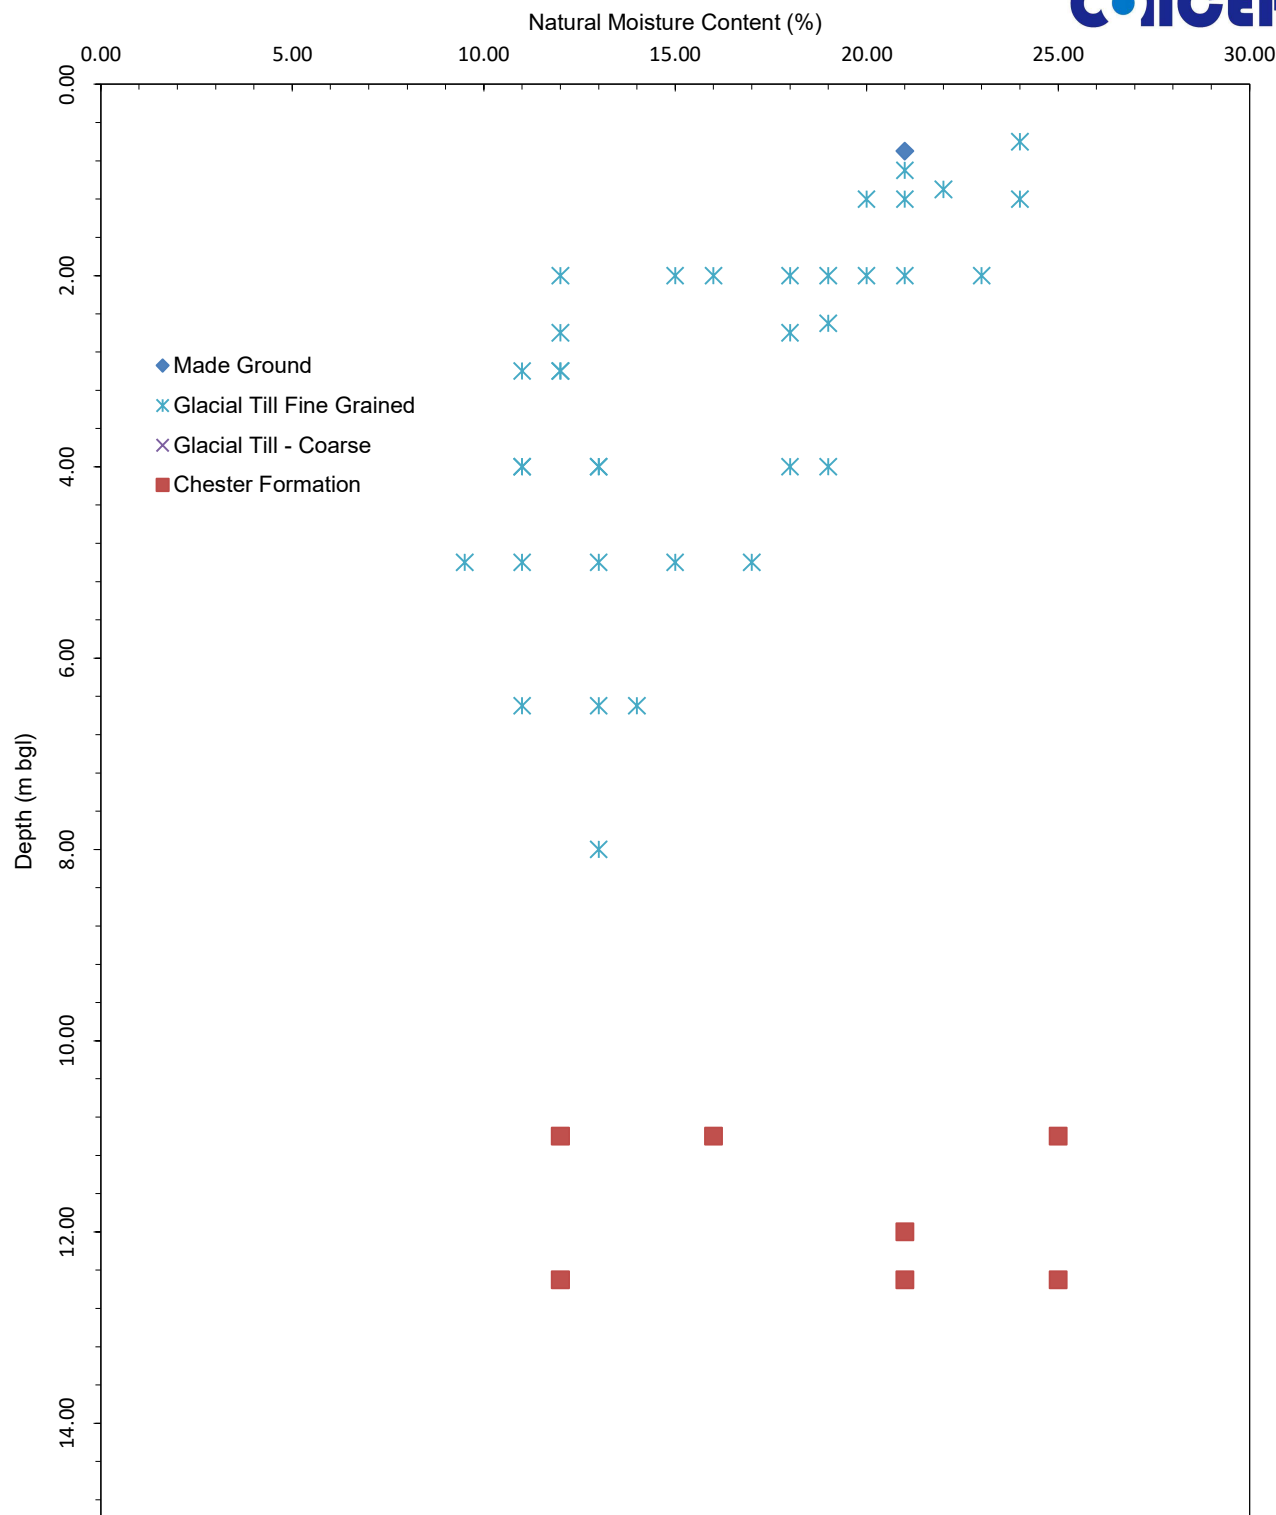
*Figure 6.1: Moisture Content V Depth*

The natural moisture content test was measured on 35 No. samples of fine grained Glacial Till and ranged between 9.5% and 24%. Figure 6.1 shows a slight decrease in the moisture content with depth.

The moisture content was measured on 7 No. samples from the Chester Formation and ranged between 12% and 25%. Figure 6.1 shows that the results are variable.

The Moisture content was measured on 1 No. Sample of Made Ground as 21%. (See Figure 6.1).

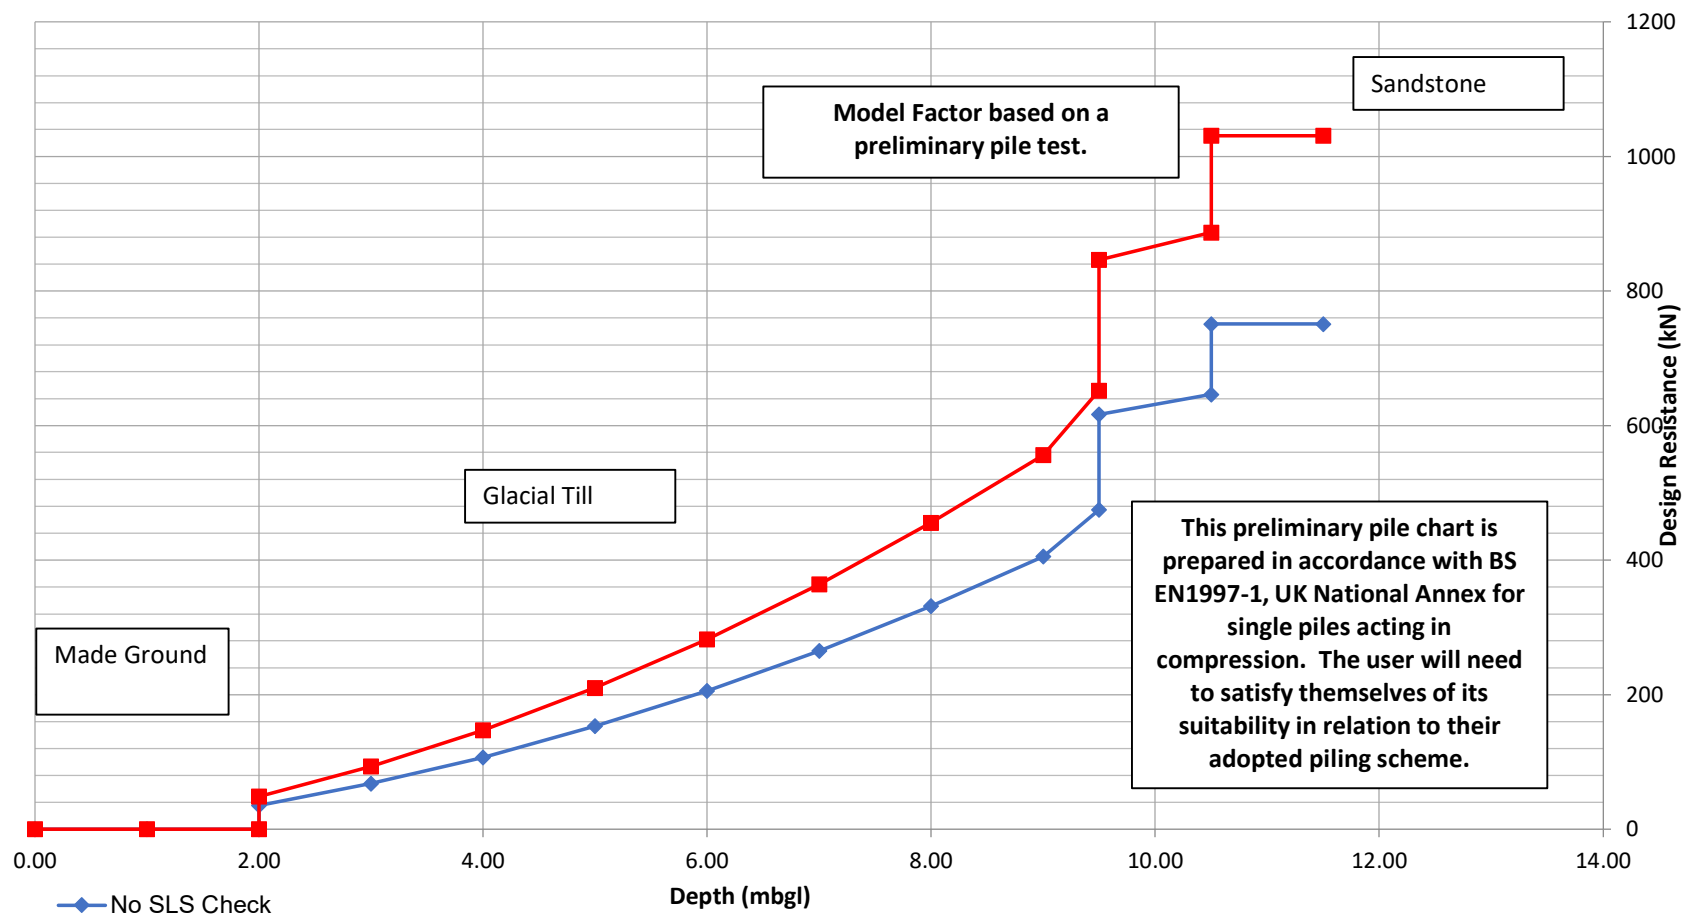
**FIGURE 8.1 - PRELIMINARY PILE DESIGN CHART**

The outline design has been carried out in accordance with BS EN1997-1, UK National Annex. The charts assume that a preliminary pile test will be conducted and present design lines for the following conditions associated with pile load testing.
