## **NX406 Phase 1 & Phase 2 Geoenvironmental Assessment Report for No 1 City Road East, Manchester, M15 4PN**

**Project No: NX406**

**Report Reference: NX406****Issue: Final****Date: 5<sup>th</sup> September 2023****Written by:**

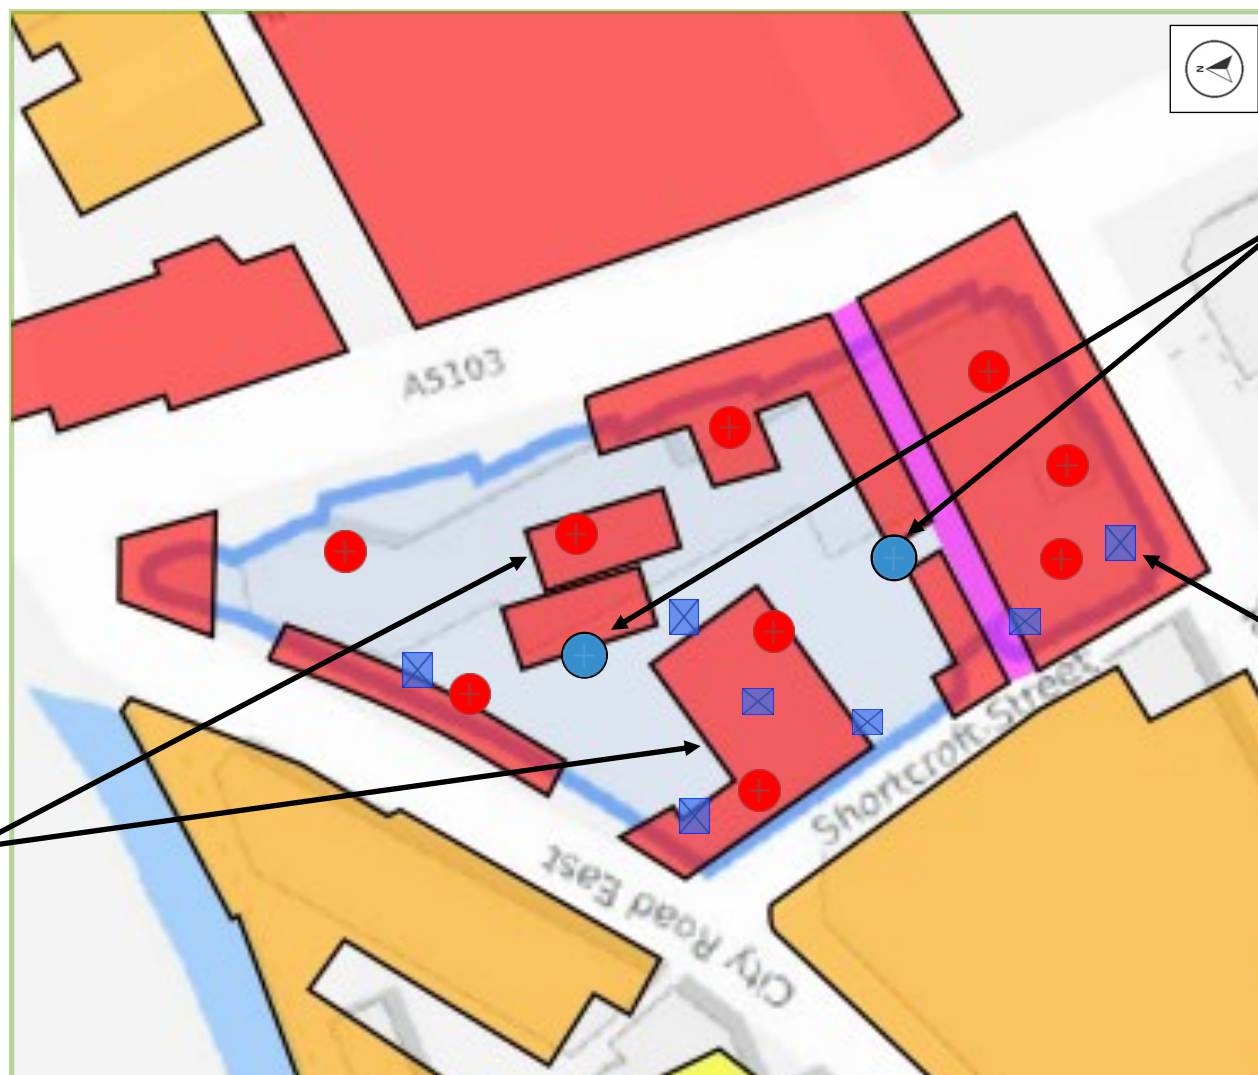
RBH1 & 2 under centre of 2no. proposed building footprints which should highlight any contaminant plume migration from the adjacent gas works

WS and TP exploratory holes within the south of the site. Areas of investigation comprise former road and timber yard.

WS and TP exploratory holes within the centre of the site. Areas of investigation comprise former Saw Mill hosting former incinerator/chimney.
