# Buttress

## College House Baronial Hall Significance and Methodology for repair of stone flag flooring at Chethams School of Music

### Approach

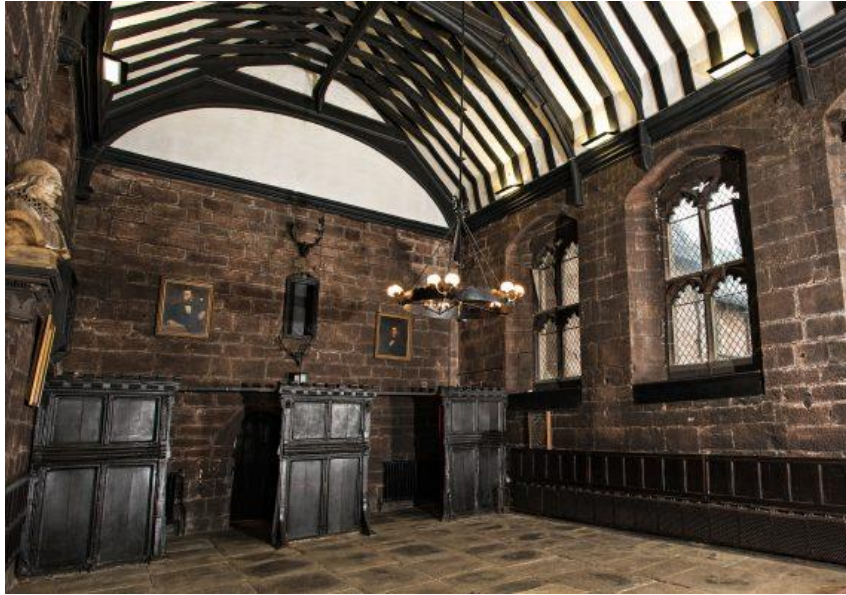
*The Baronial Hall showing the screens passage*

The purpose of the screen was to keep out draughts and to conceal the entrances to the buttery and pantry situated at the back of the hall. At the top of the hall an impressive oak canopy projects over a raised dais, where the warden and visiting dignitaries would have dined at high table.

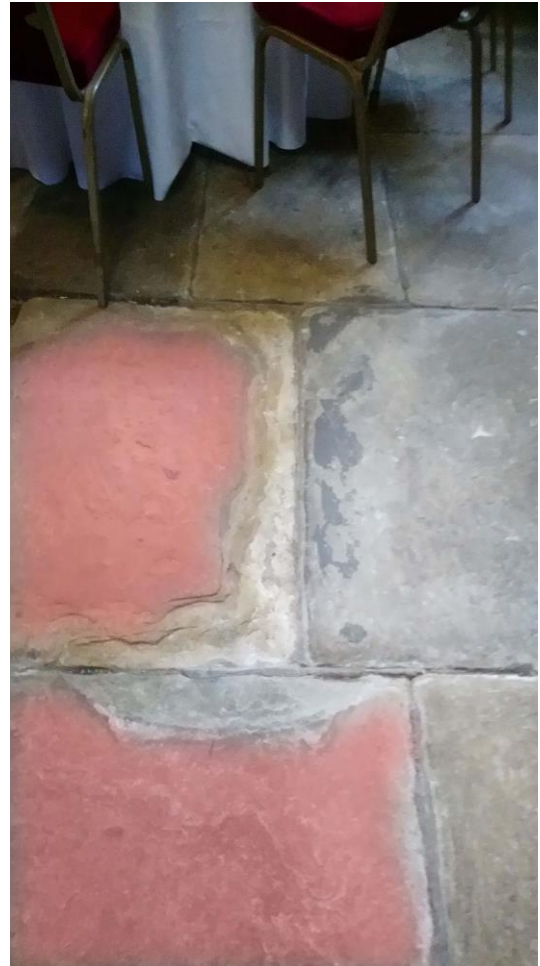
Below is an image which illustrates the proposed methodology of repair using the reskimming technique.

The area highlighted in red graphically illustrates the proposed material to be removed by skimming the top surface of the stone to a maximum depth of up to 25mm depending on the degree of wear.

The flags would be carefully lifted (position and orientation of flag with the Hall recorded with a chalk mark to the rear of the flag), removed from the Hall prior to skimming. Once skimmed the flags are relaid on a full lime and sand mortar bed/ Once levelled to the adjacent flags the immediate area is repointed in matching lime/sand mortar.

1. Stone flags lifted and carefully relaid to be level with adjacent stone.
2. Open joints are repointed in lime and sand mortar to match existing.
3. Where stones are significantly worn they will be carefully lifted and modified. This will involve mechanically skimming the existing stones to produce a surface with less surface irregularity. Stones with the greatest variance have wear upto a depth of 25mm. It is assumed that the flags have a thickness of at least 75mm therefore once the flags are fully rebedded on lime mortar their integrity will not be compromised.
