# Television and Radio Baseline Survey Report

Block C First Street, Manchester

Downing Living (Manchester South) Limited Partnership Incorporated

November 2023

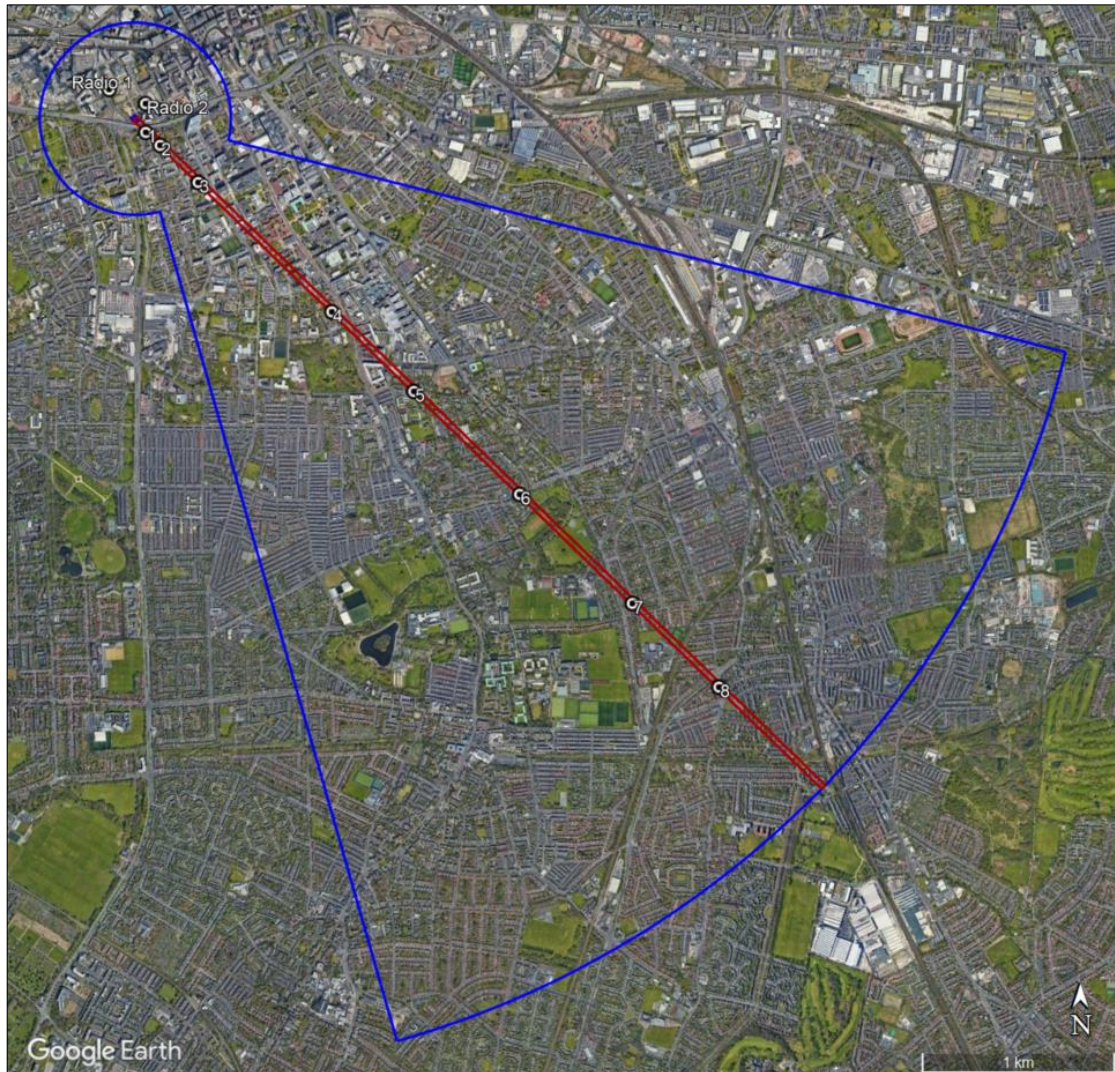
Figure 8 – TV Survey locations

Figure 8 on the following page shows the survey locations overlaid onto aerial photography. The development location and the shadow zone are also shown. Survey locations were chosen pre-survey; however, safe and available access influenced the specific position on the day (no reading was carried out at location 4 due to access). The locations shown on the following page show the actual survey locations. More readings were carried out closer to the development location. This is because interference is generally more likely the closer the location is to the obstruction. Television measurements were taken at survey locations 1 to 8. Radio measurements (see Figure 9 on page 22) were taken at survey locations Radio 1, Radio 2 and 1.

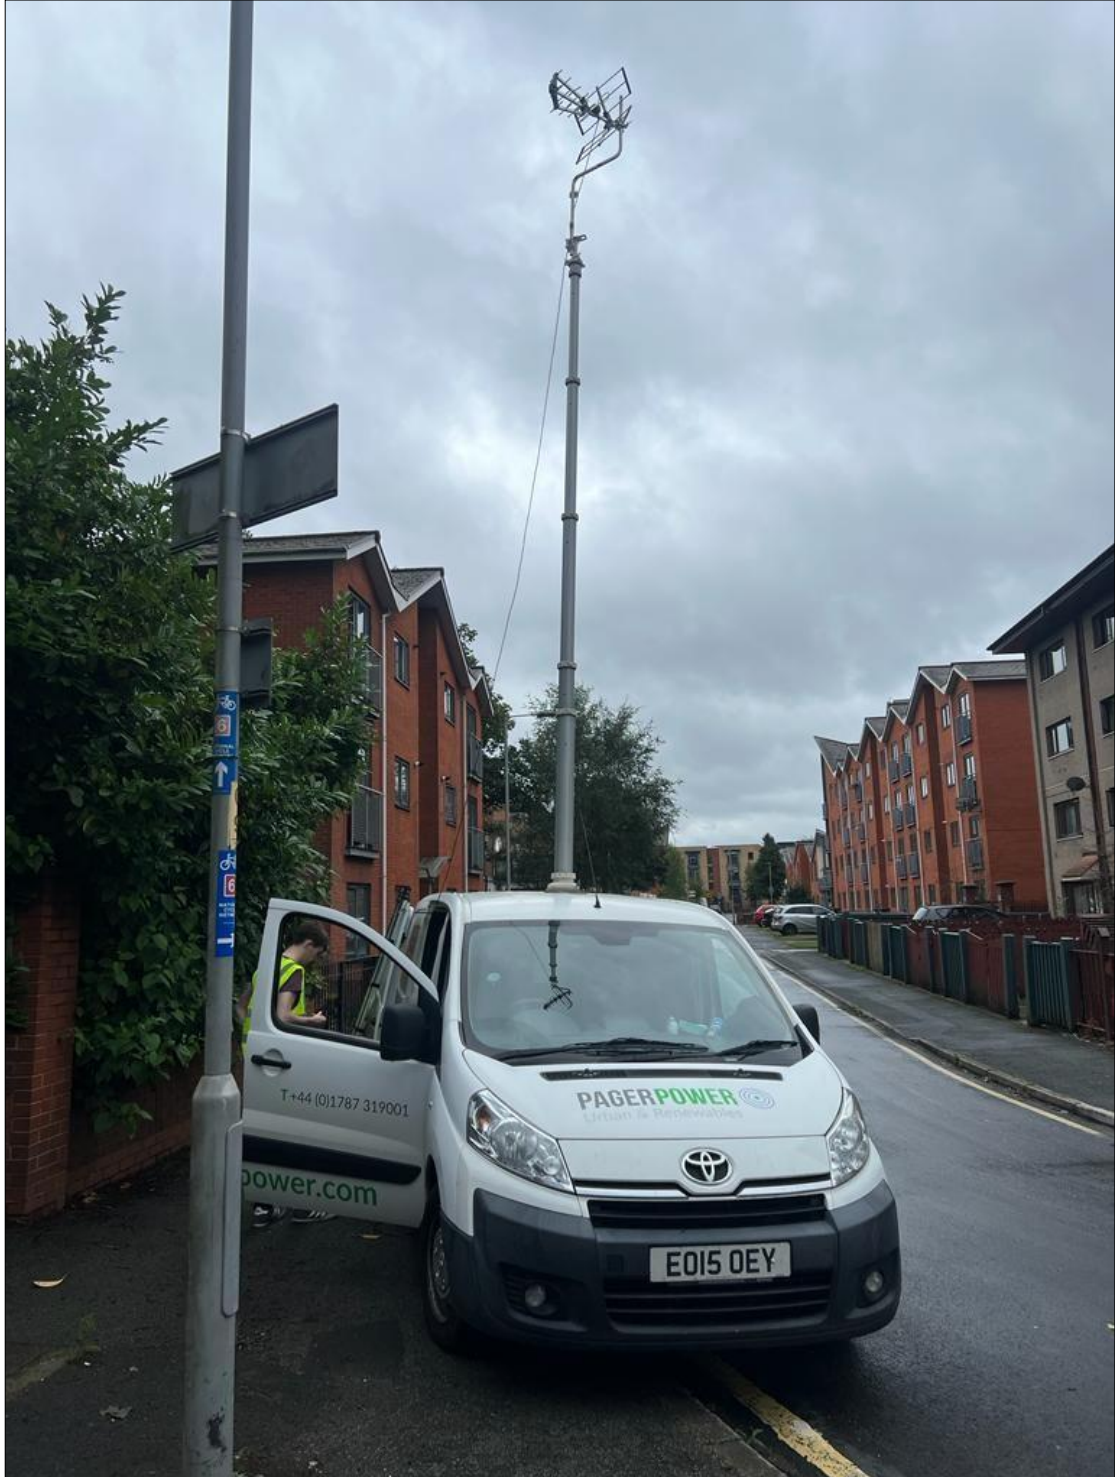
Location 1

| Location | Average Measured Signal Strength (dB) | Remarks | High-Level Conclusion |
|---|---|---|---|
| 1 | <p>Main TV MUX: 54.4 (Good)</p> <p>Local TV MUX: 36.3 (Moderate)</p> | <p>One HP<sup>7</sup> UHF<sup>8</sup> aerial directed towards the Winter Hill transmitter was observed. No satellite dishes were observed.</p> <p>All main multiplexes displayed fine picture and audio quality. Signal fluctuations of less than or equal to 0.5dB. The local multiplex displayed fine picture and audio. Signal fluctuations of less than or equal to 0.3dB.</p> | <p>This location is approximately 70 metres from the development.</p> <p>Two-stories properties are located near this location.</p> <p>A reduction in signal strength is likely based on the proximity to the development and the height of receiving aerials; however, the effects are unlikely to be noticeable for the main multiplexes based on the current signal quality. Effects may be noticeable for local multiplexes.</p> |

Notes: One Horizontally Polarised (HP) aerial orientated towards Winter Hill observed

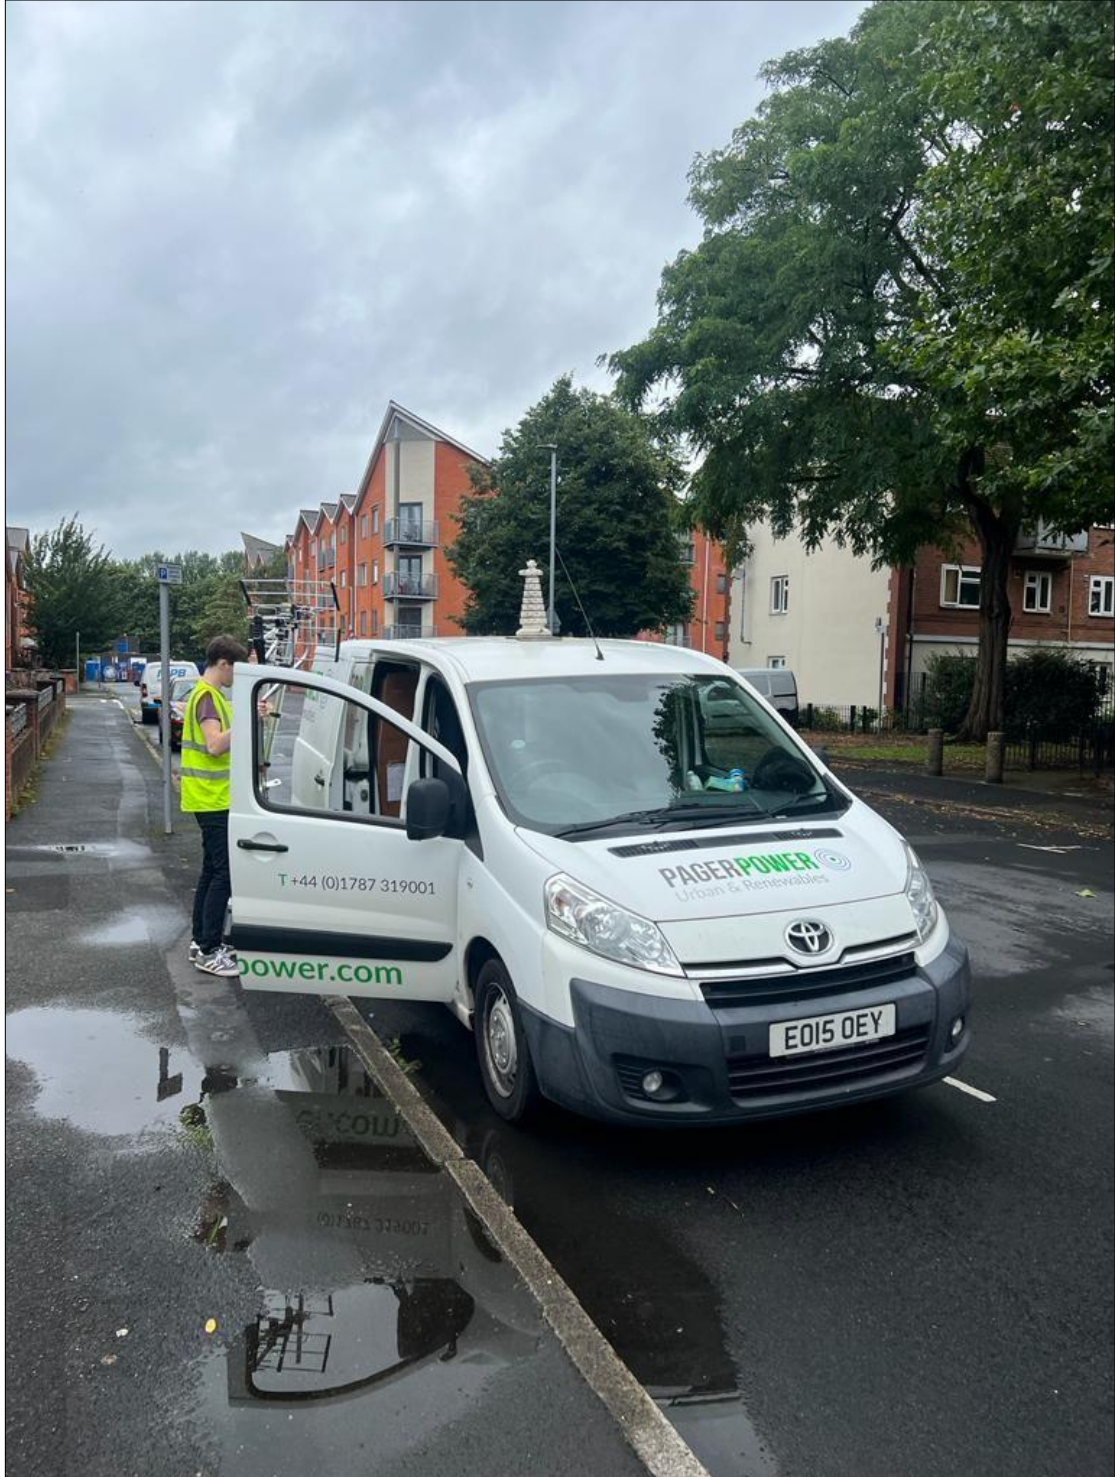
## Location 2

| Location | Average Measured Signal Strength (dB) | Remarks | High-Level Conclusion |
|---|---|---|---|
| 2 | <p>Main TV MUX: 48.5 (Good)</p> <p>Local TV MUX: 30.1 (Low)</p> | <p>Multiple HP UHF aerials directed towards the Winter Hill transmitter were observed. No satellite dishes were observed.</p> <p>All six main multiplexes displayed fine picture and audio quality. Signal fluctuations of less than or equal to 0.5dB. One local multiplex displayed fine picture and audio. The other local multiplex did not decode. Signal fluctuations of less than or equal to 0.2dB.</p> | <p>This location is approximately 170 metres from the development.</p> <p>Four-stories properties are located near this location.</p> <p>A reduction in signal strength is likely based on the proximity to the development and the height of receiving aerials; however, for the main multiplexes, the effects are unlikely to be noticeable based on the current signal quality. Effects will likely be noticeable for local multiplexes.</p> |

Notes: Multiple HP aerials orientated towards Winter Hill observed

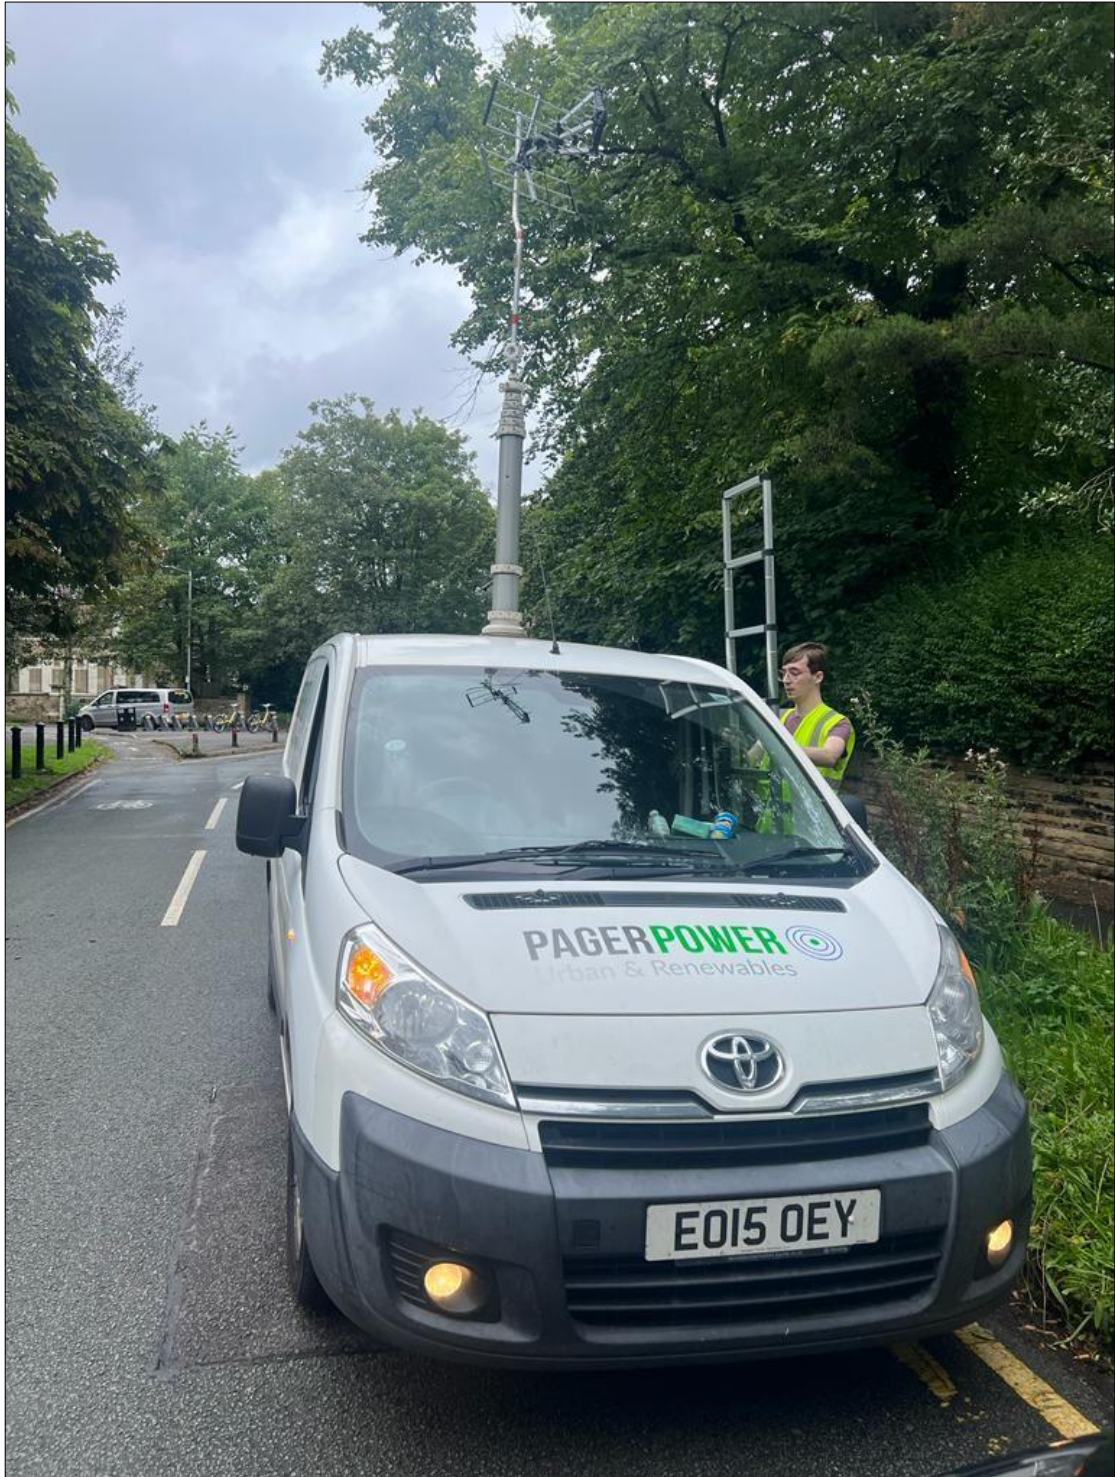
Location 5

| Location | Average Measured Signal Strength (dB) | Remarks | High-Level Conclusion |
|---|---|---|---|
| 5 | <p>Main TV MUX: 43.9 (Moderate)</p> <p>Local TV MUX: 27.5 (Low)</p> | <p>Multiple HP UHF aerials directed towards the Winter Hill transmitter were observed. No satellite dishes were observed.</p> <p>All six main multiplexes displayed fine picture and audio quality. Signal fluctuations of less than or equal to 0.4dB. One local multiplex displayed fine picture and audio. The other local multiplex did not decode. Signal fluctuations of less than or equal to 0.2dB.</p> | <p>This location is approximately 1.42km from the development.</p> <p>Two-stories properties are located near this location.</p> <p>A reduction in signal strength is unlikely based on the proximity to the development; therefore, effects are unlikely to be noticeable, despite the low signal quality.</p> |

Notes: Multiple HP aerials orientated towards Winter Hill observed

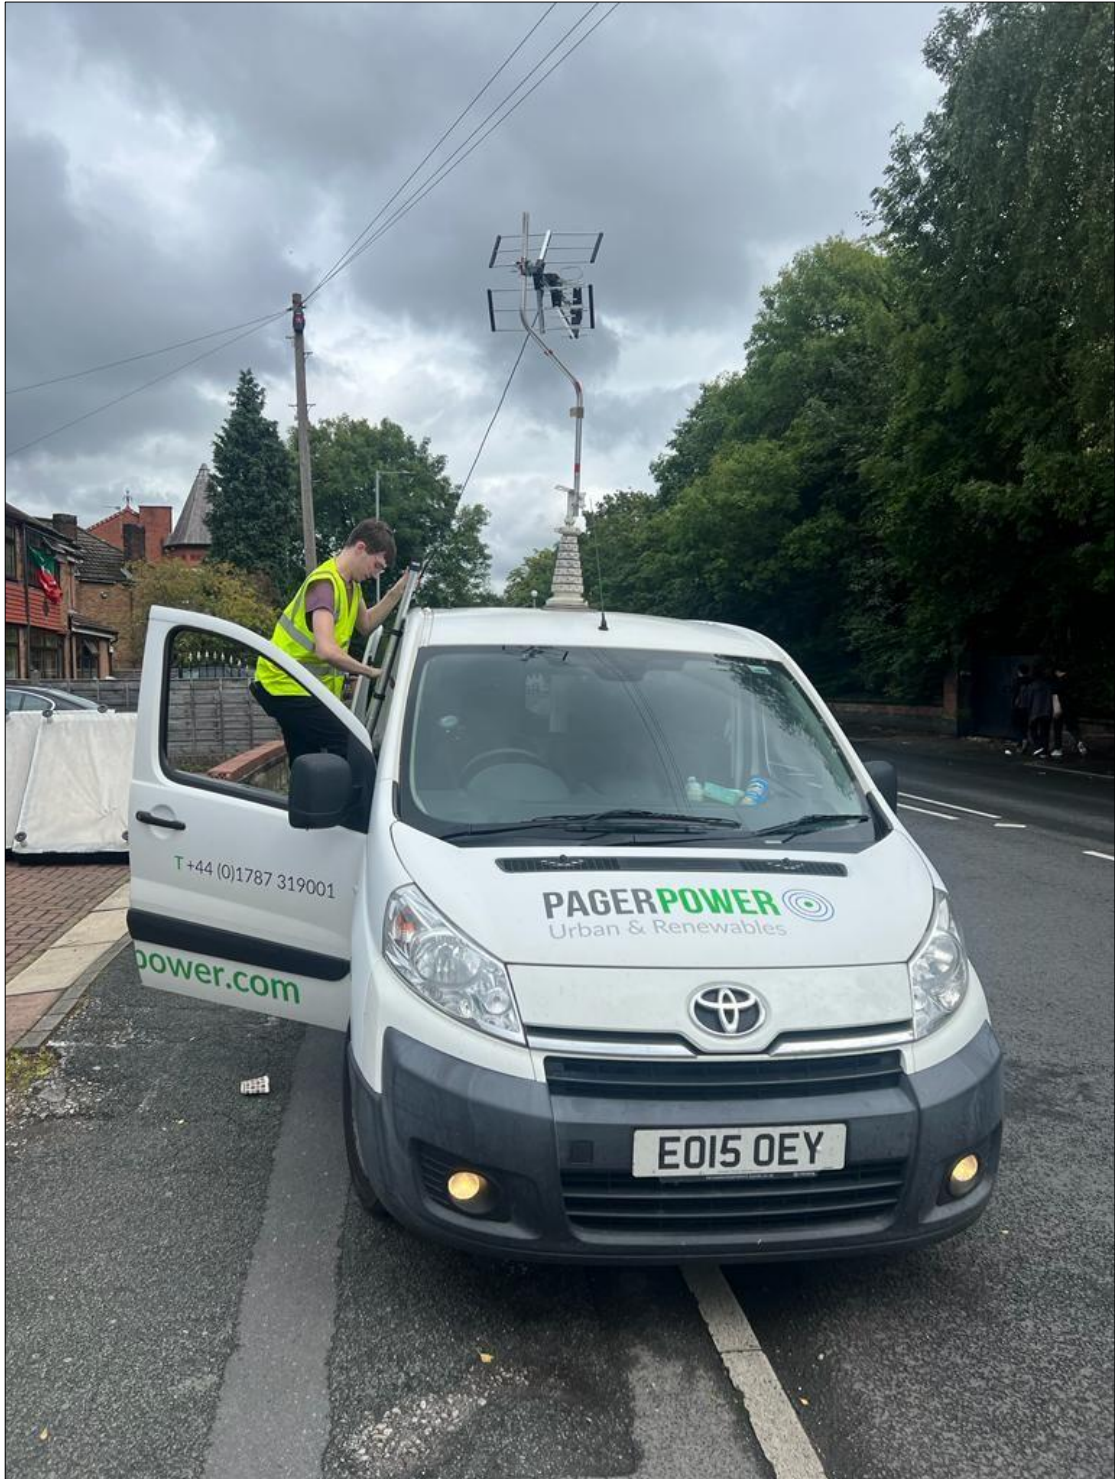
Location 6

| Location | Average Measured Signal Strength (dB) | Remarks | High-Level Conclusion |
|---|---|---|---|
| 6 | <p>Main TV MUX: 65.8 (Very Good)</p> <p>Local TV MUX: 46.8 (Good)</p> | <p>Multiple HP UHF aerials directed towards the Winter Hill transmitter were observed. No satellite dishes were observed.</p> <p>All six main multiplexes displayed fine picture and audio quality. Signal fluctuations of less than or equal to 0.5dB. The local multiplex displayed fine picture and audio. Signal fluctuations of less than or equal to 0.2dB.</p> | <p>This location is approximately 2.01km from the development.</p> <p>Two-storey properties are located near this location with aerials directed towards Winter Hill.</p> <p>A reduction in signal strength is unlikely based on the proximity to the development; therefore, effects are unlikely to be noticeable, also considering the high signal quality.</p> |

Notes: Multiple HP aerials orientated towards Winter Hill observed

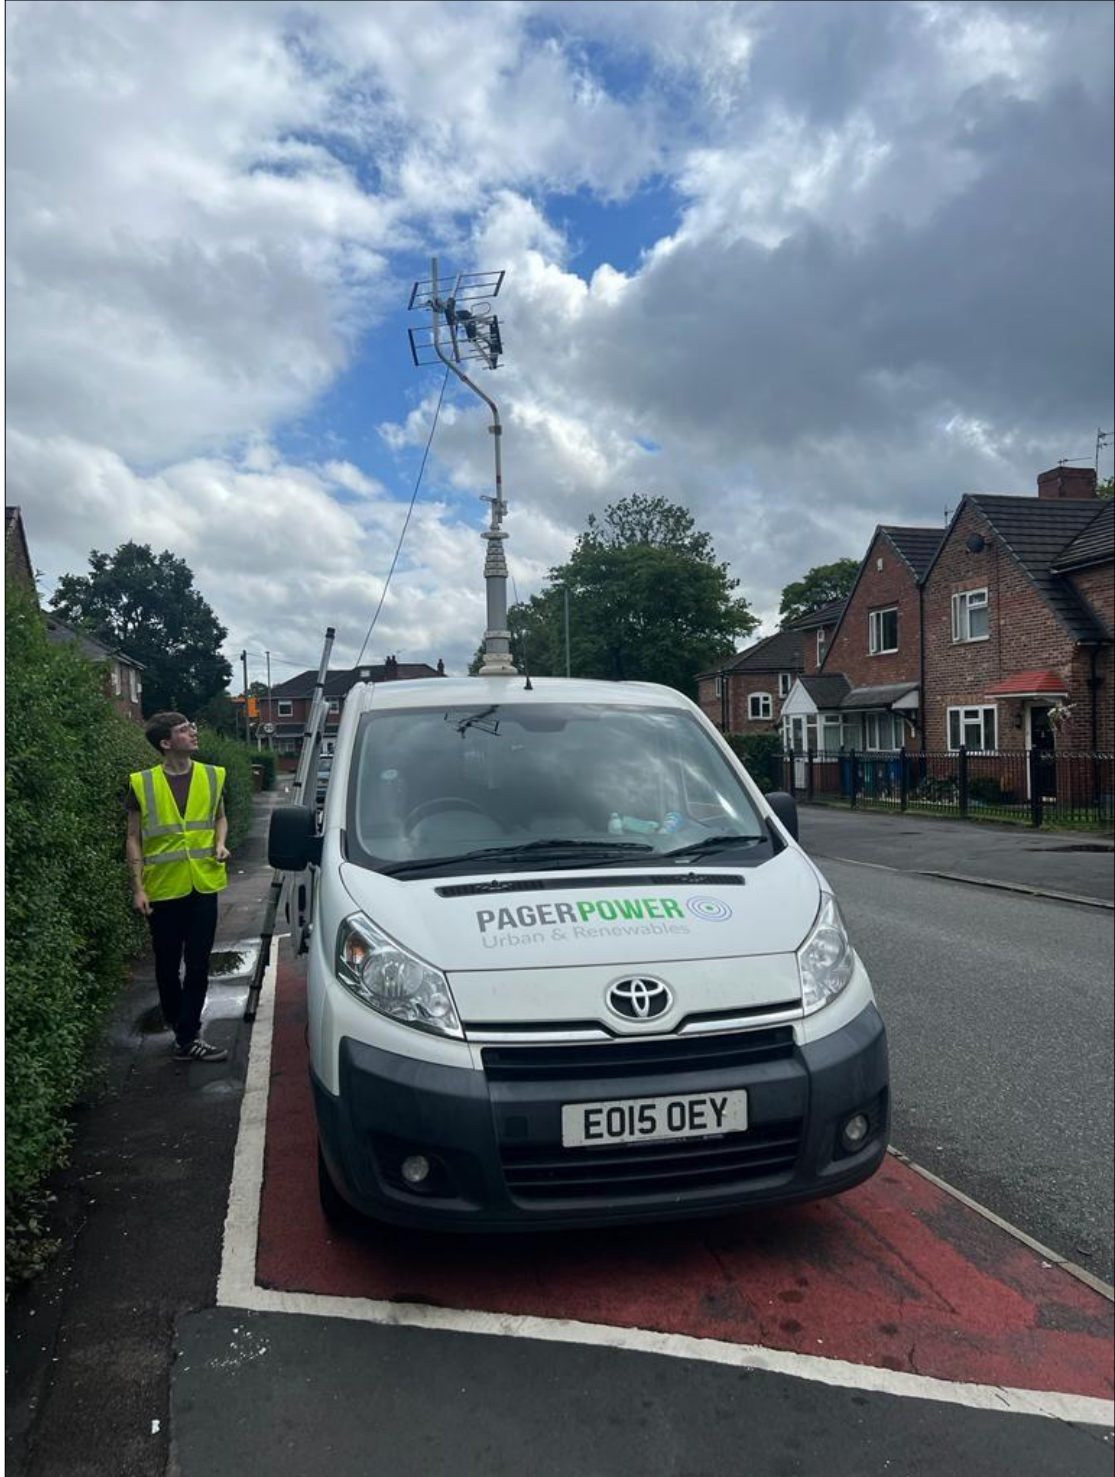
Location 7

| Location | Average Measured Signal Strength (dB) | Remarks | High-Level Conclusion |
|---|---|---|---|
| 7 | <p>Main TV MUX: 60.4 (Very Good)</p> <p>Local TV MUX: 46.7 (Good)</p> | <p>Multiple HP UHF aerials directed towards the Winter Hill transmitter were observed. No satellite dishes were observed.</p> <p>All six main multiplexes displayed fine picture and audio quality. Signal fluctuations of less than or equal to 0.4dB. The local multiplex displayed fine picture and audio. Signal fluctuations of less than or equal to 0.3dB.</p> | <p>This location is approximately 2.79km from the development.</p> <p>Two-stories properties are located near this location.</p> <p>A reduction in signal strength is unlikely based on the proximity to the development; therefore, effects are unlikely to be noticeable, also considering the high signal quality.</p> |

Notes: Multiple HP aerials orientated towards Winter Hill observed

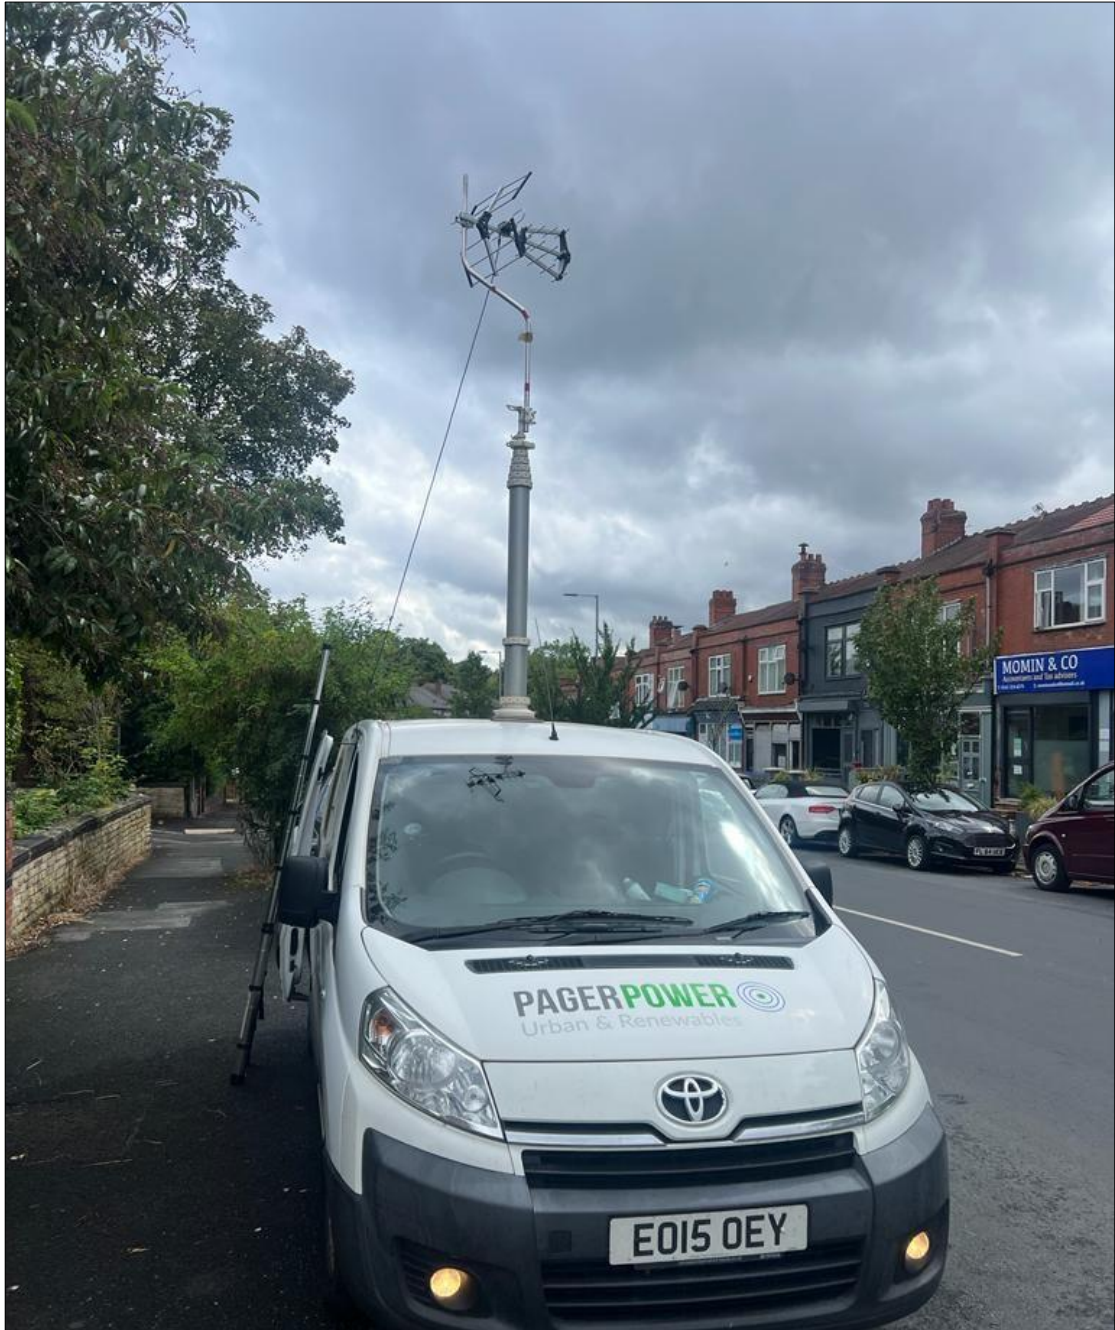
Location 8

| Location | Average Measured Signal Strength (dB) | Remarks | High-Level Conclusion |
|---|---|---|---|
| 8 | Main TV MUX: 69.7 (Very Good)<br>Local TV MUX: 53.1 (Good) | Multiple HP UHF aerials directed towards the Winter Hill transmitter were observed. No satellite dishes were observed.<br><br>All six main multiplexes displayed fine picture and audio quality. Signal fluctuations of less than or equal to 0.2dB. The local multiplex displayed fine picture and audio. Signal fluctuations of less than or equal to 0.2dB. | This location is approximately 3.60km from the development.<br><br>Two-stories properties are located near this location.<br><br>A reduction in signal strength is unlikely based on the proximity to the development; therefore, effects are unlikely to be noticeable, also considering the high signal quality. |

Notes: Multiple HP aerials orientated towards Winter Hill observed
