# Victoria North HIF Infrastructure Works

## Controlled Waters Detailed Quantitative Risk Assessment

Reference: VNIF-ARP-ZZ-YYY-RP-CG-1000

P01 | 21 August 2023

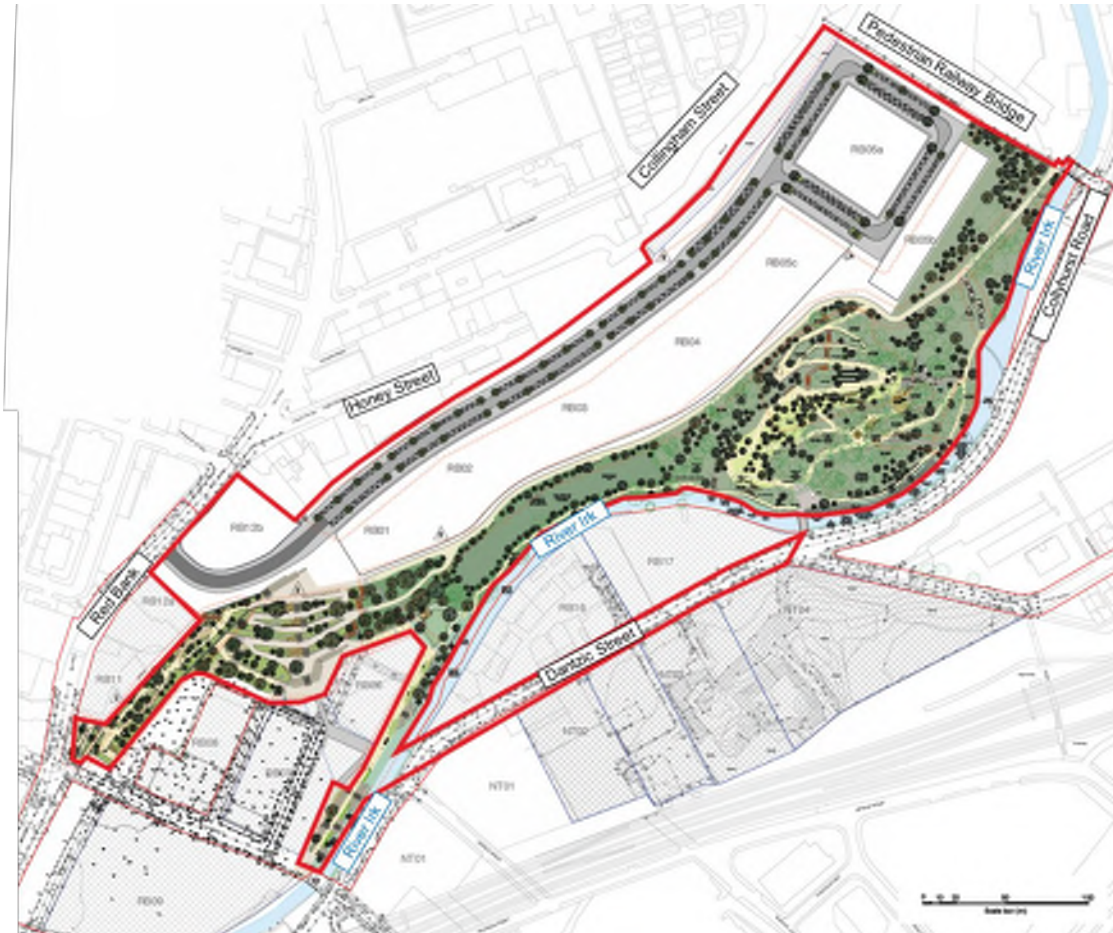
**Figure 1: Victoria North HIF Infrastructure site (red outline) and proposed development plots**

The Victoria North HIF Infrastructure site is located in the Red Bank area of Manchester, to the north of Manchester Victoria railway station. It is centred at approximate national grid reference SJ846996, see **Figure 1**.

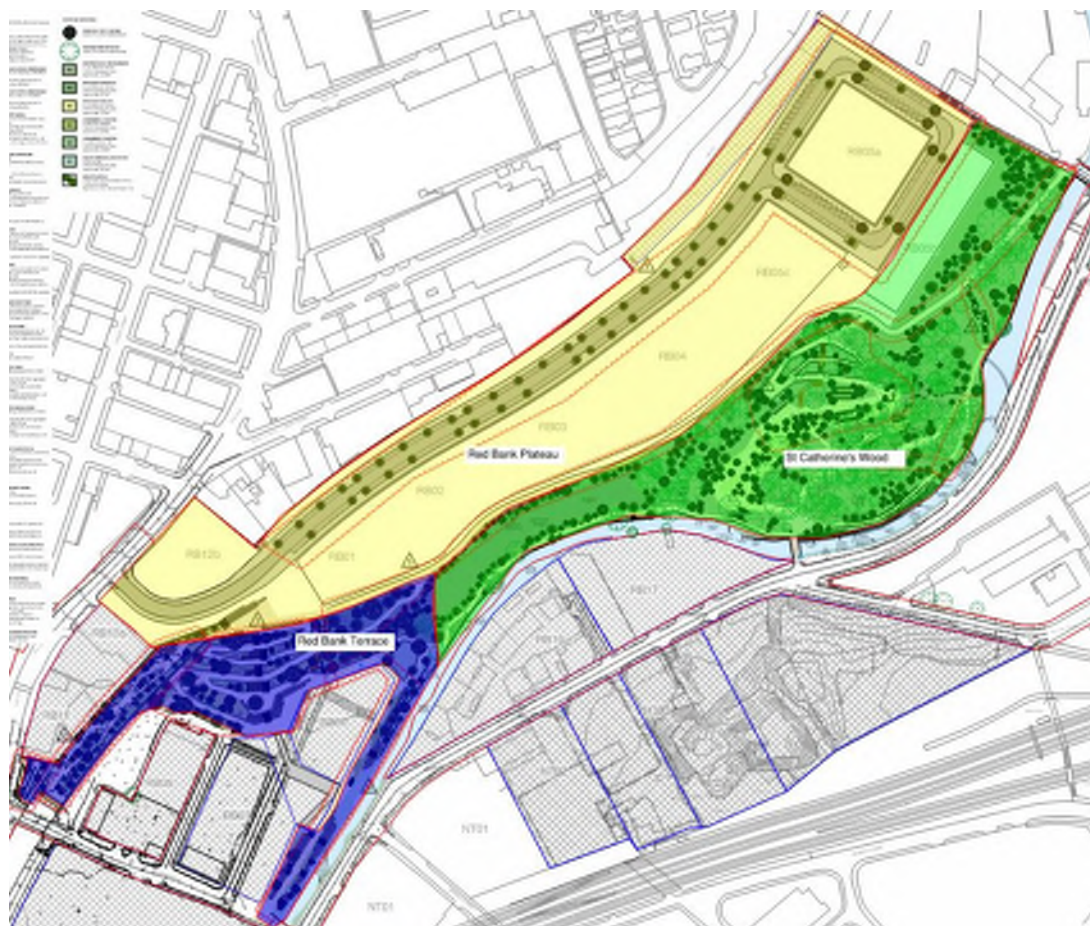
**Figure 2: Proposed development boundary and main site areas**

For the purposes of this report, the site area is taken to be the HIF Infrastructure Works planning boundary and this report refers only to the planning application site. The site boundary is outlined in red in **Figure 2** below.

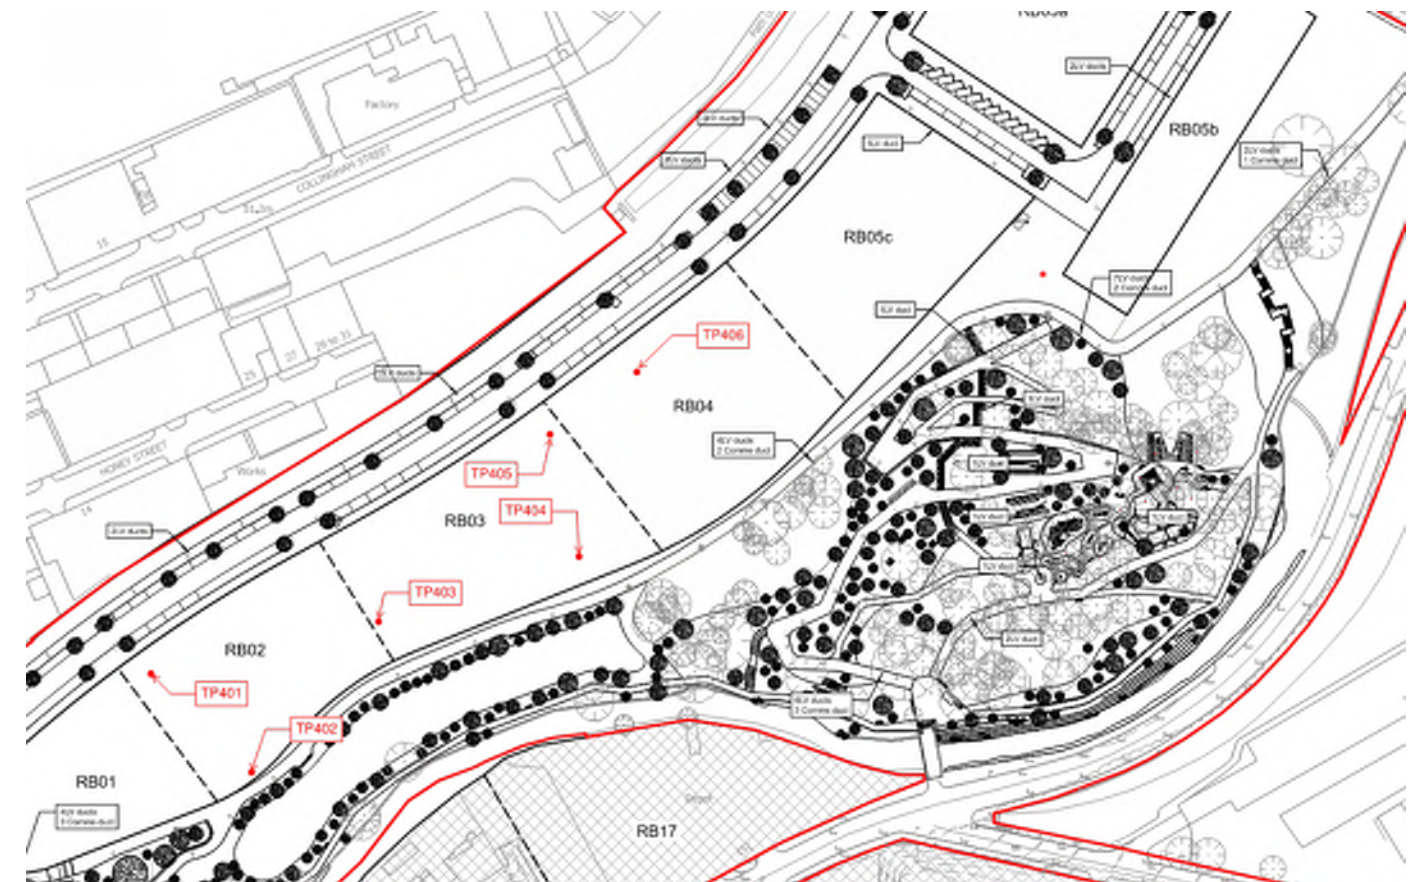
Figure 5: Initial PFAS ground investigation (January 2023) - trial pit locations

Despite careful measures being implemented to protect the integrity of the samples recovered during the January 2023 ground investigation (discussed in **Appendix B**), it was discovered during the interpretation of the data that

glass vessels had been used to transfer sub-samples from the main laboratory to the specialist laboratory for PFAS analysis. All containers used for PFAS analysis should have been plastic (HDPE). Given that the impact of this chain of custody issue could not be quantified, it was considered that the findings of PFAS analysis from the January 2023 investigation could not be relied upon without verification.

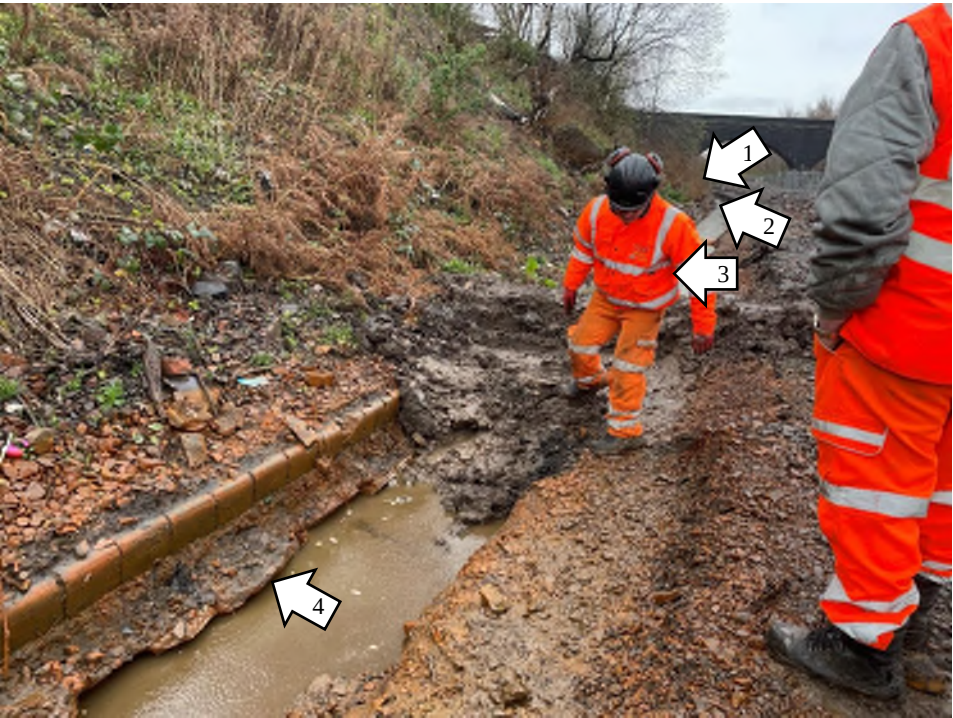
Photograph 1: Location of emerging water sampling points (March 2023 onwards - Table 7)

- Key:
1. Viaduct pipe (discharges from under the viaduct)
  2. SW08UP – upstream end of the standing water
  3. SW08DOWN – downstream end of the standing water (behind operative and clay stank)
  4. Showmen’s Guild pipe – under concrete kerb race.

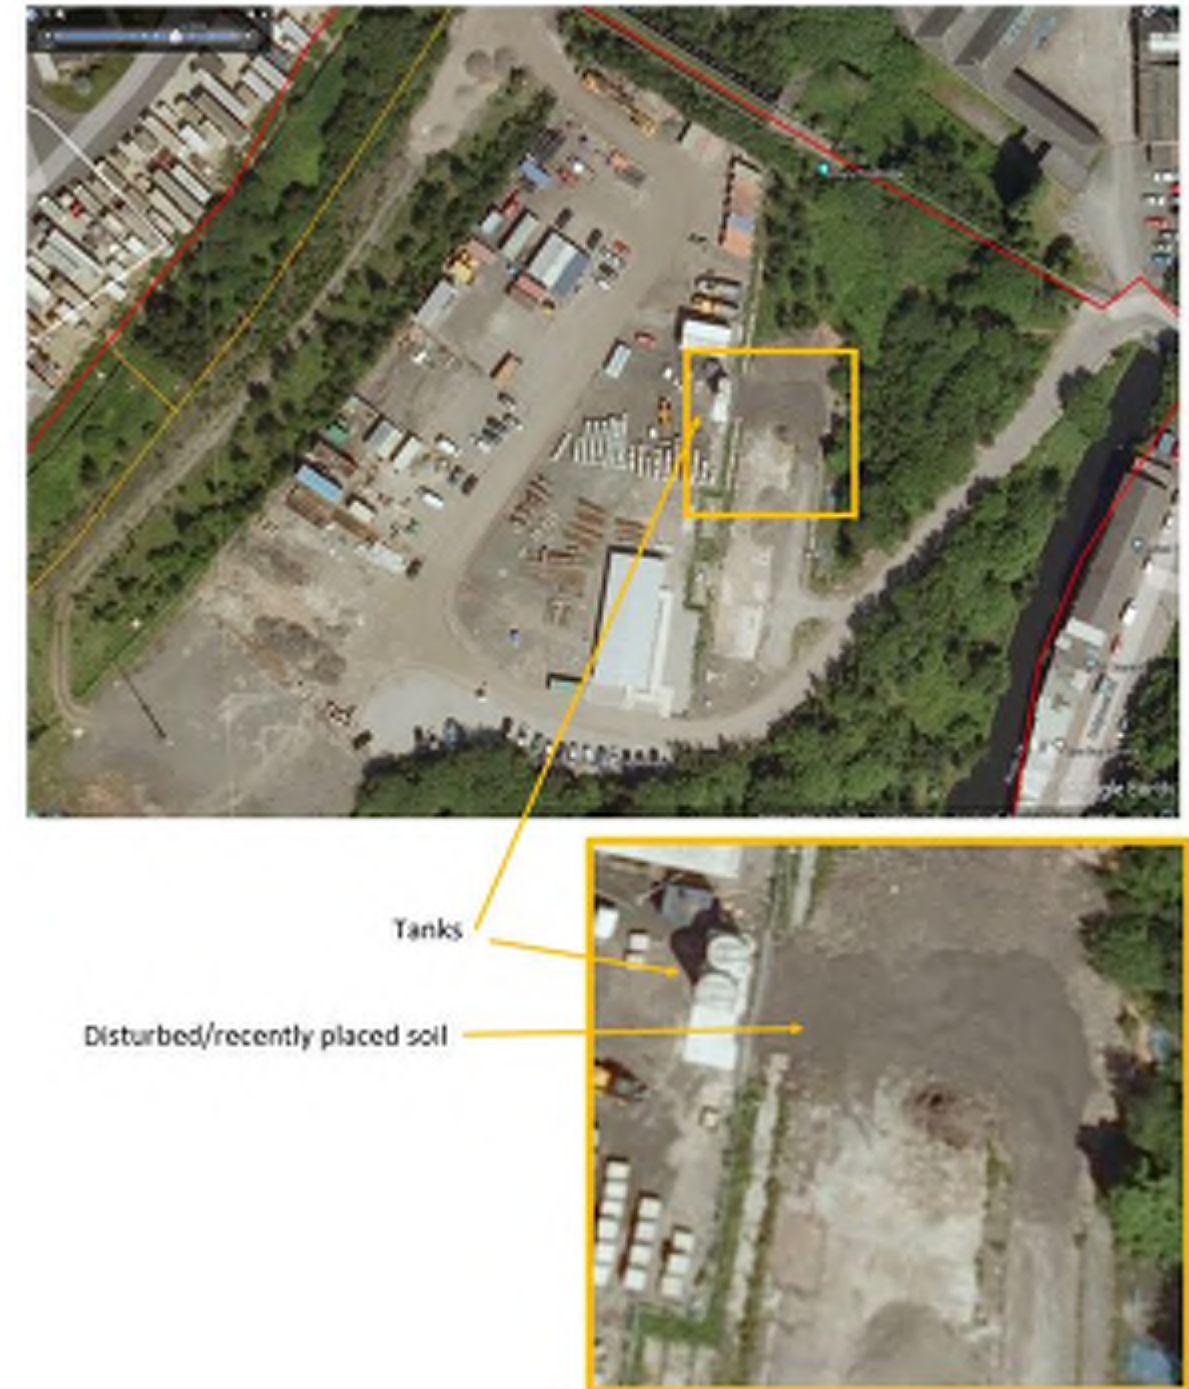
Figure 6: Google Earth image from June 2009, showing tanks in a temporary construction compound.

**Figure 6**). Adjacent to the tanks is an area of disturbed or recently placed soil. A number of products and cement additives which include PFAS are known to have been used in the construction industry [21] and it is considered that the elevated PFAS identified in TP422 and TP423 may be the result of a spillage from these tanks. On this basis, the PFAS identified in the TP422/TP423 area will be treated as a separate source.

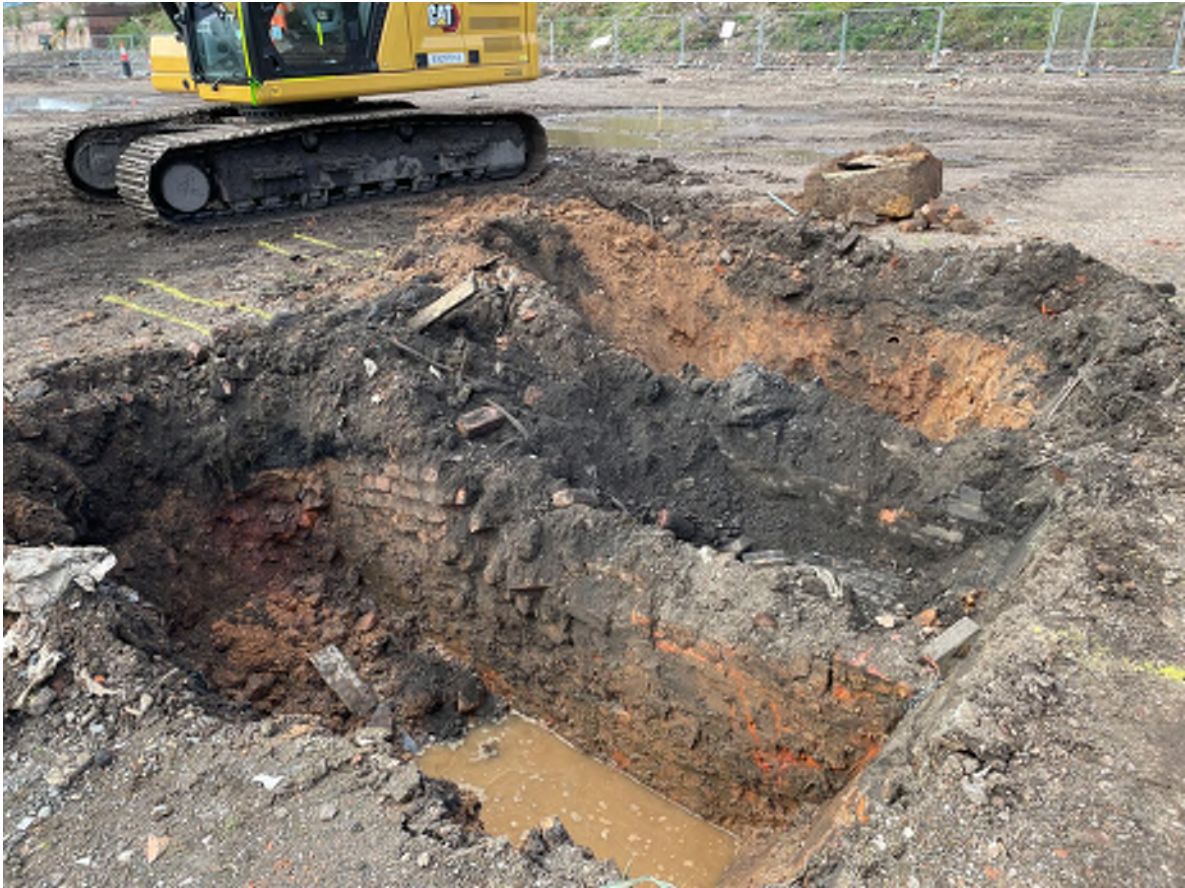
Photograph 2: – CS3 exposing carriage shed foundations with perched water inside the structure

A significant proportion of the carriage shed footprint was found to be generally dry with only limited perched water encountered (**Photograph 2**).

The sub-structure of the carriage shed was found to consist of a perimeter of brick-masonry footings. Within the sub-structure, additional localised sections of masonry were encountered, with areas of brick paving (**Photograph 3**). These are thought to have been areas used for the servicing and maintenance of rail rolling stock. The brick paved areas were found to have associated areas of visual and olfactory hydrocarbon contamination. In addition to sampling for PFAS therefore, selected samples underwent testing for phenols, hydrocarbons and VOC/SVOC, together with asbestos and metals. The results of this analysis are presented in **Appendix C** and in **Appendix C5**, have been screened against the relevant generic assessment criteria for domestic development without plant uptake (6% SOM).
