**An Assessment of an  
Archaeological Excavation at**

**First Street, Medlock Street, Plot 9  
(8), Manchester, M15 4FN**

**PCA REPORT NO: 15344**

**SITE CODE: FMS20**

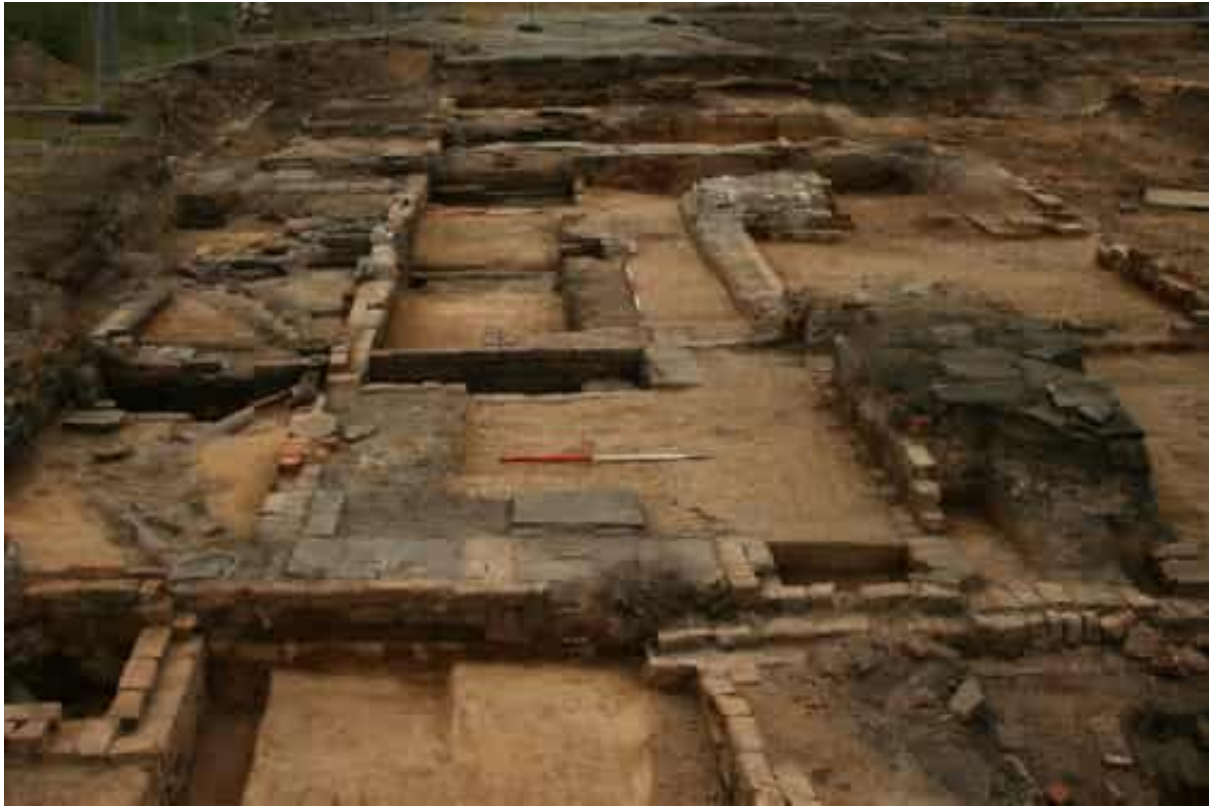
Plate 1: Easton Street terrace (H1-5), looking northwest

- 7.3.7 The earliest structural remains on the site were the terraced row of five houses (Houses 1 – 5) fronting Easton Street with yards to the west, as depicted on Bancks and Co's map of 1831 (Figure 16). It is likely this structure was retained during later development of the area, after its foundation from the early phase of residential development but it was not possible to identify this clearly from the limited excavation of the archaeological remains. The main terrace was roughly 8.3m wide (northeast-southwest) from the rear wall of the backyard to the wall fronting Easton Street, and survived to 21.50m (northwest-southeast) along the latter, extending beneath the south limit of excavation.

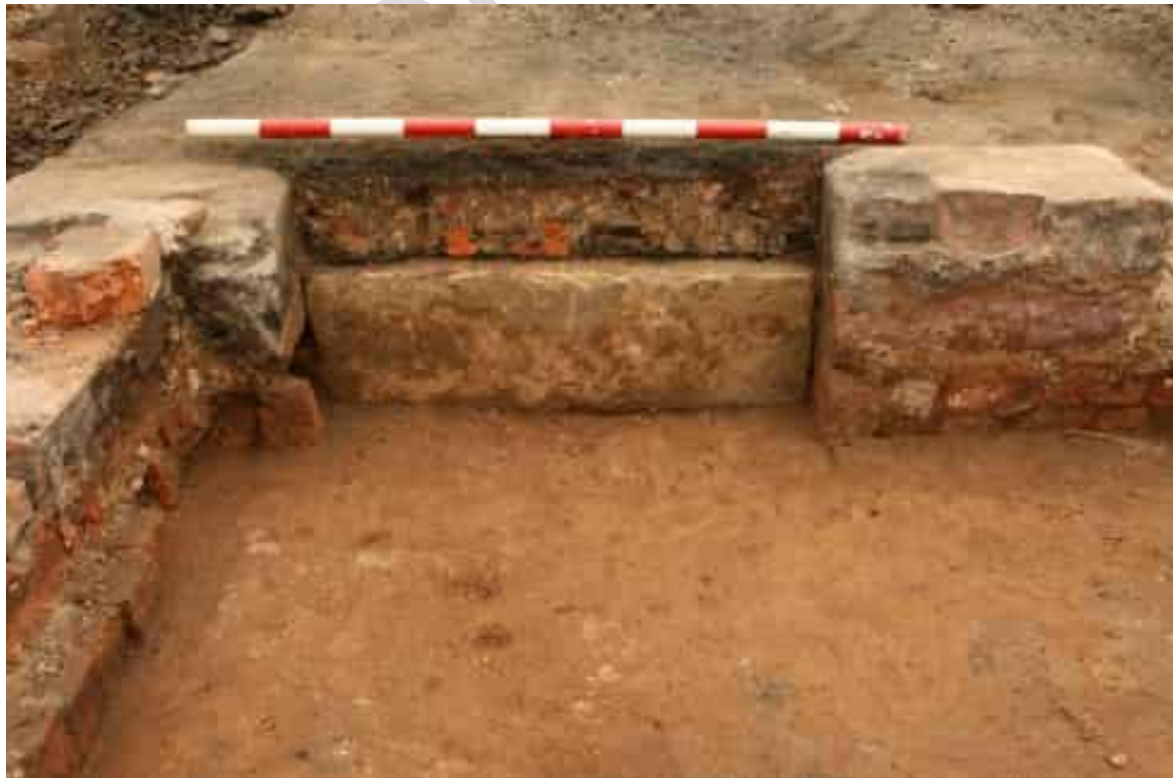
Plate 2: H1 front door threshold [573], looking northeast

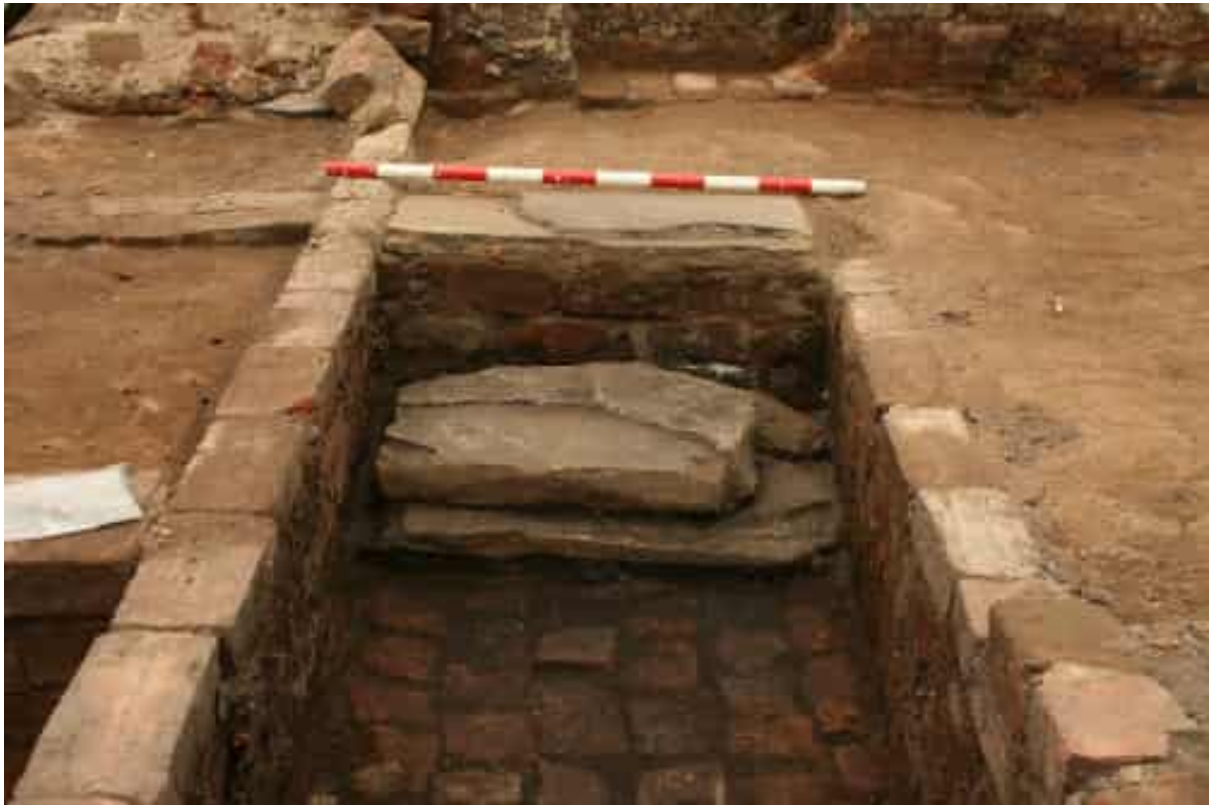
Plate 3: Detail of flags in coalstore [588] H1, looking northeast

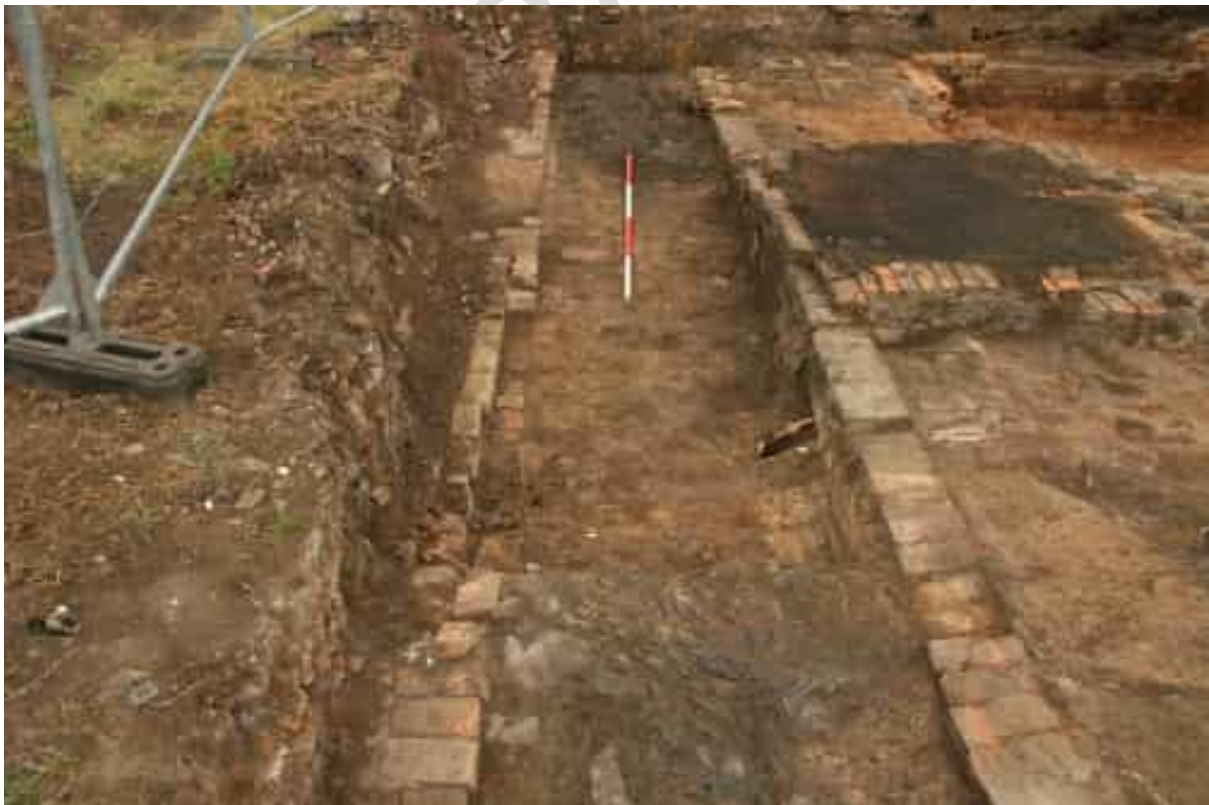
Plate 4: Cave Court [667] [729] with demolition in foreground [703] [544]

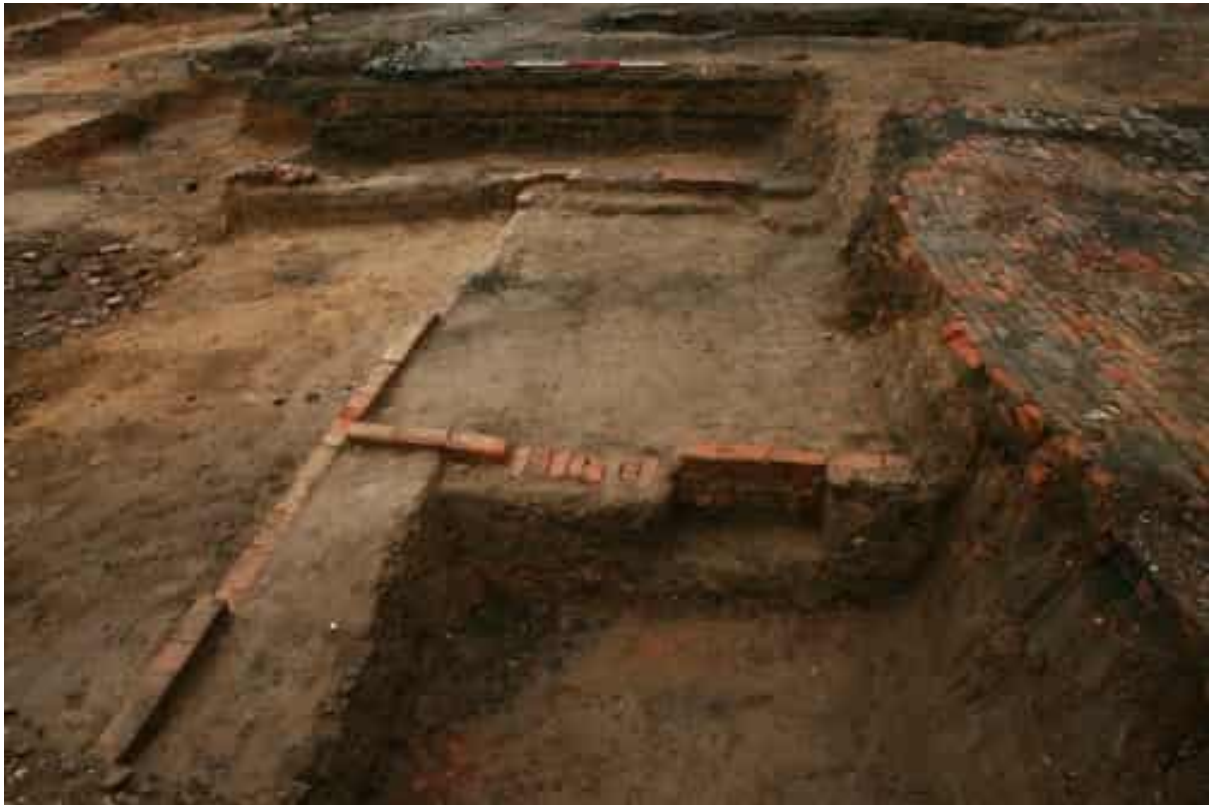
Plate 5: H6 partition walls [633] [635] and Phase 5 industrial brick surface [639], looking northwest

- 7.3.20 The partially exposed layout of H6 (G21) was represented by the construction of integral frontage (and southeast party wall) [633] and internal partition wall [635] (Plate 5). Wall [637], (presumably, the rear wall of the property, was observed just within the limit of excavation. H6 was 6.20m long and would have exceeded 2.50m in width. The partition divided the house into two rooms, the northeast/southwest interior length of the front and rear 3.66m and 2.35m respectively. The absence of any evidence for any internal features left an internal area of 10m<sup>2</sup> in the former and 7m<sup>2</sup> in the latter.

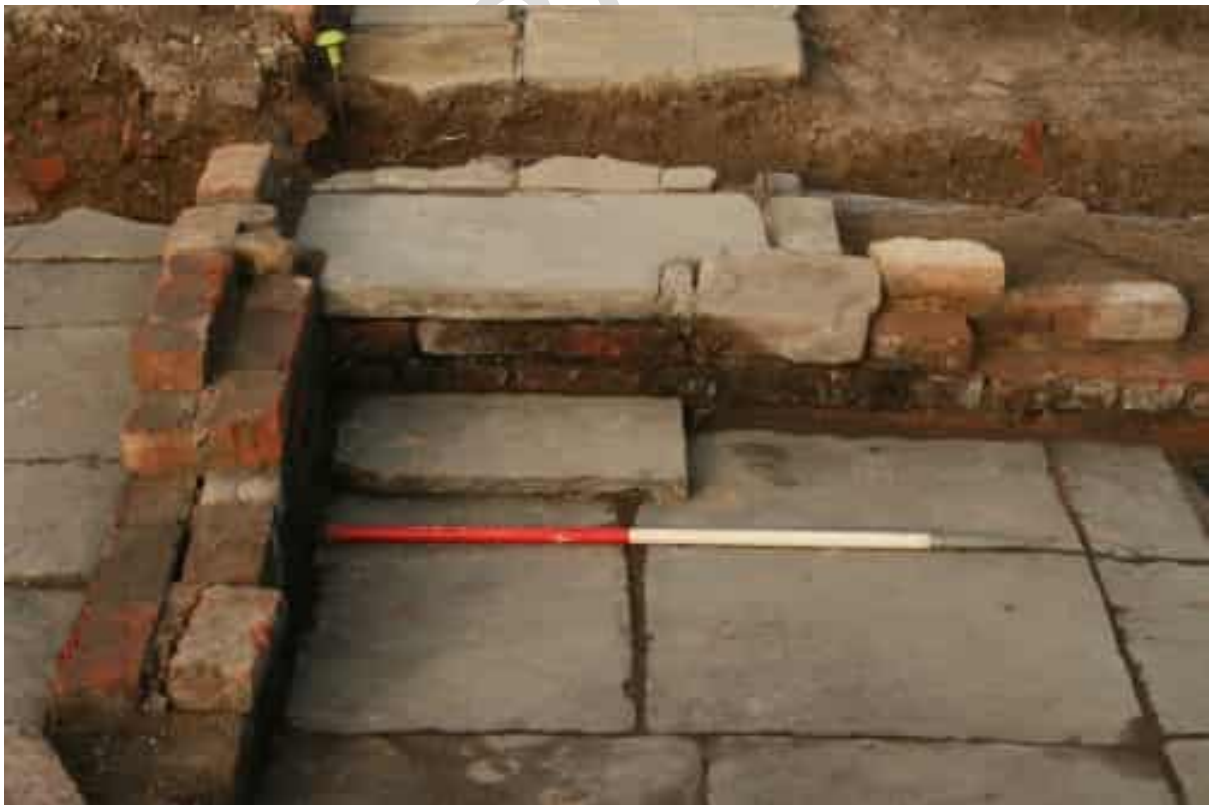
Plate 6: Rear threshold [801] H8, looking southwest

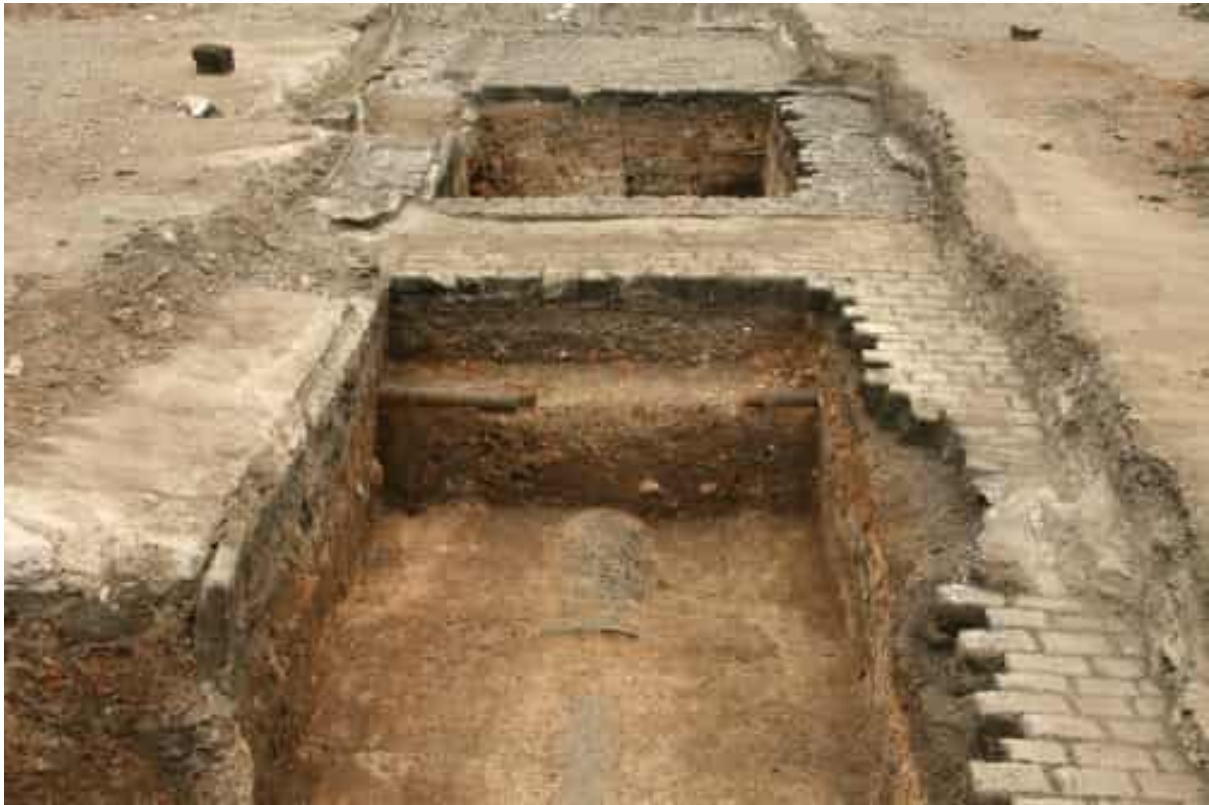
Plate 7: Newcastle Street services [539], [536] and [535], looking northwest

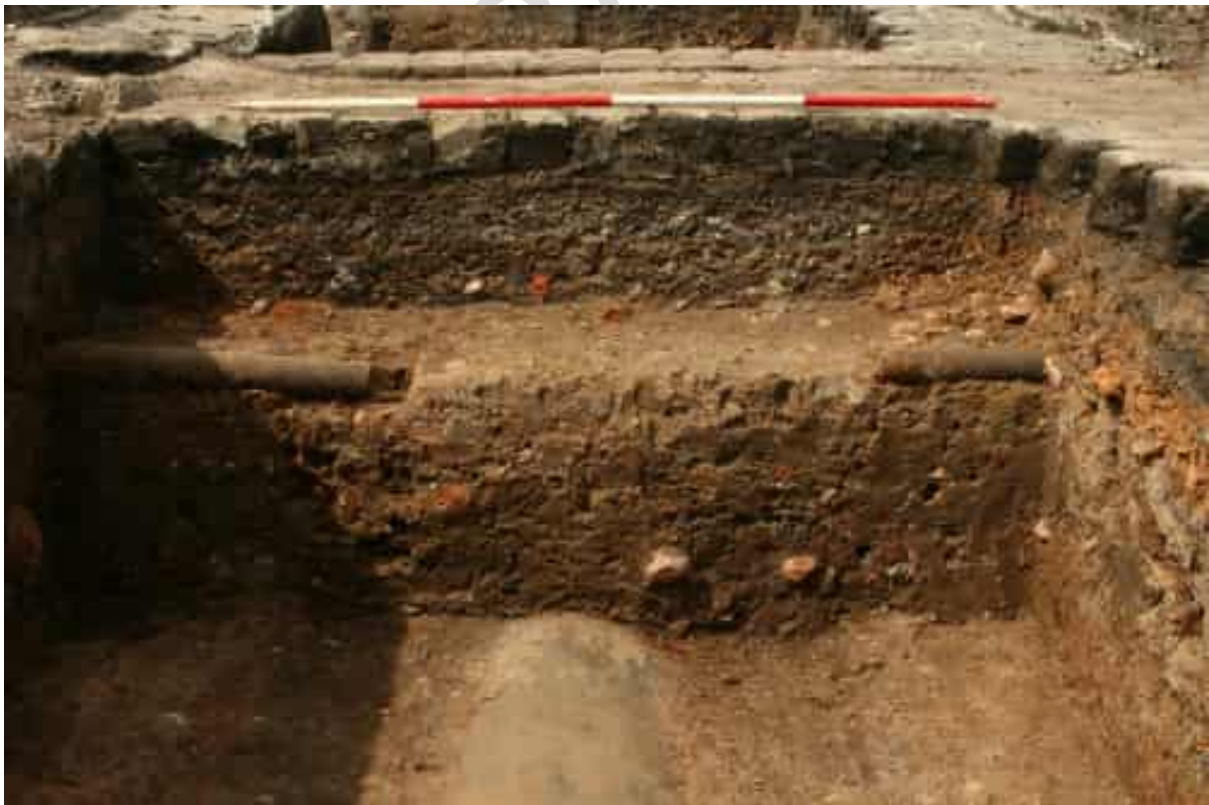
Plate 8: Newcastle Street services sequence [539], [536] and [535] detail, looking northwest

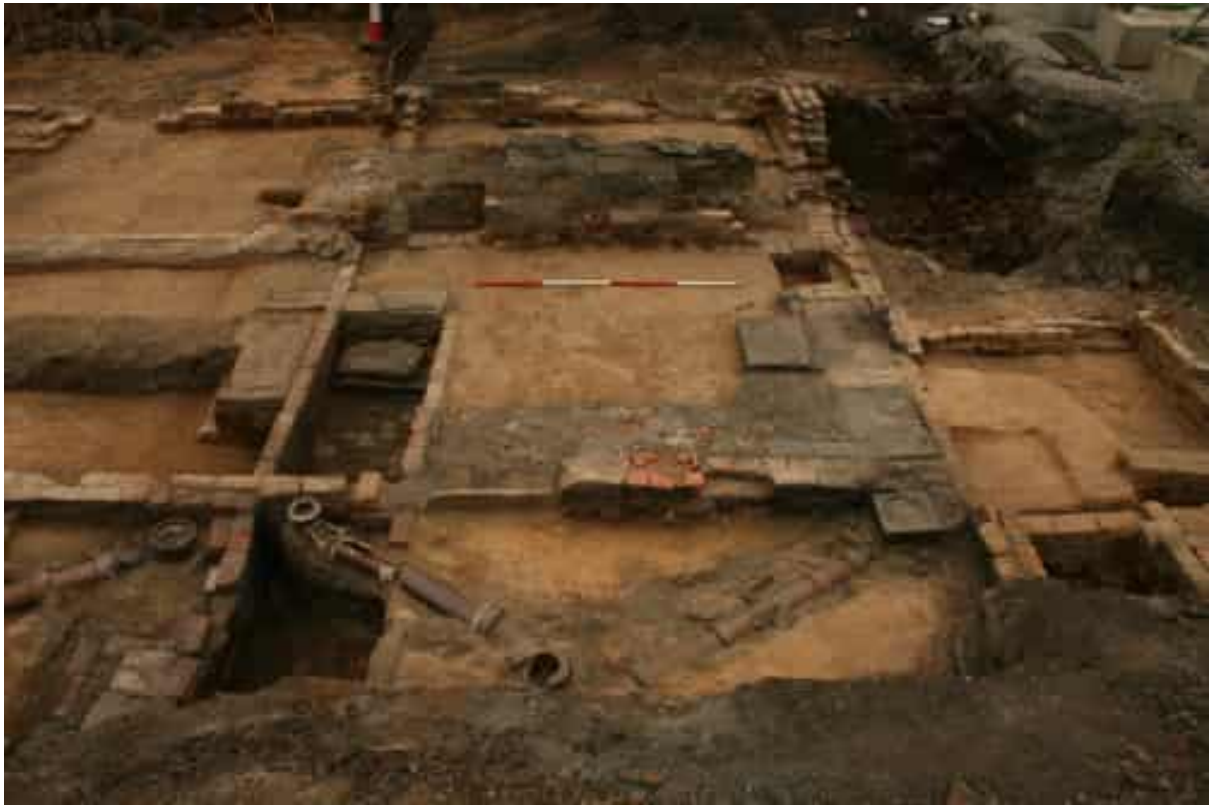
Plate 9: H1 rear yard with side room [721] and stairway/coal store [588], looking northeast

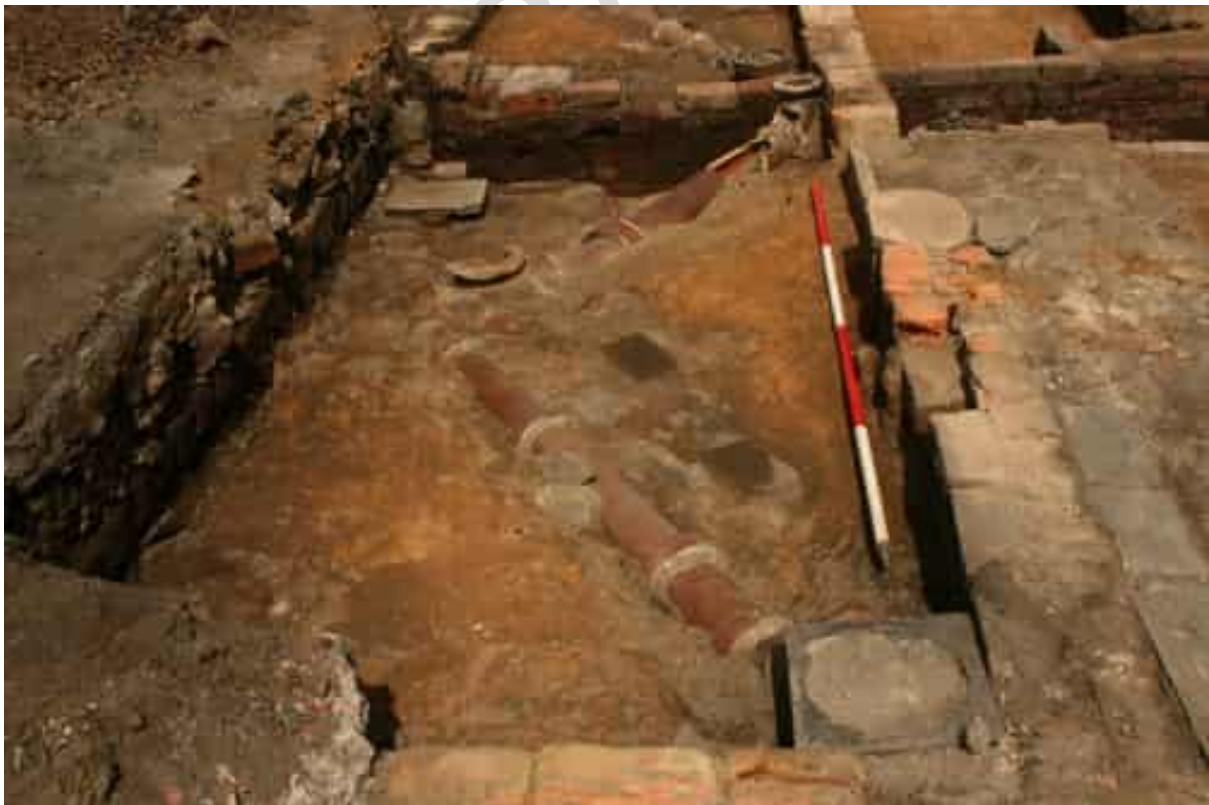
Plate 10: H1 rear yard and threshold [586] with drainage [596], looking northwest

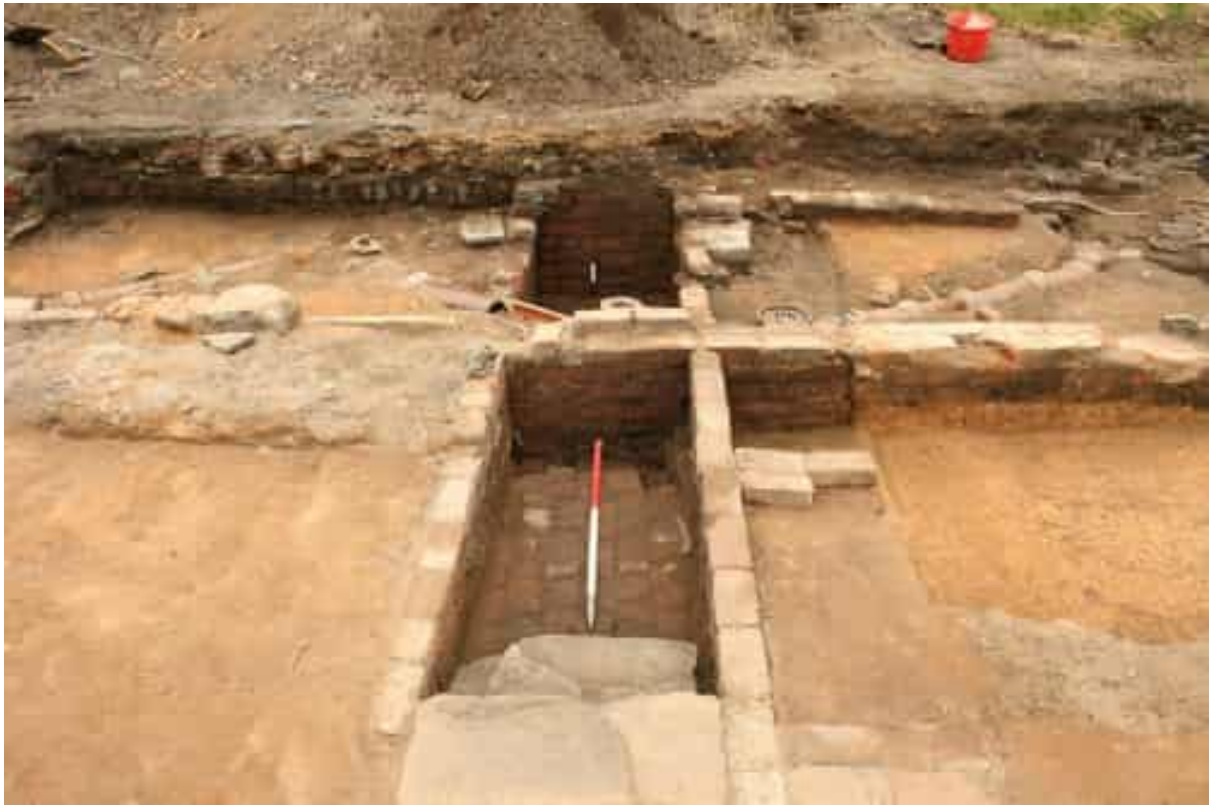
Plate 11: Staircase [588] and rear door threshold [586] and privy [592] H1, looking southwest

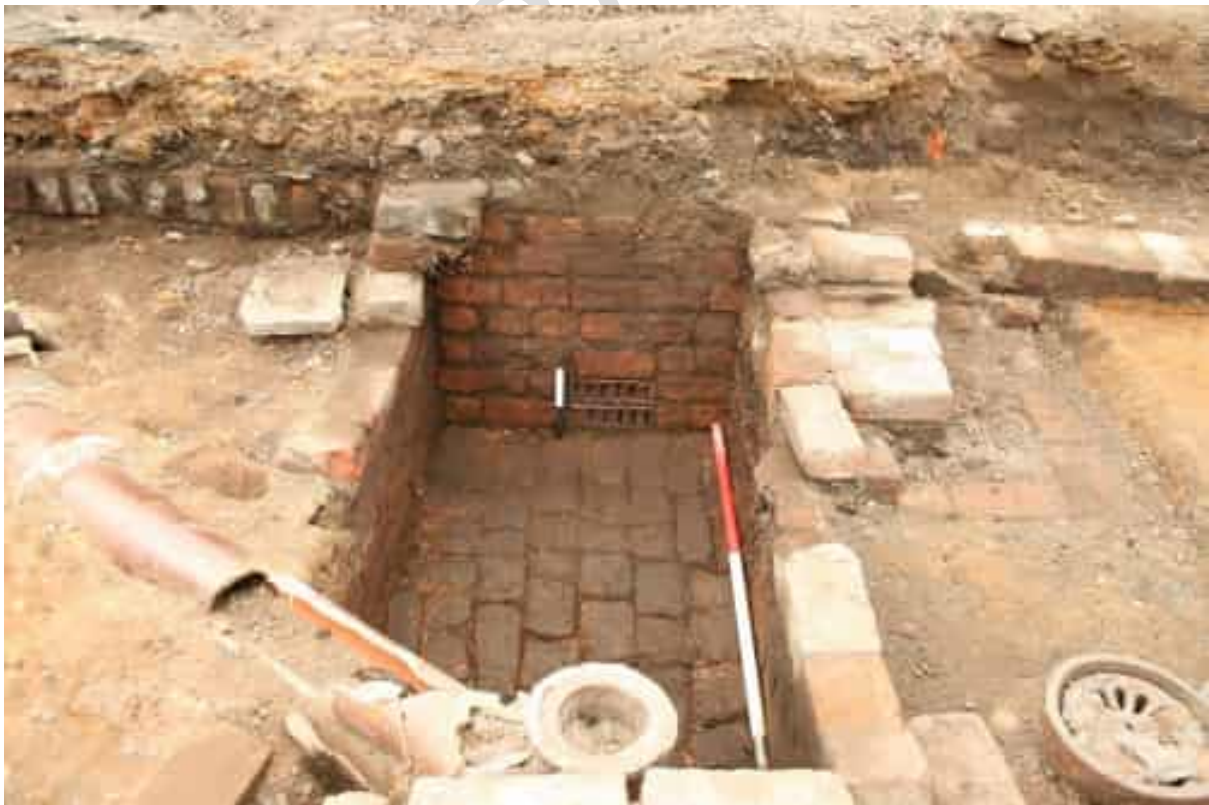
Plate 12: Early dry privy [592] H1, looking southwest

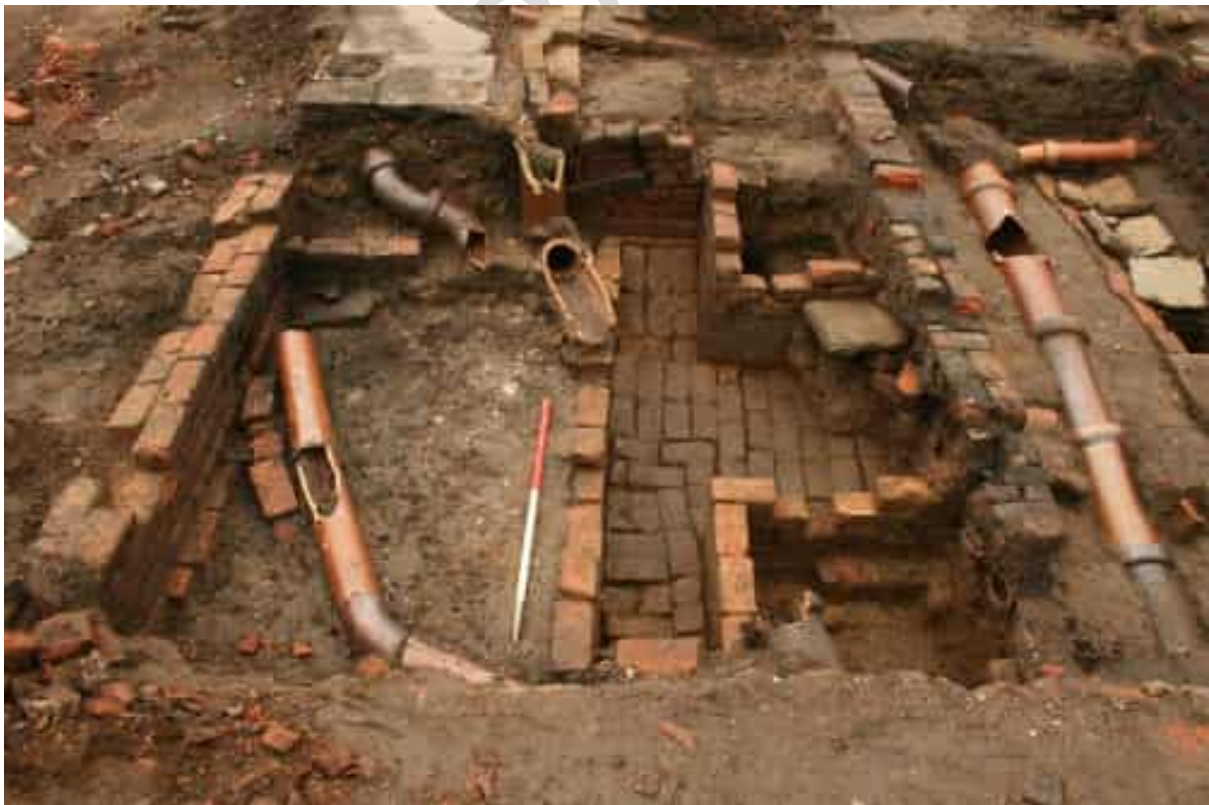
Plate 14: Remodelling of H9 yard showing later drainage [835] and earlier coal store and chute [829]

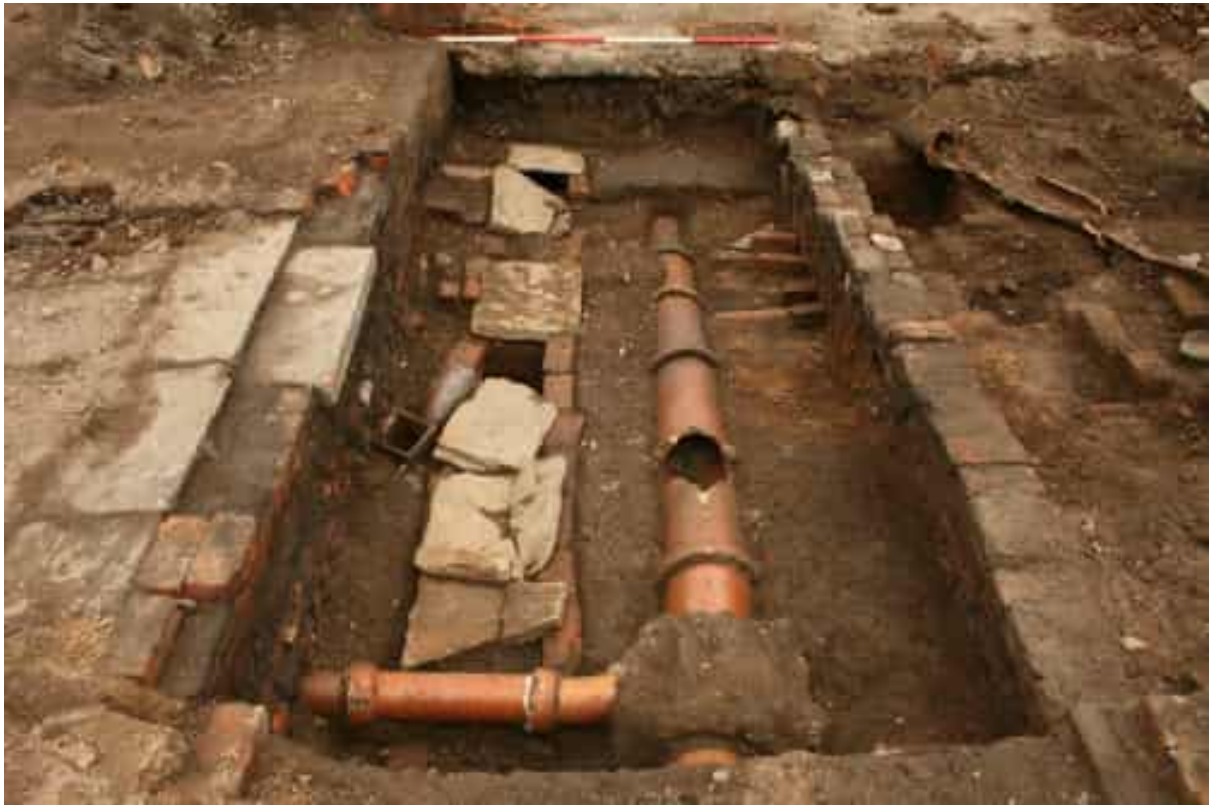
Plate 15: Sequence of earlier [791] and ceramic [811] services beneath Poland Place

- 7.3.39 The earliest services (G30) in this phase were drainage run [791] (Plate 15) along Poland Place and contemporary drains [815] and [813] (Figure 15, Section 17). They likely date from the foundation of the properties either side. Drains [815] and [813] were both linear in plan, laid roughly east-west, and served facilities in the yard of H9 [829], extending up to c.0.75m from it. They were both c.0.30m wide. They were constructed from a composite of brickwork laid end to end upon stone slabs, passing through a narrower metal grate integral to wall [817]. Ceramic pipe [815] was 0.11m in diameter and may have been an initial improvement made to aid the transfer of liquid in the existing brick-built channel. They almost certainly originally fed main northwest/southeast drainage [791]. With a 'U-shaped' channel, c.0.30m wide, drain [791] was composed from a mortar bonded structure with brick sides and base (31.63m aOD), capped with slightly disturbed sand and York Stone flags laid horizontally across at a height of 31.96m aOD. Its declivity was toward the northeast to a height of 31.15m aOD at the north extent. It was recorded to a length of over 8m, either side of modern truncation. It was truncated to the north by the cut for Air Raid Shelter (East). Four ceramic pipes [897] (Figure 15, Section 17 & 18) also formed part of this earlier drainage system on both sides of Poland place and were recorded in section just south of the raft for the modern factory [760] and beneath wall [793] and [817] (Plate 23). They were replaced by drains [811] with construction backfill [900] (Figure 15, Section 18) (Plate 15), their disuse evidenced by the mixed backfills [856] [857] accumulated in them.

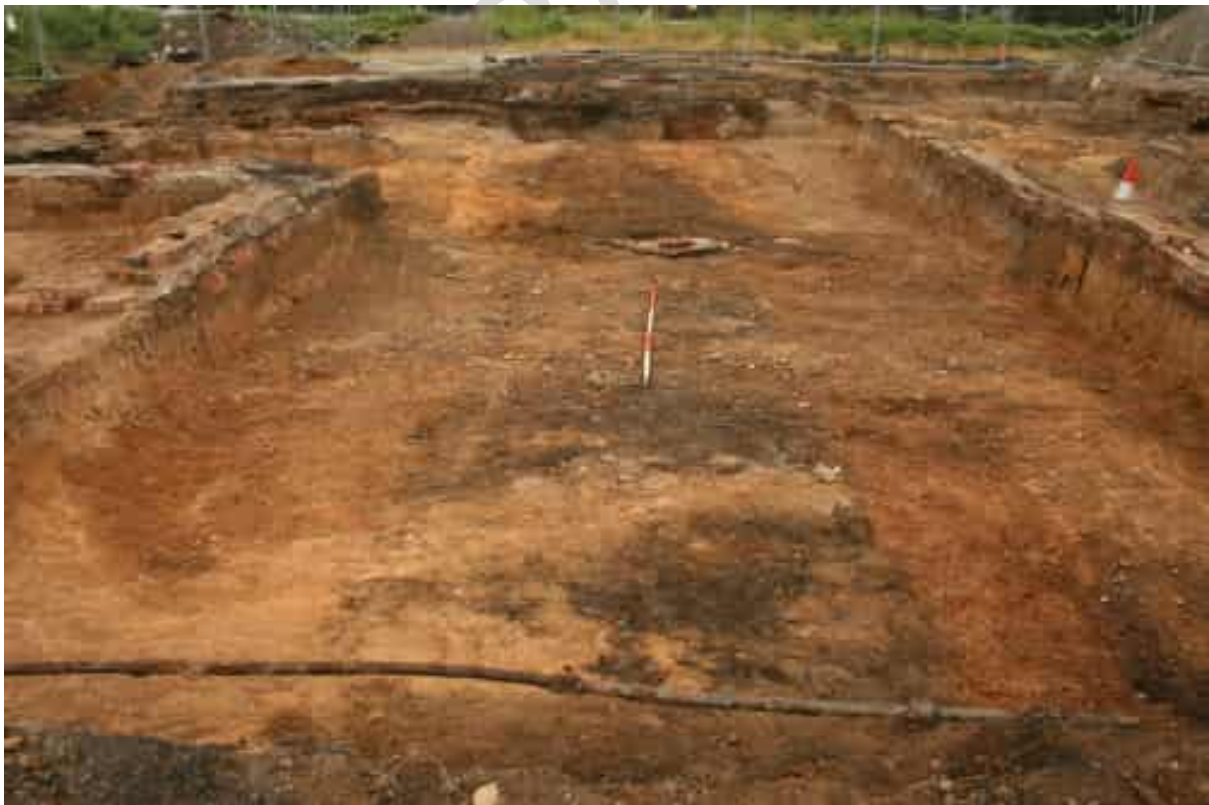
Plate 16: Easton Street unexcavated drainage [570], looking northwest

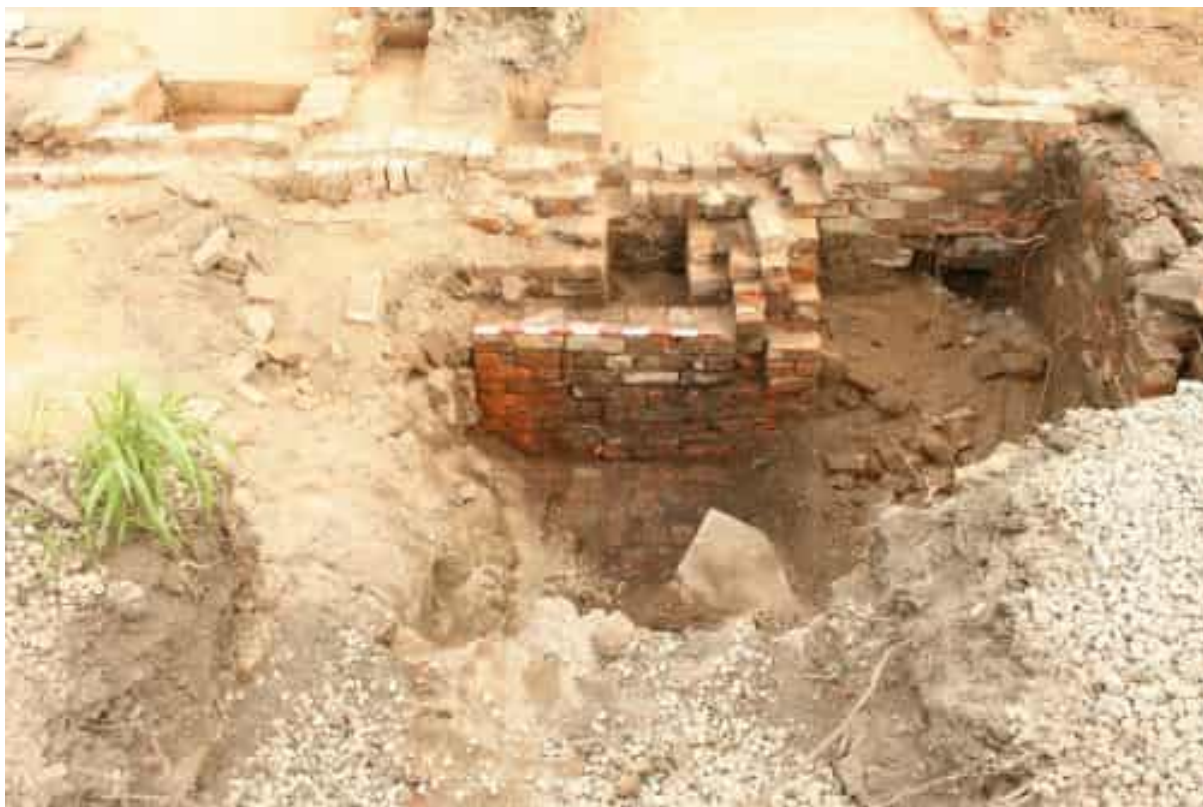
Plate 17: Cellar A fireplace [548], looking northwest

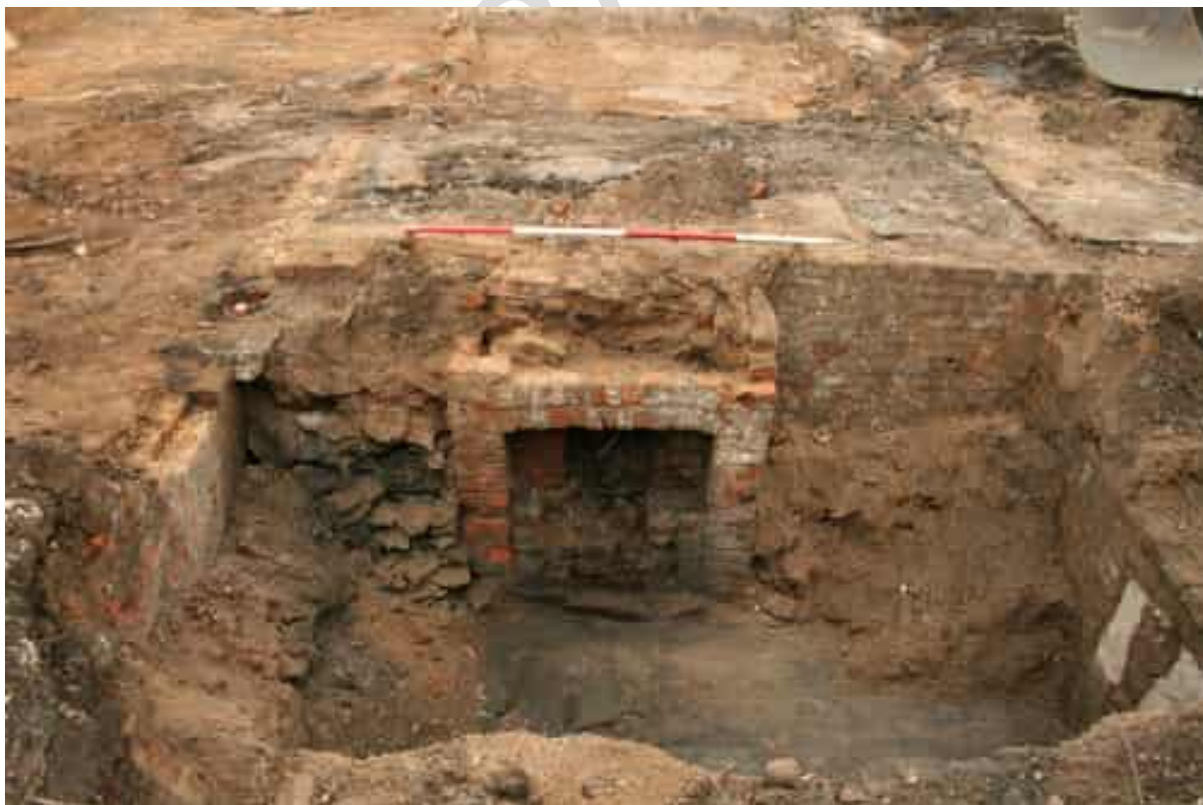
Plate 18: Cellar B fireplace [555], looking northwest

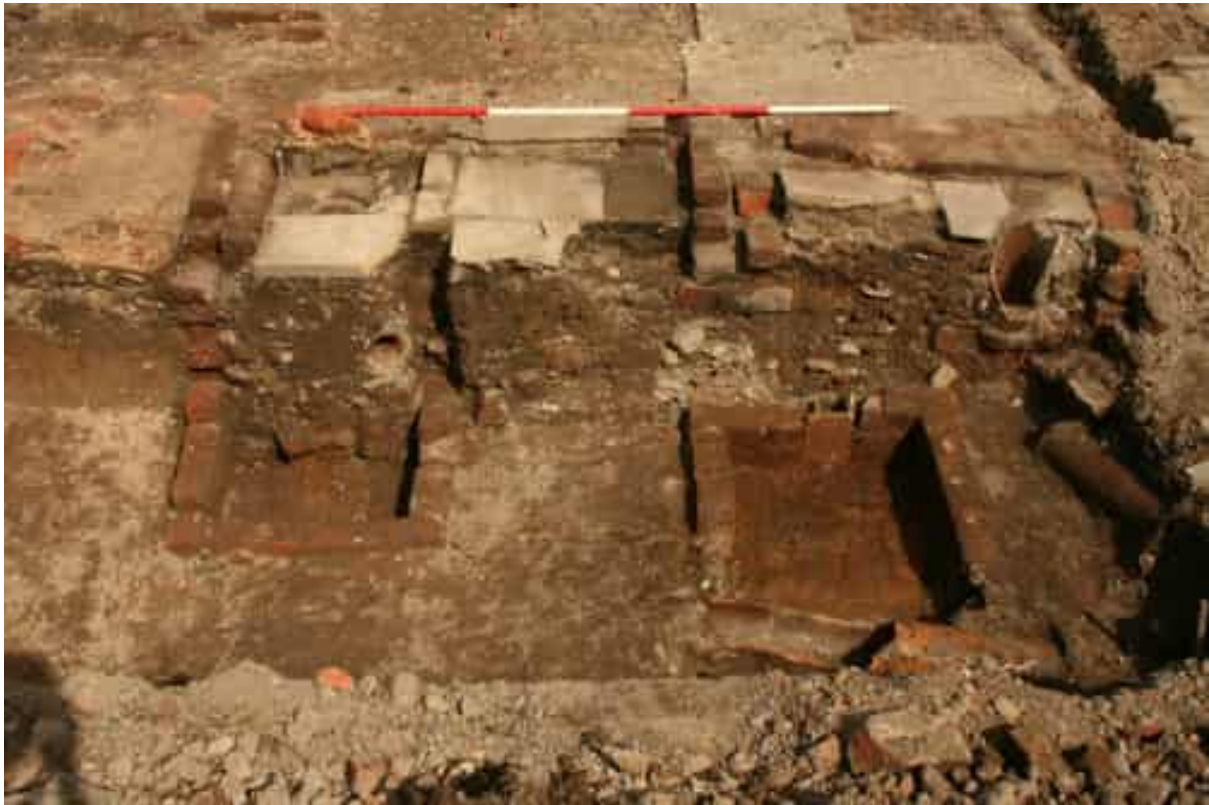
Plate 19: Early privies [779] [786] and later toilet [784], looking northwest

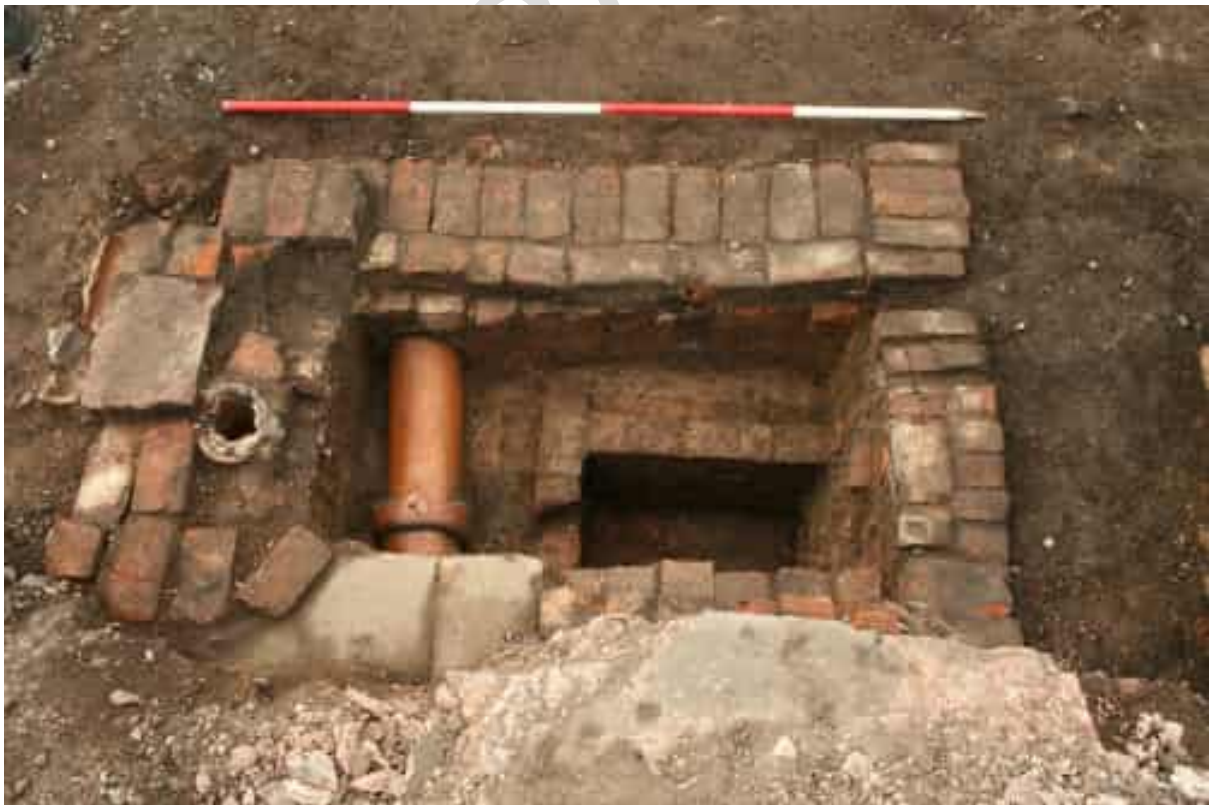
Plate 20: H12 early privy [689] and later toilet [685] structure, looking southeast

- 7.3.28 Structures in the yard of H14 (G18) were interpreted as the construction of a toilet system. They were represented by the remains of walls [687], floors [689] (Plate 20) and associated drainage [685] (Figure 8). The stoneware pipes [685] were comparable to those described in the backyards of properties along Easton Street, laid in brick and stone constructed foundations of similar standardised materials. Wall [687], survived to three courses and was laid in a header and stretcher foundation; this was probably the same construction event as surface [689], recorded at a height of 32.32m aOD, represented the earlier privy floor. Together the remains are indicative of alterations in the provision of sanitary services associated to the building. Central to the ginnel behind H14, roughly c.3.0m southwest of the yard, a lead and stoneware pipe set in a red brick structure (G17) [692], c.0.45 x 0.45m, was recorded at surface level (Figure 8) It was likely the remains of a water tap as indicated on the 1888 (published 1891) Town plan of Manchester.

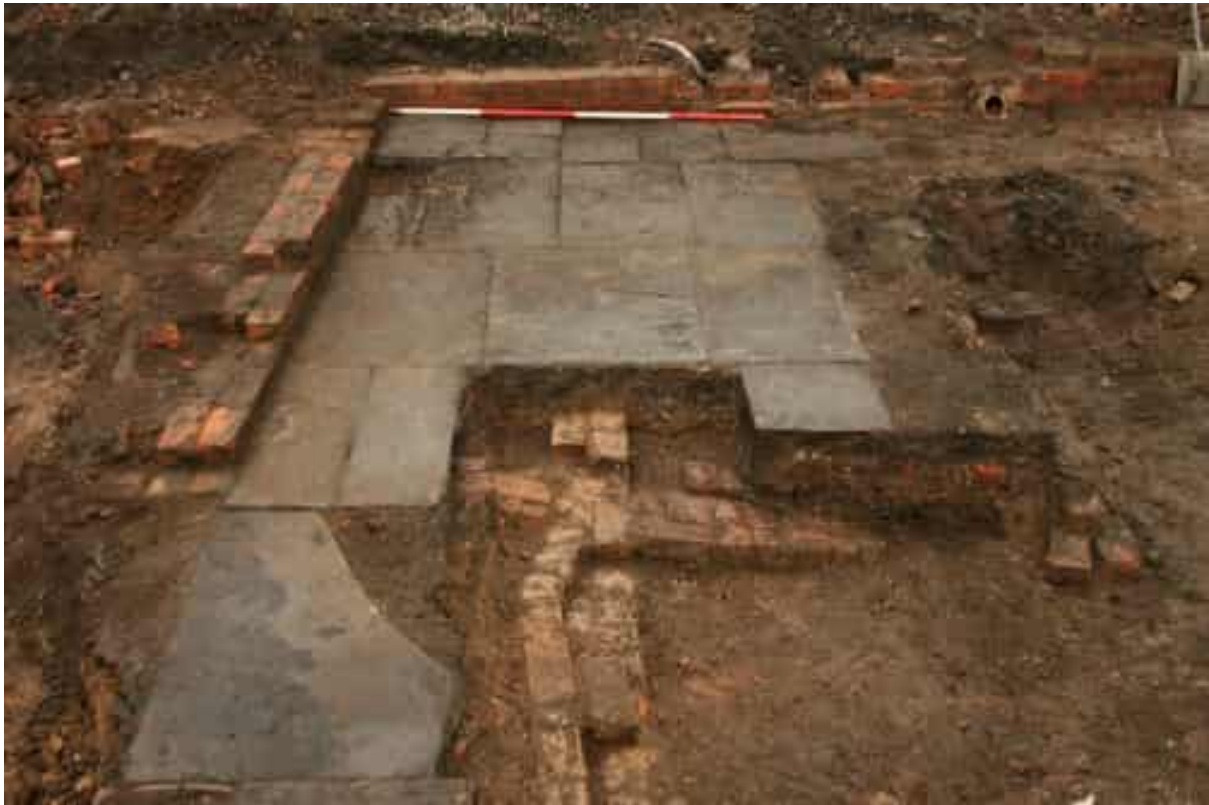
Plate 21: later H9 flagstone surface [824], above disused walls [825] [827], looking southeast

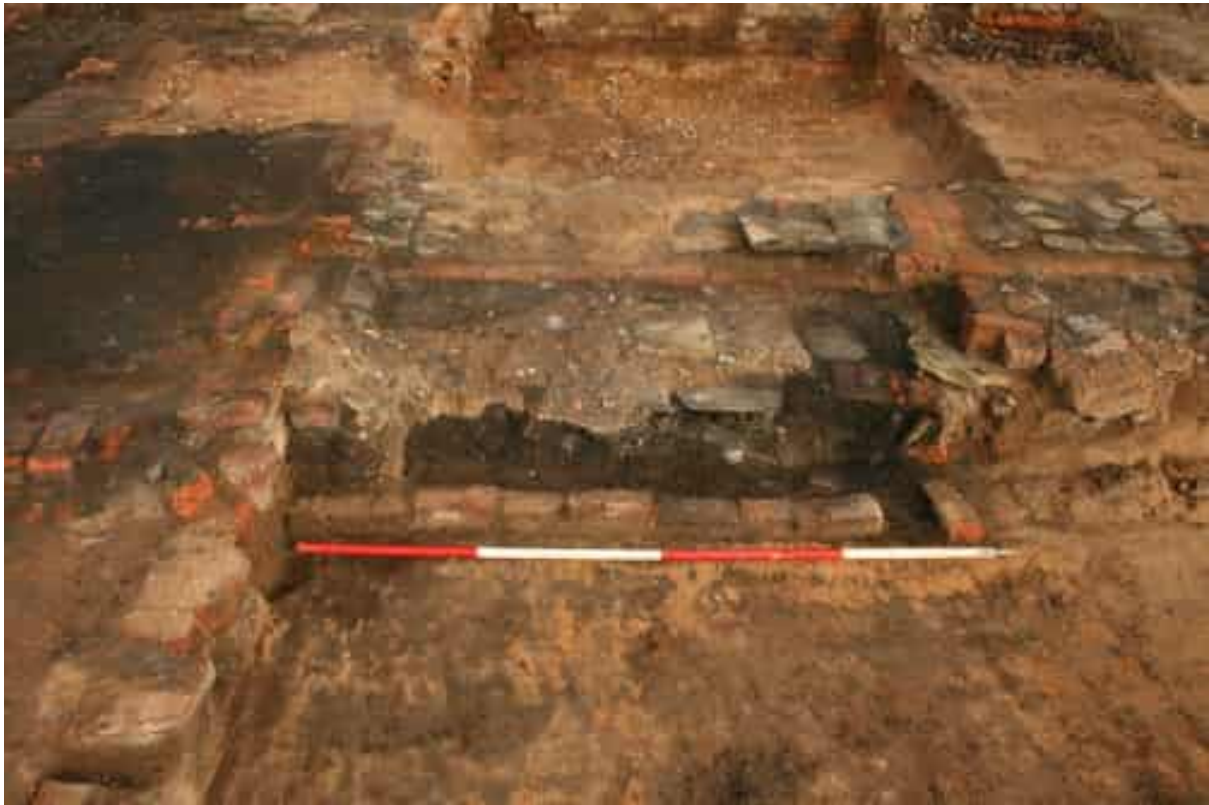
Plate 22: Infilled [734] [735] H4 coal store [656], looking northwest

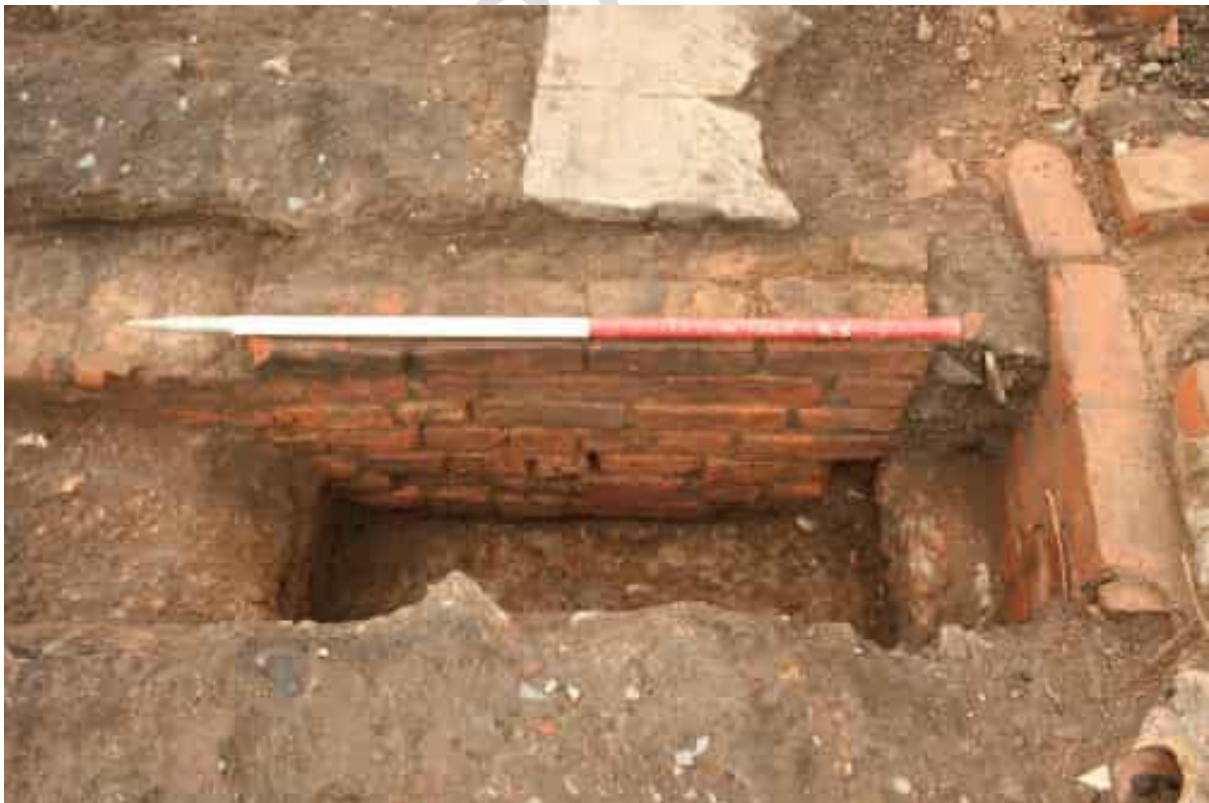
Plate 23: Wall [817] and Phase 5 industrial truncation [760] [762], looking northeast
