**An Assessment of an  
Archaeological Excavation at**

**First Street, Medlock Street, Plot 9  
(8), Manchester, M15 4FN**

**PCA REPORT NO: 15344**

**SITE CODE: FMS20**

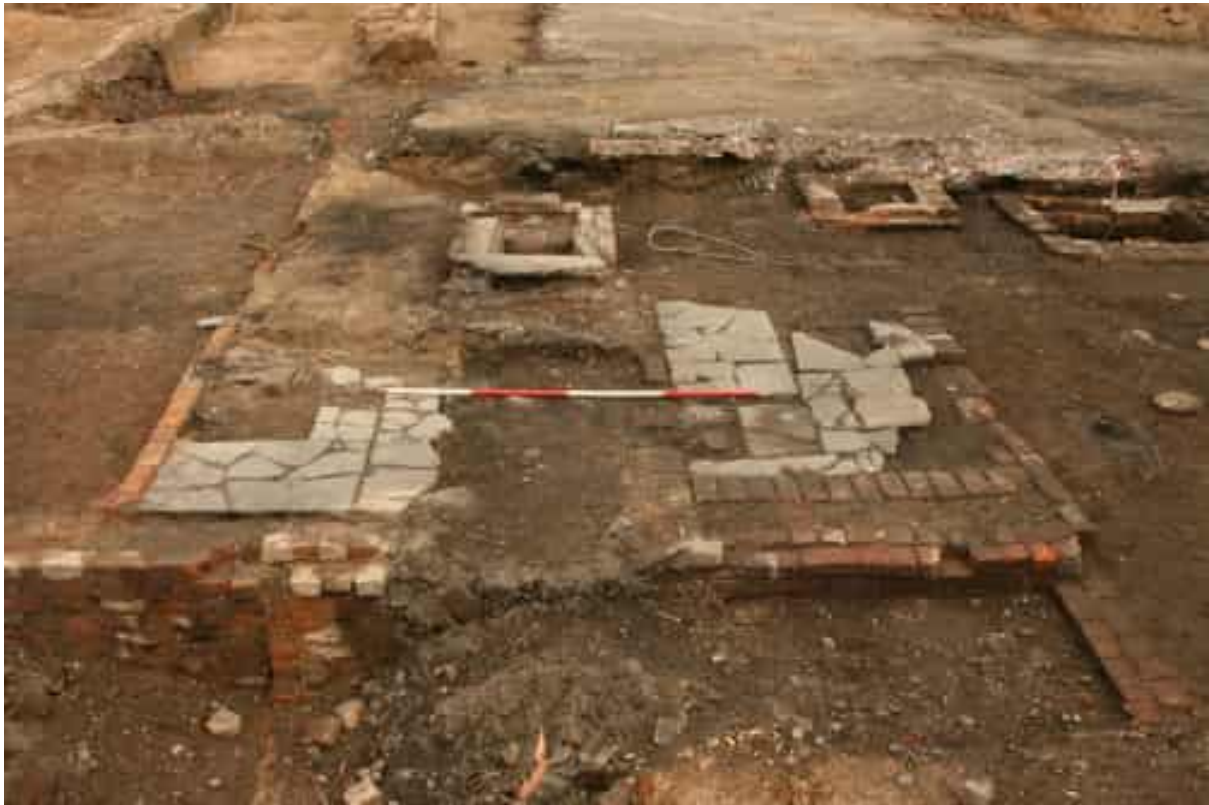
Plate 24: H7 rear room [759] and yard [683], with modern services truncation, looking northwest

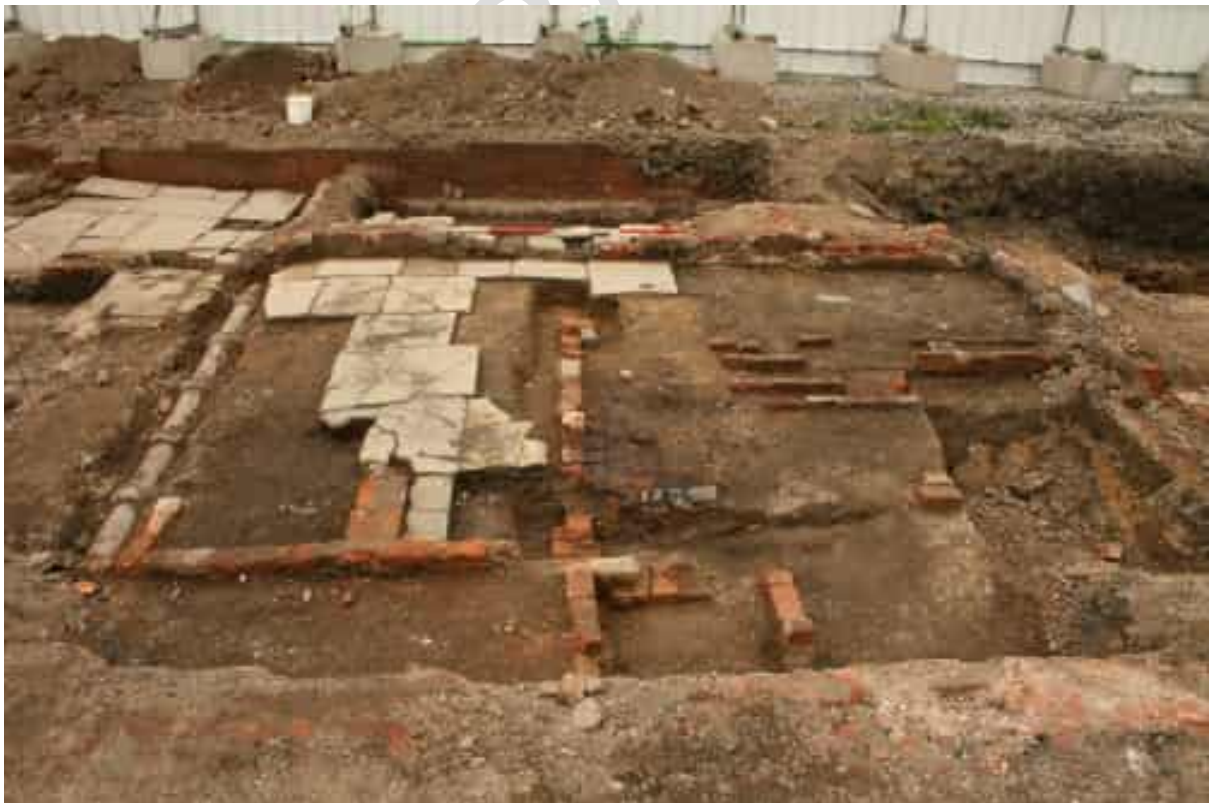
Plate 25: Rear room floor [772] and front room floor supports [769] H8, looking southeast

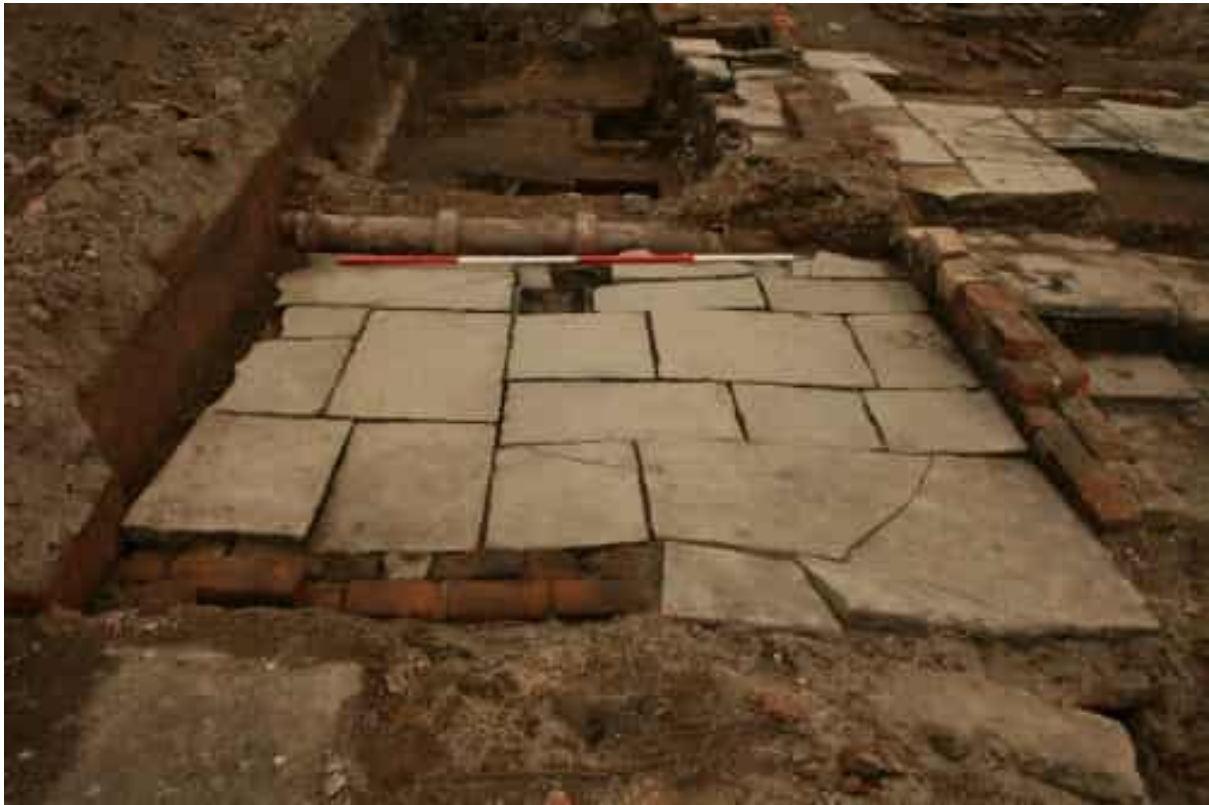
Plate 26: Later yard H11 [848], looking northwest from Poland Place

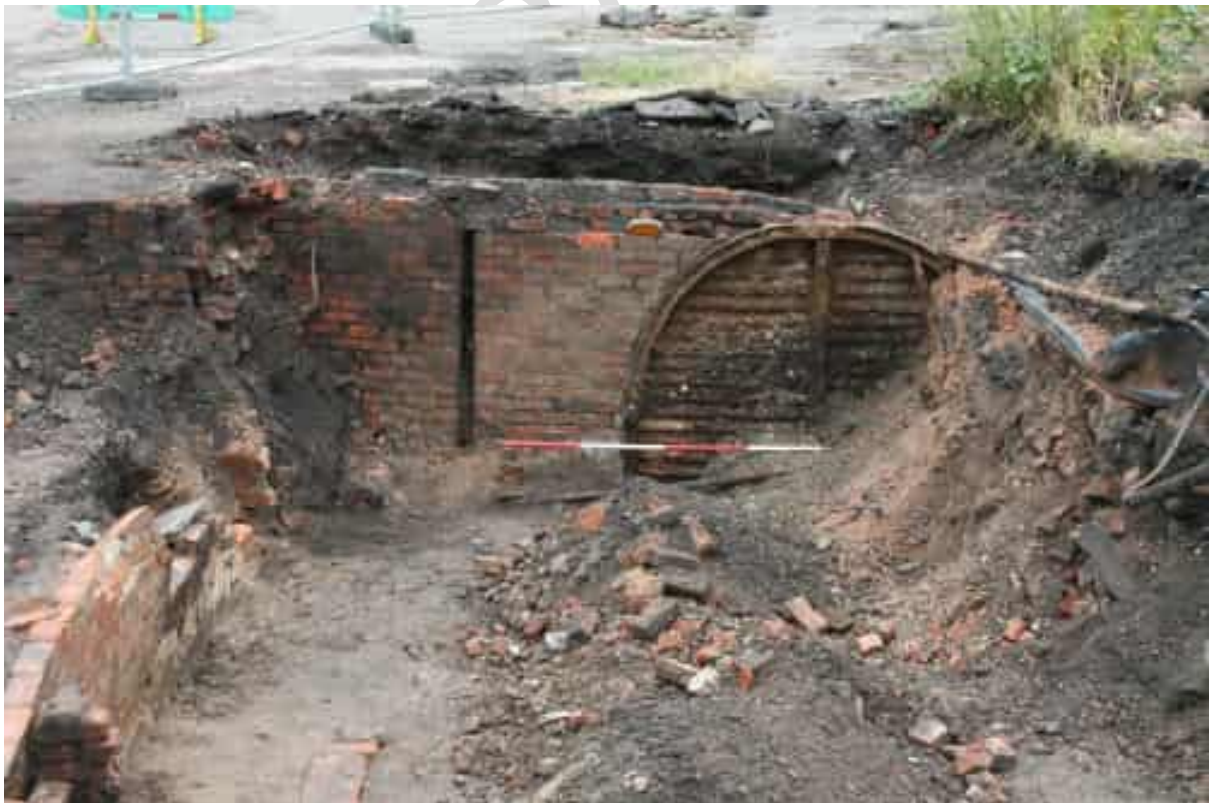
Plate 27: Air Raid Shelter East [870], Poland Place, looking northeast

- 7.5.4 Material evidence for the of the shelter (G39) on former Poland Place ARS(E) (Figure 10) indicated a composite construction from brick, degraded timber and corrugated metal. Rectangular construction cut [839] with vertical sides was up to c.9.3m long and c.2.70m wide. It was partially excavated to a depth of c.1.80m (31.09m aOD). Within it, re-used single-skinned Wall [870] (Plate 27) was represented by more than 21 courses composed of standard 230 x 100mm bricks laid mainly in a stretcher bond, with headers used to facilitate an integral timber frame running the entire exposed depth of the wall. A fused corrugated sheet, surviving *in situ*, formed an arched roof. The disuse of the structure (and possible ground levelling in preparatory to the later factory construction) was represented by a mixed demolition backfill [859].
