## A REPORT TO BROUGHTON PARK RUFC

**A feasibility report for the relocation and improvement of natural turf sports pitches at Broughton Park RUFC, Lancashire GAA and associated clubs St Peter's and Fullen Gaels.**

6<sup>th</sup> July 2023  
O\_001\_BPRUFC\_1802\_R\_2023 07 06

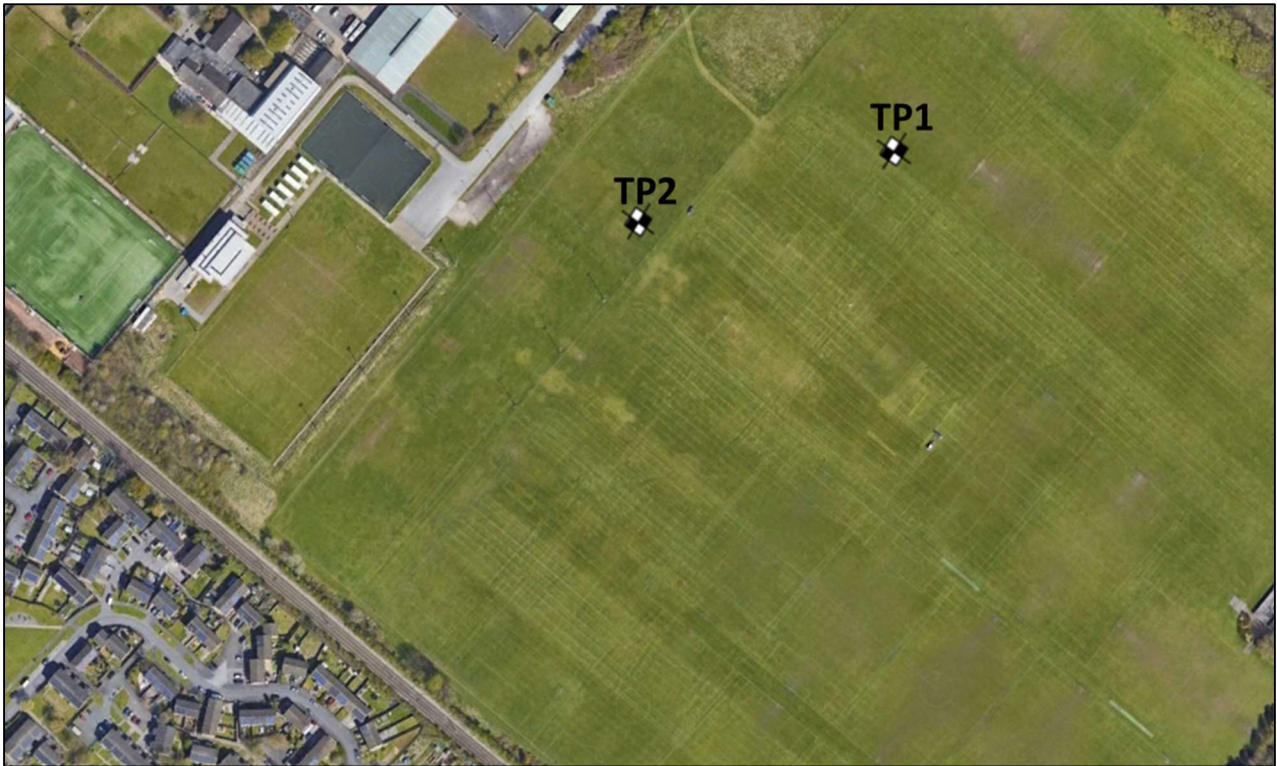
Figure 4. Site overview. TP1 to TP2 mark the approximate locations of the test pits.  
(Aerial photograph courtesy of Google Earth Pro).

Two soil test pits (TP1 to TP2, Figure 4) were excavated using hand tools to characterise the underlying soil profile.

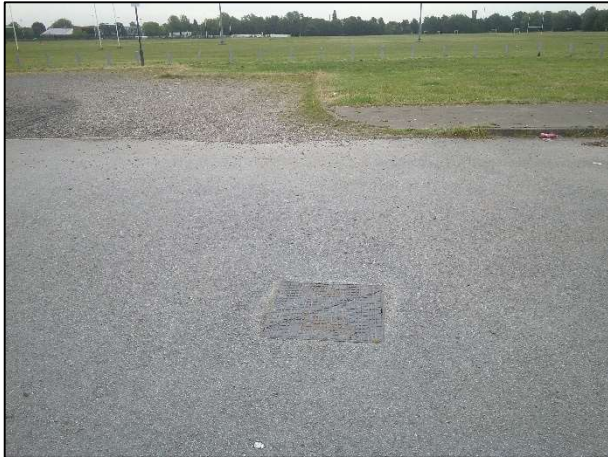
Outfall was identified as a wider site drainage scheme located within the car park. Additionally, a brook (Red Lion Brook) is located to the northeast of the site. Should the installation of any new land drain scheme be installed into the pitches, the Client must confirm a suitable outfall along with any permissions for the discharge of drainage water. No existing drainage scheme was noted within the footprint of the sports pitches.

Figure 9. IC overview toward the west.

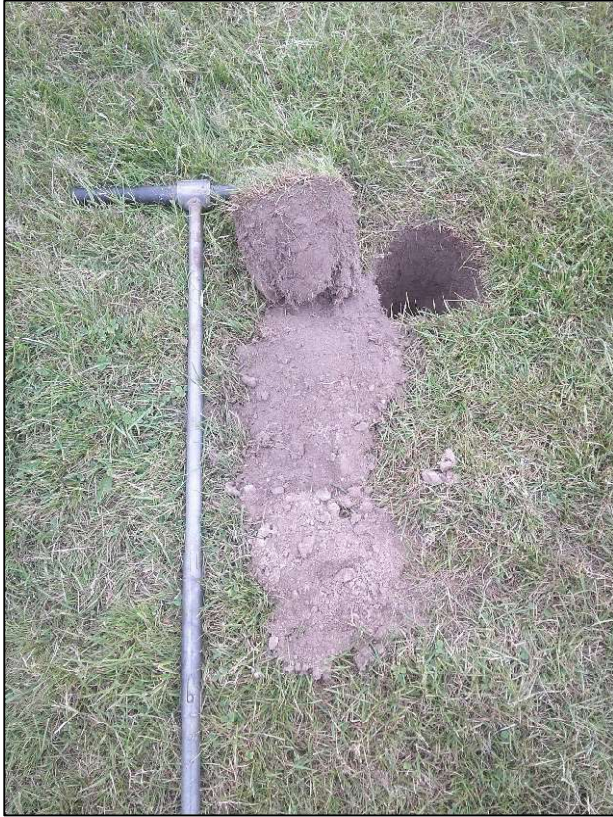
**TP1** The soil profile was found to comprise 200 mm of SANDY SILT LOAM topsoil, over lighter LOAMY SAND subsoil containing minimal stone content which extended beyond the maximum excavation depth of 0.50 m and appeared dry and powdery. (Figures 19 to 20).

Figure 19. TP1 – Sandy Silt loam topsoil.

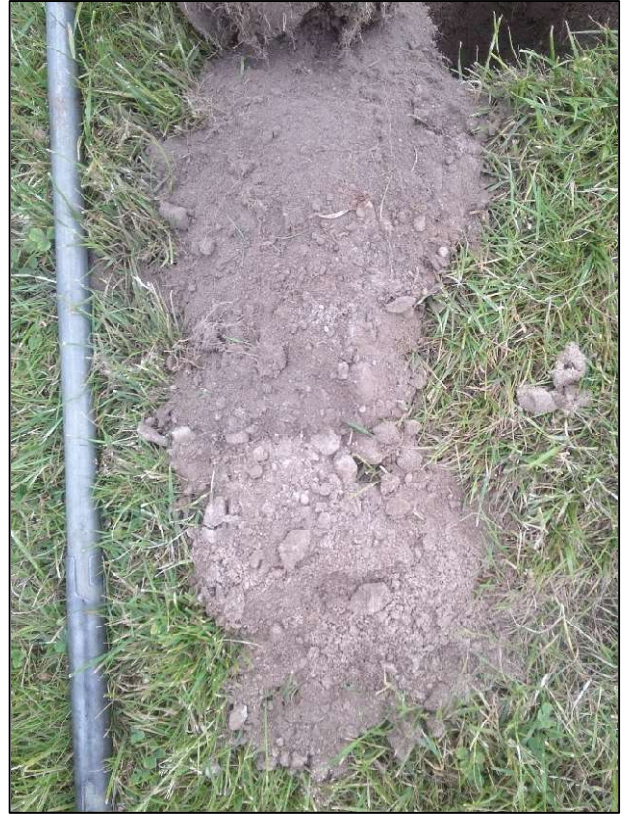
Figure 20. TP1 – Loamy sand subsoil.

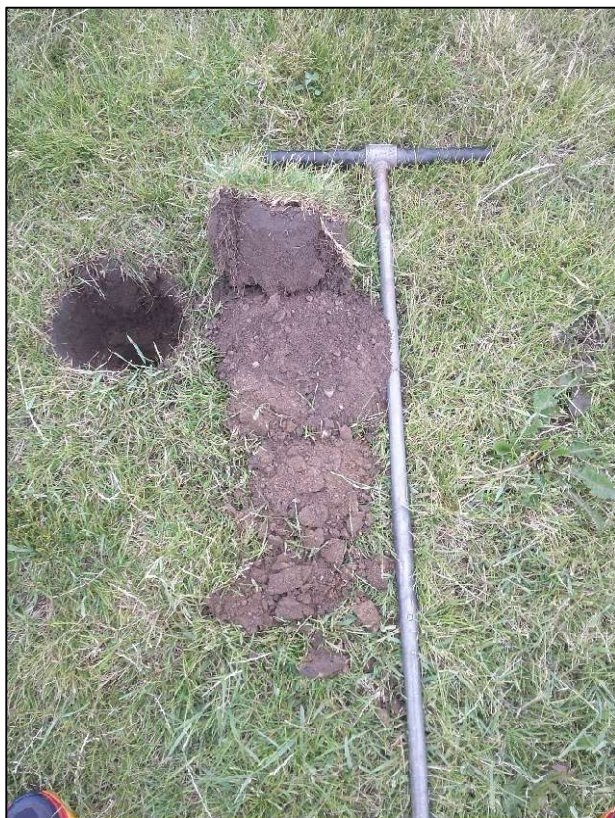
**TP2.** The soil profile was found to comprise 200 mm of CLAY LOAM topsoil, over light brown SANDY CLAY LOAM subsoil containing minimal stone content which extended beyond the maximum excavation depth of 0.50 m and appeared soft, friable, and trench able (Figures 21 to 22).

Figure 21. TP2 – Top and subsoil overview.

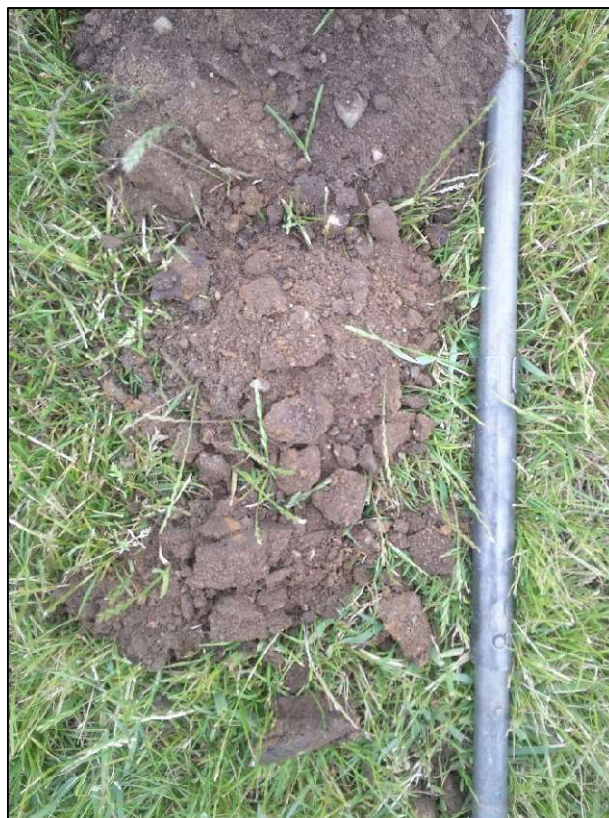
Figure 22. TP2 – Stones.

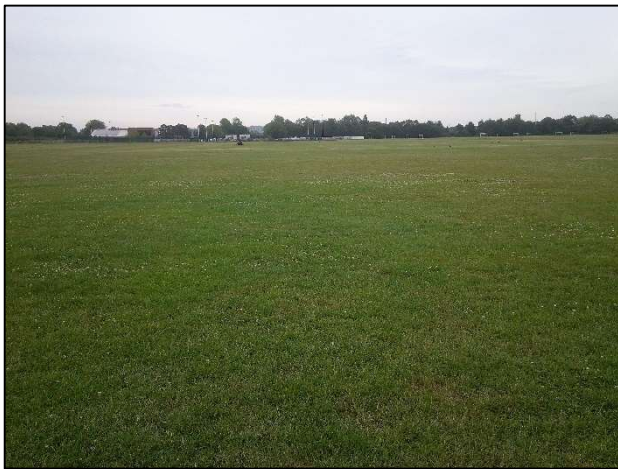
Grass cover across the pitches is currently >80% at a height of 100 mm and comprised mainly Ryegrass (*Lolium perenne*), a high weed content (~20%) was observed mainly comprised as Clover (*Trifolium repens*) and Dandelion (*Taraxacum*). Thatch/ soil organic matter was noted as ~10-15 mm. The surface exhibited as hydrophobic in areas.

Figure 24. Typical sward overview.

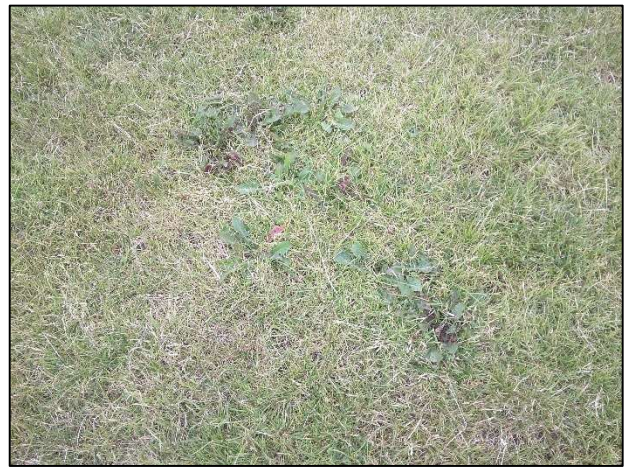
Figure 25. Sward overview with weed content.

**Weed control.** Apply a selective herbicide in the spring (if required) to combat the weeds present. This to be applied at least two weeks after the first fertiliser treatment (April) and at a time when grass growth is strong and healthy. NB. Do not apply herbicide during periods of potential turf stress, i.e., if the weather is hot and dry or if frosts are forecast. Apply herbicide strictly according to the manufacturers label recommendations and only by suitably qualified personnel.
