## A REPORT TO ALDI

### A feasibility study for the improvement of the natural turf rugby pitches at North Manchester Rugby Club

11<sup>th</sup> August 2023

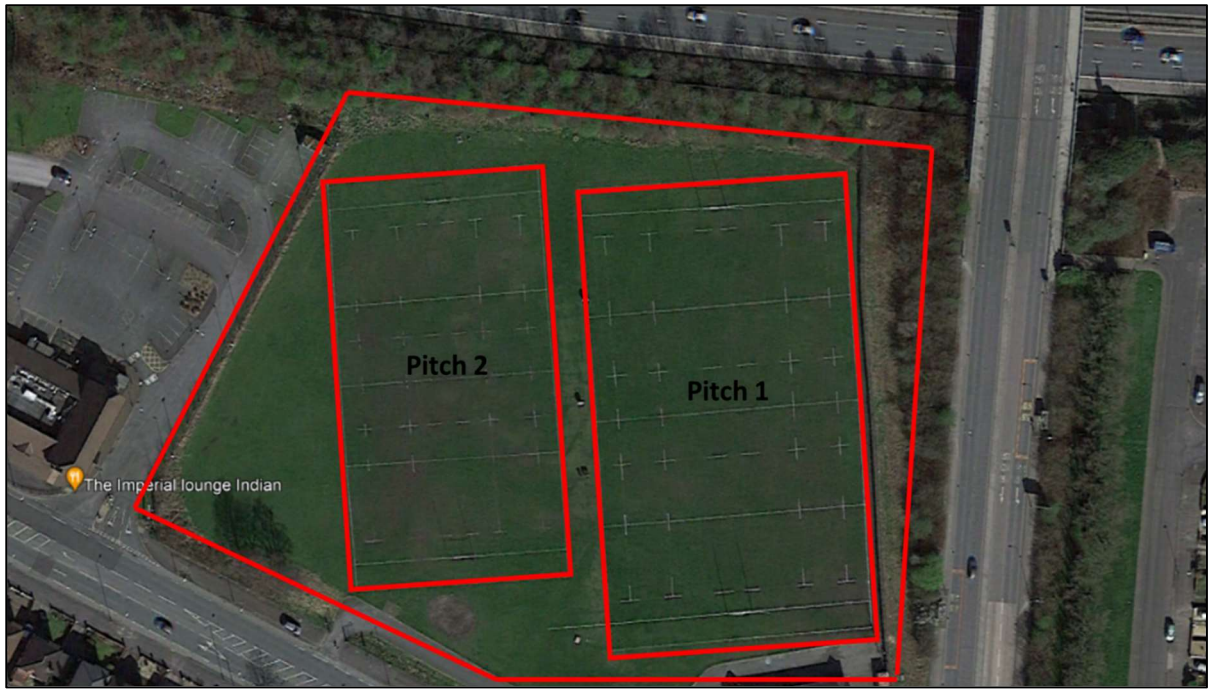
*Figure 2 Pitch locations*

North Manchester rugby club comprises of two natural turf rugby pitches. The facilities are also used by a local archery club, Assheton Bowmen. The approx. area of the site is 2 hectares.

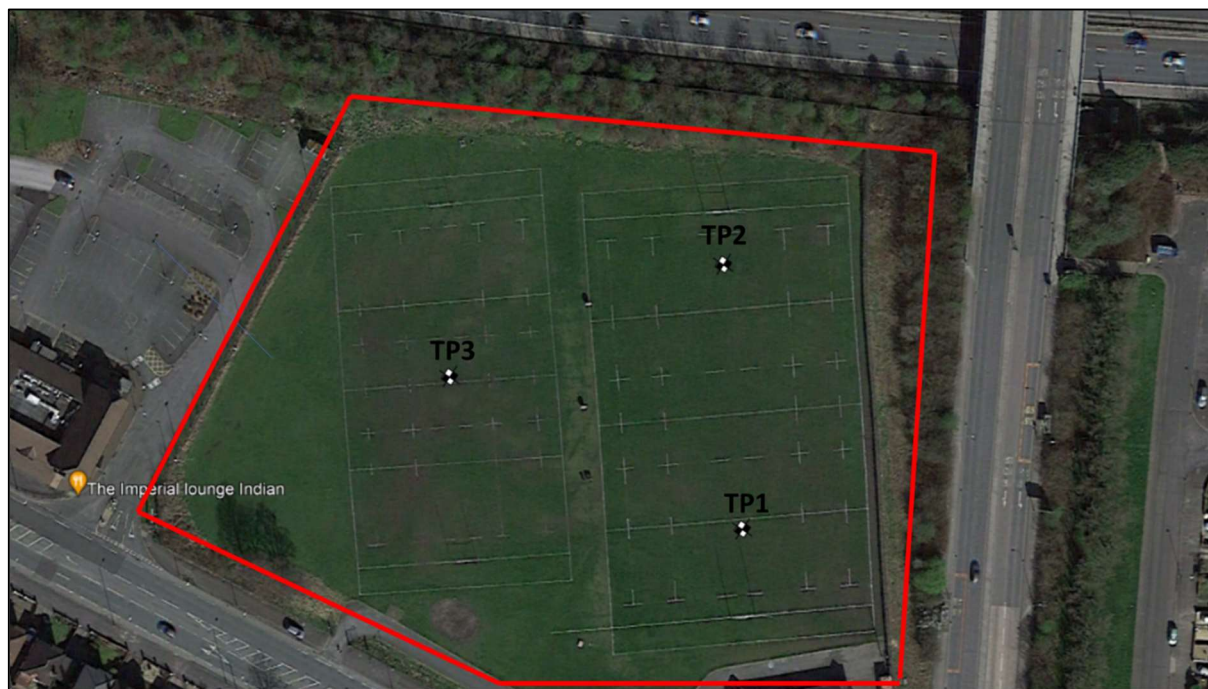
*Figure 3 Trial pit locations (TP1-TP3 mark the approximate location of the trial pits)*

Three soil trial pits (TP1 – TP3, see Figure 3) were excavated by hand at targeted locations to characterise the underlying soil profile and to determine water table depth. Two representative soil samples of topsoil and subsoil was sent for laboratory analysis to determine soil texture and pH (from Trial Pits 1 & 3).

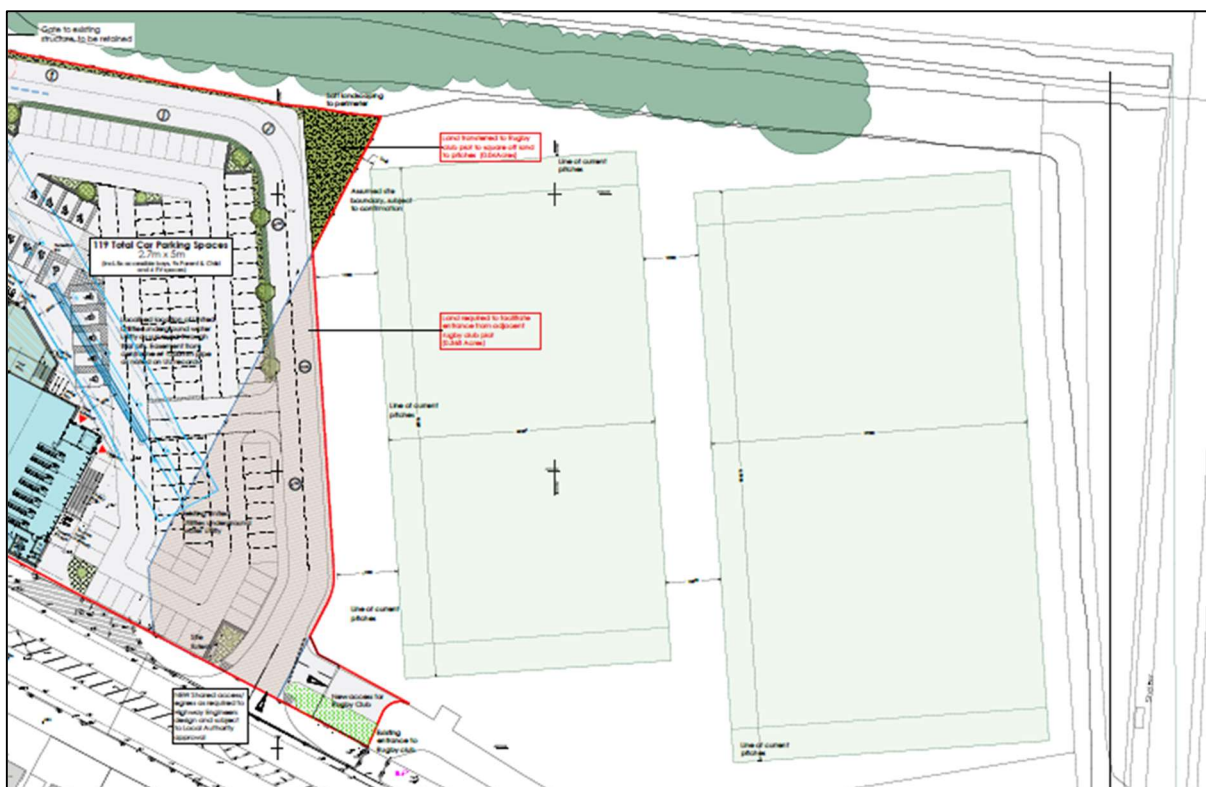
*Figure 4 Proposed development*

The objective of the feasibility study was to assess current conditions of the development area and provide details of the works for the improvement of both pitches and an area that is to be converted from car park into playing field northwest of the site.

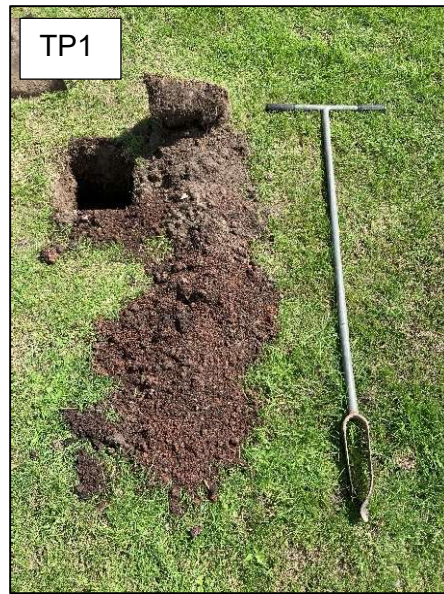
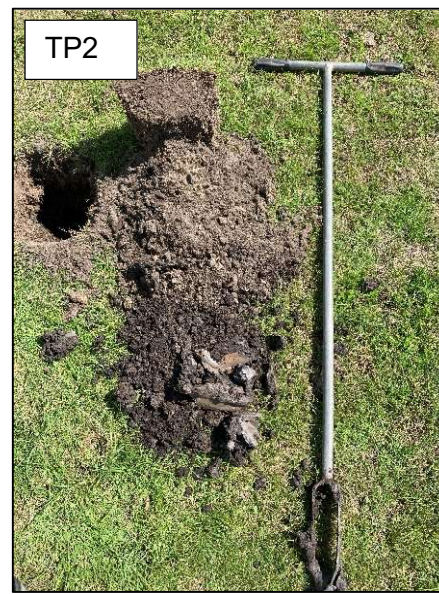
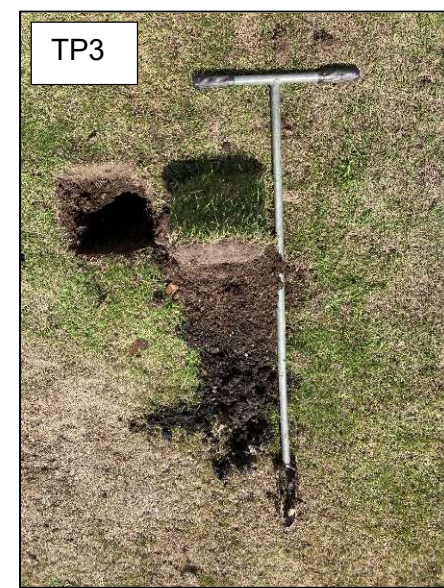
| <b>Topsoil depth</b> | 190 mm | 190 mm | 190 mm |
| <b>Topsoil texture</b> | Sandy loam | Sandy loam | Sandy loam |

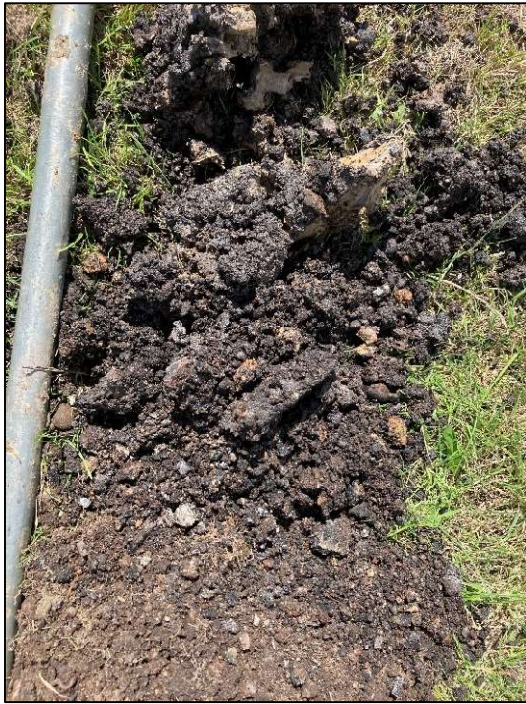
Observations during the initial site visit identified a minimal stone content within the topsoil. A grit layer containing moderate stone content was observed lower, between the topsoil and subsoil. (Circa 200 mm depth). The stones are deep enough that there should be no concern with them migrating towards the surface. However, if these are disturbed during any remediation/drainage works, they could pose a significant injury risk to patrons using the facilities.

*Figure 9 Grit layer.*

It is recommended that following any aeration or scarification works which are implemented as part of good maintenance, a thorough inspection of the pitches is undertaken to identify any stones which may have been brought up to the surface following the works. Industry Standards suggest there should be no stones greater than 20 mm in longest axis within the upper 75 mm of the soil profile and no sharp stones within this zone. Following any remediation works, it could not be guaranteed that these criteria for stone content could be achieved without the importation of additional soil/rootzone to act as a buffer.

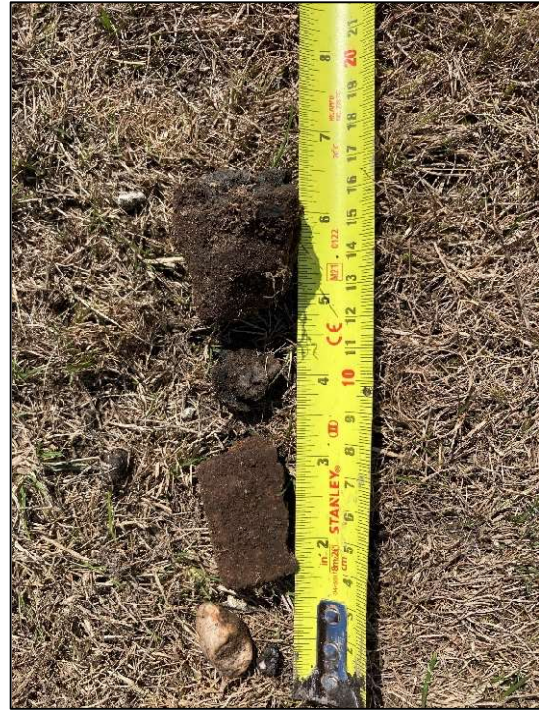
*Figure 10 Typical stone content*

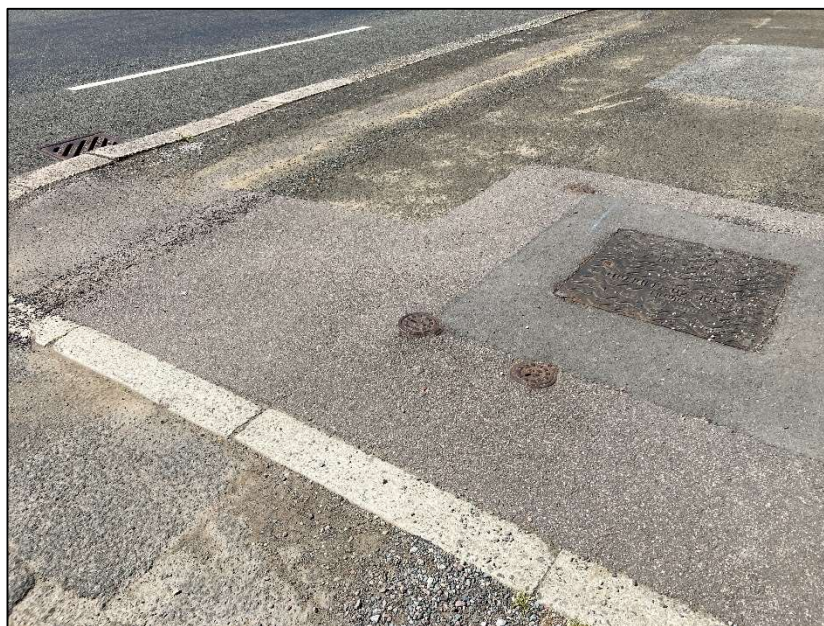
On site observations and satellite imagery confirms no drainage infrastructure is present on the two pitches. If drainage were to be installed, a suitable outfall would need to be established for these pitches. In terms of the outfall, inspection chambers have been located on the main road. No further outfall has been located on-site which could provide a means to discharge drainage water for the other pitches.

*Figure 17 Inspection chambers located near to road.*

In the absence of a water course, it may be prudent to contact relevant bodies to ascertain whether any existing drainage infrastructure can be used as outfall. The use of soakaways can be high risk and the suitability of utilising the indigenous site geology as outfall must be tested through BRE365 infiltration testing to accurately size the soakaway.

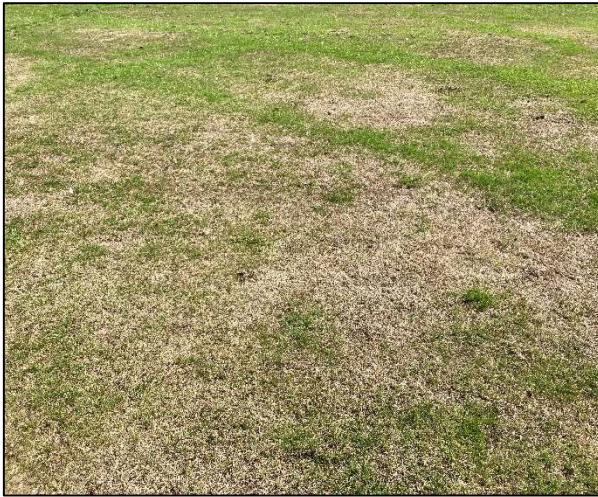
Vegetation cover was circa 85%. Turf cover was ~70% comprising perennial ryegrass (*Lolium perenne*) and Annual meadow grass (*Poa annua*). The overall sward exhibited thin/ weak areas (figure 18) with significant debris (grass clippings) evident on the surface. Sward height was observed to be ~50-80 mm and inconsistent throughout. Weed content was observed to be >10% as daisy (*Betula pendula*) and plantain (*Plantago major*).

Figure 18 Typical sward condition

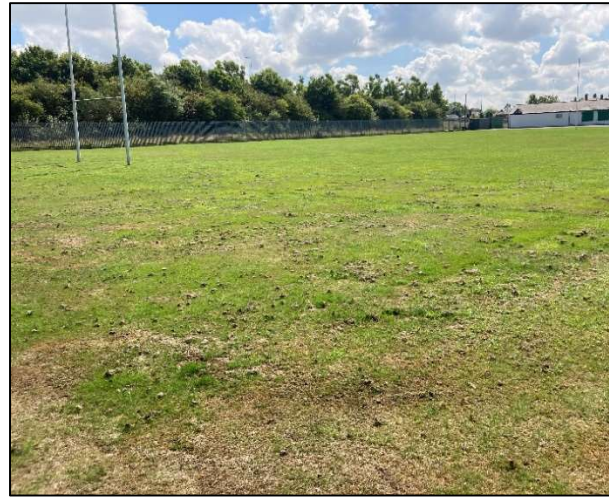
Figure 11 Surface debris

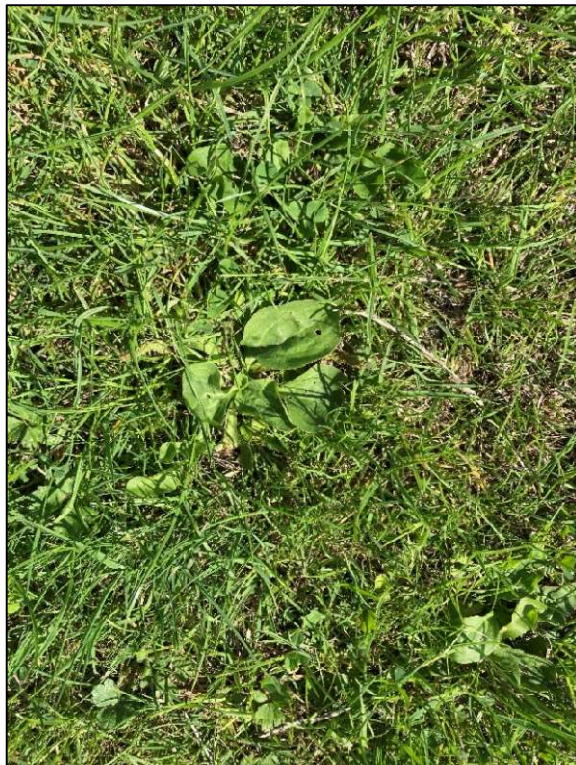
Figure 20 Typical weed content

**Weed control.** Apply a selective herbicide in the spring (if required) to combat the weeds present. This to be applied at least two weeks after the first fertiliser treatment (April) and at a time when grass growth is strong and healthy. NB. Do not apply herbicide during periods of potential turf stress, i.e. if the weather is hot and dry or if frosts are forecast. Apply herbicide strictly according to the manufacturers label recommendations and only by suitably qualified personnel.

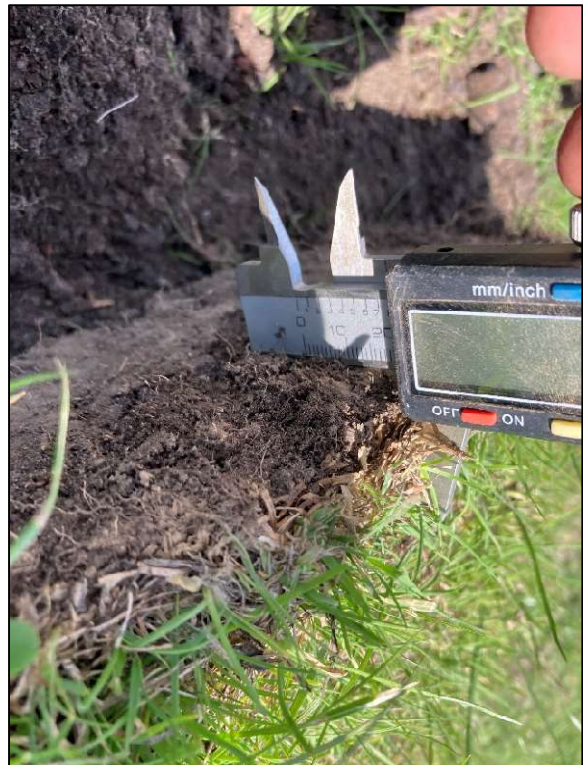
Thatch levels were also very high at ~20 mm. Thatch can cause issues with infiltration whilst providing an environment for less desirable grasses and disease. Thatch also increases hydrophobicity at the surface exhibiting as localised dry patch (LDP) and poor turf quality.

Figure 21 Typical thatch content
