# CSM - College House

## Design and Heritage Statement

March 2023 – Revised April 2023

Project name: CSM - College House, Fox's Court and Gatehouse External Works

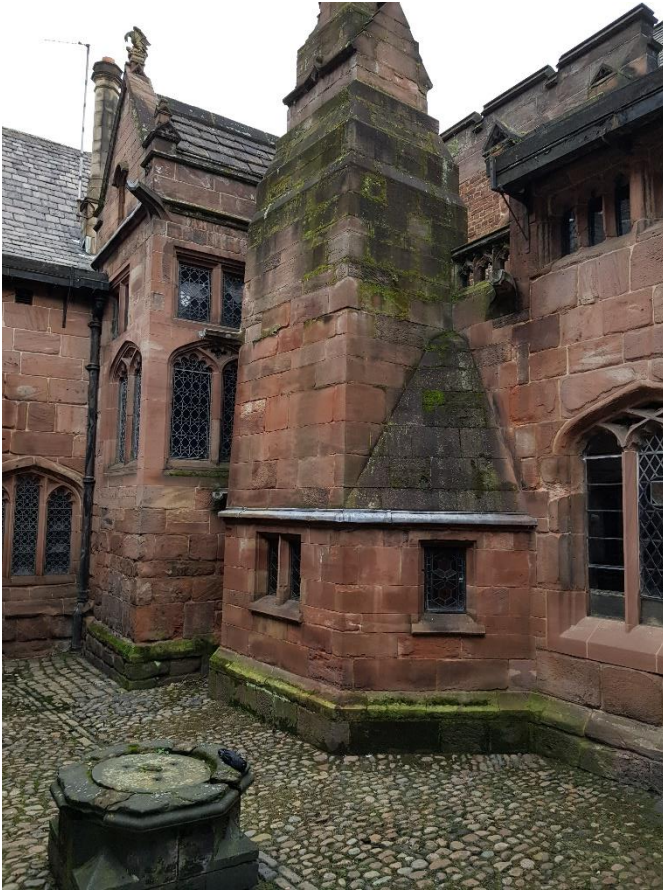
Externally in Fox's Court is a medieval well which is progressively deteriorating with open joints and significant surface erosion. The court also has a number of plastic rainwater goods which are inappropriate replacements of former cast iron down pipes.

- 3.2.5.1 The central stone well is in poor condition with indent repairs required to the masonry base. A number of stones are loose and fractures can be seen. In areas inappropriate cement mortar repairs have been introduced.

*Fox's Court Well and Chimney.*

- 3.2.5.2 The application proposes that the well is carefully dismantled with all stones numbered and recorded. Indent repairs will then be undertaken where required and the stones careful cleaned of vegetation. The well will then be rebuilt using an appropriate lime-based mortar. Samples will be produced to ensure the lime mix is appropriate to the stone composition. Masonry mortar repairs will also be undertaken at this time using a lime-based mortar mixed with stone dust to exactly match the composition and visual character of the stone. Samples will be produced to ensure an appropriate mix is specified.

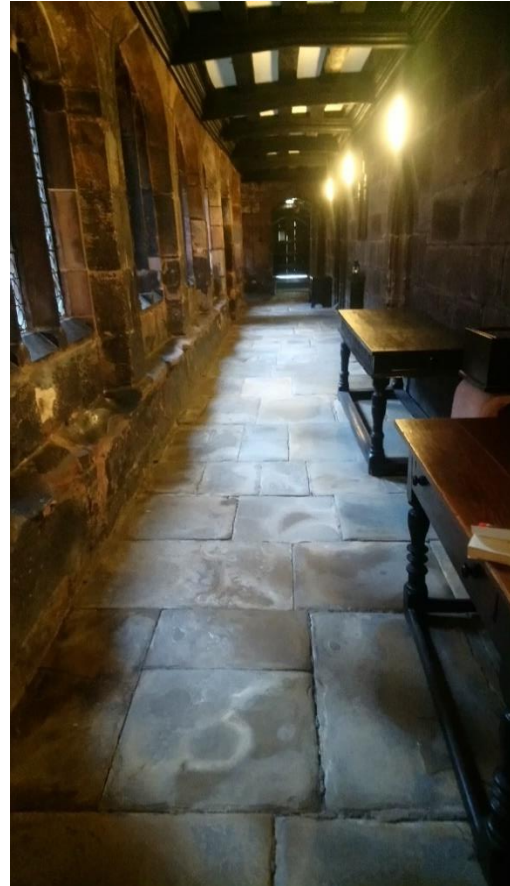
The internal floor is composed of stone flags which have undergone several phases of repair. Some of the repairs are cementitious and inappropriate. The flags are progressively deteriorating with some large fractures and loose stones.

3.2.6.1 The existing stone flags have undergone several phases of repair and some areas have been repaired with cementitious mortar. Large fractures are visible in several places and are progressively deteriorating. Several raised stones have led to trip hazards across the floor area.

*College House Baronial Hall Corridor – Stone floor condition.*

- Carefully lifting loose stones, numbering and recording them and re-bedding in their original position with a lime based mortar.
- Careful removal of cementitious mortar and replacing with a lime based mortar.
- Installing new stones to match the existing and adjacent where flags are broken or sections are missing.
- Masonry mortar repair of fractures, holes and areas of significant surface erosion. This will be conducted in a lime based mortar with stone dust incorporated to exactly match the existing stone.
- Removing and replacing stones to exactly match the existing and adjacent where the existing stones have worn beyond a safe use.
