# PHASE 2 SITE INVESTIGATION

Plots O + N, Mayfield

Mayfield Partnership Ltd

| DESCRIPTION | DATE | AUTHOR | REVIEWED BY | APPROVED BY |
|---|---|---|---|---|
| <b>Phase 2 Site Investigation Report</b> | 01/10/20 | Elizabeth Stewart<br> | <b>Liam Daley</b><br> | <b>Alex Smiles</b><br> |

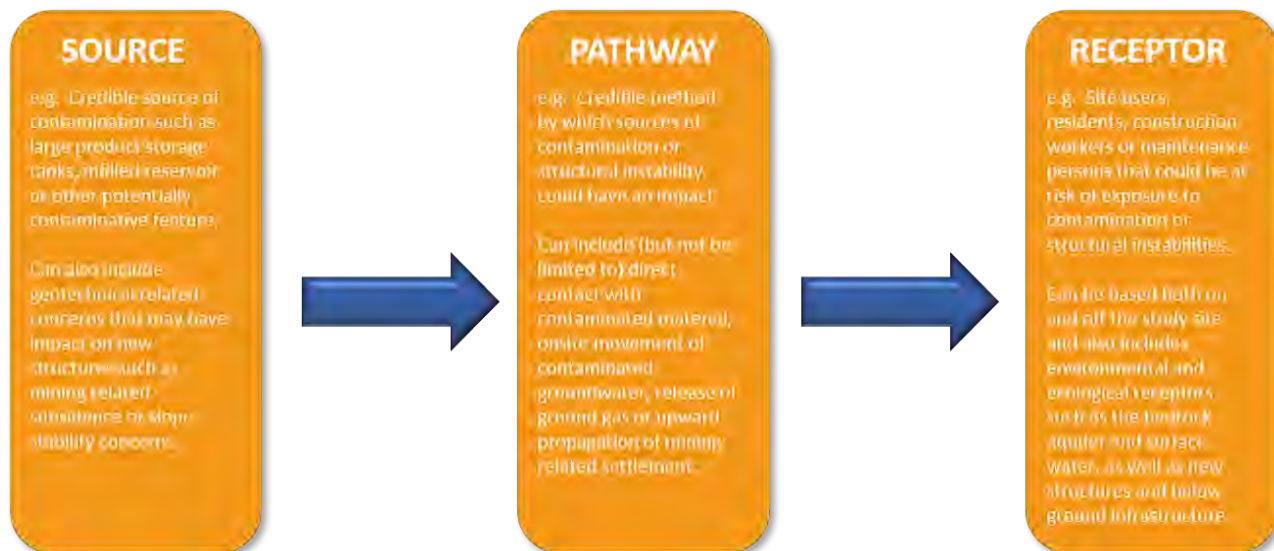
**Figure 8.0 Source Pathway Receptor Diagram**

- 8.0.1 The information obtained during the desk-based study has been reviewed to establish the Preliminary Conceptual Model for the site. This model is based around the Source / Pathway / Receptor methodology as outlined in Figure 8.0.

- 8.0.2 Risk assessment is the process of collating known information on a hazard or set hazards in order to establish actual or potential risks to receptors. The receptor may be human health, controlled waters, a sensitive local ecosystem or even construction materials. Receptors can be connected with the hazard under consideration via one or several exposure pathways (e.g. the pathway of direct skin contact and oral exposure).

- 8.0.3 Risks are generally managed by isolating or removing the hazard, isolating the receptor, or by intercepting the exposure pathway. Without the three essential components of a source (hazard), pathway and receptor, there is deemed to be no risk. In other words, the mere presence of a hazard at a site does not mean that there will necessarily be risks.

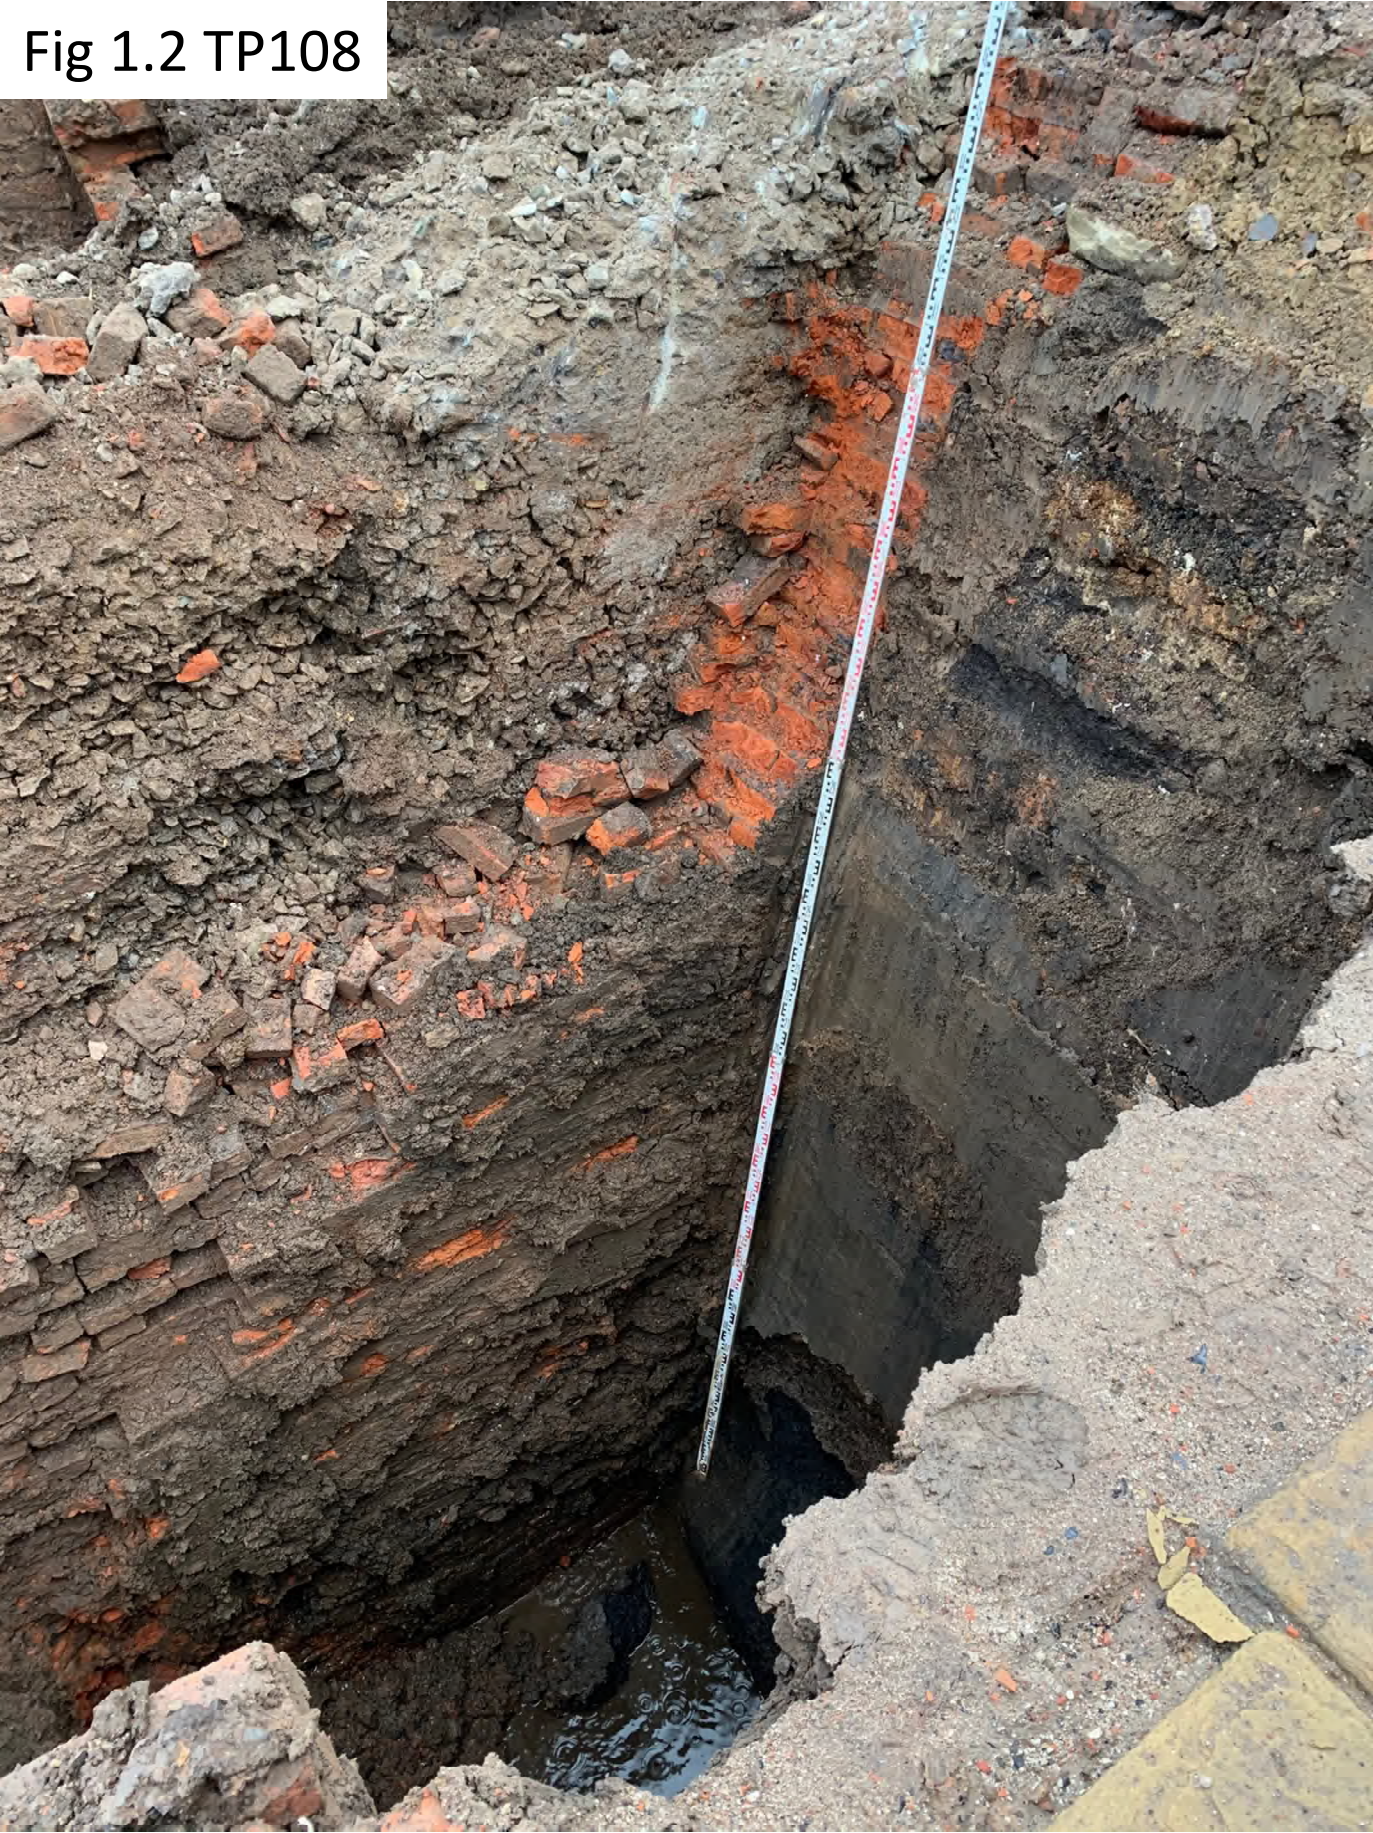
Fig 1.2 TP108

5m ranging staff for scale

- 6.1.8 Made ground was reported at all exploratory locations comprising a mixture of demolition type fill material and the Victorian construction build up of the swimming pools (a detailed description of which is provided on TP107 log and accompanying photographs within Appendix B). The depth of made ground varied around the baths to depths between 30.0 and 32.9mAOD with some brick walls and structures found to extend to significant depths beneath the site (possible relating to old drainage infrastructure) e.g. brick wall noted in TP108 that extended to a depth circa 28.8mAOD.

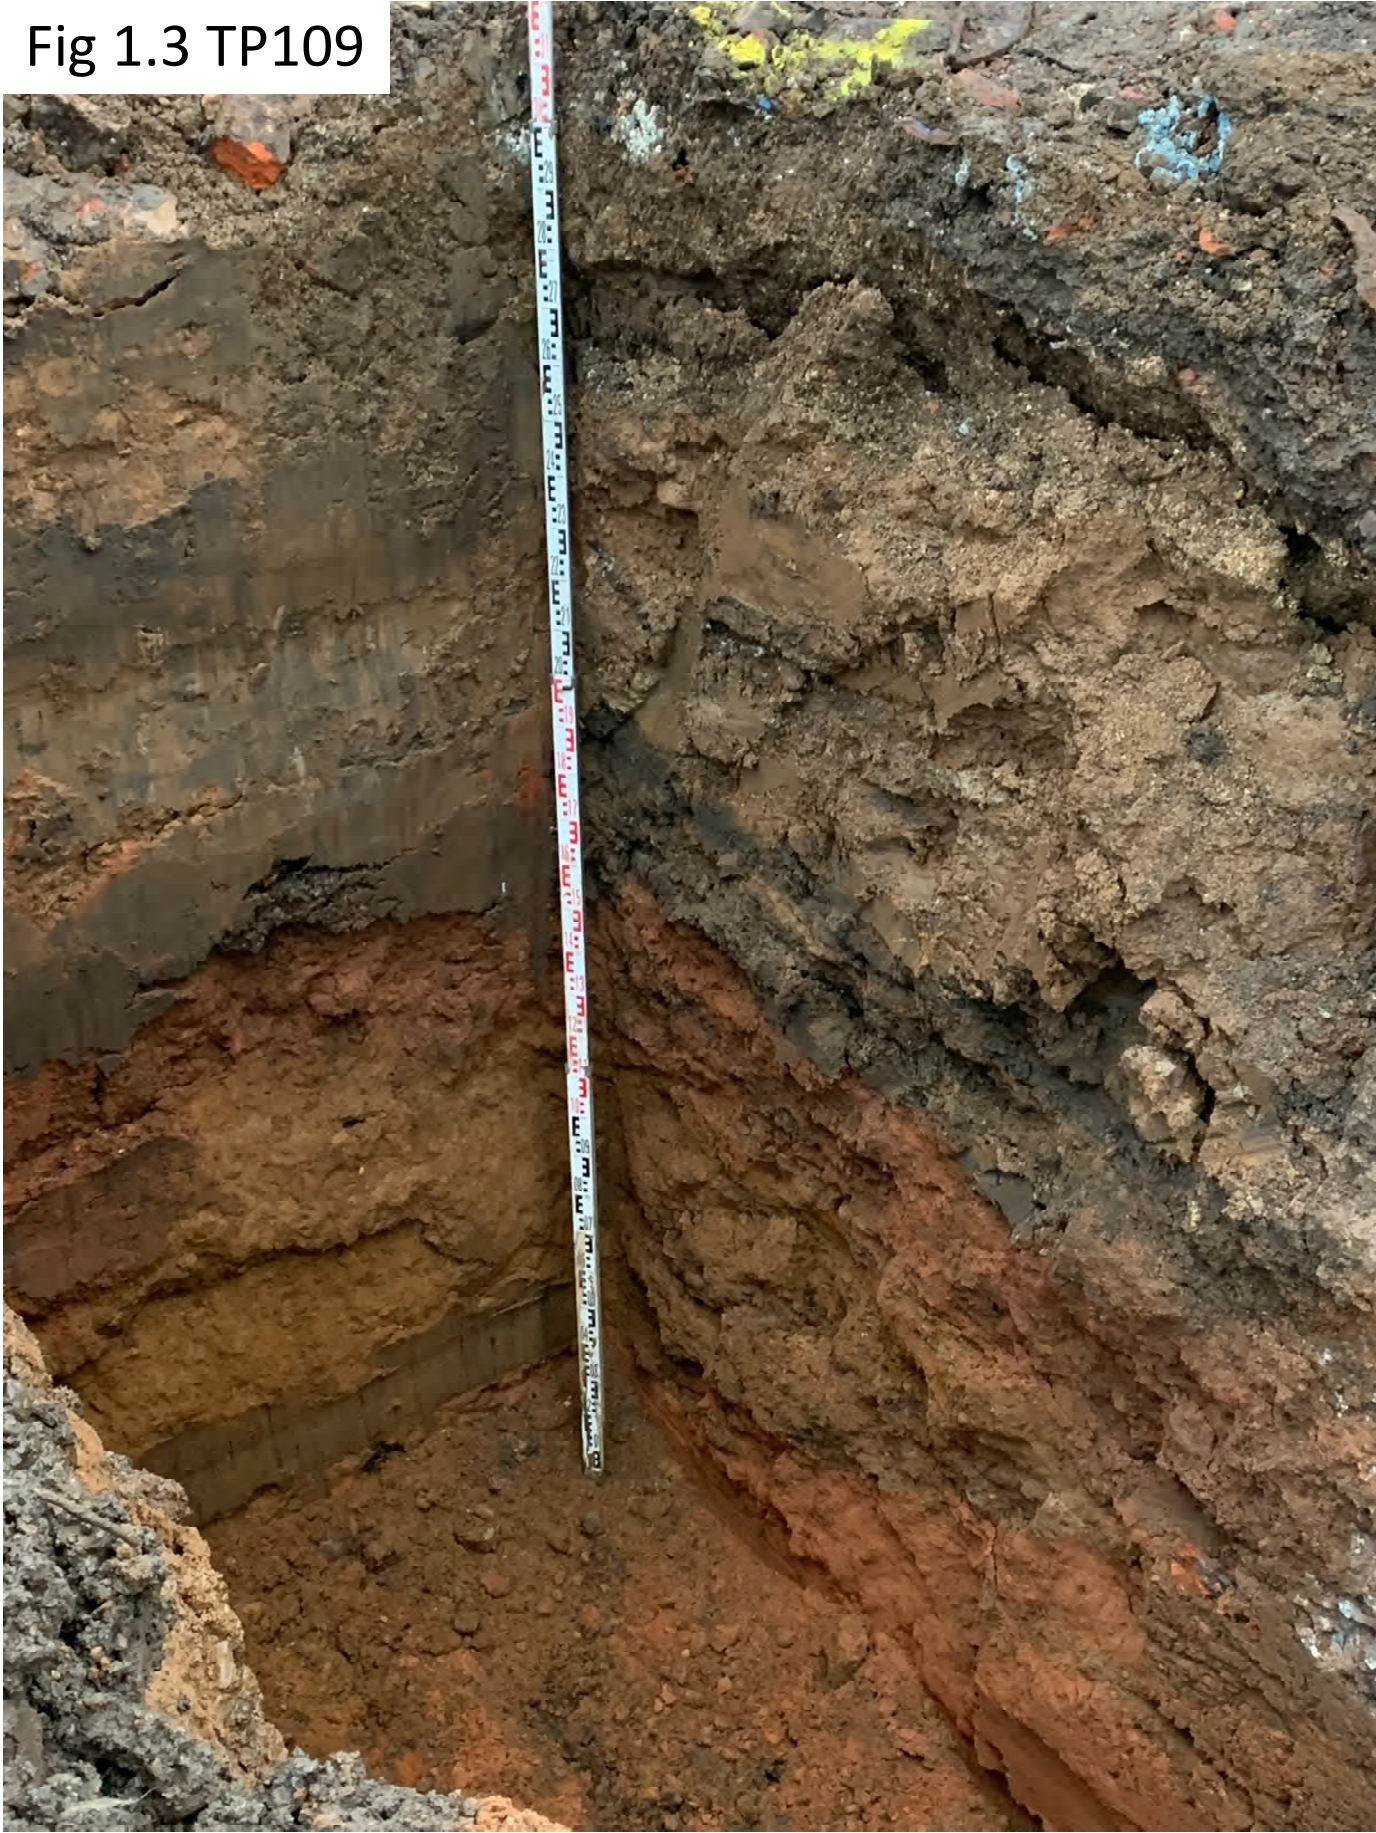
Fig 1.3 TP109

5m ranging staff for scale

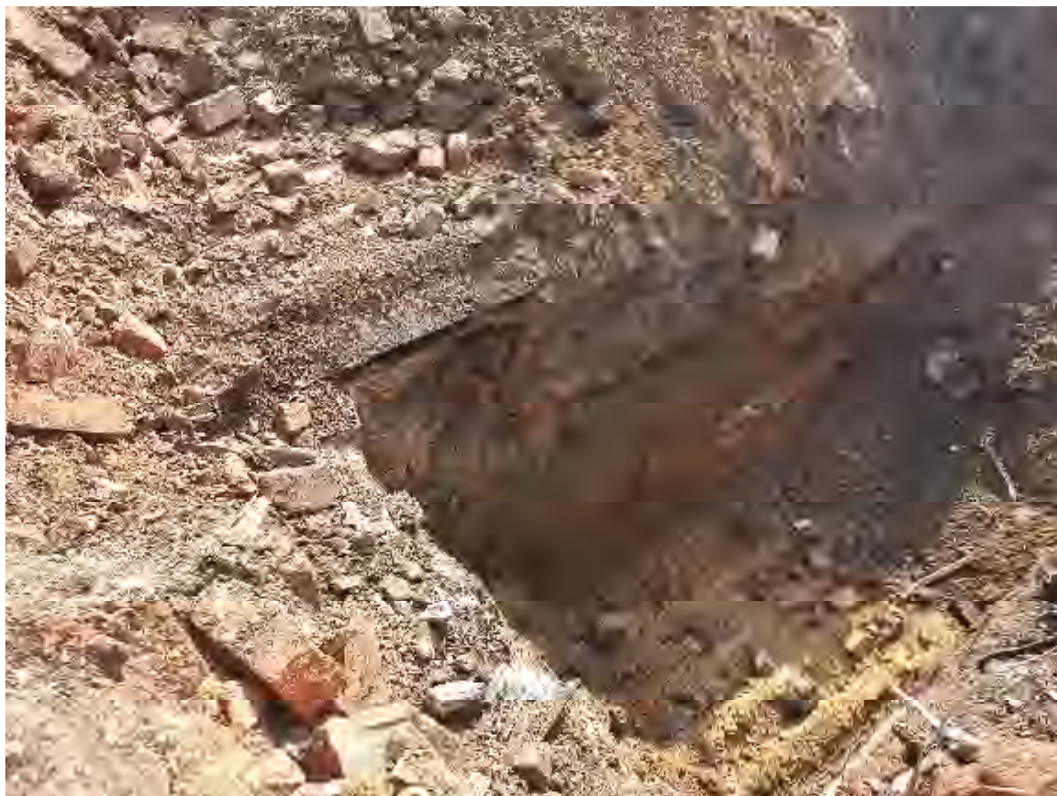
Photo No. 4: TPI02 – Made Ground / natural horizon
