# Rosedale, Newton Heath, Manchester

## Phase 2 Ground Investigation

Curtins Ref: 079193-CUR-XX-XX-T-GE-00003

Issue Date: 11 February 2022

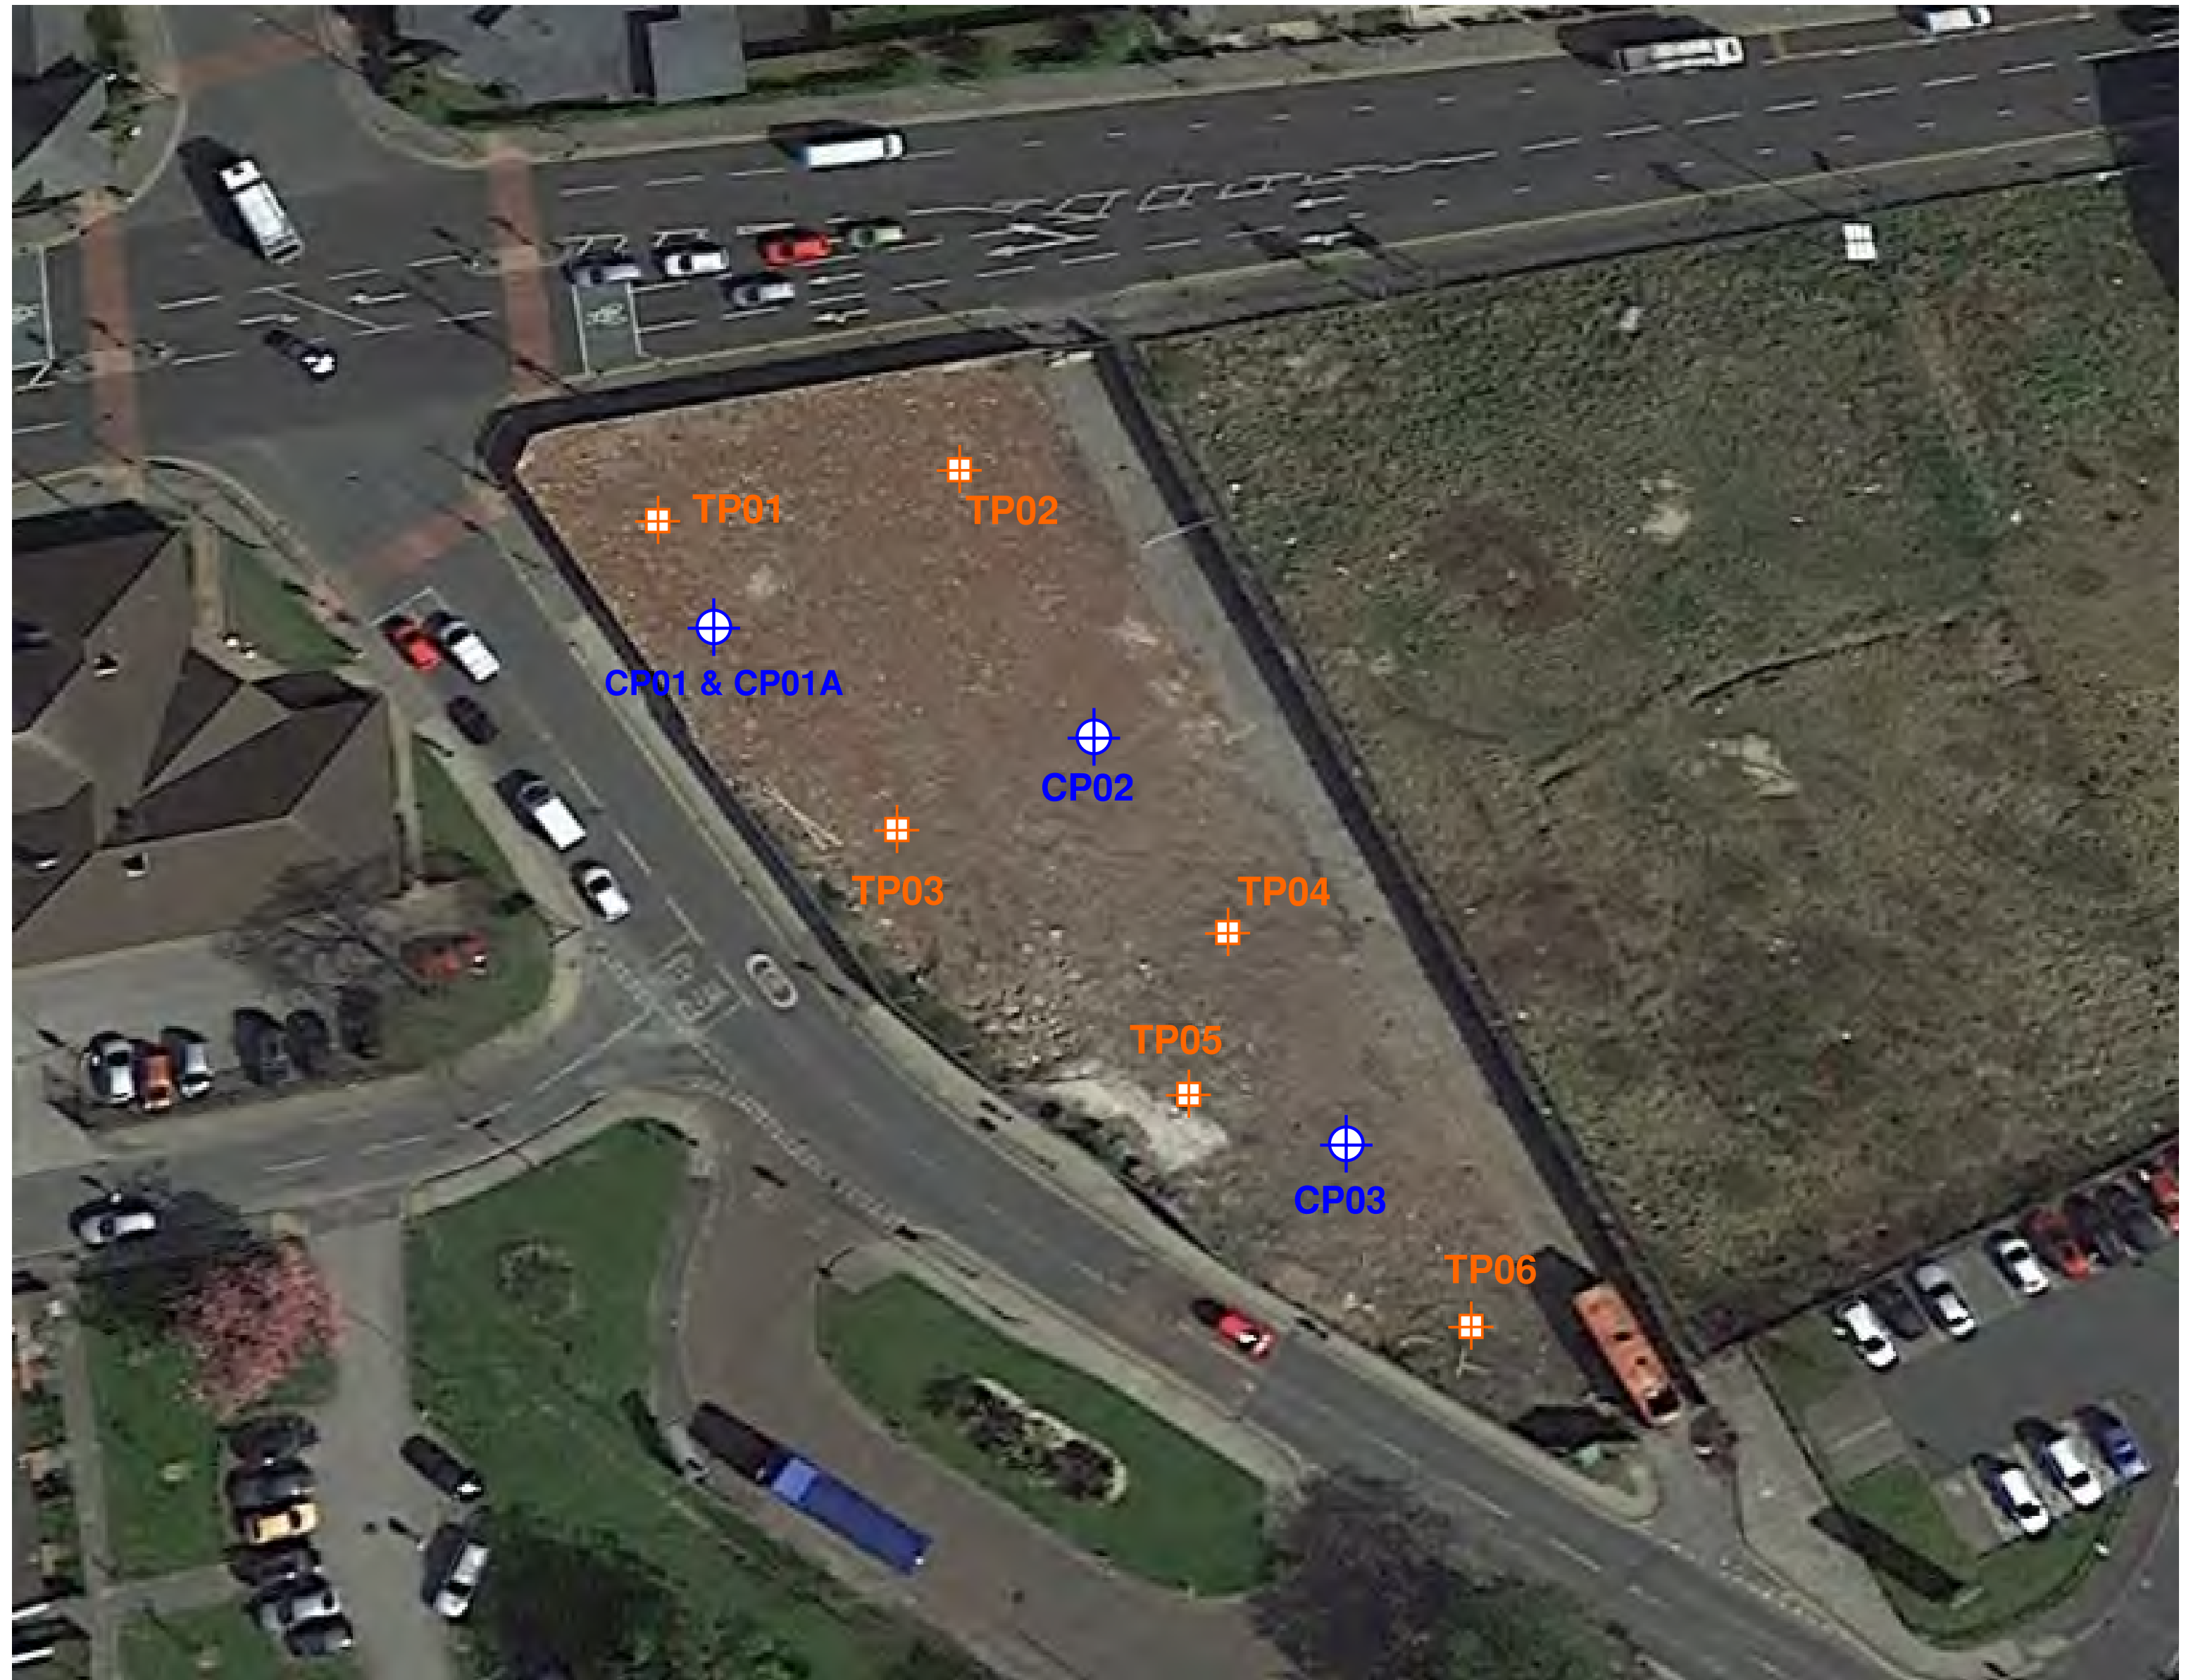
Cable Percussive Boreholes up to 30m bgl

Machine Excavated Trial Pits up 3.50m bgl
