Land at Phase 3, Crown Street, Manchester M15 4NP

## **BAT ACTIVITY SURVEY AT BUILDING 1 (GADDUM HOUSE)**

September 2023

ERAP (Consultant Ecologists) Ltd Reference: 2022-117c

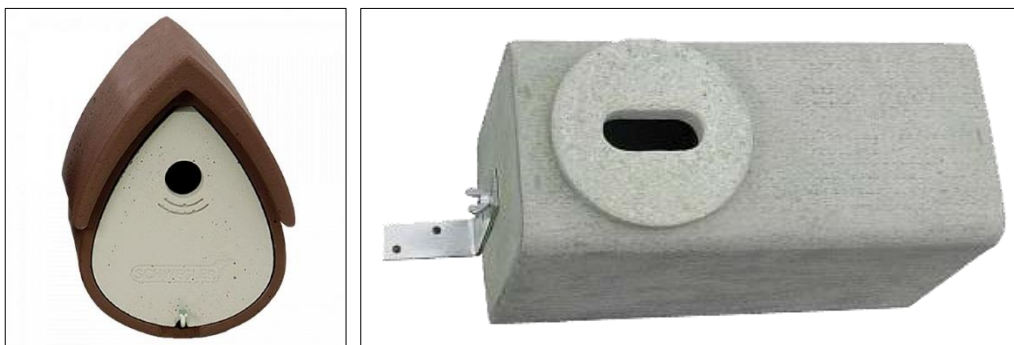
**Insert 1:** Schwegler 1MR Avianex and swift nest box

- 5.4.1 The installation of two general bird nest boxes and two swift nest boxes is recommended at the proposed new buildings.
- 5.4.2 The boxes will not be positioned over windows or doorways where droppings may become a nuisance. RSPB advice states that boxes should ideally be sited facing north to east, to avoid exposure to direct sunlight, which may cause overheating of chicks in the nest. Suitable bird nest boxes are available from NHBS Ecology ([www.nhbs.com](http://www.nhbs.com)) or Wild Care ([www.wildcare.co.uk](http://www.wildcare.co.uk)) and an example is presented at **Insert 1**:

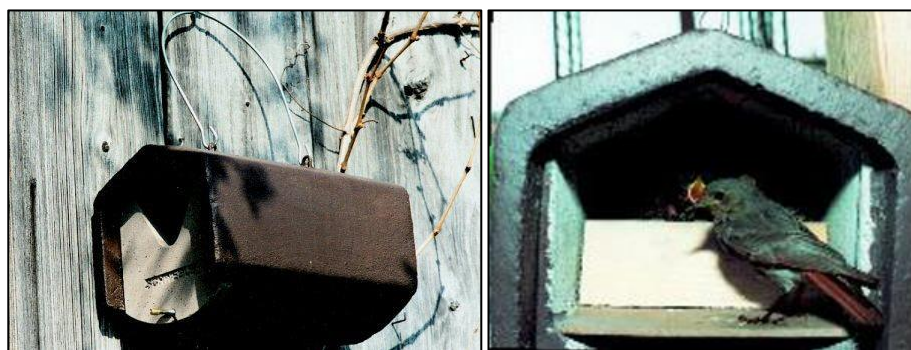
**Insert 3:** Suitable bird boxes for black redstart

- 5.4.9 Two Schwegler 2HW nest boxes will be installed on a north-facing wall within the roofing area. These nest boxes are recommended in the GMBAP for black redstart.
- 5.4.10 The model of box is shown at **Insert 3**.

5.4.12 The black redstart nest boxes are to be checked annually in September / October. Old nest material and other debris will be removed and any damaged or fallen boxes to be repaired / reinstated.

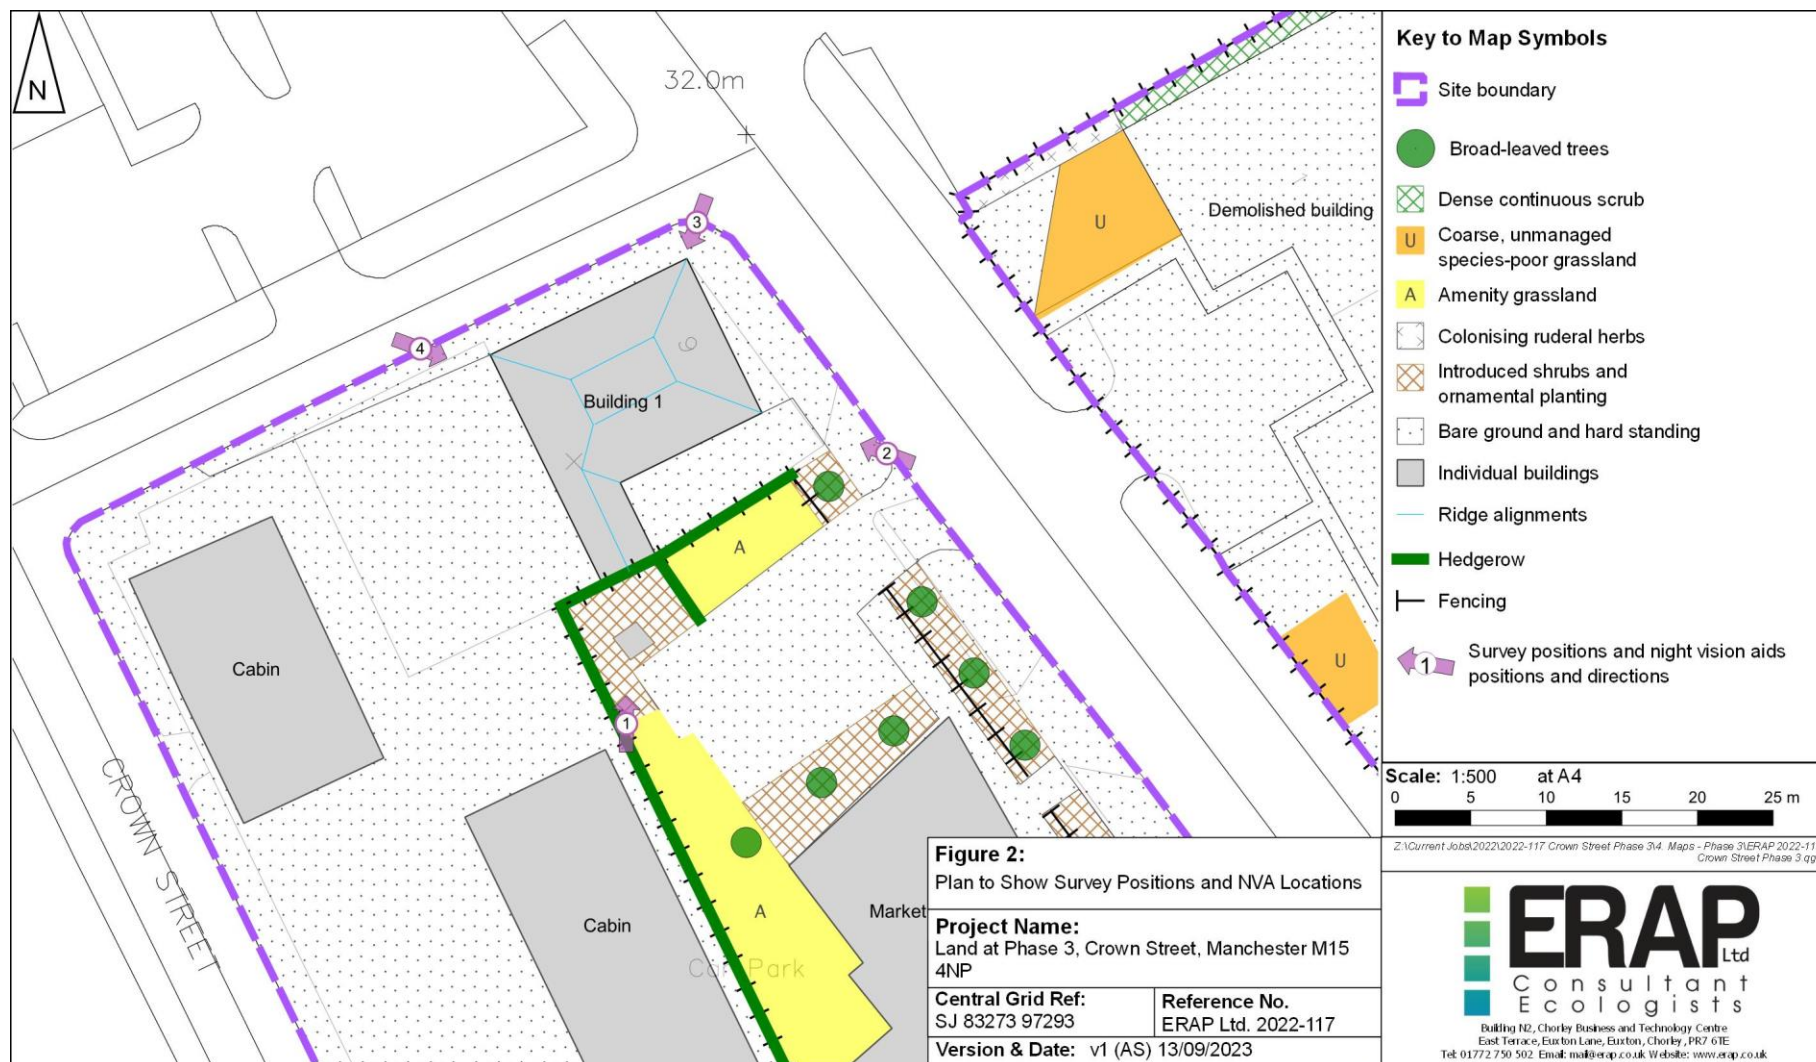
**Figure 2: Plan to Show Survey Positions and NVA Locations**

- 2.1.1 One dusk emergence survey, supplemented by night vision aids (NVAs), was conducted at Building 1 (Gaddum House) on 7<sup>th</sup> August 2023. The survey was conducted under suitable conditions.
- 2.1.2 The dusk emergence survey commenced at least 15 minutes before sunset, and continued until at least 1.5 hours after sunset.
- 2.1.3 Surveyors, experienced in conducting bat surveys, were positioned at suitable locations to maximise the coverage of the building to determine any entry or emergence by roosting bats. Any bat emergence or re-entry activity was recorded, with brief notes relating to bat activity at each survey position collated at the end of the survey.
