# ROYAL BUILDINGS, MANCHESTER

## Preliminary Bat Roost Assessment Report

*June 2023*

Table 3.1 Building Photographs

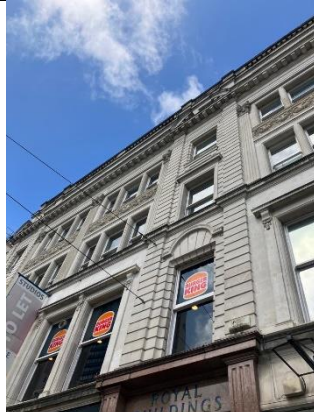
3.2.1. A four-storey white brick office building with a slate tile roof. The external brickwork was found to be sealed and in good condition with no gaps or crevices identified throughout the brickwork of the external walls. The walls throughout the dwelling did not provide any PRF's.

| Feature | Photograph |
|---|---|
| Front of the elevation. | |

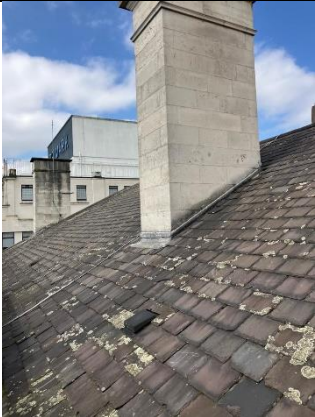
| <i>External slate tile roof</i> | |

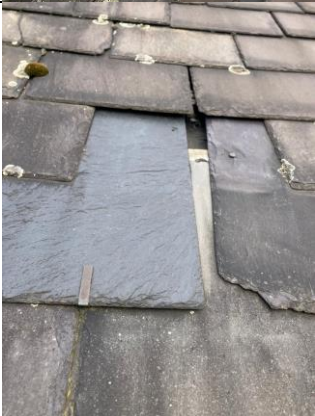
3.2.4. Externally, the windows and doors throughout the building were well sealed and do not provide any internal access. The roof consisted of slate tiles and was accessible throughout the survey. There were several cracked tiles identified along the roof. A notable slipped tile was located on the eastern aspect of the roof and a notable area of slipped tiles were also located on the southern aspect. There was an area of slightly lifted lead flashing surrounding the north-eastern chimney. There were no other notable features identified along the roof, all ridge tiles were well sealed, and all chimneys were made up of breezeblock which were also sealed, they did not create any PRF's. All eaves at the end of the slate tiles could be closely inspected throughout and they were also well sealed.

| <i>Slipped slate tile</i> | |

- 4.1.4. The PWMs would be undertaken under the supervision of a licenced bat ecologist to reduce the risk of killing or injuring any bats that may be affected during proposed works on the roof:

- The licenced ecologist will undertake a daylight inspection to assess the status of the site for bats prior to works commencing on site.
  - The licenced ecologist will attend site on the day of the scheduled works to undertake a search for bats in relation to the potential roosting features identified during the PRA prior to the works commencing. If any bats are located, all works will cease, and Natural England is to be contacted immediately and a licence to be obtained.

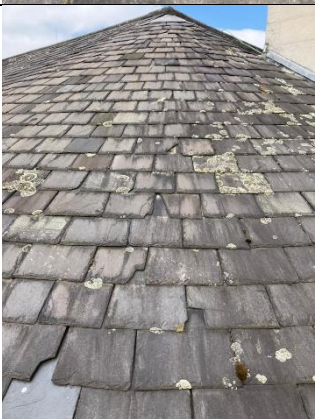
| <i>Cracked tiles along the roof.</i> | |

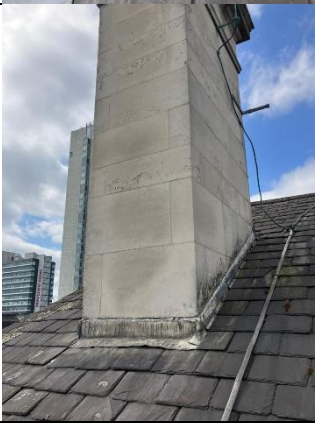
| <i>Lifted led flashing surrounding chimney.</i> | |

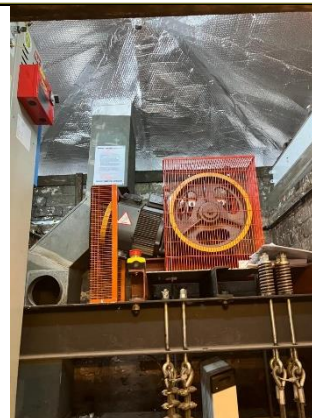
3.2.2. All internal rooms throughout the building are currently used as offices or teaching areas, some of these rooms are currently vacant, all rooms are well sealed and rendered throughout. There was an accessible loft space within the building which could be fully inspected throughout the survey. The entrance into the loft space consisted of a small square area surrounded by thermal foil insulation throughout, this was well sealed and did not provide any PRF's.

Entrance room with foil insulation.

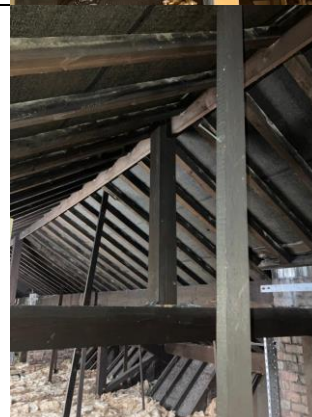
3.2.3. The remainder of the loft space consisted of roofing felt with supporting wooden beams throughout. A wooden footpath was located throughout the loft which allowed for a full walk through, the remainder of the floor consisted of insulation. The roofing felt was found to be in good condition overall with only some tears occurring throughout the loft. A red brick wall was located on the south-western aspect of the loft, which was mainly sealed with only minimal gaps, these gaps could not support roosting bats and were not considered a PRF. There was a total of two red brick chimneys located within the loft space which were found to be well sealed throughout. A total of three gaps were located adjacent to a redbrick chimney on the north-eastern aspect of the loft. A further gap was located on the north-eastern aspect of the roof adjacent to the second redbrick chimney, it was unknown if these led externally as they were not accessible internally. However, the gaps were not identified on the external inspection. There were no bat droppings or feeding remains identified throughout the loft space.

Internal loft space

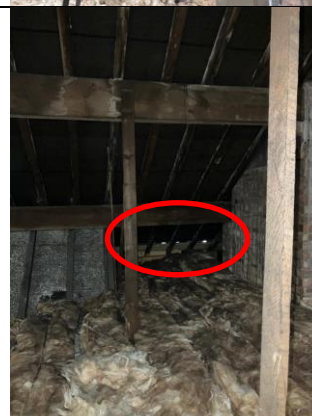
Internal loft space with gaps in roofing felt circled.

3.3.1. The survey identified multiple PRF's throughout the building in relation to the slate tile roof and the tears within the roofing felt. The building was assessed as providing 'low' bat roosting potential due to the identified PRF's.
