## **BAT PRESENCE / ABSENCE SURVEY**

### **2 Banner Walk**

Beswick  
Manchester  
M11 3TD

| UES reference: | UES03959/02 |

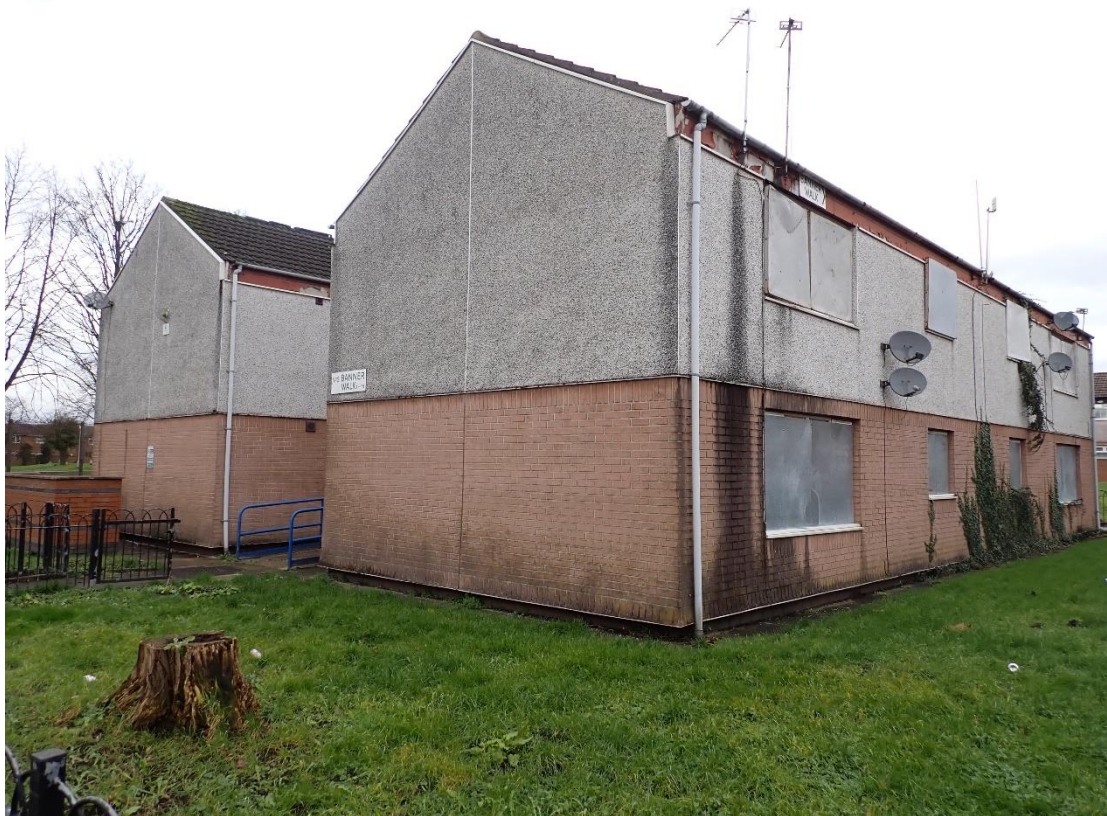
Photograph 1. South-eastern aspect of the building.

cluttered to present a PRF (Photograph 2). The walls are constructed from red brick, with a pebbledash render on the upper half of the building and a PVC capping (Photograph 1). There is a gap at the top of the wall plate where it connects with the bargeboard on the eastern aspect of the building near a window that provides a PRF (Photograph 4). Sections of the wall on the eastern aspect of the building are also obscured by ivy, but this is too cluttered to be a PRF (Photograph 2). On the northern aspect of the building there is an electrical box which is open at the bottom and could present a PRF (Photograph 7). The electrical box was inspected using a torch and binoculars; however, it could not be fully inspected from the ground level during the survey due to the height of the feature. Most of the windows were covered in metal sheets or wooden boards which could provide PRFs for bats as there are gaps between the coverings and the windows that vary in size (Photographs 2 and 15). The features were inspected using a torch and endoscope where necessary, and no evidence of roosting bats was found.

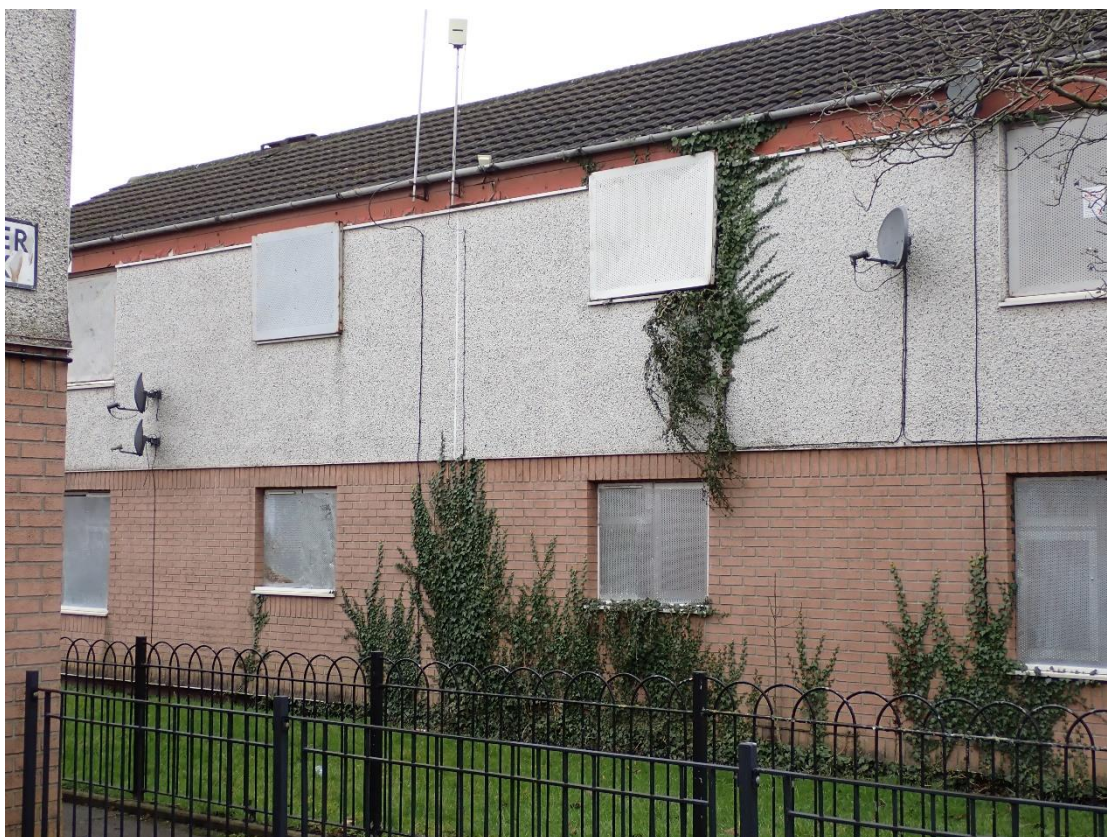
Photograph 2. Eastern aspect of the building.

Wooden bargeboards are located at the eaves of the building, but they are in relatively poor condition due to peeling (Photograph 4). There is a gap underneath the bargeboard on the southern aspect of the central corridor (Photograph 5) and a gap within the bargeboard on the northern aspect of the central corridor (Photograph 6), that both provide PRFs. The bargeboard on the eastern aspect of the building is partially obscured by ivy, however, it is too

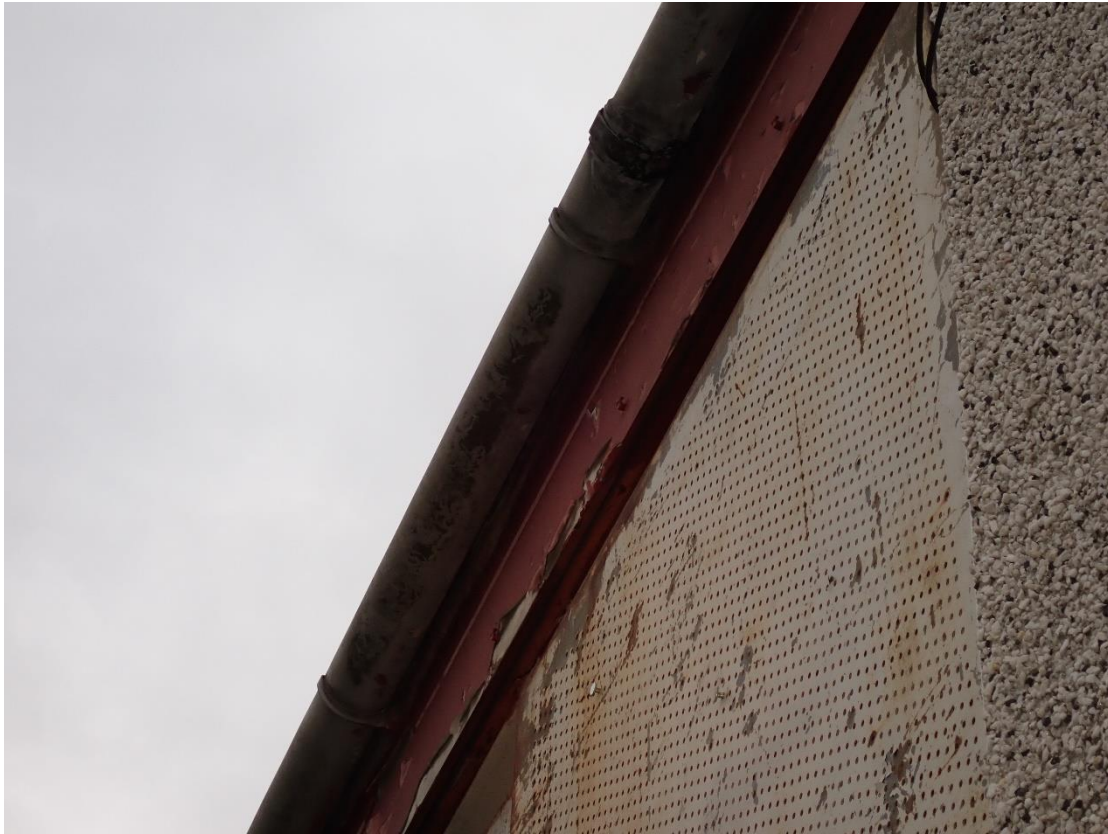
Photograph 3. Potential roosting feature where the wooden bargeboard meets the underside of the roof tiles, behind the drainpipe.

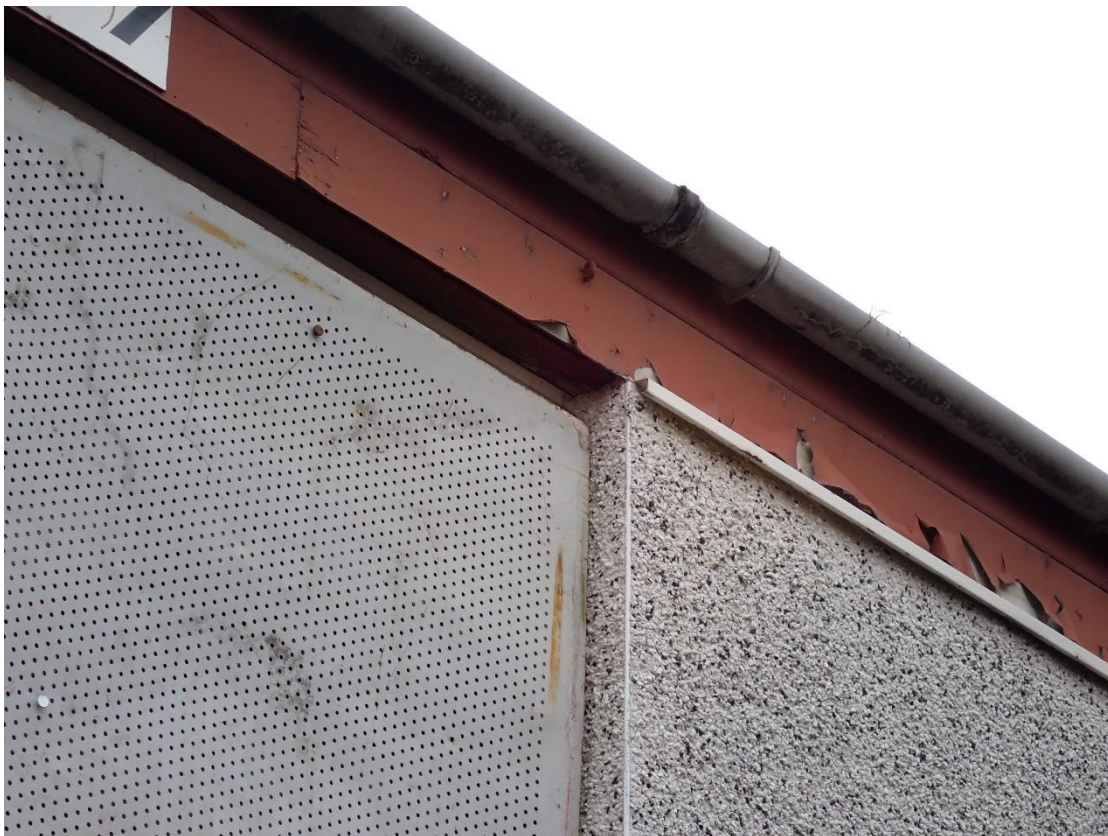
Photograph 4. Wooden bargeboards located at the eaves of the building.

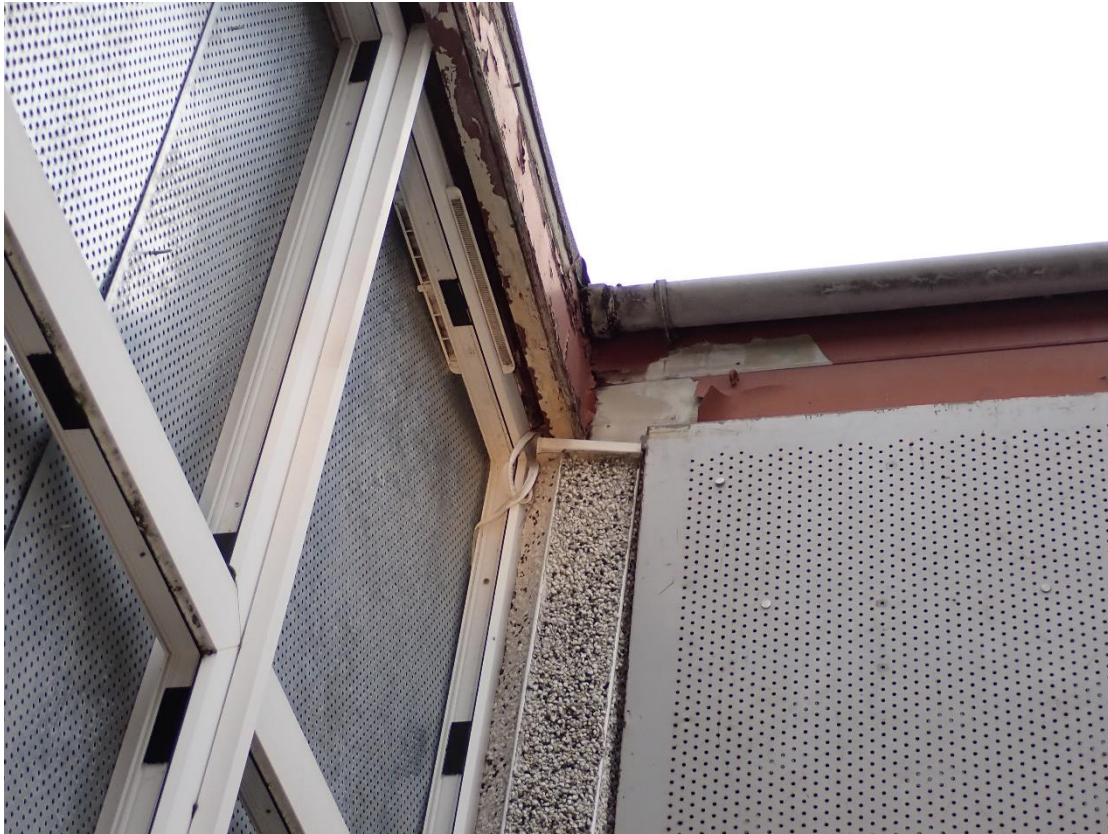
Photograph 5. Gap under the bargeboard on the southern aspect of the central corridor.

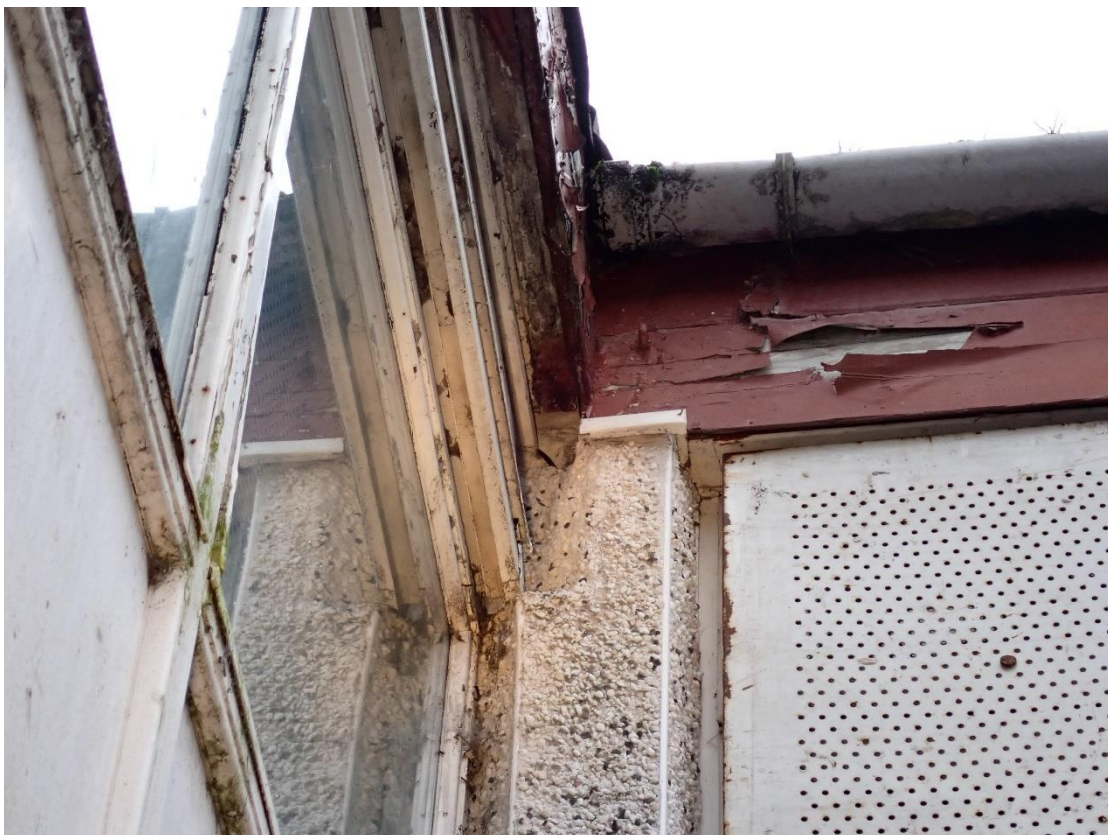
Photograph 6. Gap in the bargeboard on the northern aspect of the central corridor.

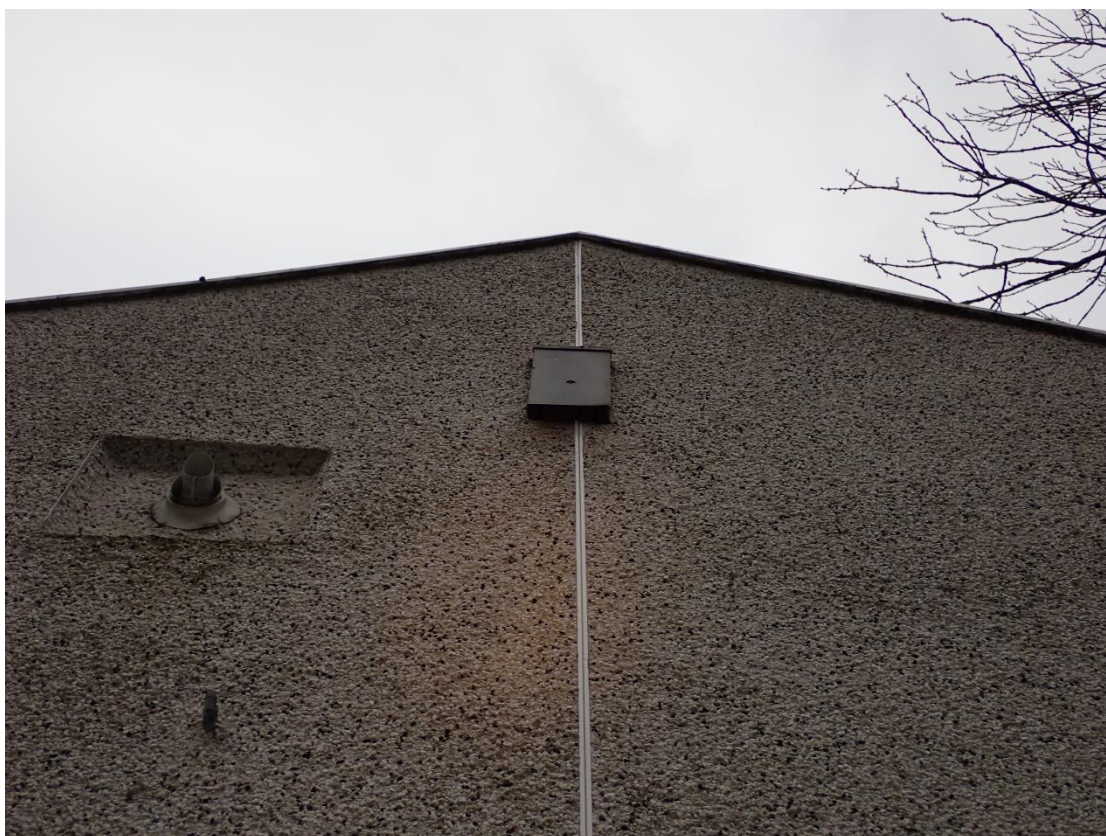
Photograph 7. Electrical box on the northern aspect of the building.

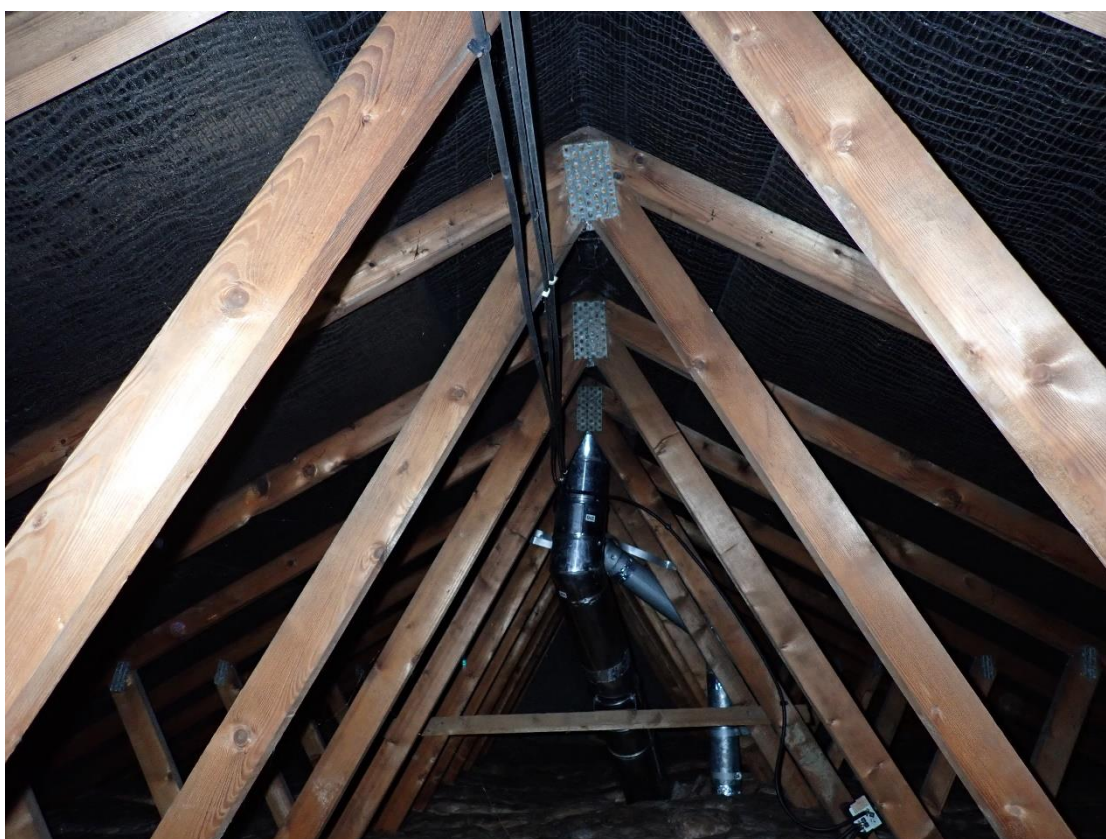
Photograph 8. Loft space of Flat 13; representative of all of the loft spaces in the building.

Each of the four flats on the first floor have separate loft spaces, all of which share the same construction layout. The loft spaces have a queen's post truss structure with a bitumen felt roof lining (Photograph 8). Each of the internal loft spaces had a central ventilation system with a gap around it that provided a potential access point into the loft (Photograph 9).

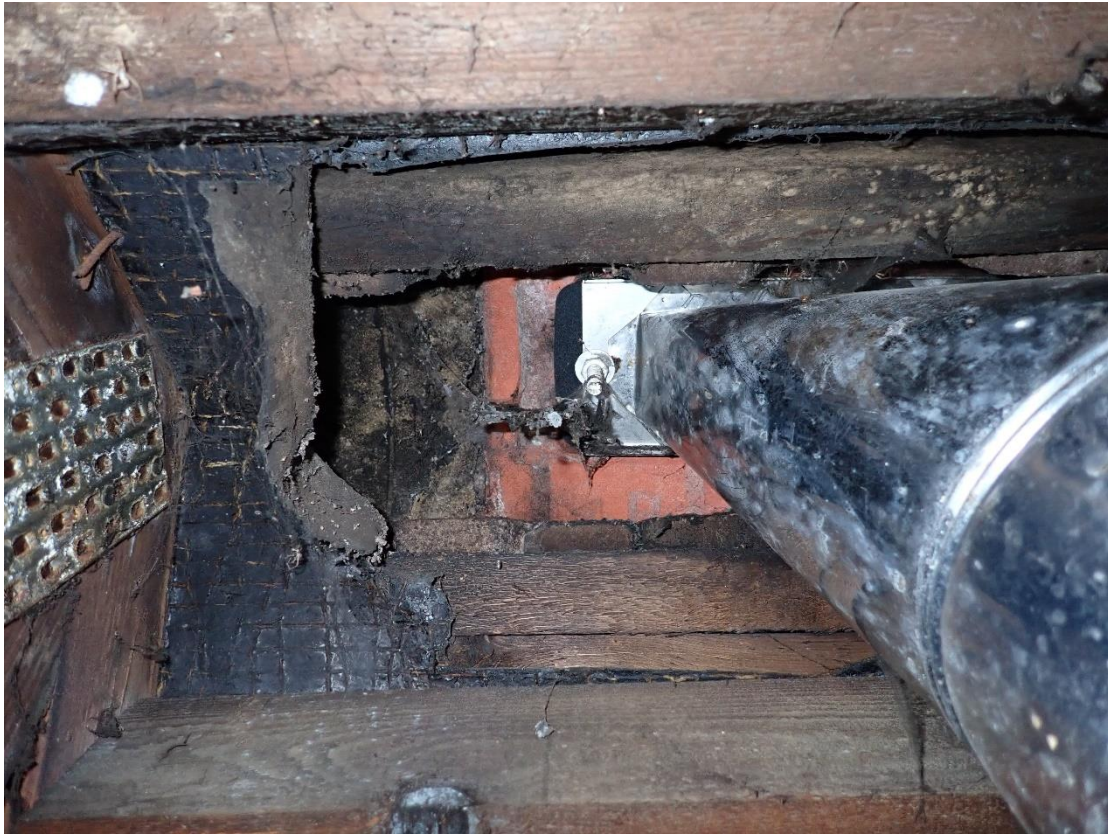
Photograph 9. Ridge tiles are visible around the central ventilation system in Flat 13. The same feature is present in each of the loft spaces.

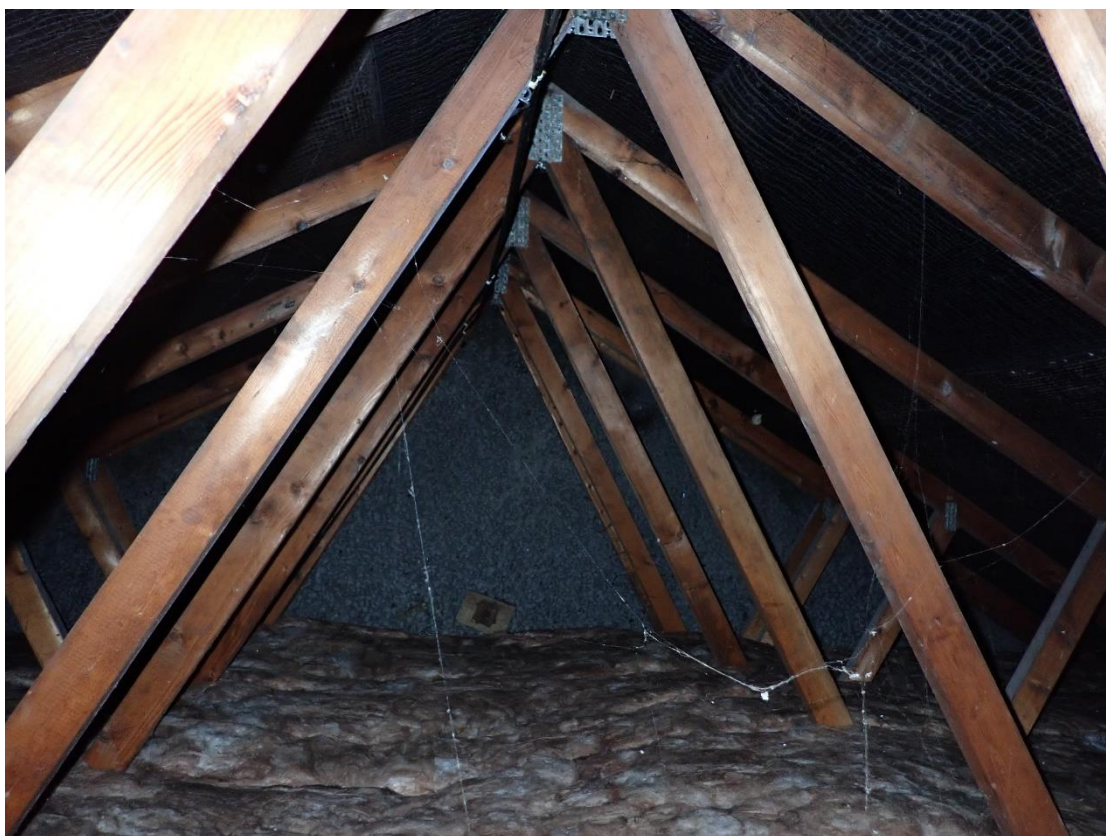
Photograph 11. North internal stone render wall and rock wool floor insulation in Flat 13.

There are two internal stone render walls in each of the loft spaces, on the northern and southern aspects (Photographs 10 and 11). The stone walls were in good condition in all of the loft spaces with no noticeable cavities, except for Flat 11. The floors are insulated with mineral wool insulation and there were no draughts in the loft spaces during the survey (Photograph 11).

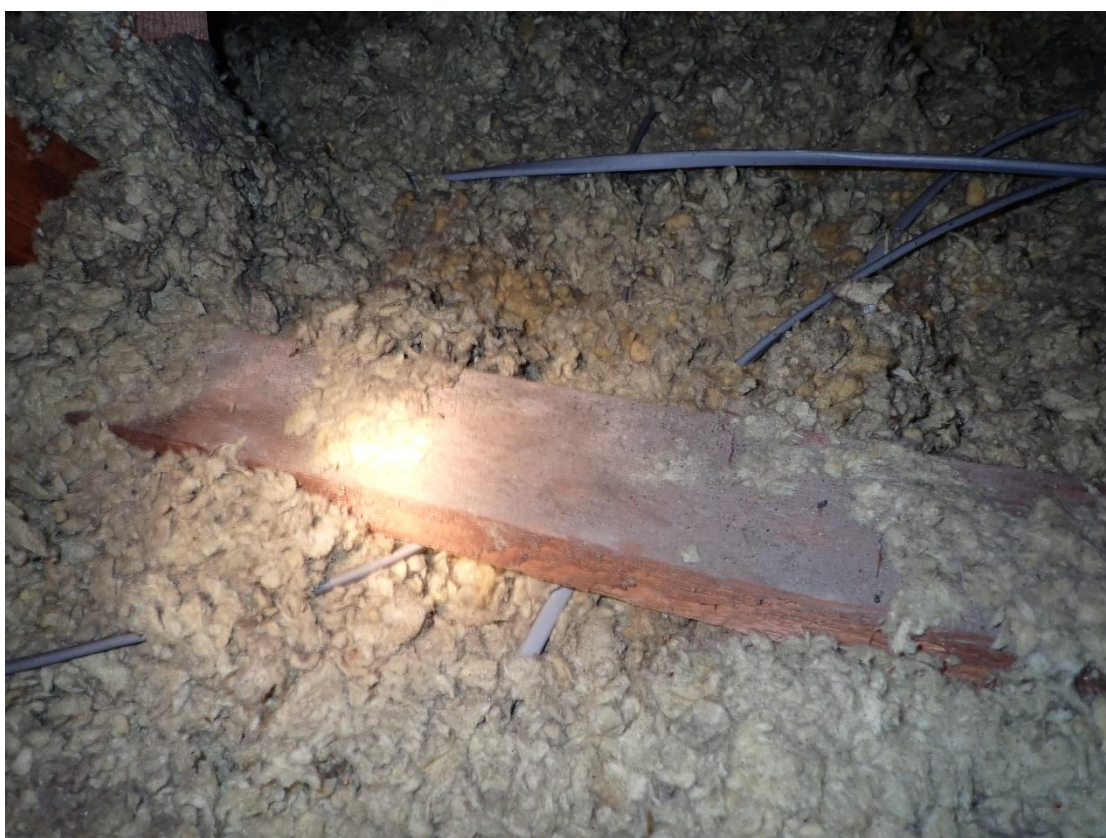
Photograph 12. Mouse droppings identified in the loft space of Flat 9.

**Flat 9** is located on the north-eastern aspect of the building and the loft space was accessed by a ceiling hatch. A section of the roof space was also visible from the cupboard in the bathroom. Old mouse droppings were identified in the loft space (Photograph 12), but no evidence of roosting bats was found.

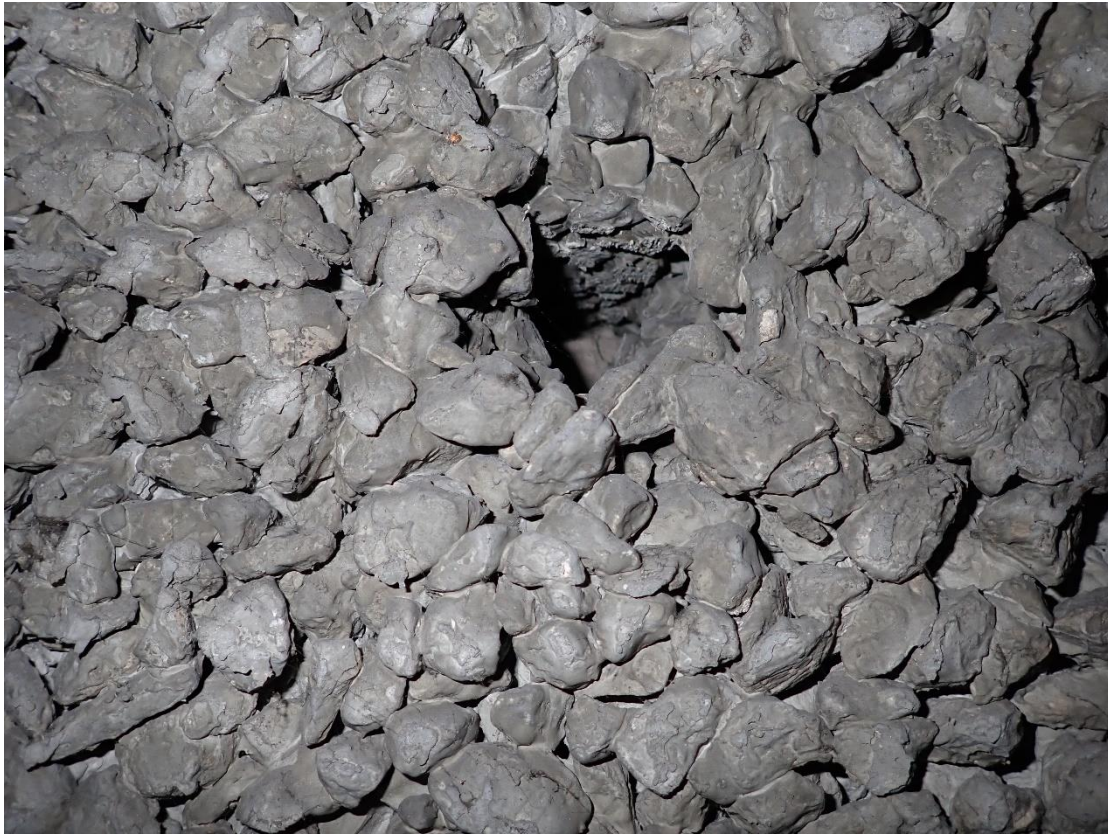
Photograph 13. A hole in the south internal stone render wall in the loft space of Flat 11.

**Flat 11** is located on the south-eastern aspect of the building. The internal stone render wall on the southern aspect has a cavity that provides a PRF. The feature was inspected but no evidence of roosting bats was found (Photograph 13). Mouse droppings were identified in the loft space, but no evidence of roosting bats was present.

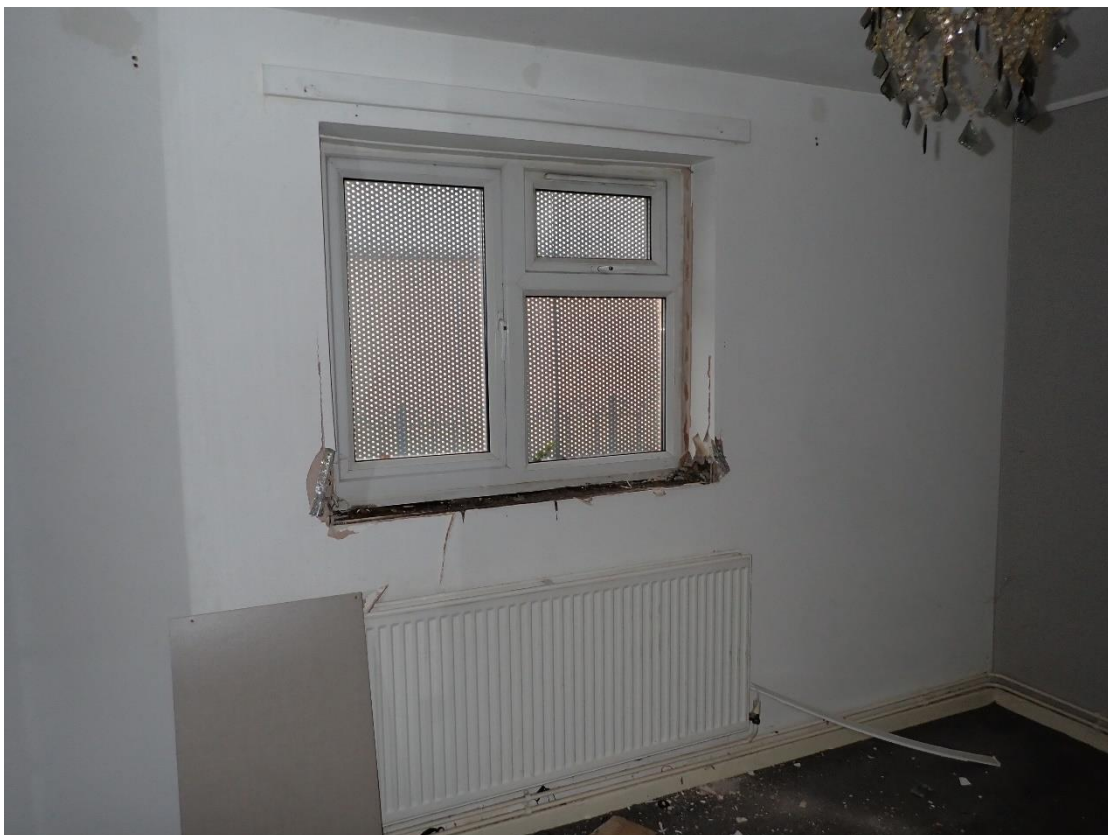
Photograph 14. Flat 1.

The four flats located on the ground floor of the property (Flats 1, 3, 5 and 7) were also inspected (Photographs 14 to 18).

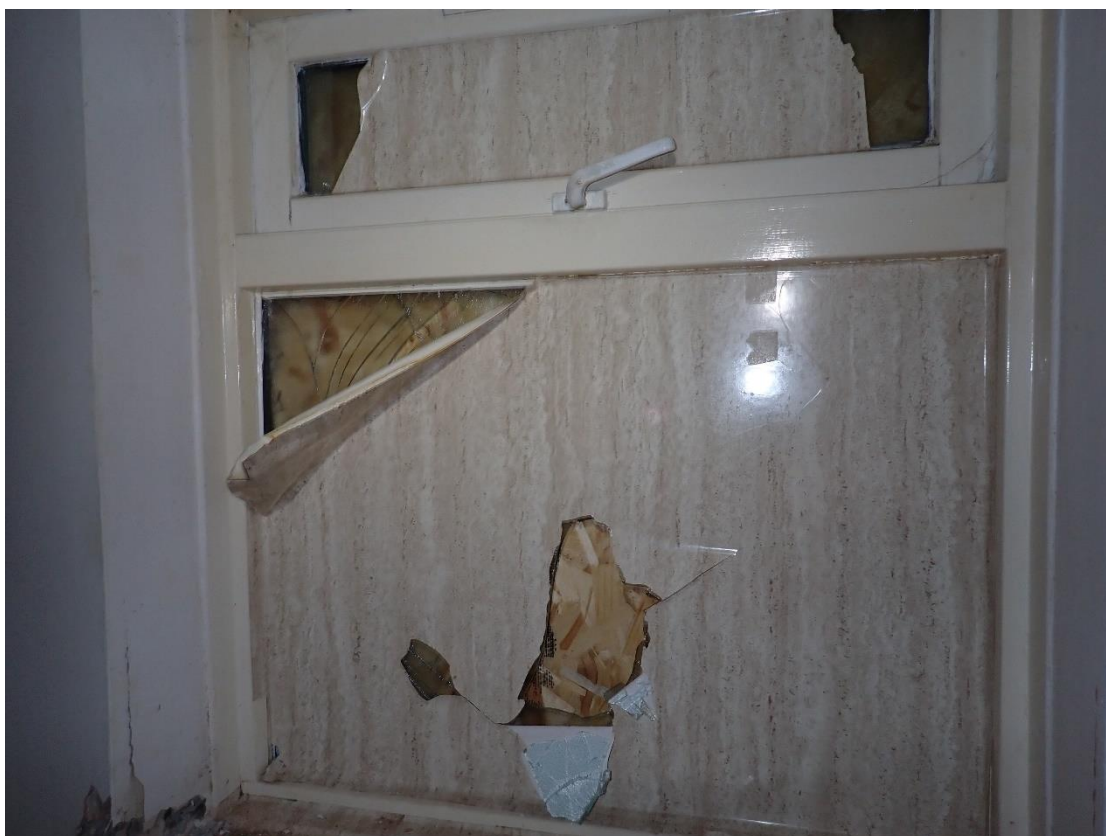
Photograph 15. Wooden boards behind a window in Flat 1.
