# LONGLEY LANE, NORTHENDEN

## Preliminary Bat Roost Assessment & Nocturnal Bat Survey Report

*August 2023*

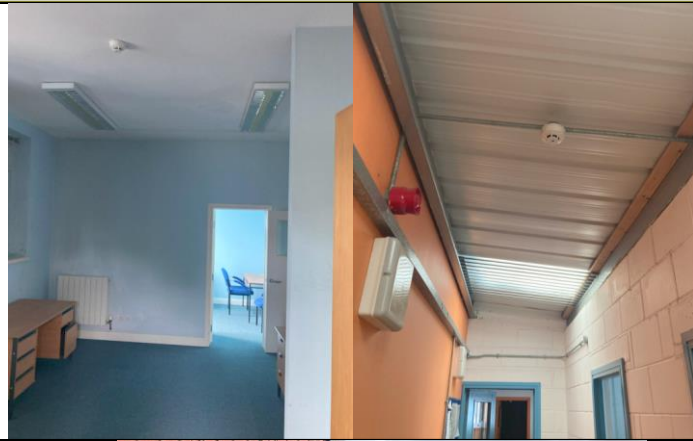
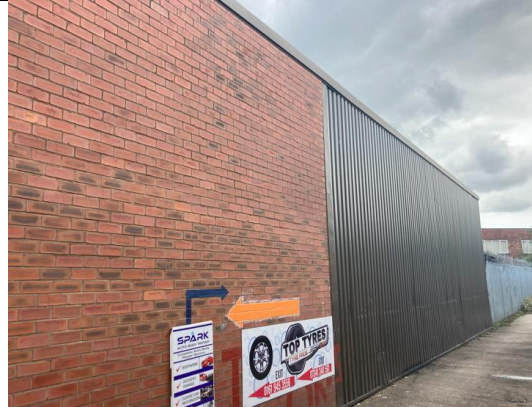
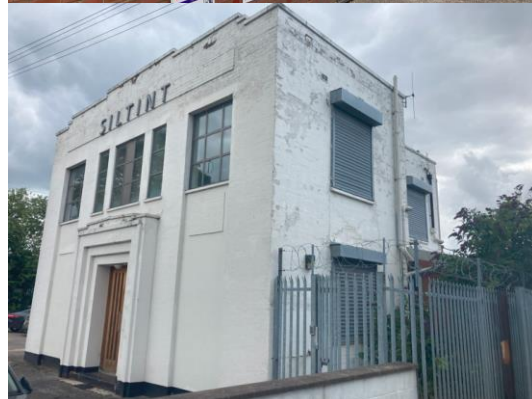
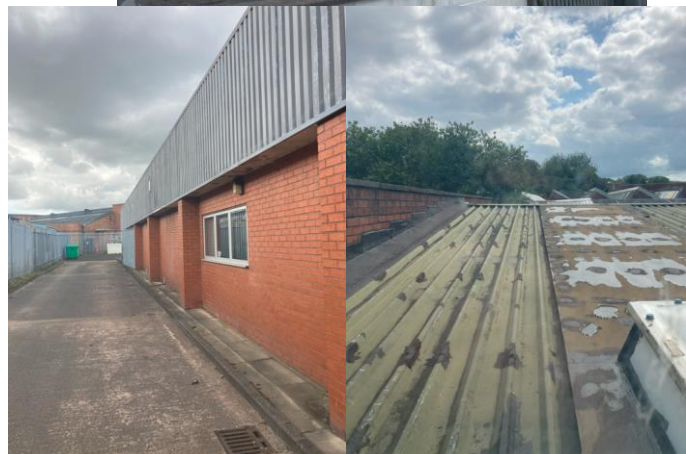
External building photographs – Redbrick warehouse building. brickwork mostly well sealed. White brick building all well sealed. Corrugated metal walls, no gaps, well-sealed.

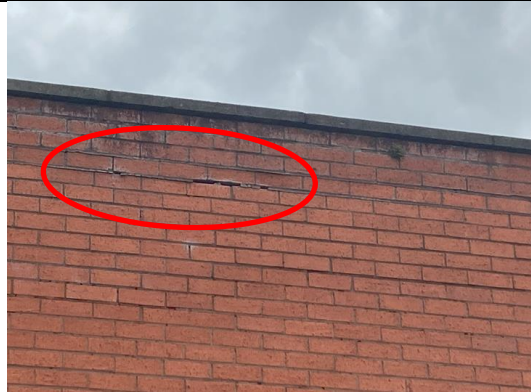
- 3.2.5. A gap in a vent was present on the southwest aspect. This may lead into the building and provide internal access for roosting bats.
- 3.2.6. Gaps in mortar were identified on the northeast aspect of the building. This may lead to a crevice and be utilised by crevice dwelling bats.

*Gaps in mortar on the northeast aspect*

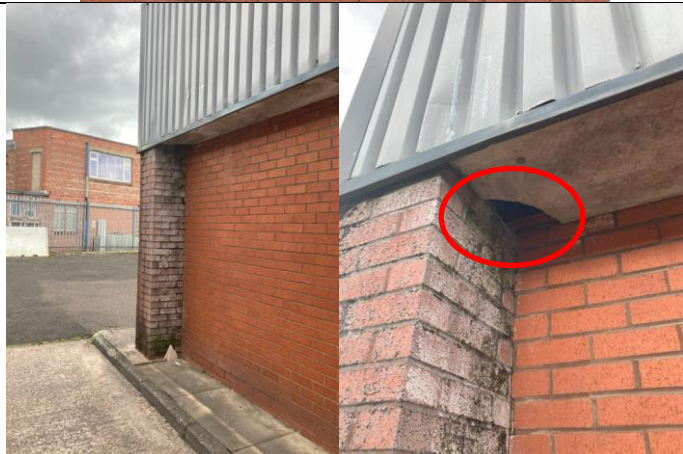
- 3.2.4. An external gap in the soffit boarding on the southern corner of the southeastern aspect may provide a PRF, suitable for low numbers of crevice dwelling bats.

*Gap in soffit boarding located in south corner of southeast aspect.*

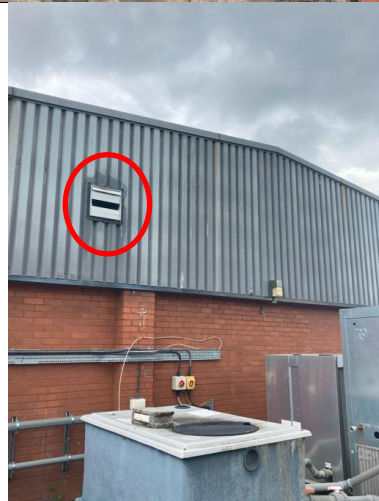
*Gap in vent on southwest aspect.*

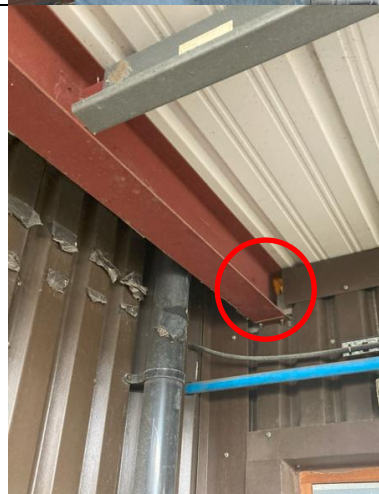
- 3.2.8. Please refer to Table 3.1 for photographs.
- 3.2.9. The survey identified limited PRFs and potential external access points in relation to the gap in soffit boarding, gap relating to the iron support and missing mortar. As such, the building was assessed as having low bat roosting potential.

*Gap next to steel support beam giving internal access.*
