# Bat

# Presence-Absence Survey

Building B3

7 Chapel Street

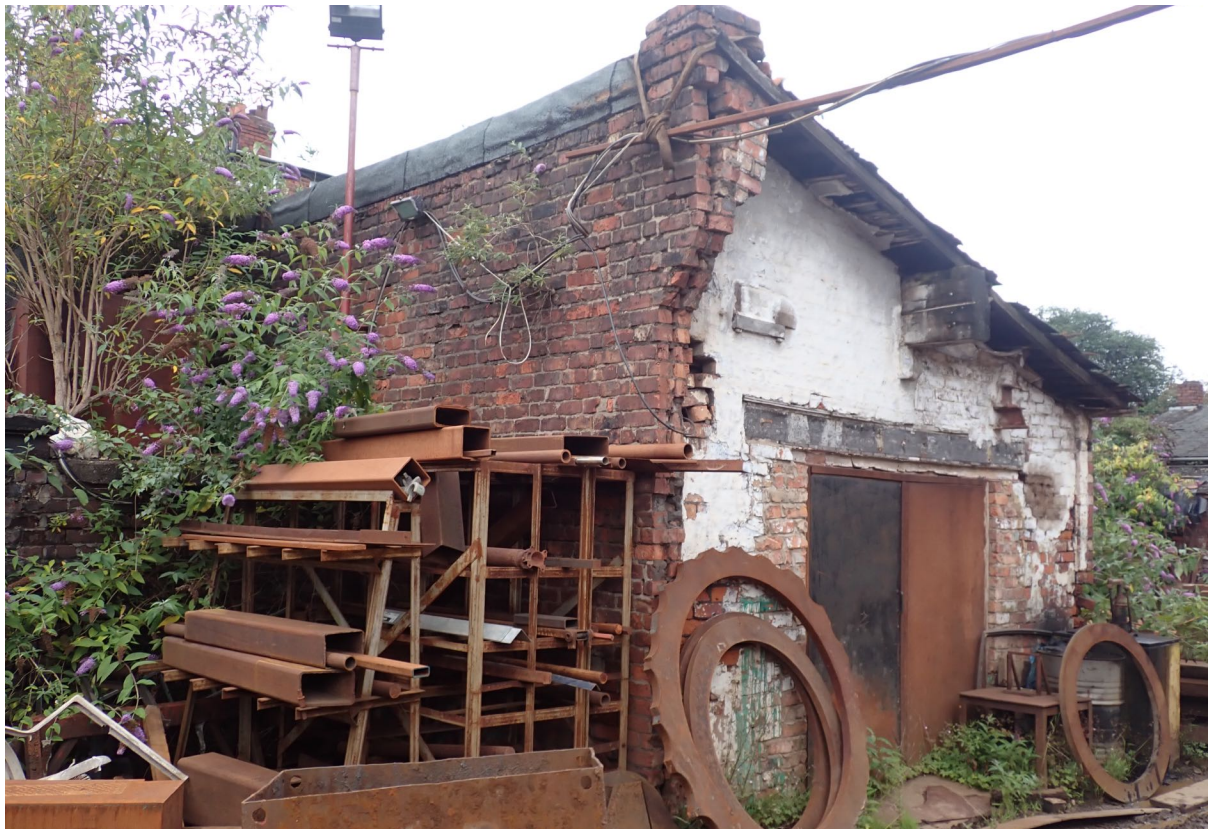
3.1a - The front of the house, and driveway.

Building B3 is a brick storage shed, which was formerly part of a larger workshop to the south. The building has been sealed shut. It has a single pitched roof covered with slate roof tiles, with bitumen felt laid on top. The roof pitch faces east; gable ends face north and south. There are no chimneys, and no lead flashing is fitted. Timber fascia boards are fitted at the eaves on the east side.

Walls are solid brick with no insulating cavity, lintels are timber, sills are timber. Window frames are timber, and have been bricked up from the inside, glass is partially intact. The building is in poor condition, with a number of gaps between roofing materials and brickwork on the southern wall. Roof tiles are covered with a continuous mat of bitumen felt, with no gaps between tiles or felt.

Timber fascia boards are in poor condition, with minor gaps which could lead into the building. Walls are in reasonable condition, although there are a number of gaps and holes on the southern wall.

With the exception of gaps at the eaves, and gaps in brickwork on the southern wall, there are no features externally which are likely to be used by roosting bats.

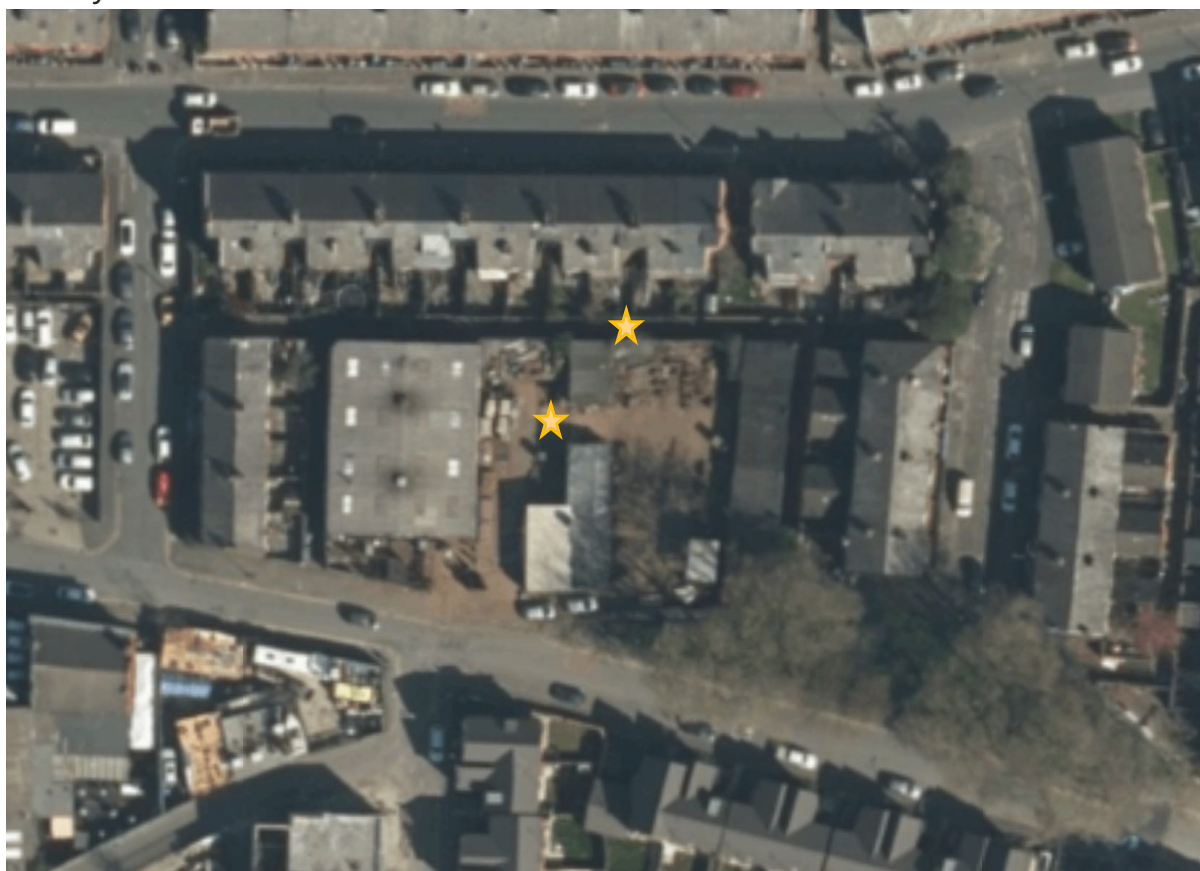
4.1a – Surveyor locations and bat activity.

The only bat recorded during the survey was a common pipistrelle at 22:14, 69 minutes after sunset. The bat was heard passing to the south of the site.

The level of bat activity during the survey was low with no other passes recorded. A maximum of one bat was recorded in flight at any one time during the survey.

No bats were recorded emerging from the building during the survey.
