# **APPENDIX IV PHOTOGRAPHS**

## **E3P EXPLORATORY HOLE LOGS**

| Project Name: Kenyon Lane | Project No. 16717 | Co-ords: 387579.00 - 401148.00<br>Level: | Date<br>22/06/2023 |

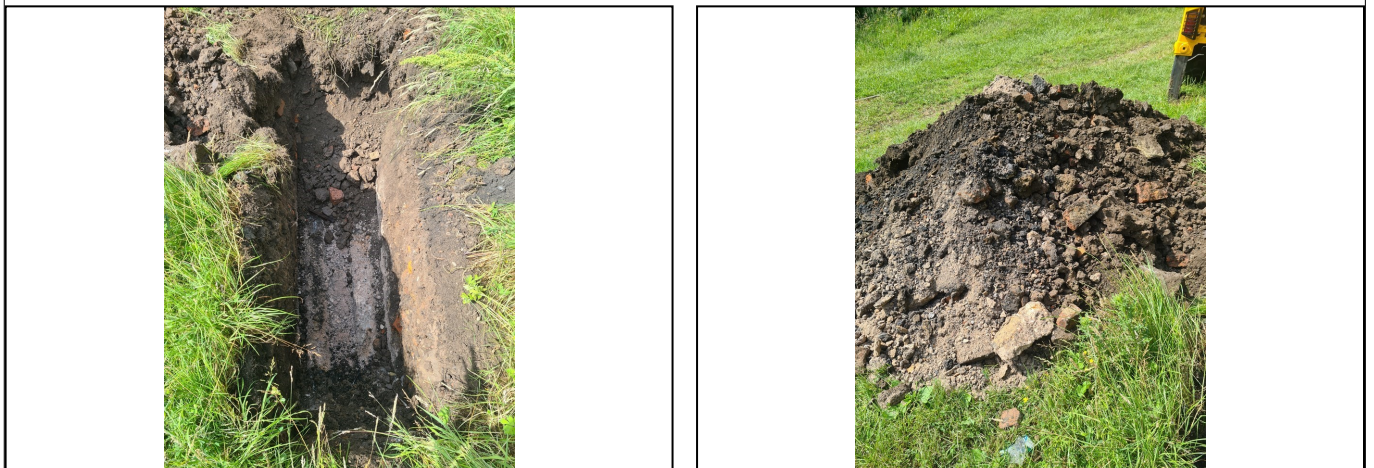
Trial Pit 102

| Water Strike | Samples & In Situ Testing | | | Depth (m) | Level (m) | Legend | Stratum Description | |
|---|---|---|---|---|---|---|---|---|
| | 0.20 | ES | | 0.30 | | | MADE GROUND: Greyish black slightly gravelly clayey medium to coarse sand with frequent roots and rootlets. Gravel is fine to coarse subangular to angular of brick and mudstone. (Topsoil) | |
| | 0.80 | ES | | 1.10<br>1.20 | | | MADE GROUND: Greyish brown clayey gravelly medium to coarse sand with pockets of black silty clay and frequent cobbles. Gravel is fine to coarse subangular to subrounded of brick, mudstone and plastic. Cobbles are subangular to angular of intact bricks. | 1 |
| | | | | | | | MADE GROUND: Concrete. (Recovered as a greyish brown sandy gravel) | 2 |

Remarks: 1. Terminated on concrete slab at 1.20 m bgl. 2. Strong hydrocarbon odour encountered from 0.70 m bgl.

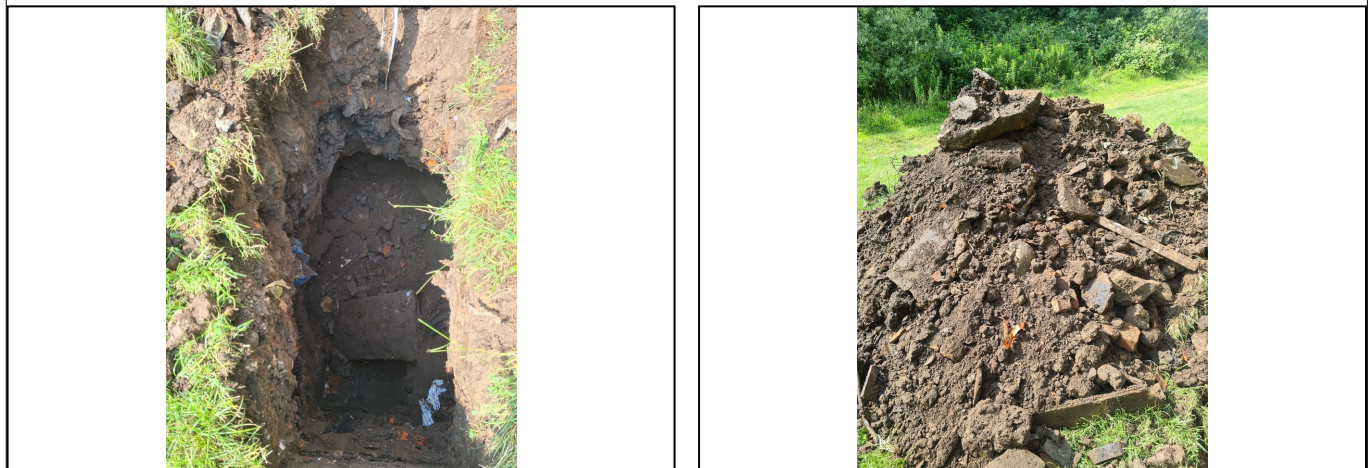
Trial Pit 103

| Water Strike | Samples & In Situ Testing | | | Depth (m) | Level (m) | Legend | Stratum Description | |
|---|---|---|---|---|---|---|---|--|
| | | | | 0.25 | | | MADE GROUND: Brown slightly gravelly clayey medium to coarse sand with frequent roots and rootlets. Gravel is fine to coarse subangular to angular of brick and mudstone. (Topsoil) | |
| | 2.00 | ES | | 2.50 | | | MADE GROUND: Greyish brown clayey gravelly medium to coarse sand with frequent cobbles. Gravel is fine to coarse subangular to subrounded of mudstone, glass and brick. Cobbles are subangular to angular of bricks, metal, plastic and wood. | |

Remarks: 1. Terminated at 2.50 m bgl due to large concrete blocks restricting excavation. 2. Slight organic odour encountered within Made Ground.
