# Appendix A

## Emerging Water Discovery

# Appendix A1 - BAM Report on initial Cheetham Hill Culvert

## On site investigation works to attempt to locate the believed route of Cheetham hill culvert

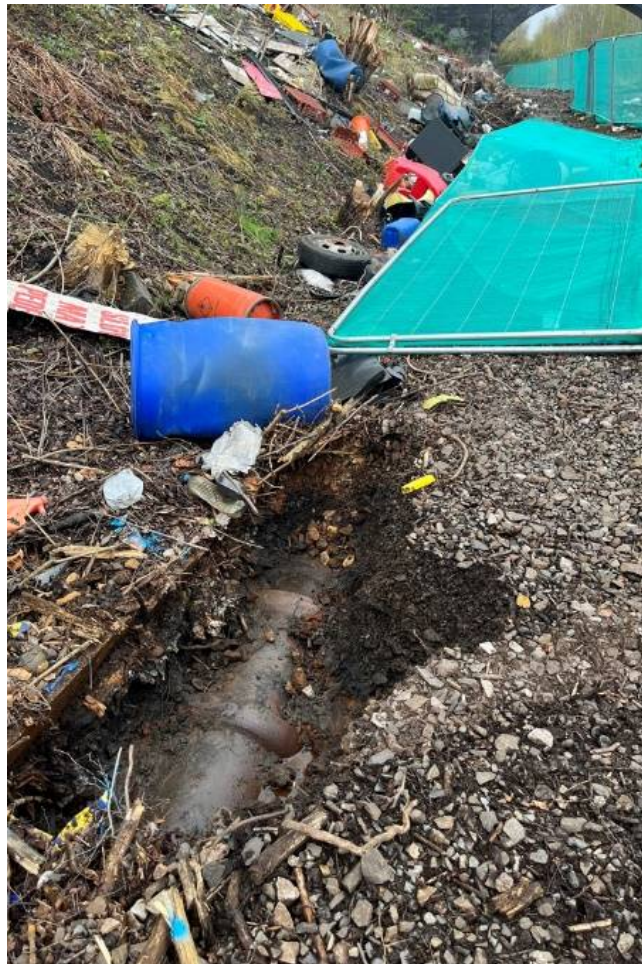
B. Clay pipe work of culverted section of drain

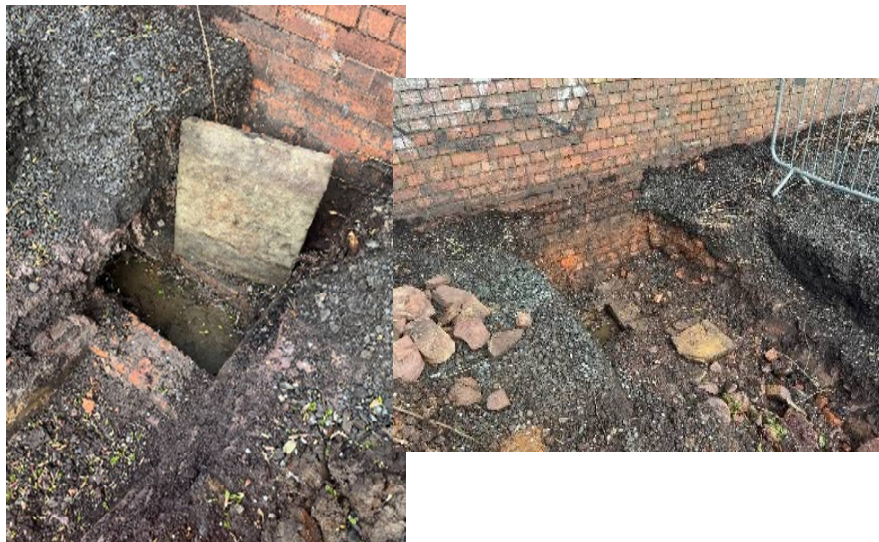
D. Identified areas of culvert/drain construction

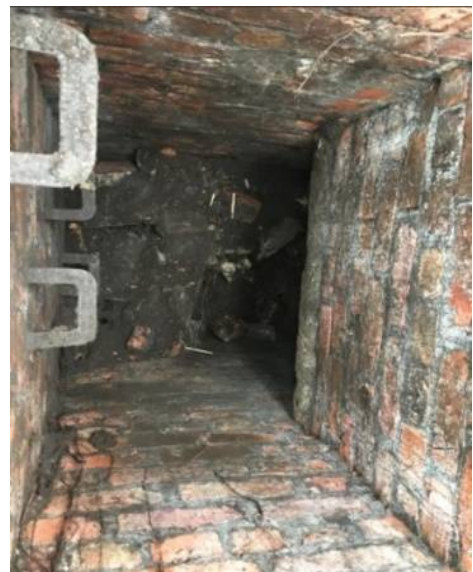
F. Manhole Chamber

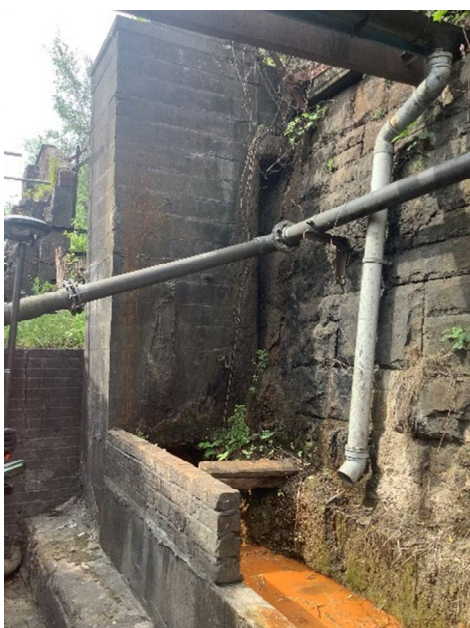
Photos taken 2022 Showing route of culvert to river outfall

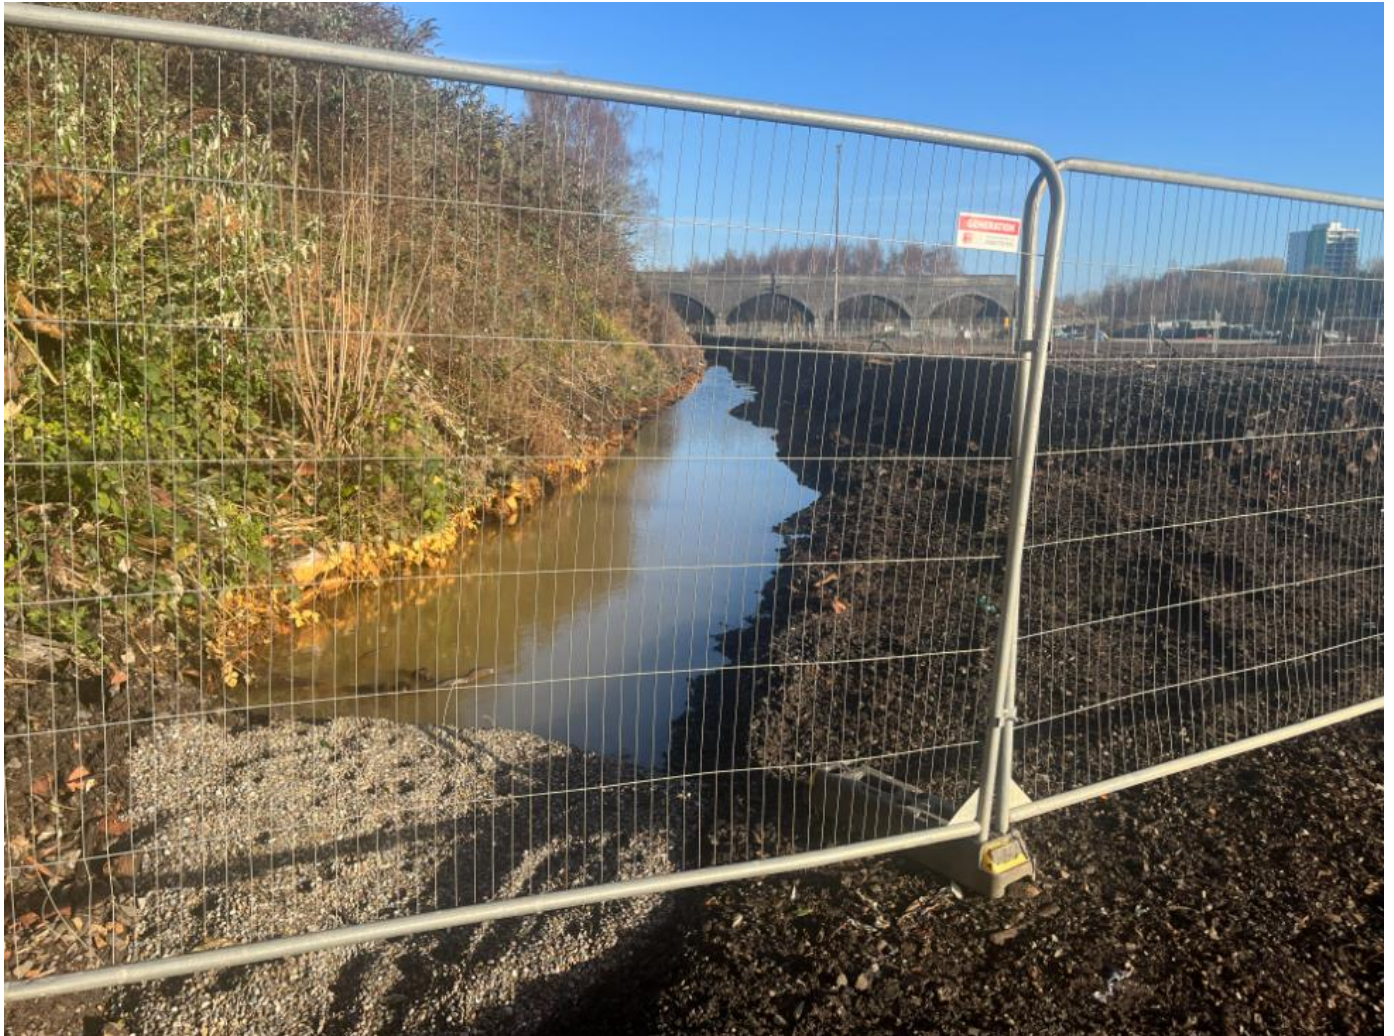
1. Standing water backing up towards Lowry Bridge, coming from a pipe under Lowry Bridge and a pipe under Showman's guild.

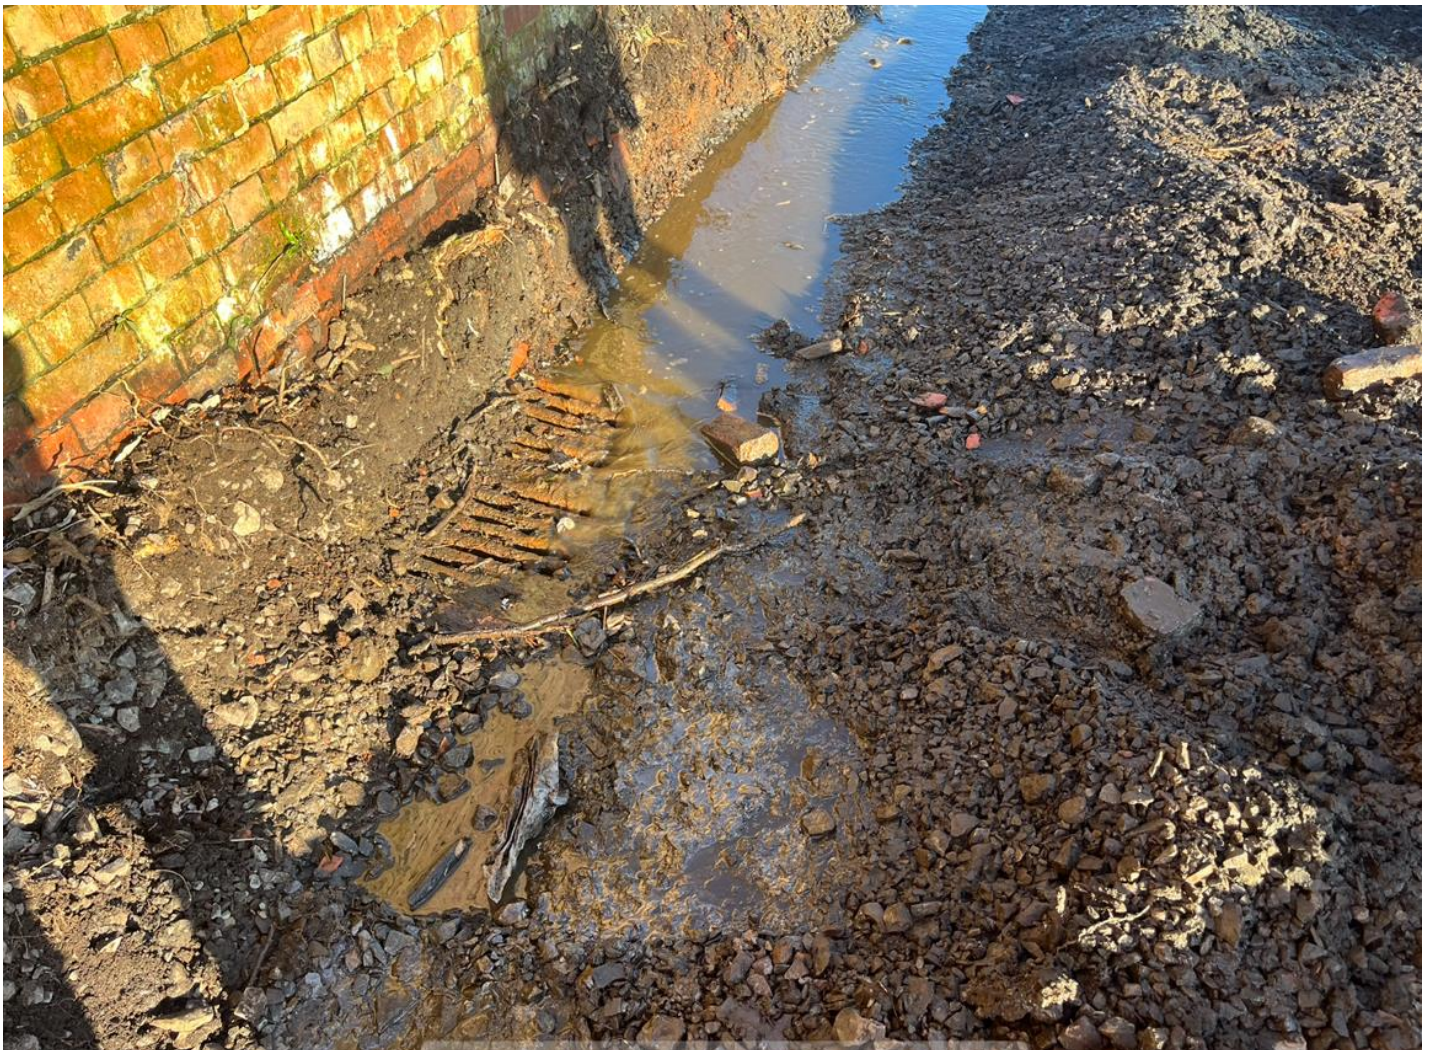
2. The water has been running into an underground channel via this 800mm x 400mm grate. The channel consists of a brick and Yorkshire Stone slab construction, consistent with what we have seen elsewhere on site. We believe this channel would have been the original carrier of the water, but it became derelict and damaged at some stage leading the water to spout out of the surface.

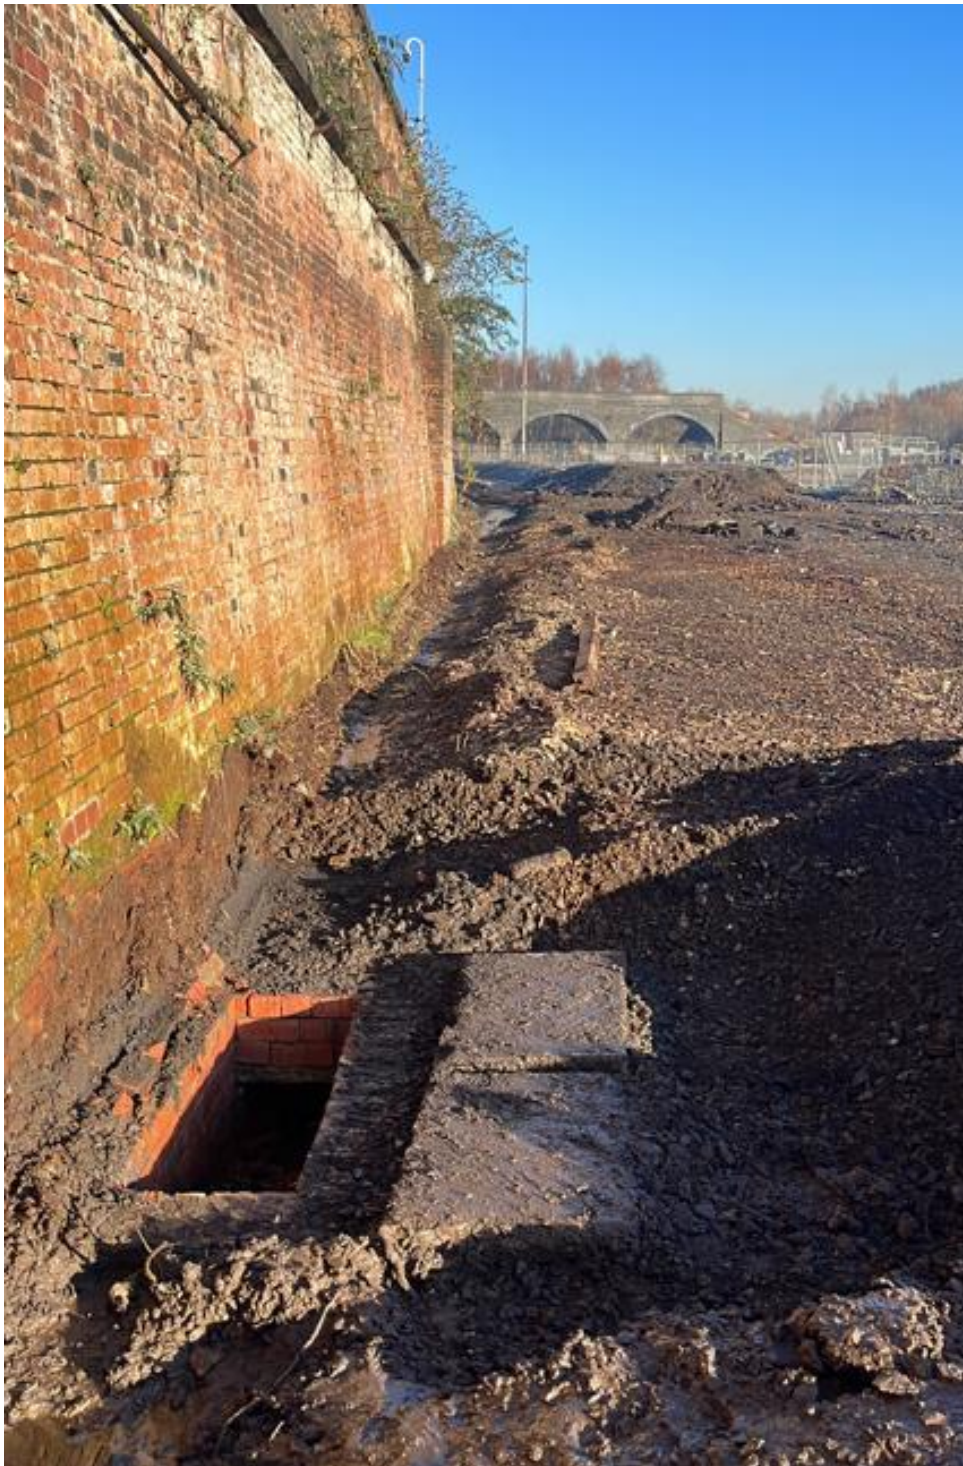
3. From the grate, the underground channel leads to a chamber which has been built on to the combined sewer run which travels across site. We believe the reference number for this on UU drawings is 6605. Upon discovery, this chamber was covered with 2no Yorkshire stone slabs. The invert level in the chamber is 1.5m.

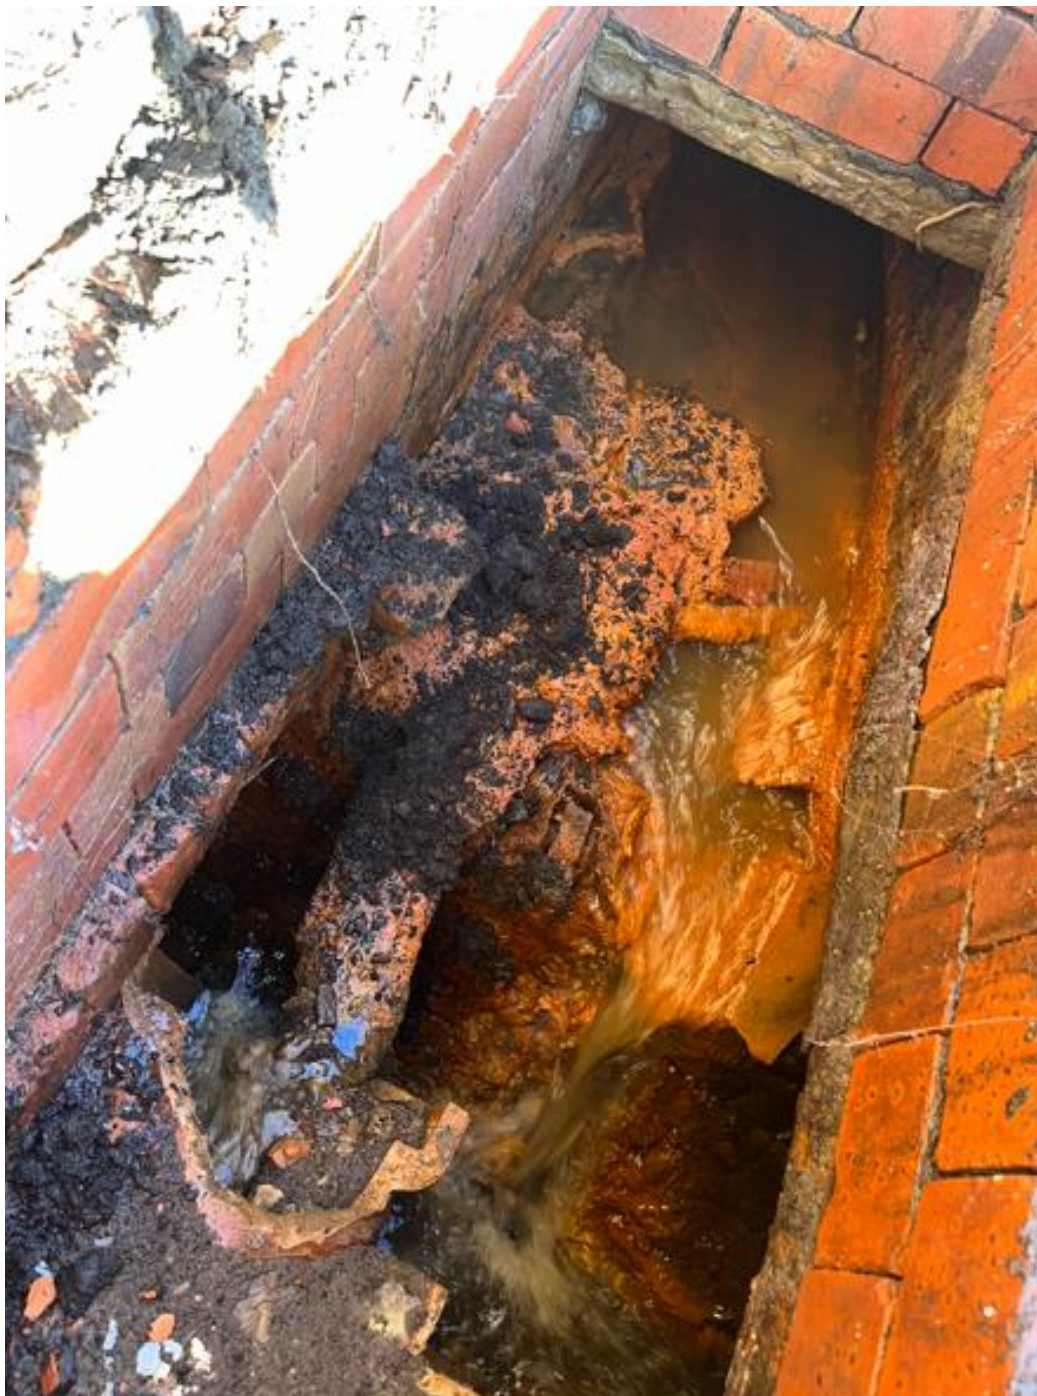
4. This image shows a view of the inside of the chamber. There are 2 ceramic pipes coming in from the South West, and the channel coming in from the North East. We have not investigated these pipes further as they are blocked although one appears to run under Honey Street Wall. The sewer comes from under the wall and is a 700mm round brick construction.

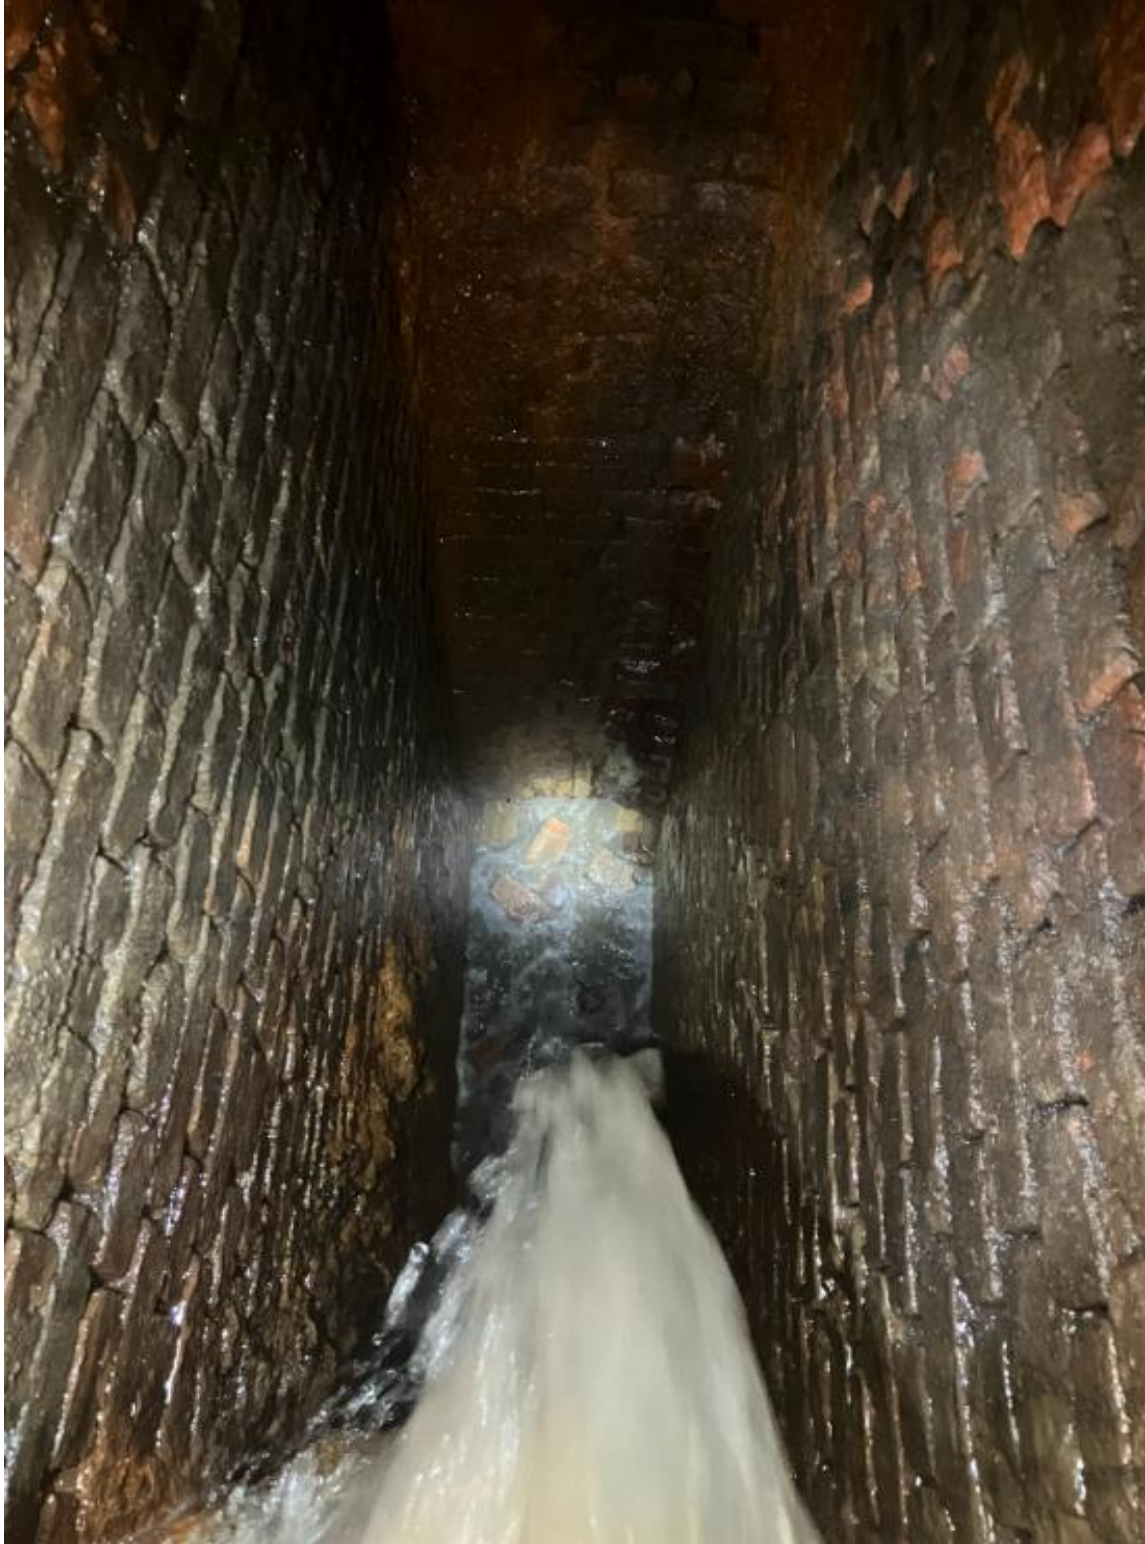
5. Approximately 13m downstream there is a 4m vertical shaft. This shaft does not go up to the surface.

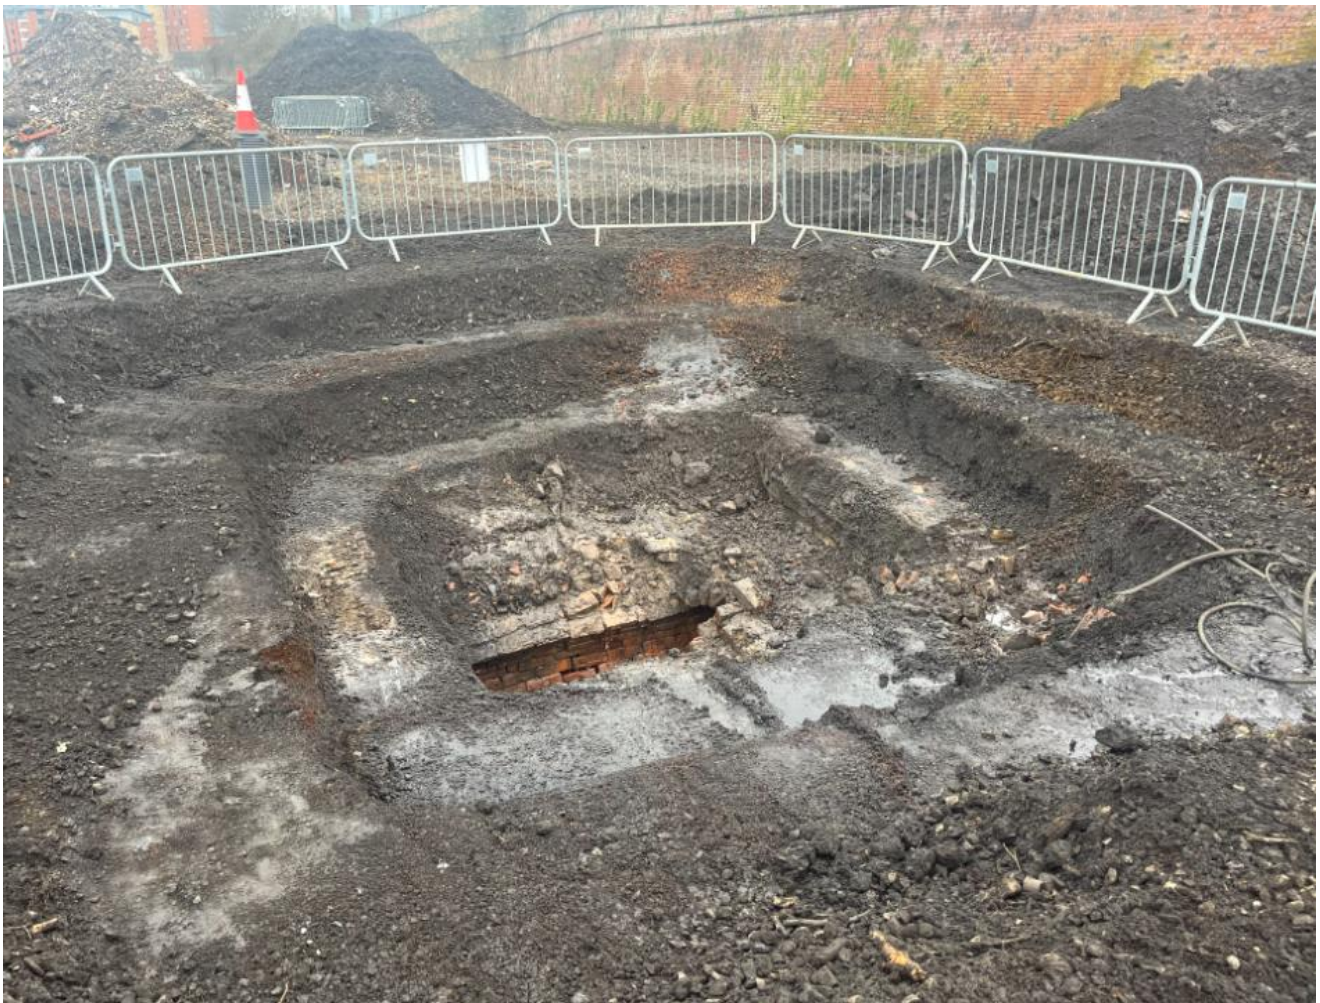
6. This photo shows the sewer from ground level, immediately before the drop shaft. We plan to continue our investigations to identify if there are any clashes between this sewer and the proposed highway and surface water drainage system in this area.

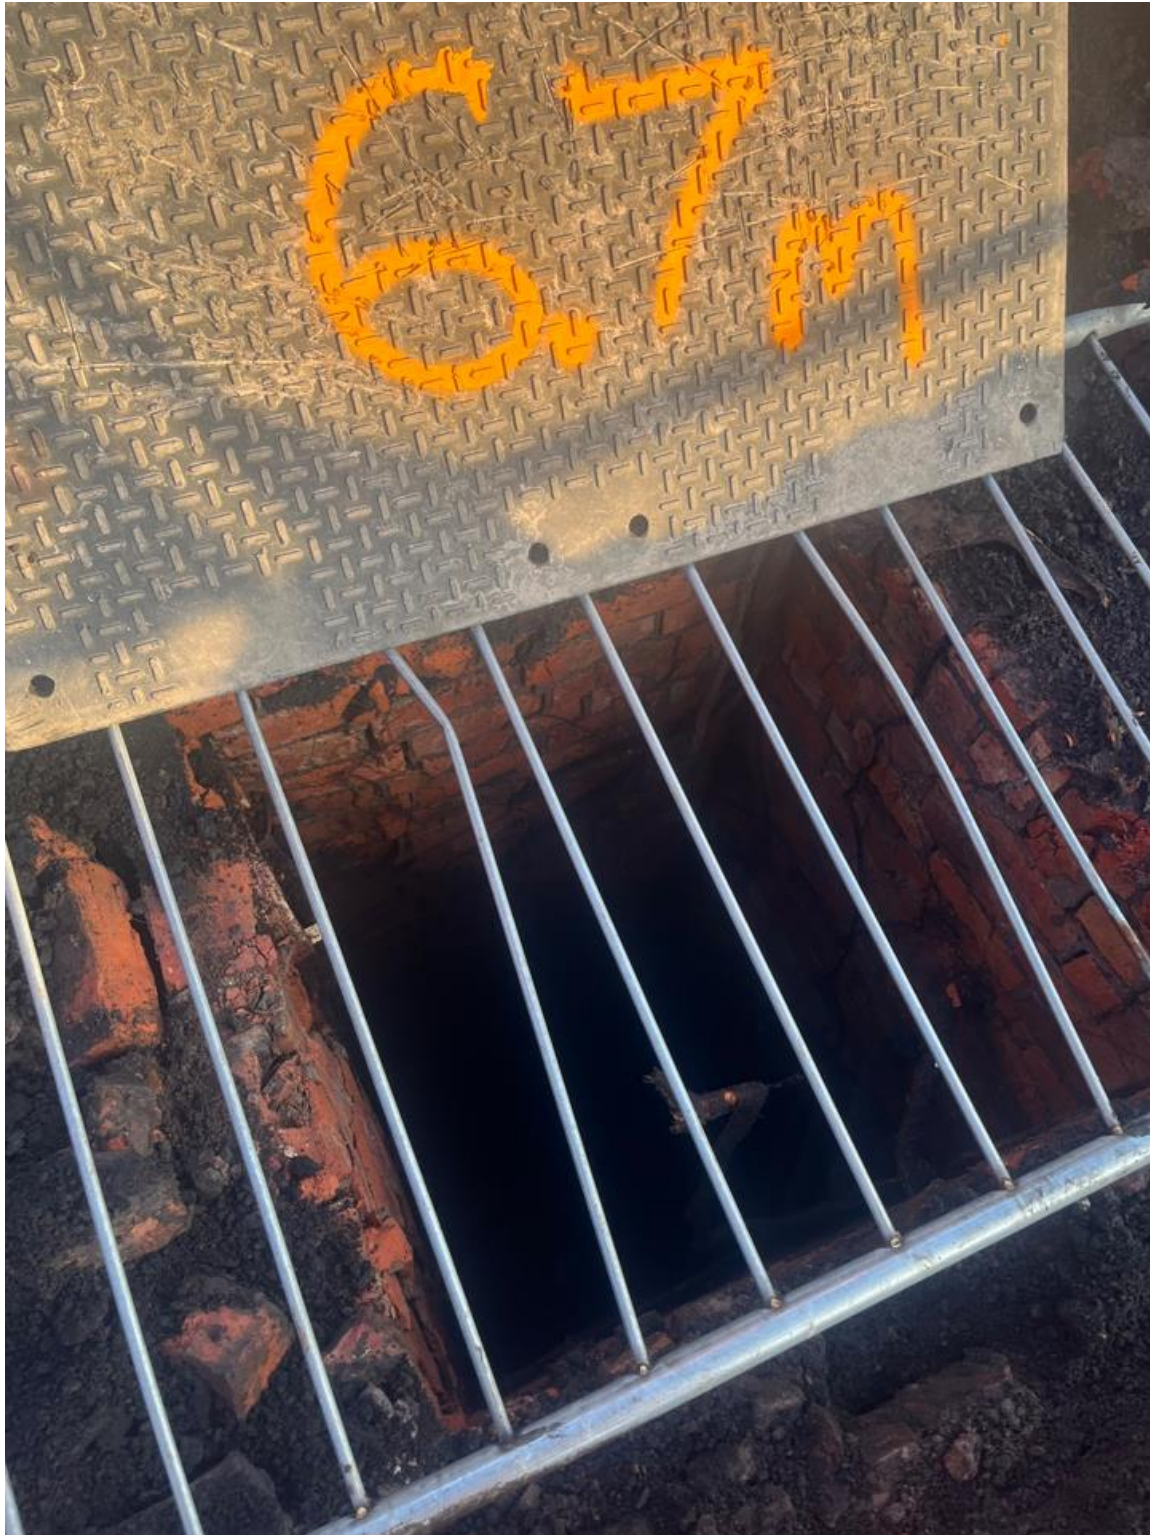
7. A further 11m downstream, there is a chamber that has been buried since we started on site. It is approximately 6.7m deep to invert. This chamber was uncharted on UU records.

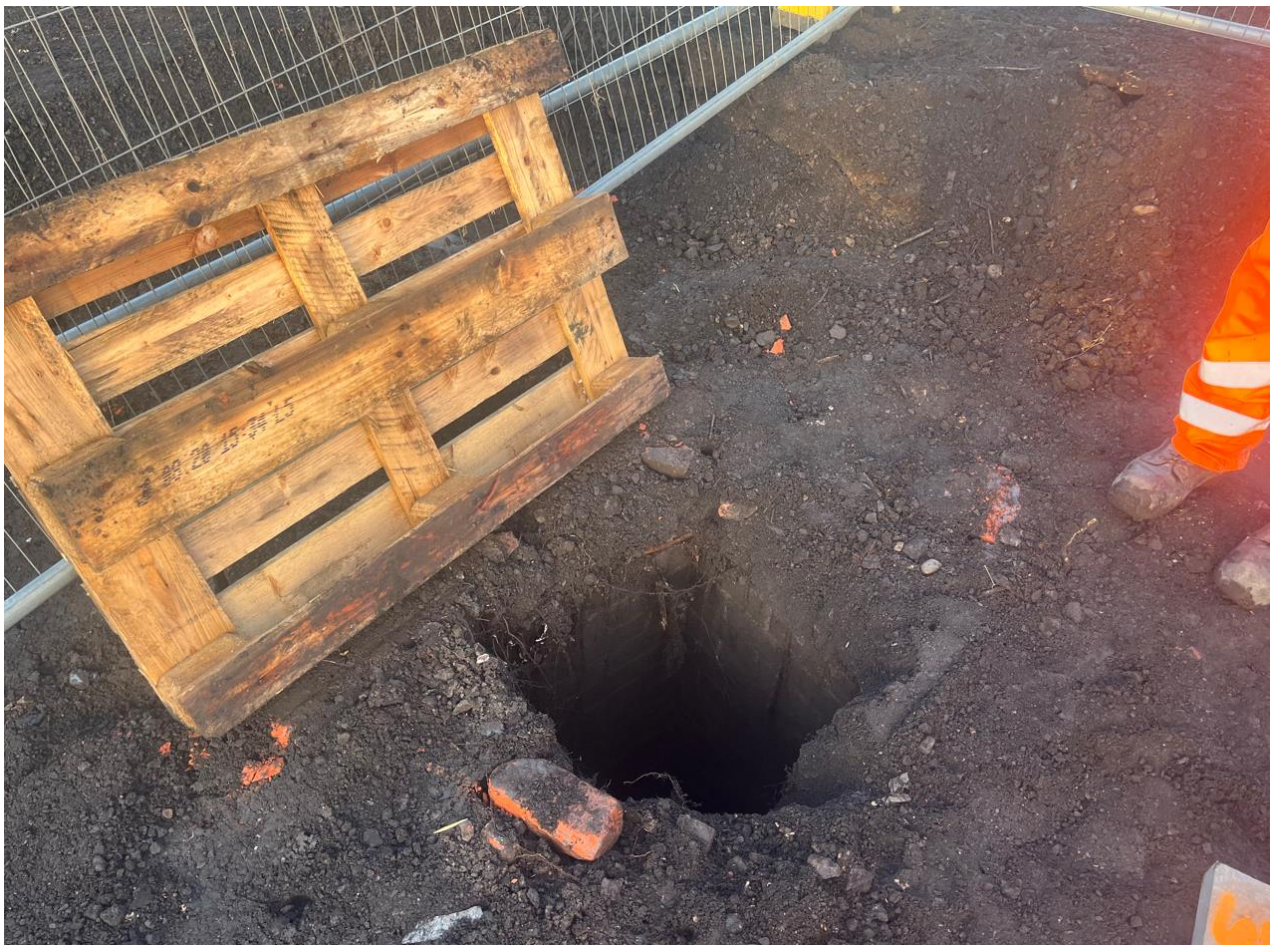
8. A further 35m downstream, there is another chamber which we suspect is UU chamber reference 6602. This chamber is approximately 12m deep. From here, the run continues to the 13m deep manhole at the top of the embankment which is uncharted by UU. It then proceeds to the CSO chamber adjacent to the river and eventually ends up in the sewer in Dantzic Street.
