# GEOSHIELD Verification Report

LOCATION/GRID LINE: Upper Raft Slab - Pour 3

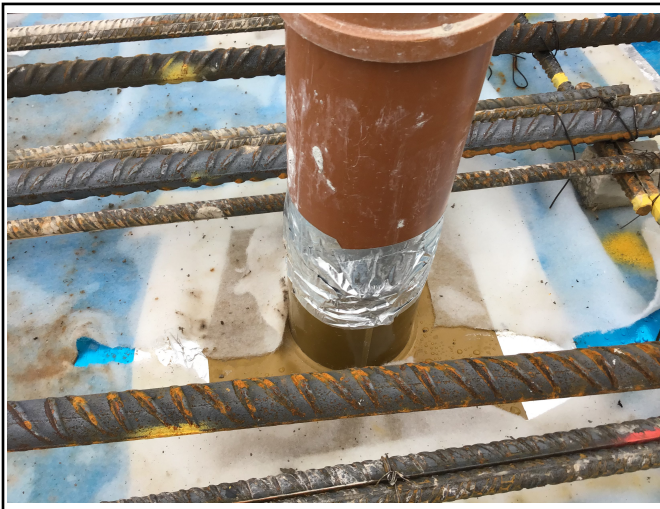
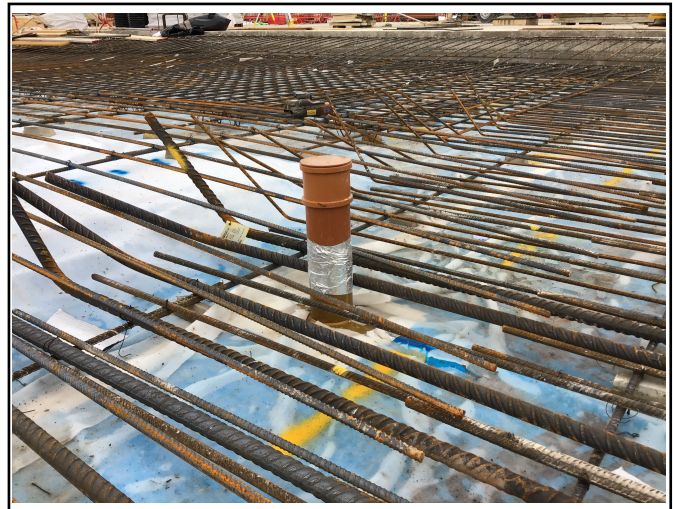
## VERIFICATION ITEM TWO

NOTES: Sealed Pipe Penetrations

The Visqueen Standard Gas Barrier has been cut tight the the pipe penetration and double sided butyl tape has been applied and overlapped in a square around it. A top hat has then been placed over the pipe and sealed to the membrane with the applied

double sided tape. A jubilee clip has then been applied to the neck of the pipe penetration as per design and finished with silver foil tape.

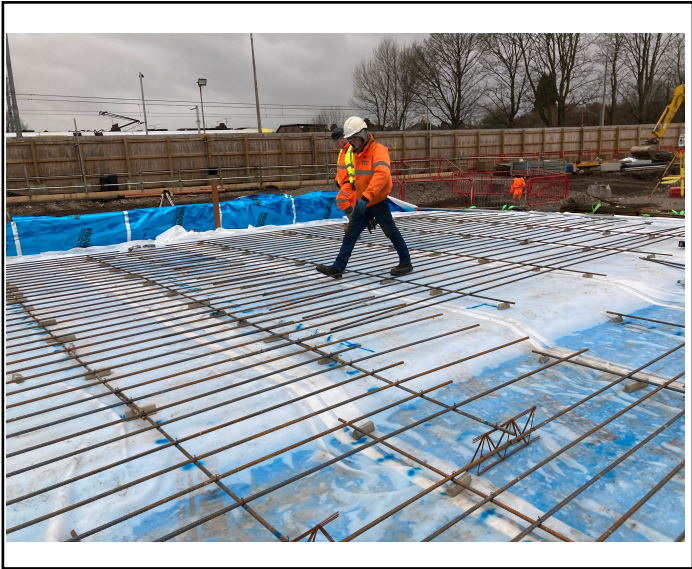
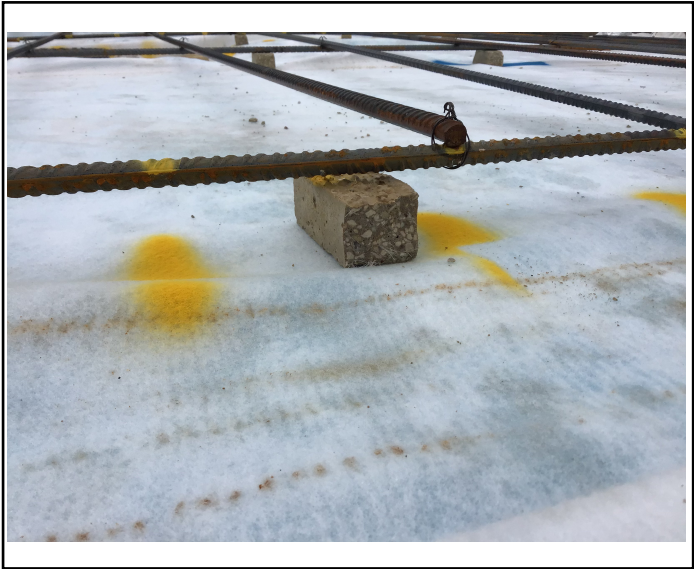
## VERIFICATION ITEM THREE

NOTES: Fleece and Spacer Install

Once the installation of the Visqueen Standard Gas Barrier was complete, a protective fleece was applied. Concrete spacers were then placed onto the fleece before steel rebar was installed. The concrete spacers form a void between the steel

and the fleece, protecting the membrane from potential damage.
