Project: **ORMOND BUILDING,  
MANCHESTER**

EXISTING PLAN ON  
GINNEL BASEMENT

| 078665 - CUR - XX - B1 - DR - S - 0001 | | P02 |

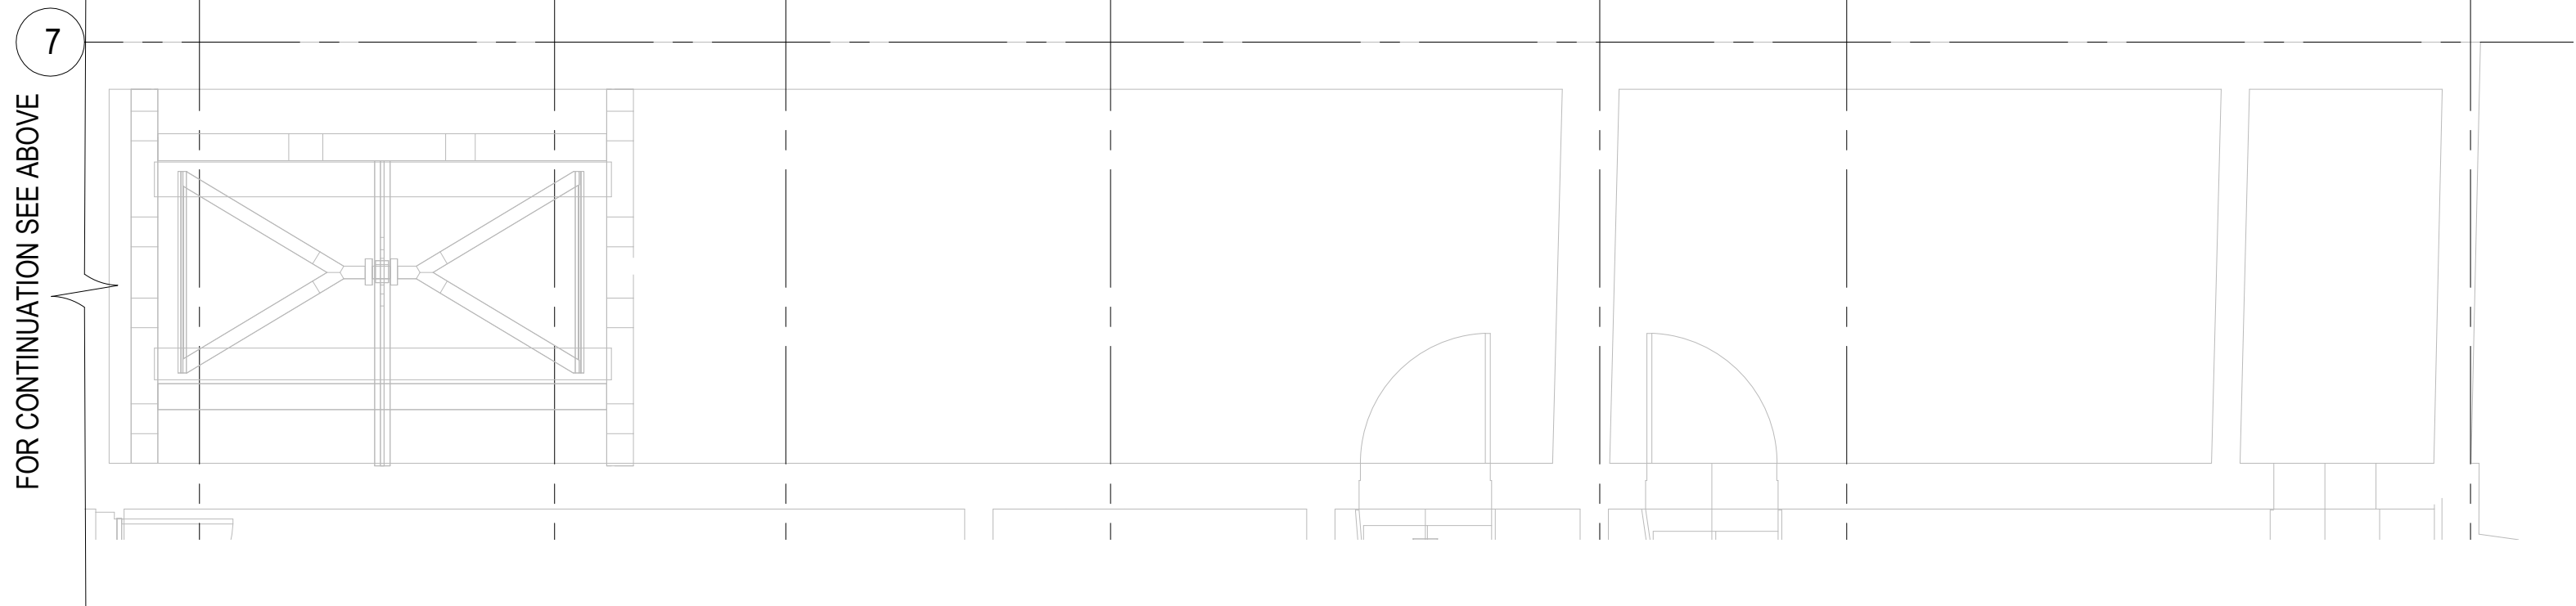
GENERALLY SLAB HAS EXPERIENCED VARYING DEGREES/LEVELS  
OF LOCALISED MINOR DEGRADATION WHICH IS PRIMARILY DUE TO WATER INGRESS EVIDENT DURING VARIOUS  
SITE WALKOVER

- REPAIR OF EXISTING STRUCTURE WILL BE  
REQUIRED. DETAILS OF REPAIR LOCATIONS /  
DETAILS TO BE CONFIRMED FOLLOWING SURVEY  
RESULTS / SOFT STRIP
