# GEOSHIELD Verification Report

## VERIFICATION ITEM ONE

LOCATION/GRID LINE: Upper Raft Slab - Pour 1

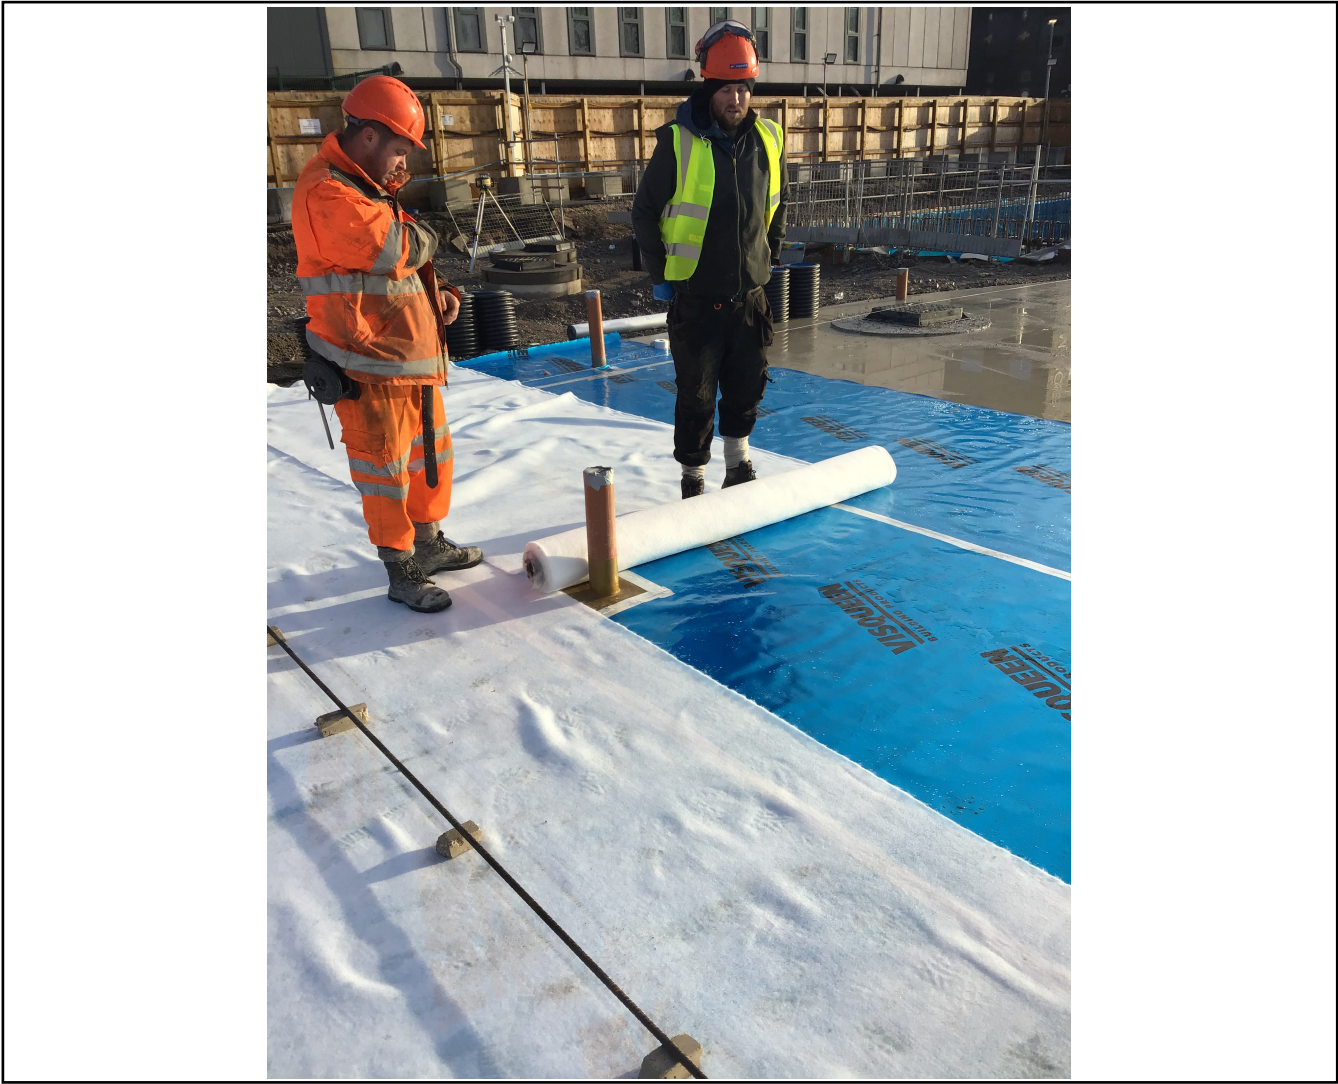
Overview photograph of the area verified during installation

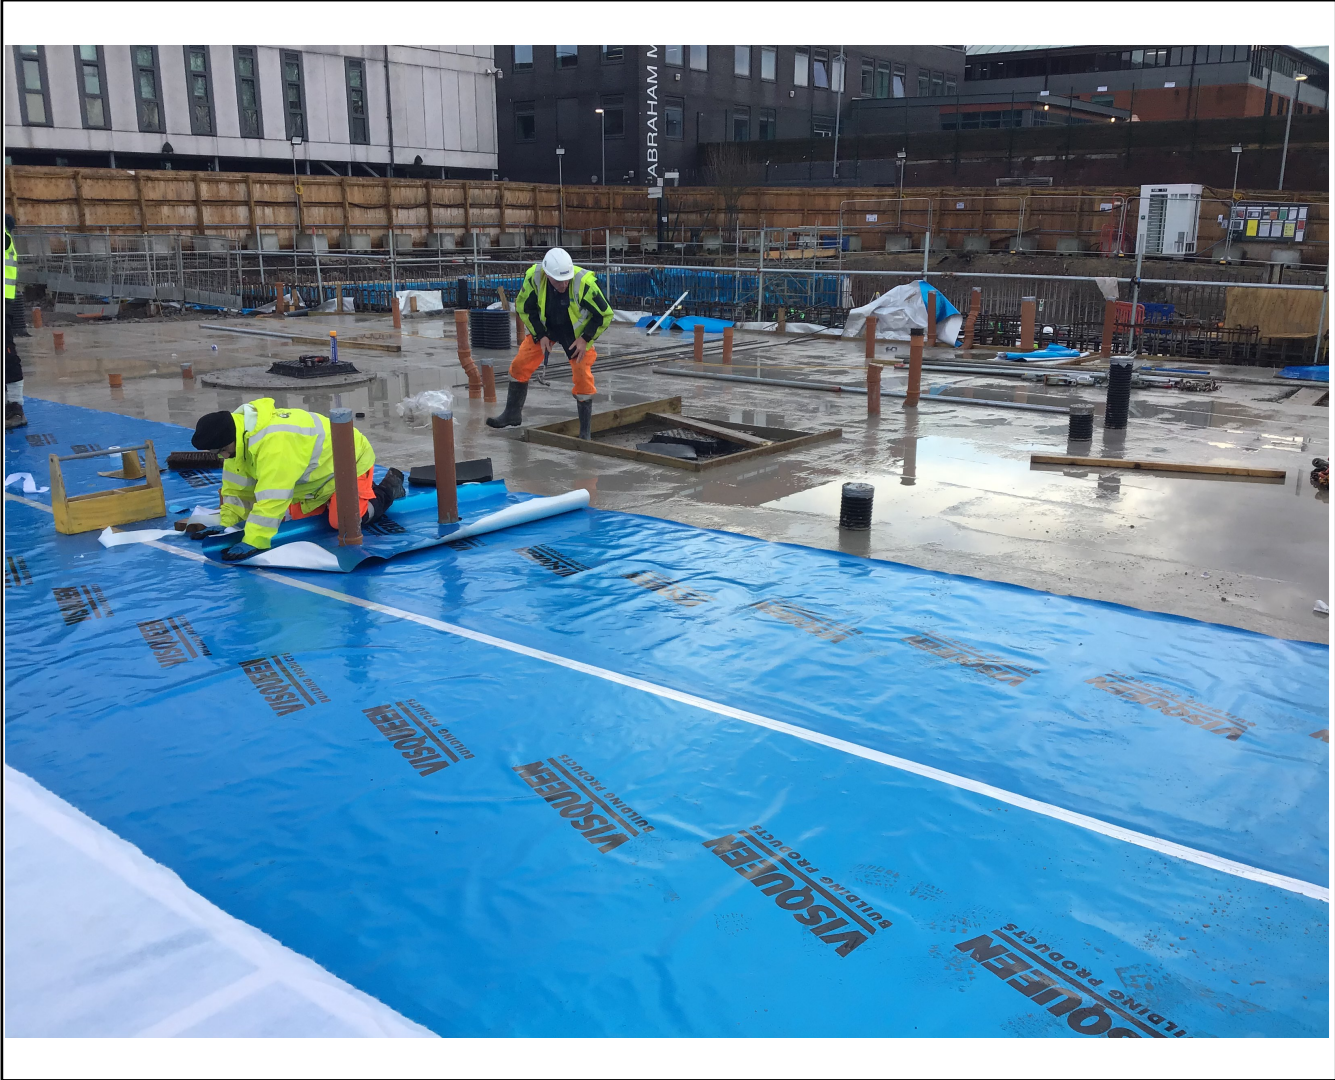
Overview photograph of the area verified during installation

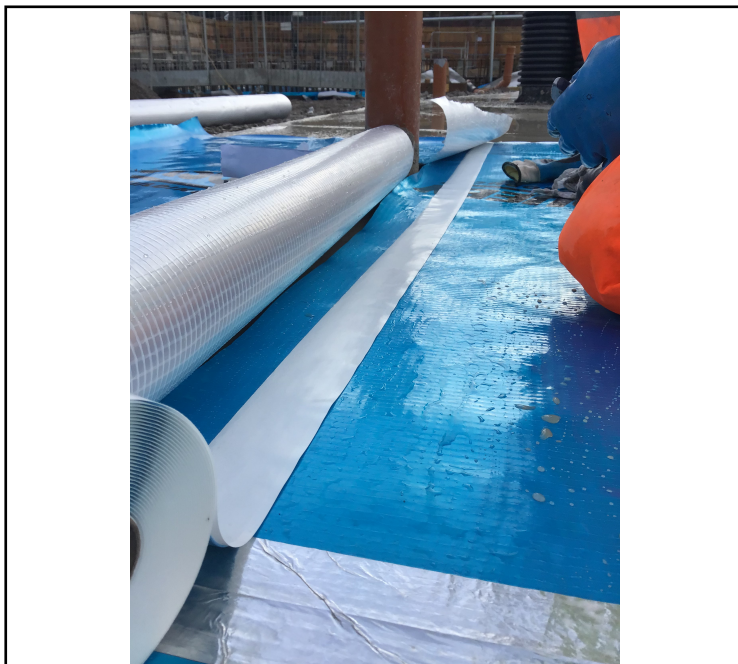
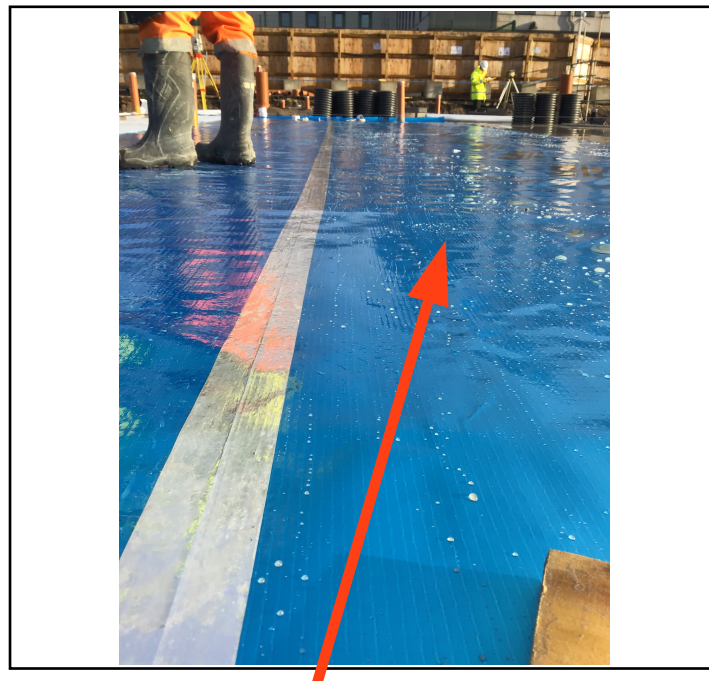
NOTES: Tape Lap Joint

Visqueen Standard Gas Barrier has been installed to the area of the Upper Raft Slab

Pour 1 Overlaps of 100mm minimum have been created which have been sealed using

Visqueen double sided butyl tape, forming a complete and continuous gas barrier.

. The above photos show the application of double sided butyl tape. Visqueen silver foil tape has been used to complete the detail.

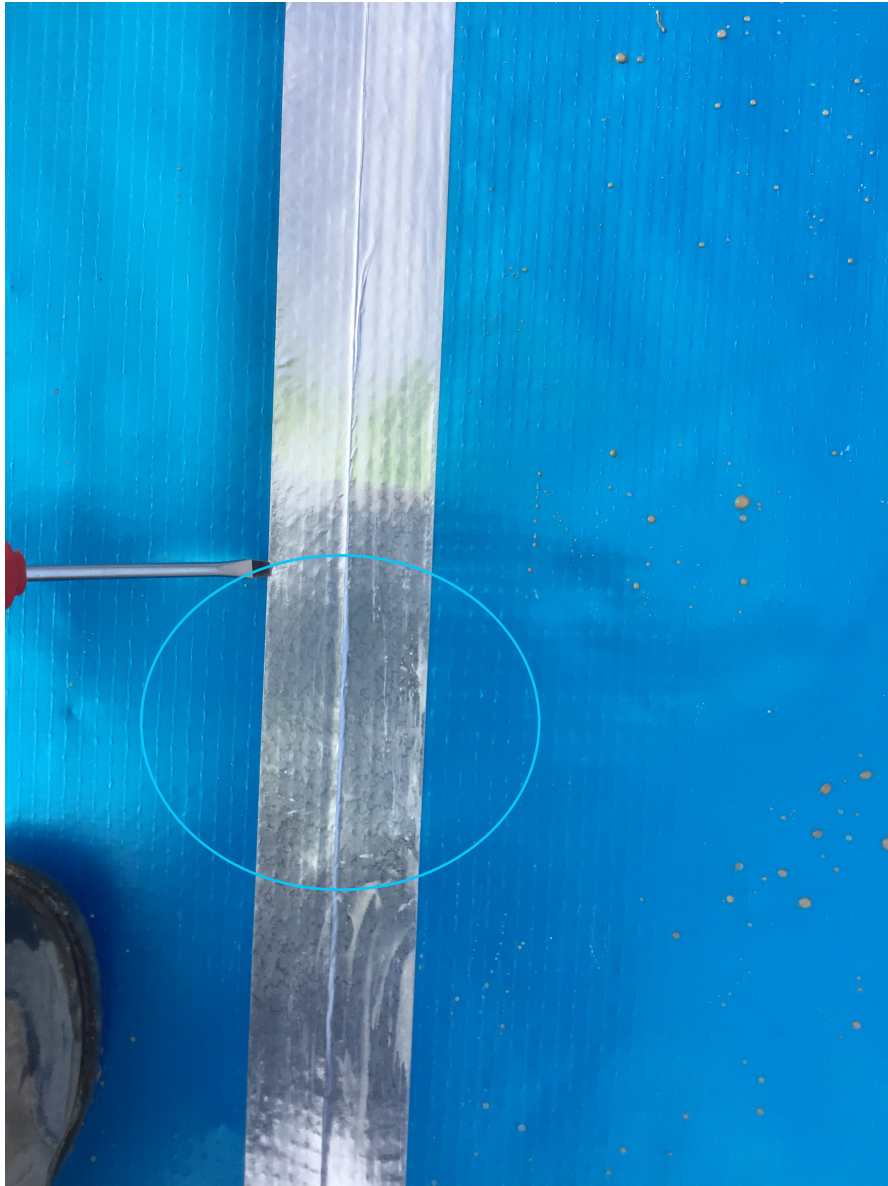
Due to no access air lancing was not conducted however this was replaced by a thorough pick and probe test. Testing returned no faults with the material installed to manufacturers specification and an excellent overall standard.

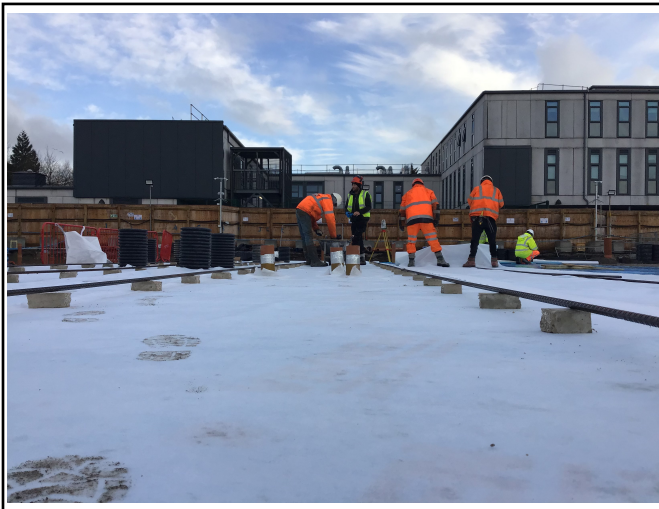
The left photo shows a roll of Protective Fleece used during the installation.

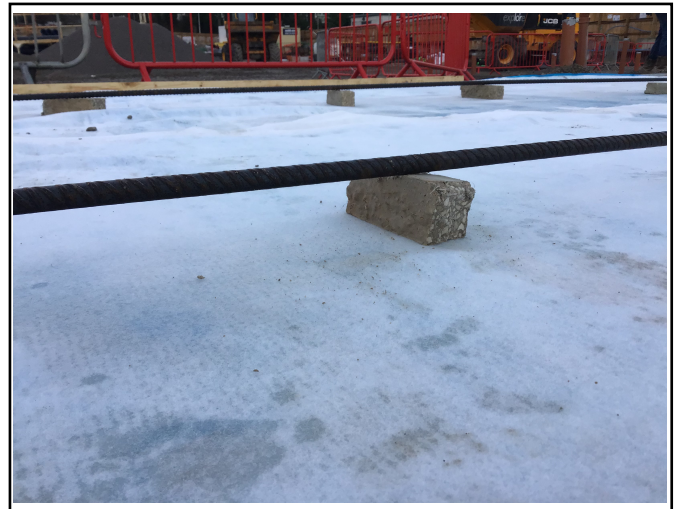
Protective Fleece has been installed to the Visqueen Standard Gas Barrier, this is designed to protect the membrane from follow on trade and UV light damage. This has also been overlapped stopping any areas from being exposed.

The right photo shows the fleece installed protecting the membrane from steel mesh and any other follow on trades.
