job title Abraham Moss Library and Leisure Centre

job no. 1620005164

purpose Site visit to undertake Environmental Watching Brief

The purpose of this technical report is to document the post-demolition ground investigation and to provide an updated site-specific risk assessment, as well as to provide any additional recommendations / requirements which are over and above those already identified within the Ramboll April 2021 Remediation Strategy.

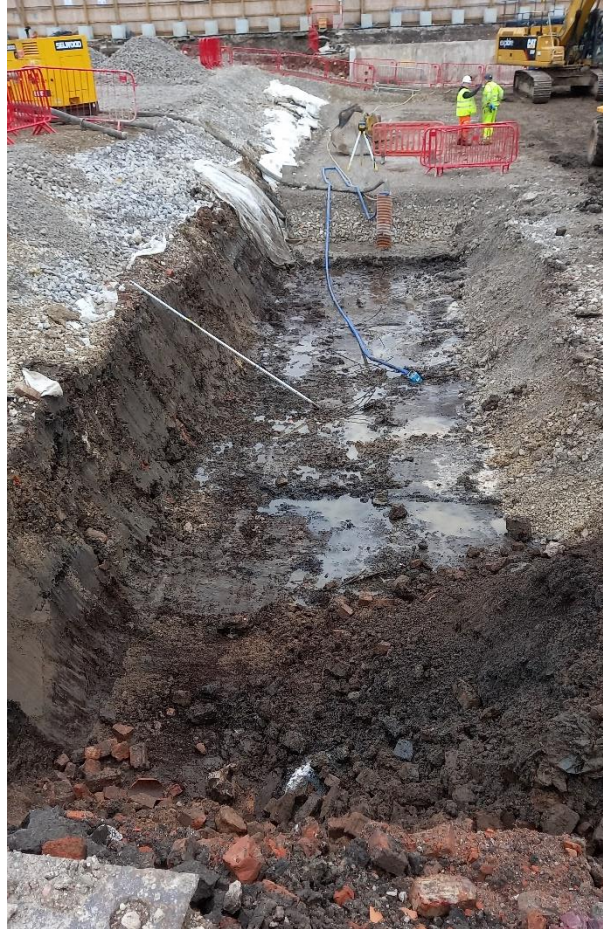
**Photo 43:** Ground conditions beneath the broken out concrete in the south-western basement area. Photograph taken facing the north-east on 09/11/2021.

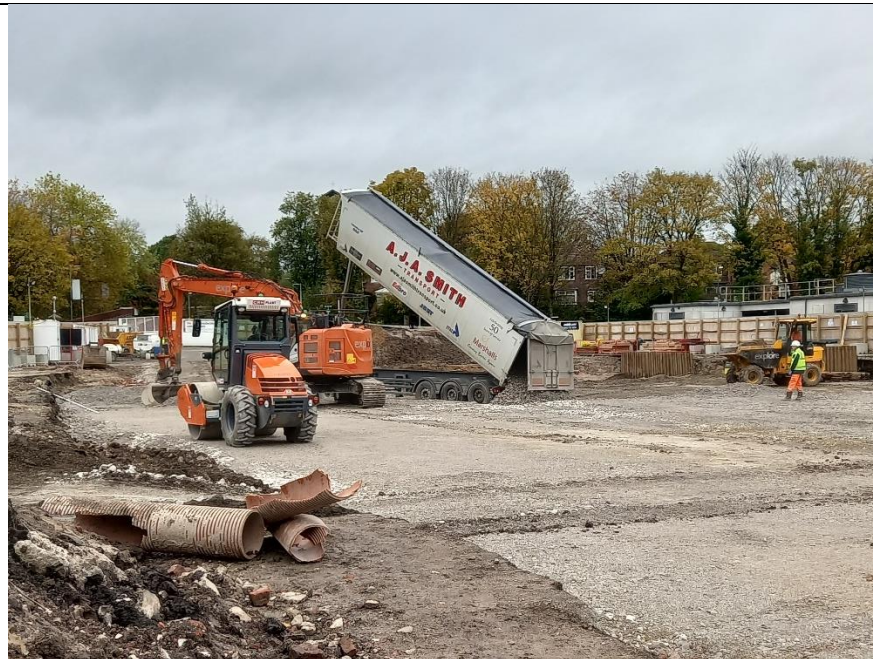
**Photo 44:** Imported materials used in the backfill of the excavations. Photograph taken of the upper raft, facing the north and north-west on 09/11/2021.

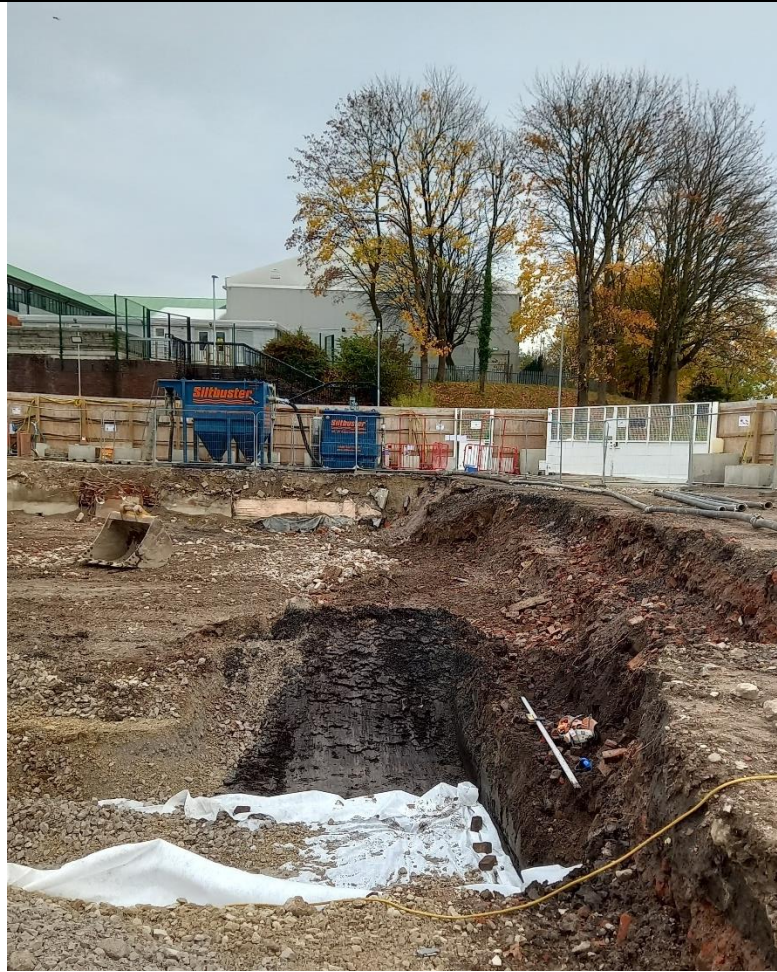
**Photo 45:** Excavation along the southern basement wall. Photograph taken facing the south-east on 09/11/2021.

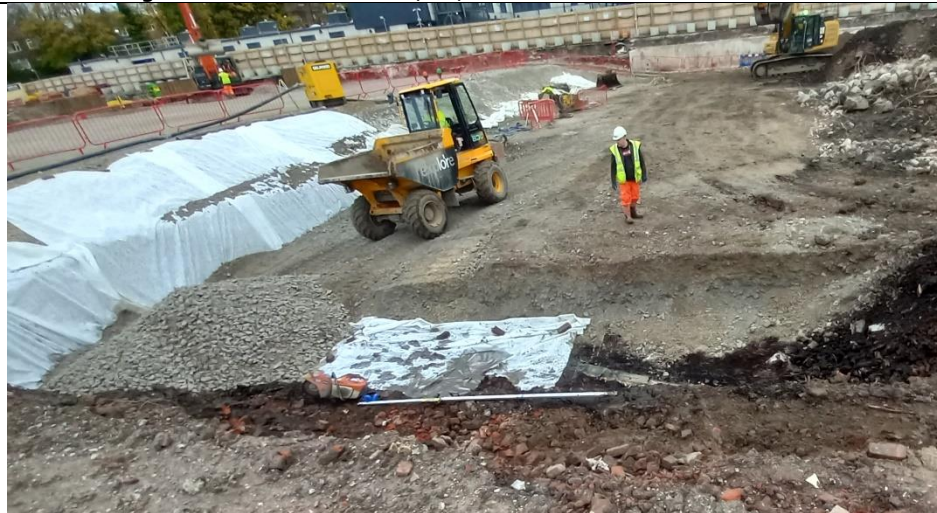
**Photo 46:** Progress photo of the excavation works along the southern basement wall. Photograph taken facing the north / north-east on 09/11/2021.

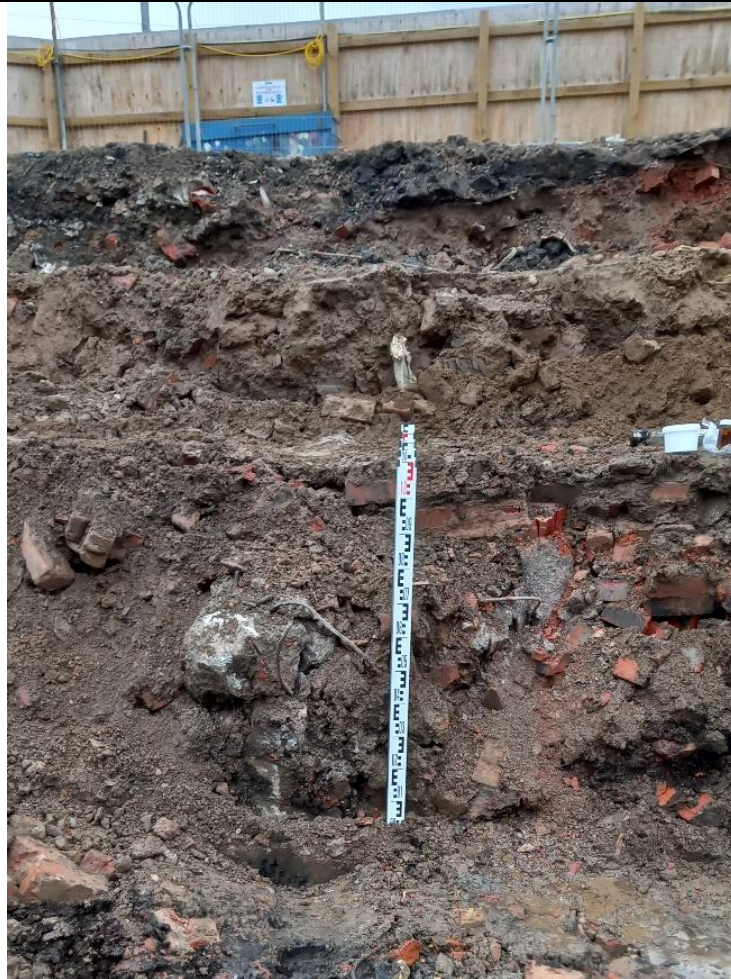
**Photo 47:** Ground condition along the southern basement wall – sample LR03. Photograph taken facing the south on 09/11/2021.

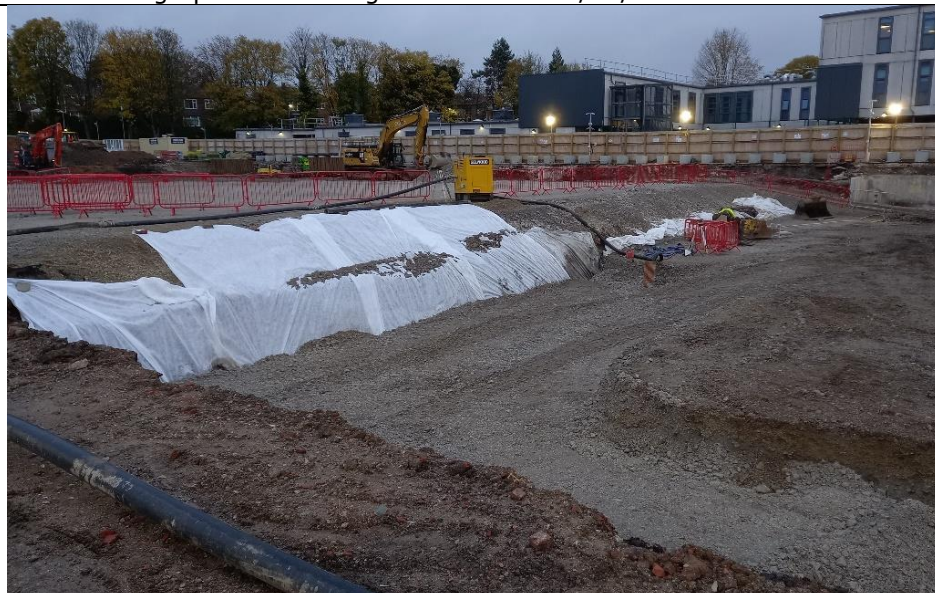
**Photo 48:** View of the backfill in the south-western area of the basement. Photograph taken facing the north on 09/11/2021.

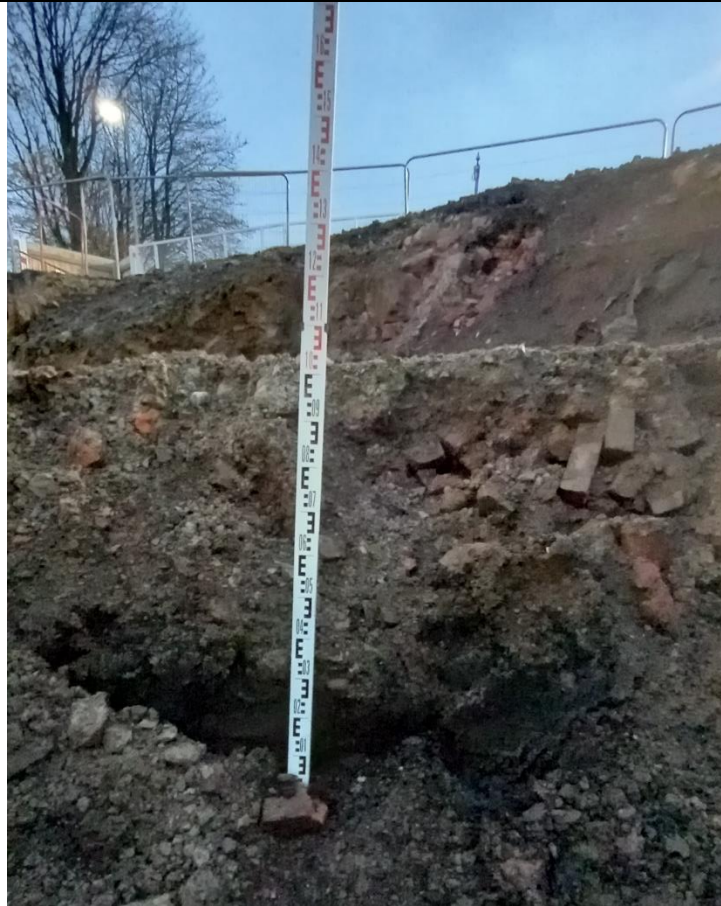
**Photo 49:** Ground conditions along the south of the basement wall. Sample LR04 retrieved from here. Photograph taken on 09/11/2021.

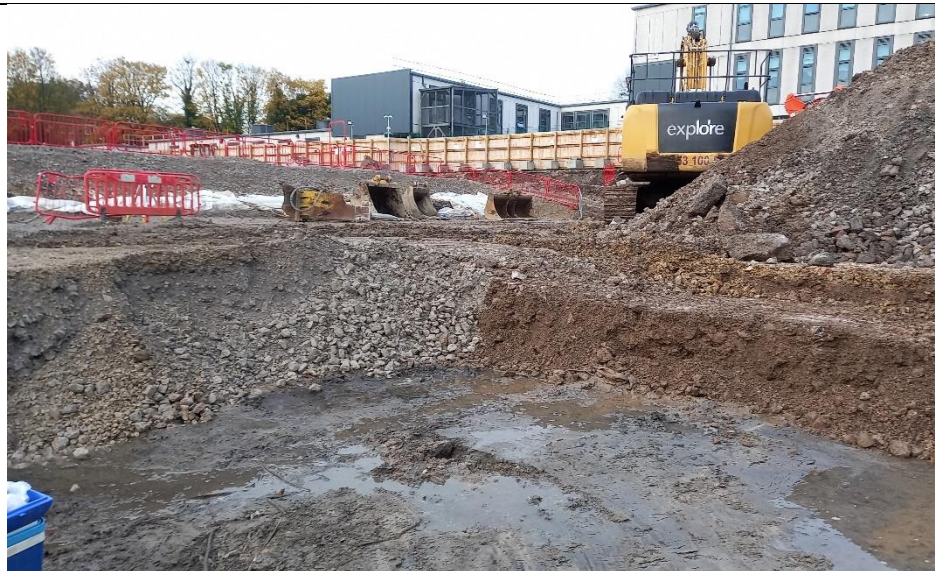
**Photo 50:** The excavated area where the contamination was previously encountered, south of the basement area. Stockpiled material to the right of the photograph. Samples LR05 and LR06 retrieved from base of the excavation. Photograph taken facing the north on 10/11/2021.

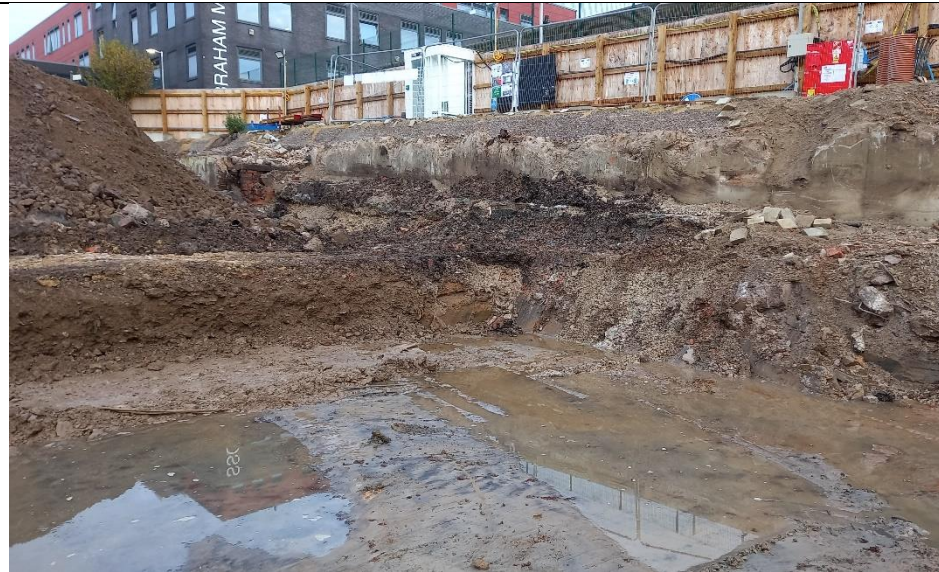
**Photo 51:** View of the excavation towards the eastern basement boundary. Photograph taken facing the north-east on 10/11/2021.

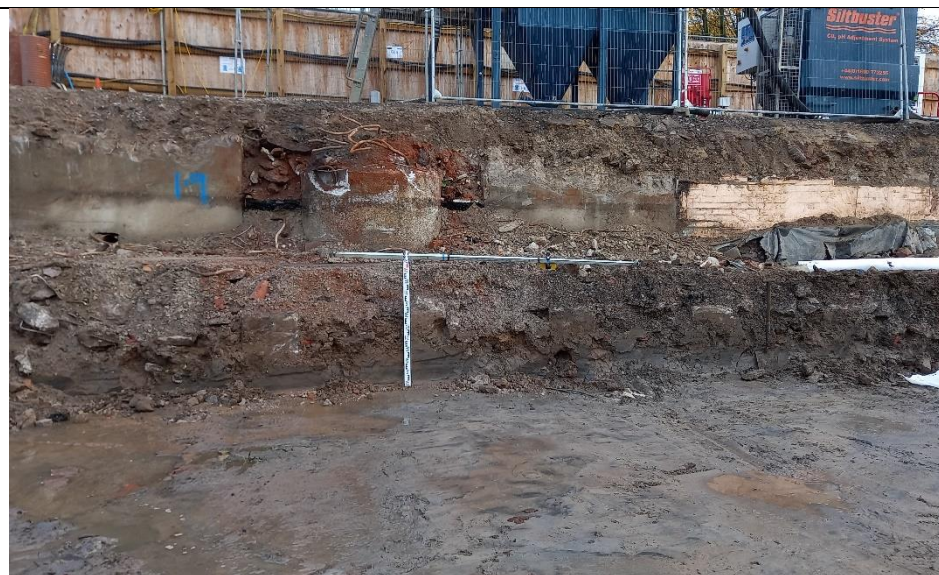
**Photo 52:** View of the excavation towards the south-eastern basement boundary. Measuring staff indicates location of LR07. Photograph taken facing the south-east on 10/11/2021.

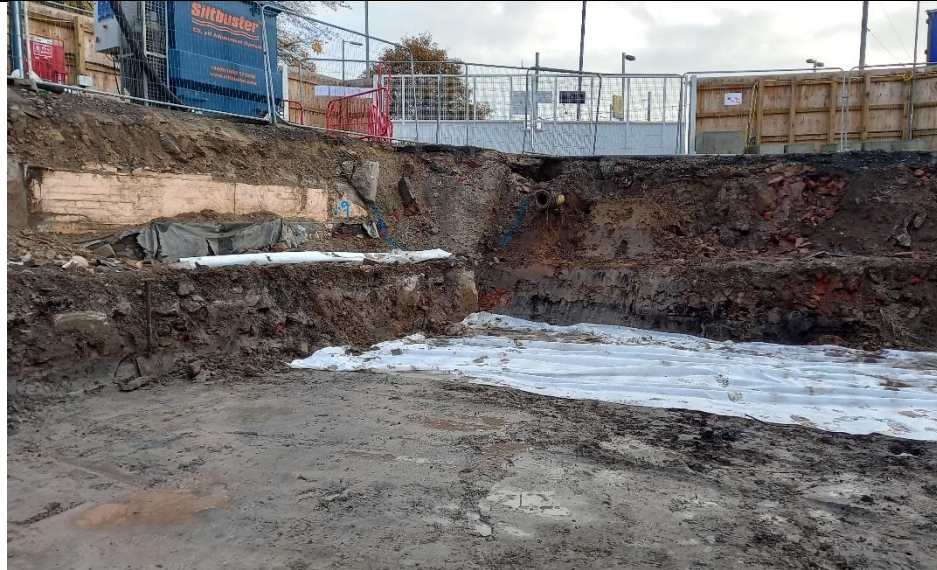
**Photo 53:** View of the excavation towards in the south-eastern corner of the basement boundary. Photograph taken facing the south on 10/11/2021.

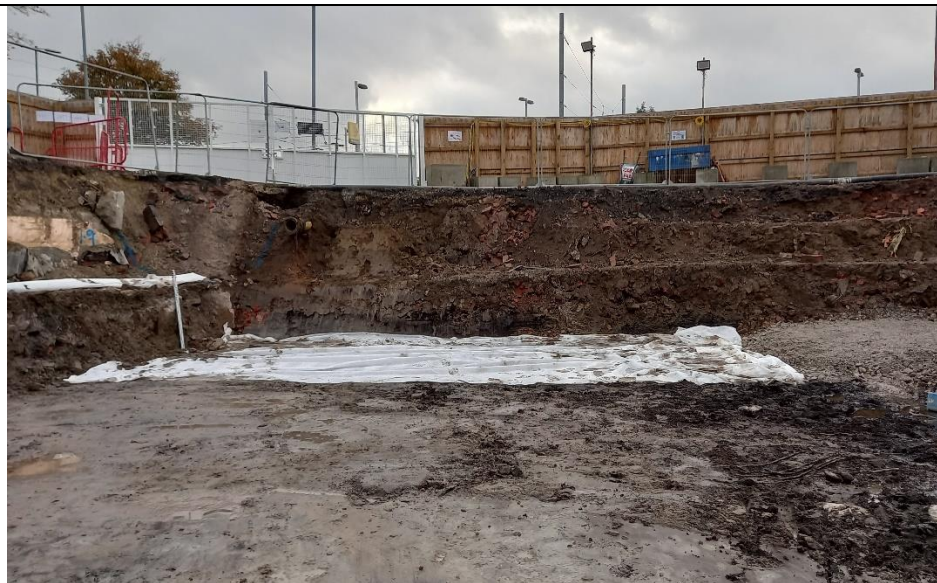
**Photo 54:** View of the excavation along the southern basement boundary. Measuring staff marks location of sample LR08. Photograph taken facing the south on 10/11/2021.

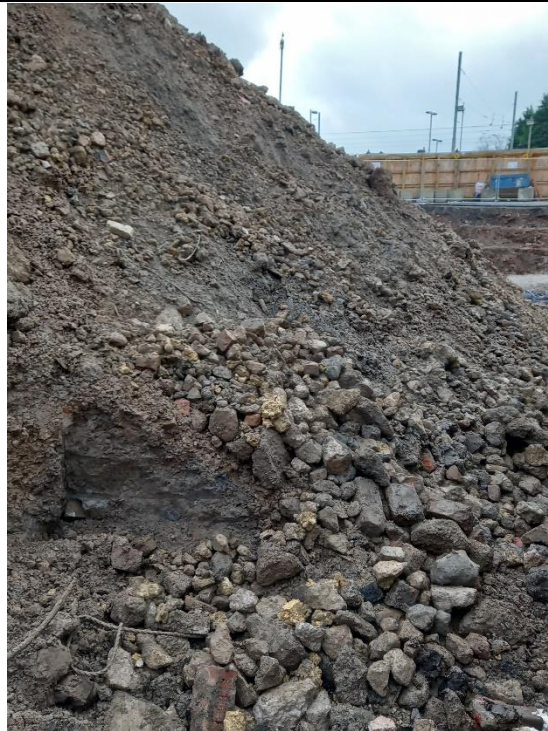
**Photo 55:** View of the excavated material from the southern-eastern basement area. Photograph taken on 10/11/2021.

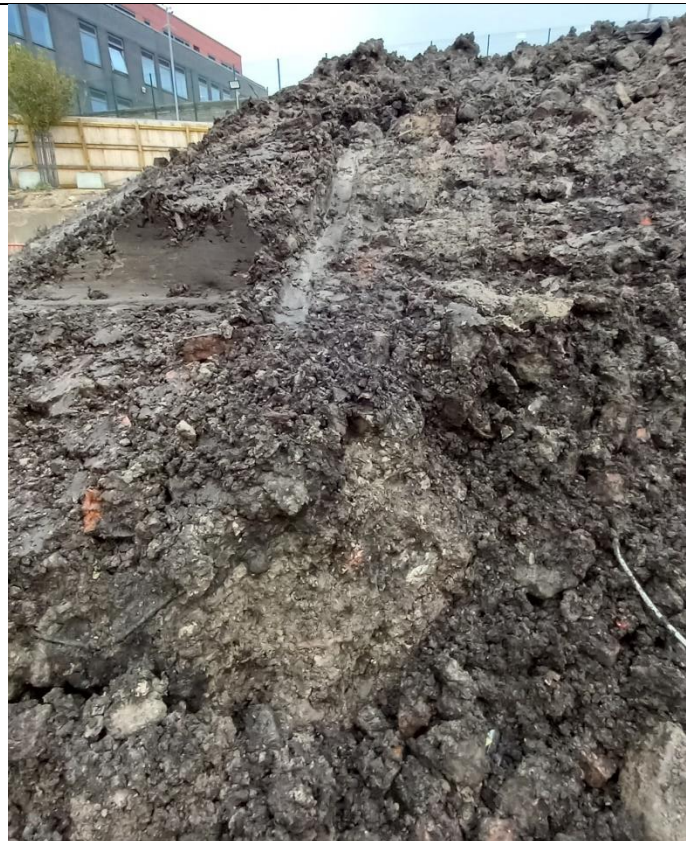
**Photo 56:** View of the excavated material from the southern-eastern basement area. Photograph taken on 10/11/2021.

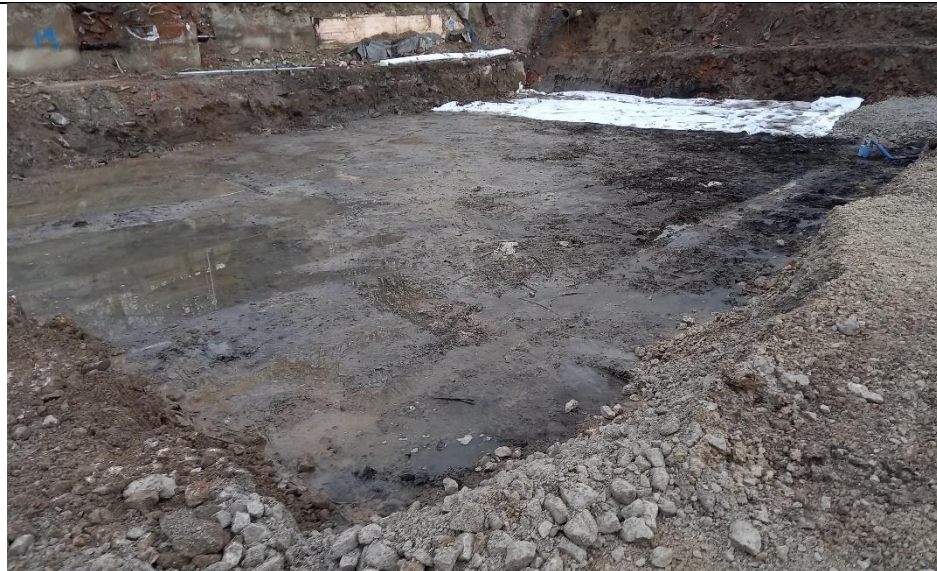
**Photo 58:** View of the excavated area in the south-east of the basement prior to backfill. Photograph taken facing the south on 10/11/2021.

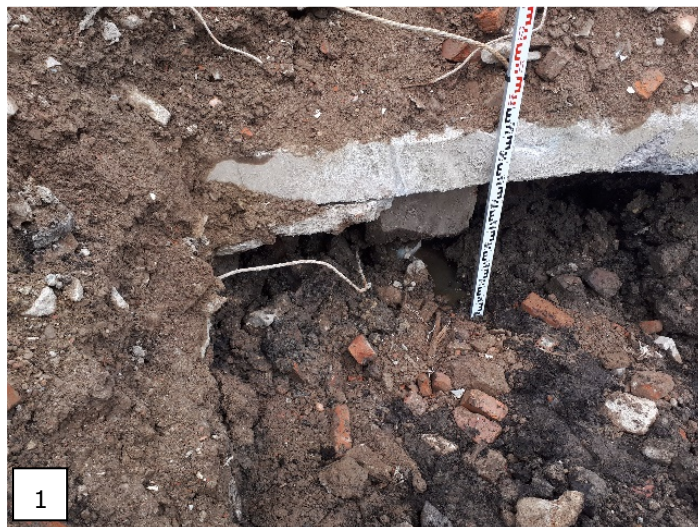
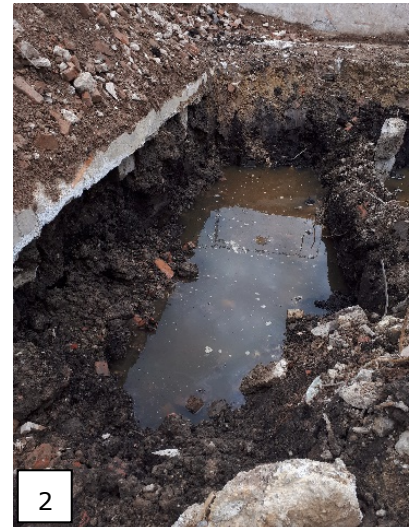
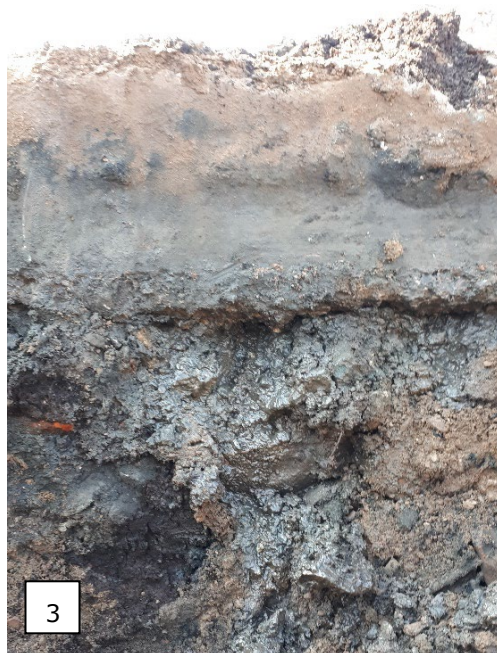
During the additional site visit in September, an area was excavated directly across from LR01/LR02. Sample VS17 (see Photographs 3 and 4 overleaf), which is directly north-east of the aforementioned suspected impact, was noted to have olfactory evidence of potential hydrocarbon impact and a PID reading of 67.3ppm. PID reading of 1.3ppm was recorded beneath the suspected impact at 0.6m. Further north-east of VS17, soils were recorded with faint hydrocarbon odour and PID of 33.4ppm in VS14 at 0.50mbgl (within the same material as impacted soils).

**Photographs 1 to 4:** **Photograph 1:** Sample Location LR01 and 02 showing foundation slab; **Photograph 2:** showing excavation alongside impact (no contamination identified); **Photograph 3:** View of the VS17 soils and **Photograph 4:** Location of VS17 in relation to LR01/LR02.
